Corrosion-Fatigue Failure of Gas-Turbine Blades in an Oil and Gas Production Plant

Abstract: This paper investigates the root cause of a failure in gas-turbine blades, made of Nimonic-105 nickel-based superalloy. The failure was reported in two blades in the second stage of a turbine-compressor of a gas turbine in the hot section. Two failed blades were broken from the root and from the airfoil. The failure took place after 20 k h of service exposure in the temperature range 700–850 °C, with the rotating speed being in the range 15,000–16,000 rpm. The microstructures of the failed blades were studied using optical/electron microscopes. Energy dispersive X-ray spectroscopy (EDS) was employed for phase identification. Results showed that failure first initiated from the root. The dominant failure mechanism in the root was concluded to be corrosion-fatigue. The failure scenario was suggested based on the results obtained.

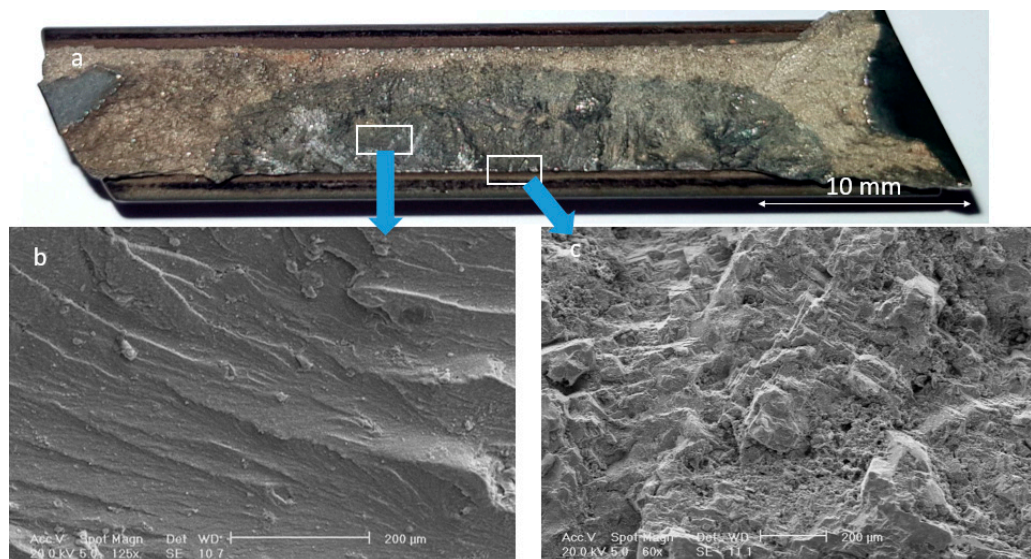
Figure 3 shows stereomicroscope and SEM micrographs of the fracture surface from the blade that failed from the root. As shown in Figure 3a, the fracture surface has two areas: the dominant grayish area and the rest of the surface. This is a typical fracture surface when fatigue is the governing damage mechanism. Figure 3b,c show SEM micrographs of two areas, highlighted in Figure 3a. The former image (Figure 3b) shows typical beach marks, indicating that fatigue is an active mechanism. Further down to the edge, there is a clear change in the fracture surface (Figure 3c). The surface at the edge of the failed blade is covered with some deposits, which were analyzed by EDS. Results of EDS analysis of the microstructure at the edge (presented in Figure 4) showed that surface deposits are rich in Cl, K, Na, and Ca. This, together with the fact that there is a high concentration of oxygen in the analysis, indicates that these deposits are in fact corrosion products. It is highly likely that the aforementioned elements come from the fuel/gas.

Figure 3. (a) Stereomicroscope and (b,c) scanning electron microscope (SEM) micrographs of the fracture surface of the blade, failed from the root.

From the results obtained, it can be concluded that the failure in the blade, broken from the root, was controlled by the simultaneous activation of corrosion and fatigue. Corrosion-fatigue is a common degradation mechanism in moving components exposed to high-temperature harsh working conditions [21]. Corrosion fatigue essentially takes place under the synergistic activation of corrosion and dynamic loading. This degradation mechanism is one of the most common reasons for the failure of turbine blades [22]. Corrosion fatigue is undoubtedly one of the most complex failure mechanisms. Both mechanical and chemical aspects of failure in this case are equally important. Any mitigation measure to avoid this failure necessitates a multi-disciplinary approach. Corrosion-fatigue failure of the blade root in this case has possibly originated from corrosion pits/products deposited at the root/airfoil interface. The results showed that corrosion products/deposits in this case mostly contained CaO, Na₂O, KCl, and NaCl. The sensitivity of turbine blades to corrosion-fatigue initiation largely depends on the integrity of the passive film on the surface [22]. The breakdown of this passive film

together with the deposition of oxide/corrosion deposits create an ideal condition for corrosion-fatigue crack initiation. The film breakdown and deposition of corrosion products causes anodic/cathodic sites, leading to an accelerated localized anodic dissolution reaction and, hence, localized corrosion [23]. The formation of corrosion-induced surface irregularities creates stress riser centers on the surface [24]. In case these surface irregularities exceed a critical size, a fatigue crack is likely to initiate. The crack then propagates under dynamic loading condition, finally leading the failure of the turbine blade.

- Given that both corrosion and fatigue mechanisms were involved in this failure, it is important to minimize mechanical vibrations and to reduce contaminants in the system. The latter necessitates further investigation on the origins of the Cl, Na, and Ca-containing residues and how they can be controlled/eliminated from the system.
