The Restoration of the Exterior

Colour, Form and Space

1 / THE RESTORATION OF THE EXTERIOR

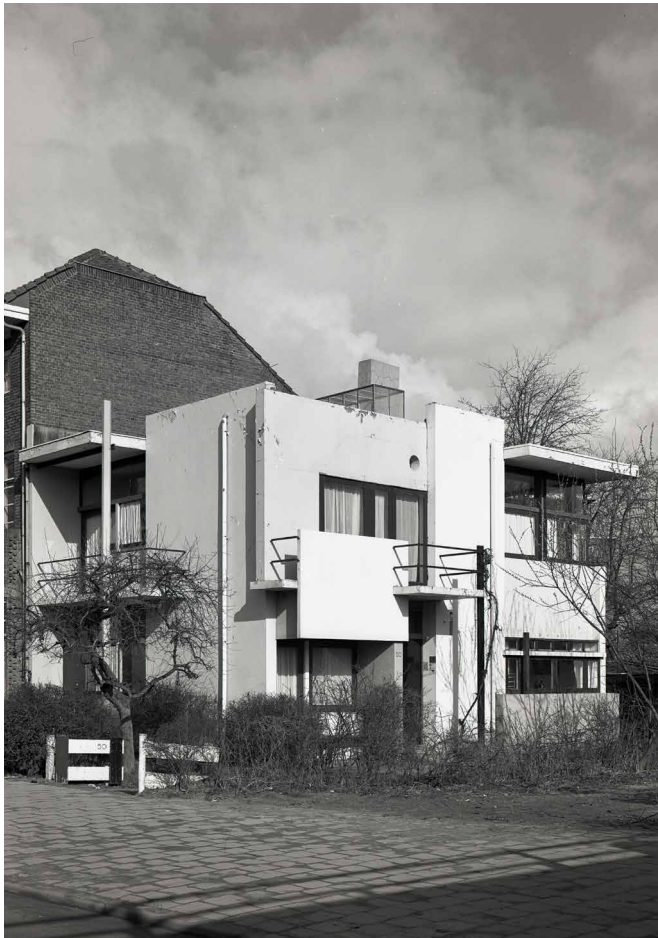
FIG. 1.1 In the beginning of the 1970s the state of repair of the Schröder House left a lot to be desired

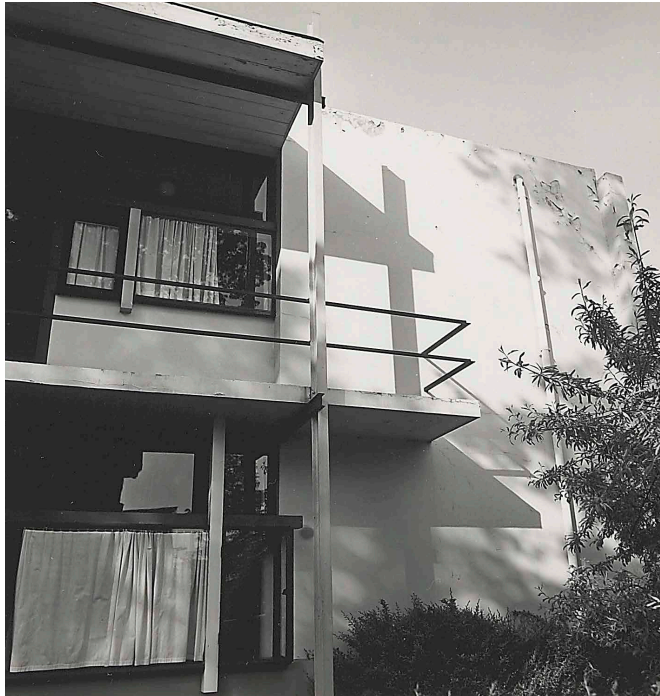
FIG. 1.2 Damage to the house became increasingly visible

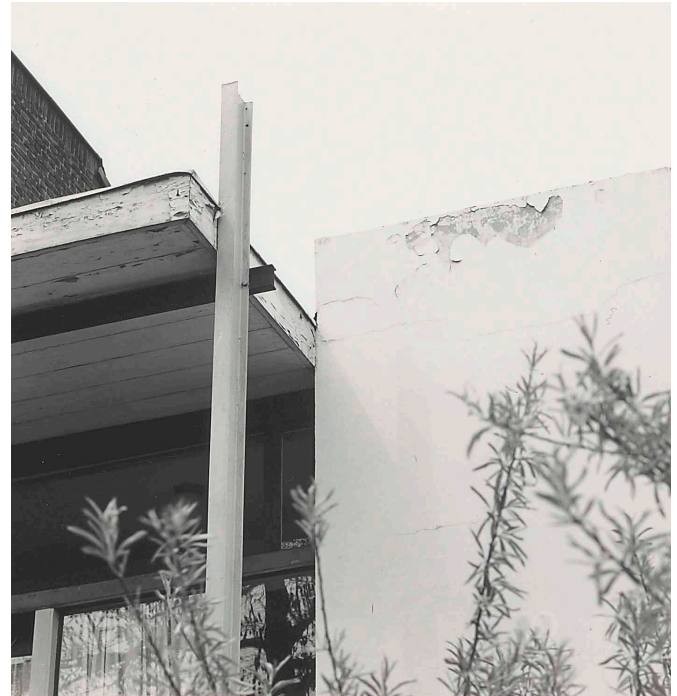
FIG. 1.3 Plasterwork and wood exhibited serious blemishes

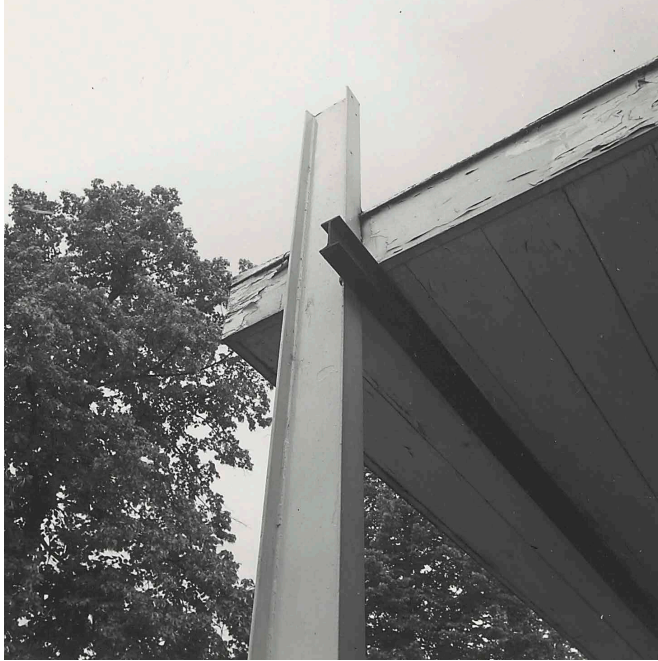
FIG. 1.4 Unconventional constructions made the house vulnerable

This was mainly because Rietveld considered the spatial effect and associated appearance, and the optical effect, more important than a stable and sound construction [FIG. 1.4]. This had resulted in unusual combinations of traditional and modern materials (and their properties) and techniques which, after the passage of so many years had started to exhibit all manner of defects. For example, the way the steel beams had been tailed into the (single-skin) brickwork had led, through the action of moisture, to rust and hence to cracks in both brickwork and plaster. At Rietveld's insistence, the concrete slabs used for the balconies had to be very thin so that here, too, moisture had been able to corrode the steel edges, which had started to rust, and the concrete had begun to display cracks [FIG. 1.5].

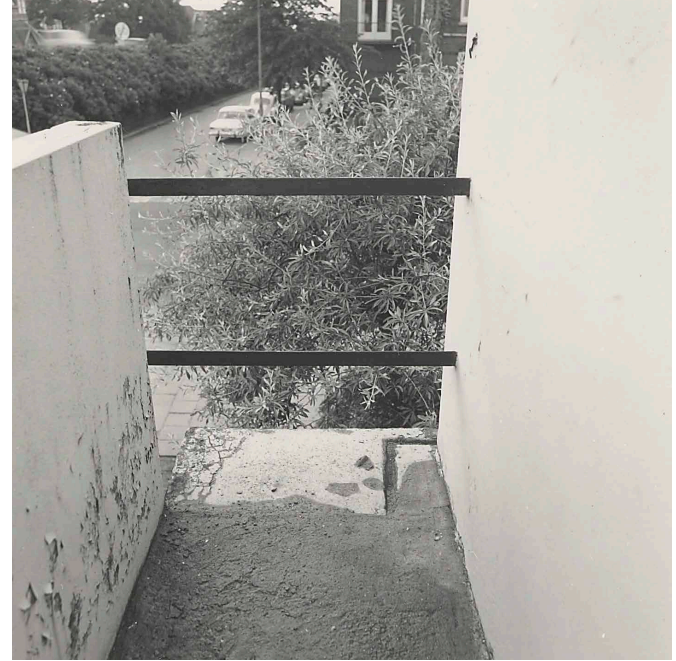
FIG. 1.5 After 50 years the concrete of the balconies also showed signs of cracks and damage

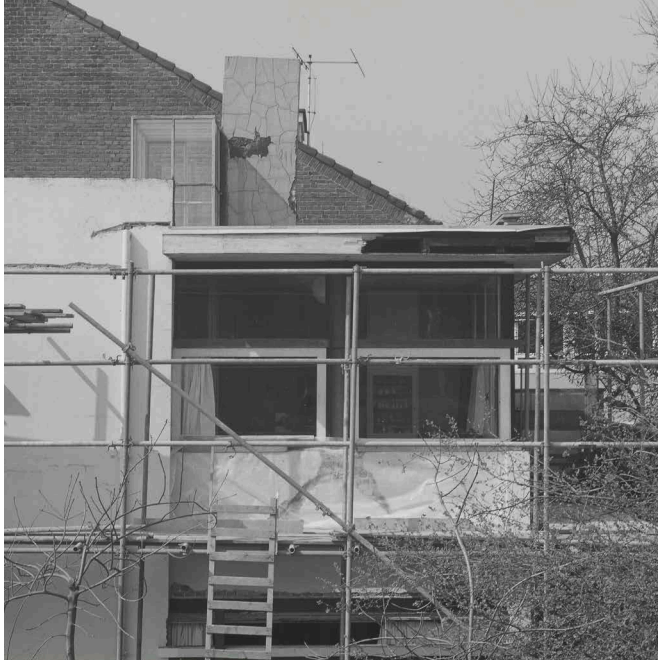
FIG. 1.7 The roof required extensive repairs to prevent further sagging and leaks

The roof construction and finishing employed had given rise to sagging, resulting in numerous leaks [FIG. 1.7]. The skylight needed to be replaced. Likewise, much of the timber used in windows and doors, which Rietveld had dictated should be flush with internal and external walls, in other words without sills or projecting edges, was due for replacement. This was especially true of the windows and balcony door in the east elevation, followed by Truus's room. The damage and defects were treated invasively by Mulder, using contemporary materials and techniques, in order '[to] achieve the durability desired by Truus Schröder [FIG. 1.8]. Not through restoration according to traditional standards, but to a large extent through reconstruction of the form using a new, technically superior method.' According to Mulder this was the result of the RDMZ's 'wise decision' to keep the agency's officials well away from the work.²⁸

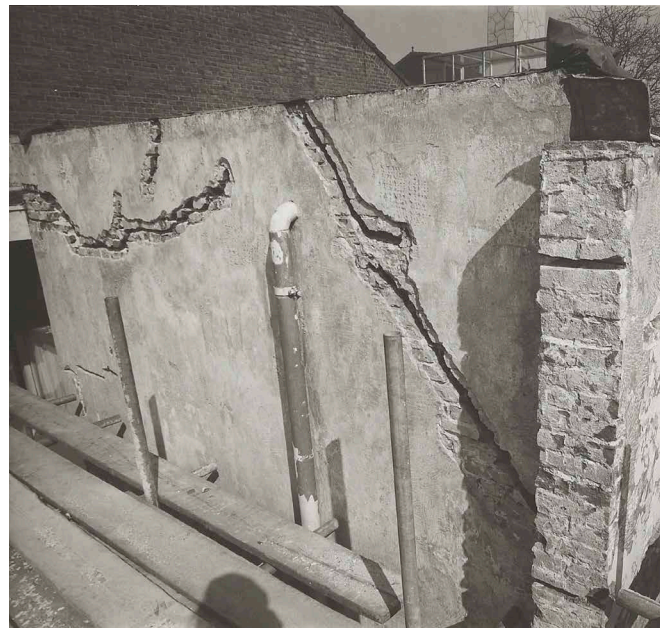
The restoration of the exterior was carried out between March and September 1974. The cracks in the plasterwork were mainly in the east and south elevations and once that plaster had been chipped away cracks were also discovered in the brickwork behind it [FIG. 1.9].²⁹ The Stichting Onderzoek en Voorlichting (Foundation for Research and Information, SOV) of a firm specializing in plastering, terrazzo and plasterboard (STS) had been asked for advice and in February it had provided detailed instructions for the repair and treatment of damaged sections of brickwork and plaster, for the joints between plasterwork and wood, and for the concrete. SOV's J.F. (Hans) Geerken provided advice on the method as well as on the specific composition of the materials to be used. In accordance with this advice, Mulder

FIG. 1.9 The brickwork displayed deep cracks

had the cracks in the brickwork treated with a synthetic mortar that was then coated with a synthetic dispersion to ensure that the rendering coat would adhere. Where the cracks were only in the plasterwork, the mortar layer was re-rendered and then plastered to the same level as the existing plasterwork, on which the existing layers of paint were still present. Instead of applying a fine render to the base coat, Rietveld had the plasterer impart texture directly to the (hardened) rendering coat. The circular motion of the trowel produced a grainy effect.³⁰ Geerken saw to it that the various stages of this work were carried out according to instructions.

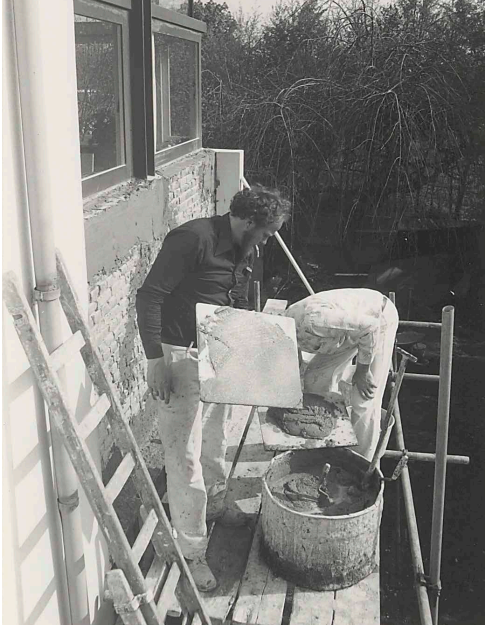
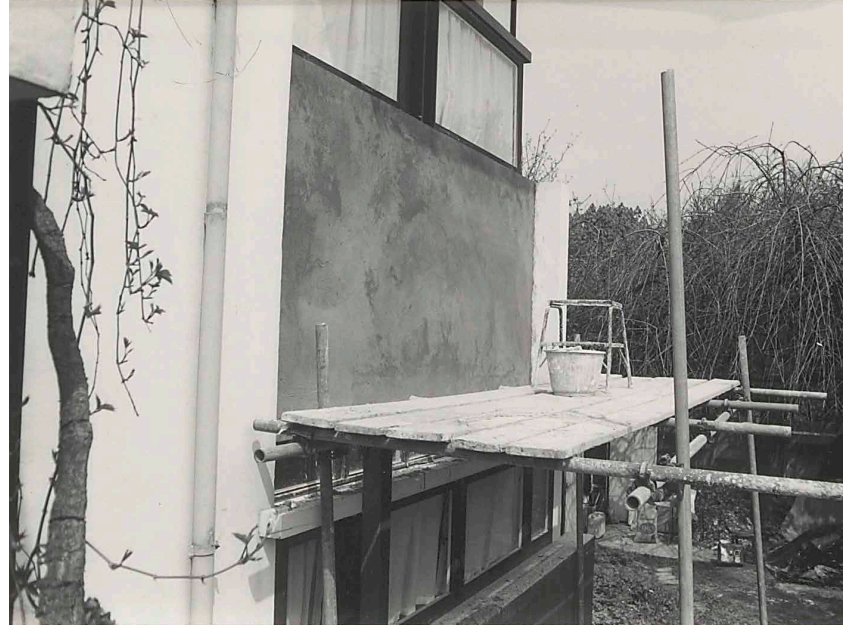
FIG. 1.11 After the plaster with hairline cracks was removed, the new render was applied in a single homogeneous coat

Work started at the end of April and after the removal of the layer of mortar it was discovered that the repairs to the brickwork using synthetic mortar had held up well. The substrate was homogeneous, and according to Geerken the brickwork was of reasonably good quality.³⁹ Thus the problems lay with the rendering. Even more radical decisions were then taken on site. 'The render that had remained in place during the restoration also had to be removed in order to achieve a single homogeneous plaster coat and to avoid problems with joins between old and new work [FIG. 1.10/1.11].'⁴⁰ Whether this literally meant that all the

All kinds of repairs had been carried out, and the house was also a melange of different materials and constructions. It was consequently decided that it would be best to limit the number of materials and adhesive surfaces as much as possible. The new coat would be applied in one operation.³⁸

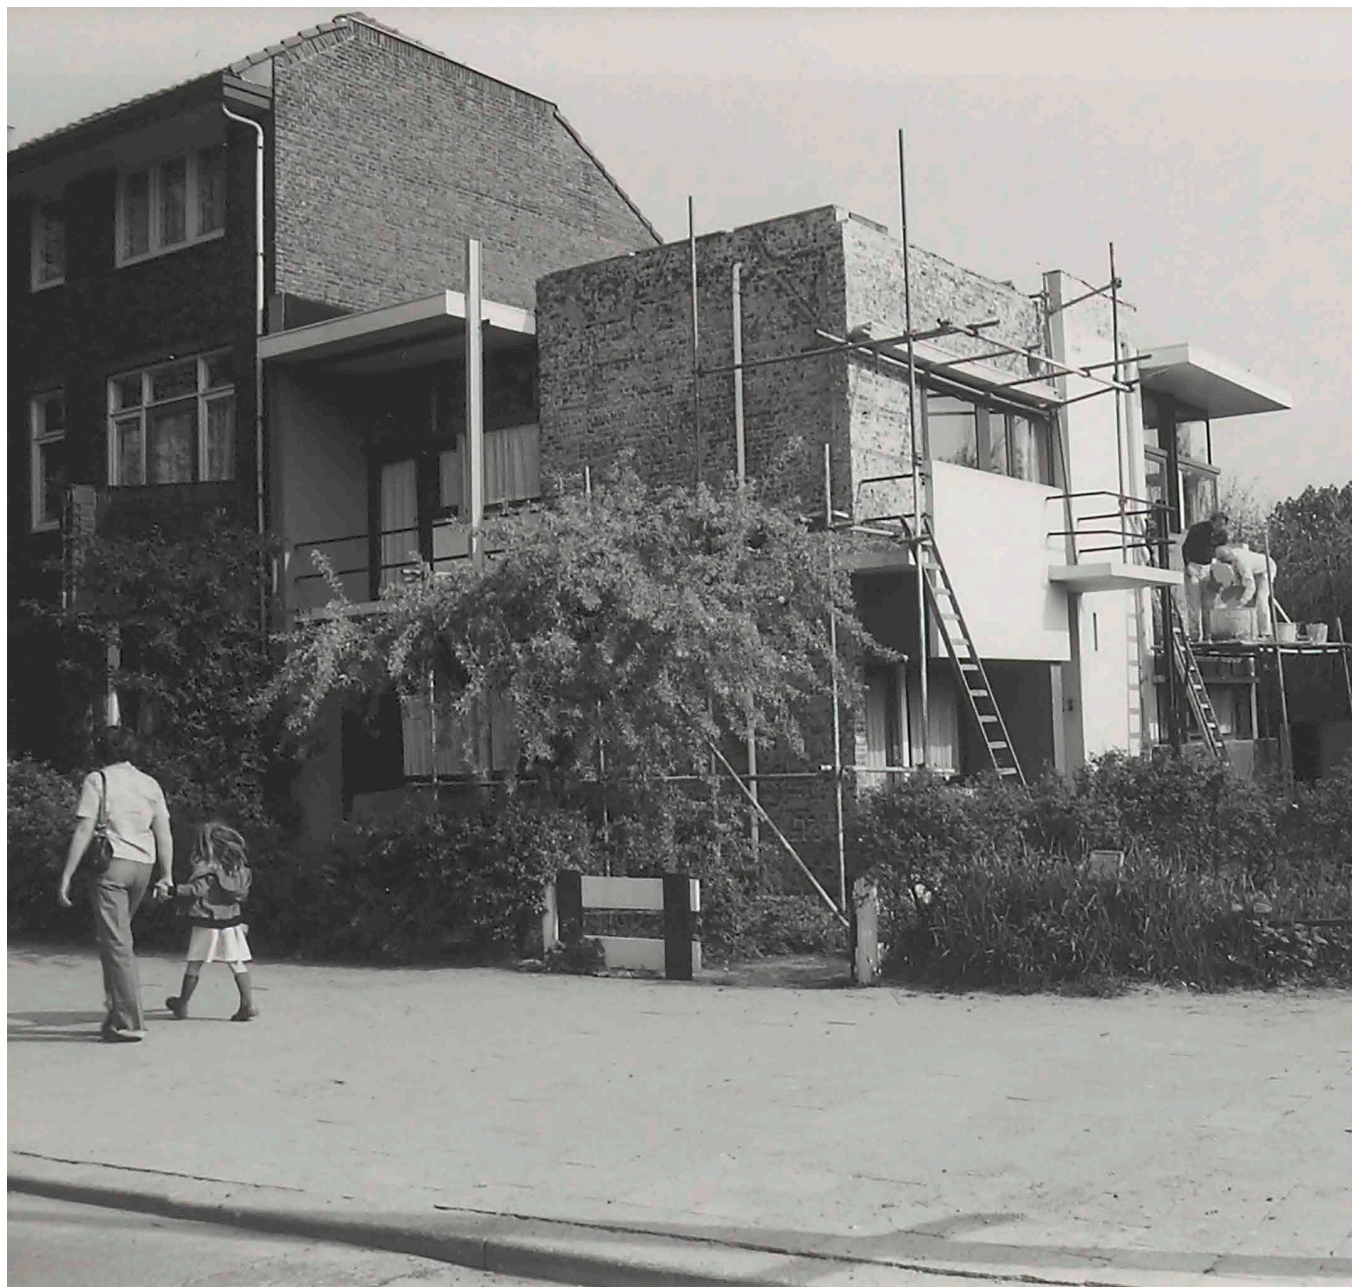
walls of the house should be replastered or just the walls with problems is not entirely clear from the report. Photographs taken during the restoration show bare brick walls but also sections with the render still intact, such as the surfaces below the kitchen window and the studio on Prins Hendriklaan [FIG. 1.12/1.13/1.14]. Because the photographs are undated it is difficult to determine whether the areas of render still visible in the photos were retained or perhaps also removed. When asked about this, Mulder was initially unable to recall precisely what had happened. However, in 2018 he wrote: 'Only on smaller surfaces that had not been repaired did the original render remain in place, such as the ground-floor walls below the windows in the kitchen and on Prins Hendriklaan. Large sections also remained in place on the white surfaces in the entrance elevation and the rear elevation.'⁴¹

FIG. 1.12 South elevation (Prins Hendriklaan) with bare brickwork

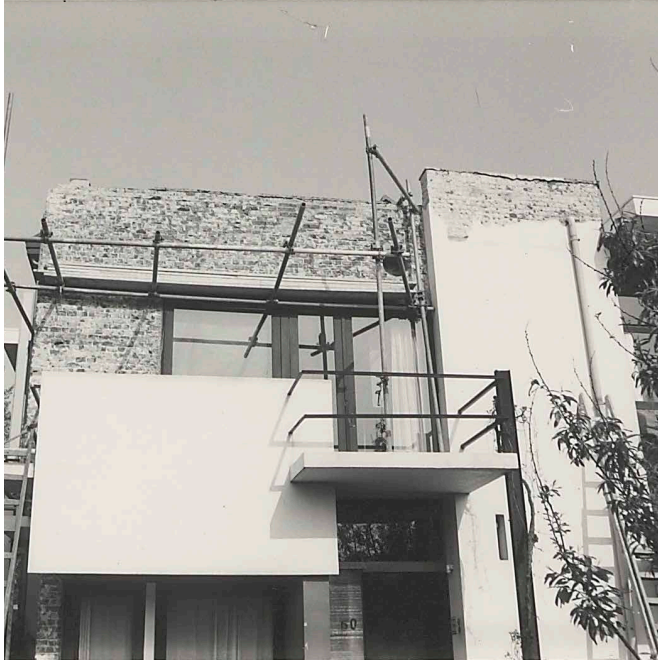
FIG. 1.13 East elevation with the plaster chipped away yet again

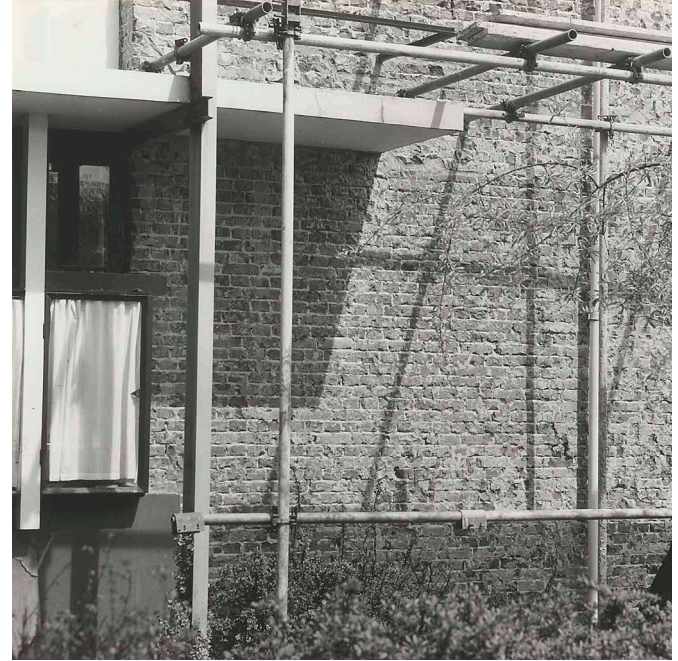
FIG. 1.14 Traces of plaster still visible on the wall below the studio window on Prins Hendriklaan
