### **A case study**

Materials

# Wear Induced Failure of Automotive Disc Brakes—A Case Study

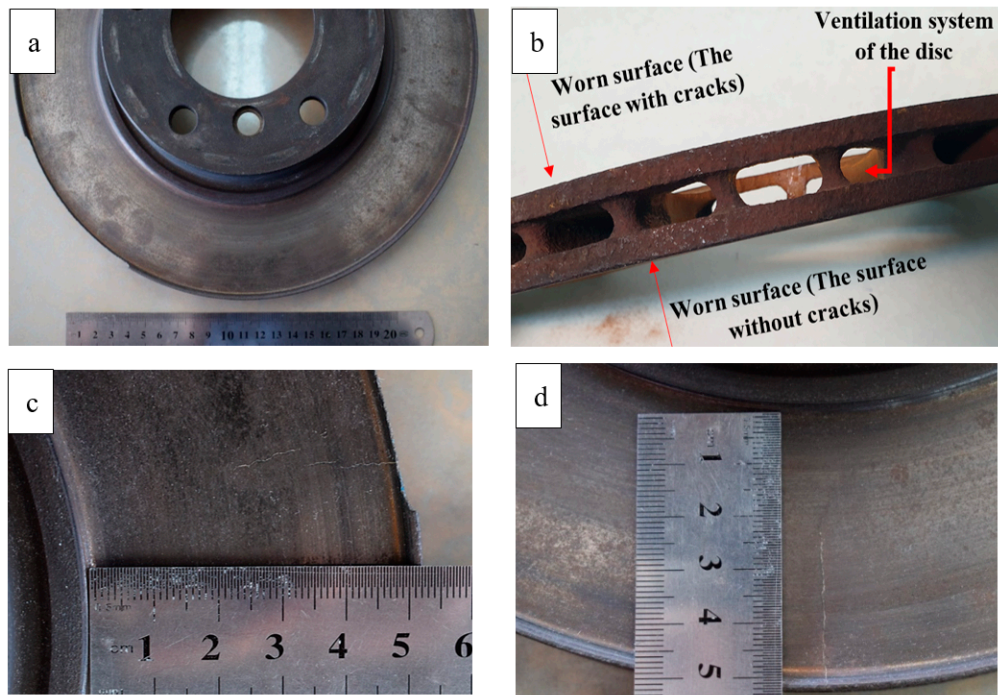
The failure, in this case, was related to the gray cast iron (Fe-3.3% C, 2.1%Si, 2.2% Mn, 0.2%P and 0.1%S, given by the supplier) disc brake in an automobile (see Figure 1a,b). The failed disc had been in service for approximately 10 years. The mileage when the failure was reported was 100,000 km (10 years of service). The disc had been in operation in temperature variations between  $-10\text{ }^{\circ}\text{C}$  (in winter) to  $35\text{ }^{\circ}\text{C}$  in summer in a rather dry atmosphere. The disc was a ventilated one and it was cast with two sides being in contact with the break-pad simultaneously. However, micro-cracks were formed only on one side. The observed failure was in the form of radial cracks, which appeared to be initiated at the outer edge of the brake disc. There were two rather large cracks, with one being approximately 30 mm and the other one being around 40 mm (see Figure 1c,d). The former crack was in fact two separated cracks, propagated in one direction, while the latter one was a straight continuous crack. There was no indication of the crack branching on the surface.

Figure 1. (a,b) Optical images of the disc and (c,d) images of the cracks at the surface of the brake disc.

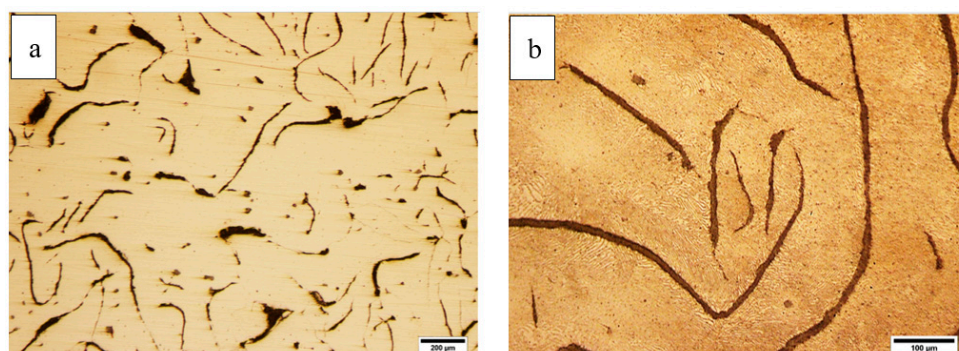
Figure 2 shows optical microscope images of the disc before and after etching. As shown, graphite flakes were distributed in a pearlite matrix. Graphite flakes are excellent thermal conductors, making gray irons good thermal conductors as well. This also has to do with the fact that graphite flakes form an interconnected network, forming an easy path for heat transfer. Moreover, graphite flakes are known to absorb sounds created by the brake pad-brake disc contacts [20]. Figure 3 shows the SEM images of cracks on the surface of the disc from the top view and from the cross-section. The former image shows that crack openings on the surface in some areas were as large as 200  $\mu\text{m}$ . It appeared that these large openings on the surface were formed due to the spallation of rather large chips from the surface. The remainder of these chip-like features were still visible inside the crack. Further away at the right side of the crack, there was a spot (roughly 200  $\mu\text{m}$   $\times$  100  $\mu\text{m}$ ), which was seemingly the area from which a surface chip spallation had taken place. Figures 3b and 4 are images of the cross-section of the crack. There was no branching or any major deviation from the straight line. Figure 5 shows the laser profilometry of the surface topography in the vicinity of the crack. There were deep ups and downs parallel to each other [21]. Sharp edges on the surface were indications of surface cutting and abrasive wear on the surface.

Figure 2. Optical microscope images of the microstructure in (a) as-polished and (b) etched conditions.

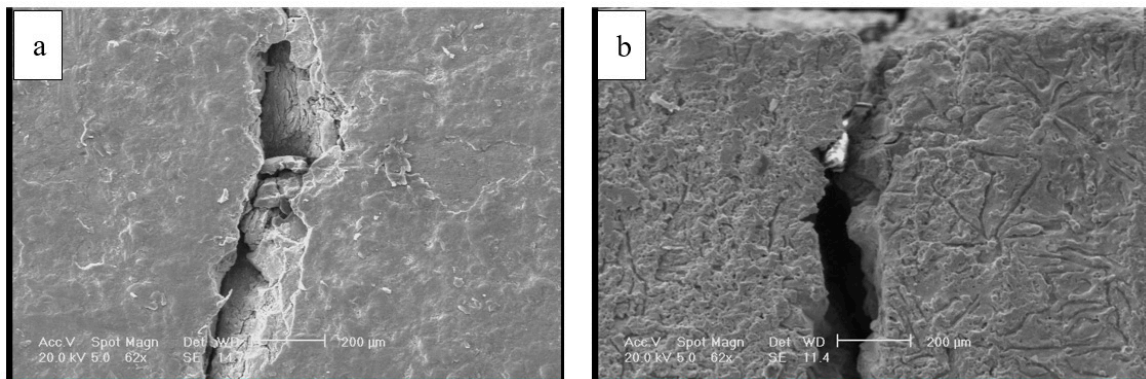
Figure 3. Scanning electron microscope (SEM) images of the crack, in (a) top view and (b) cross-section.

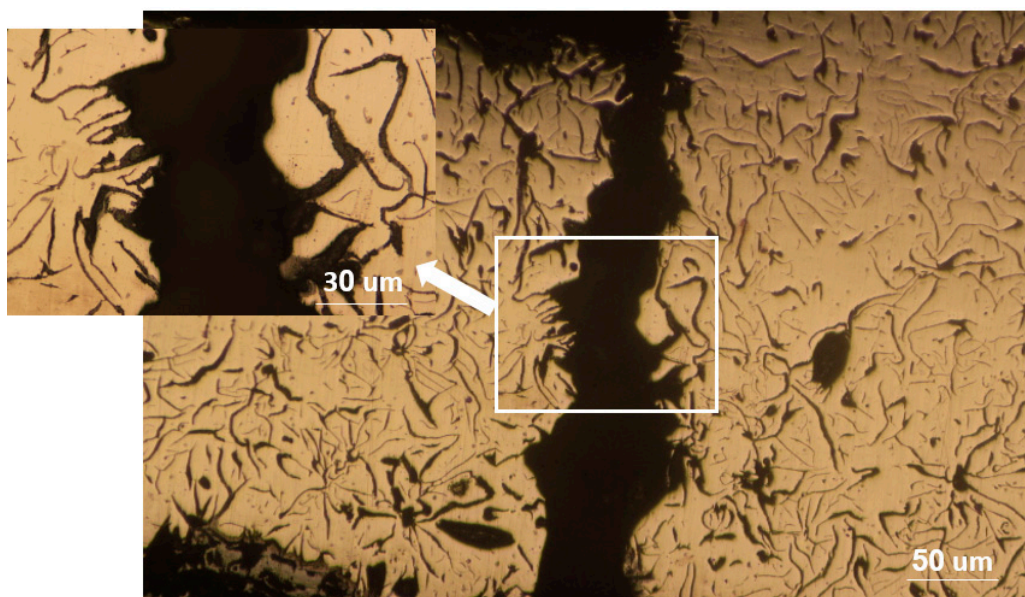
Figure 4. Optical microscope image of the cross-section of the crack.

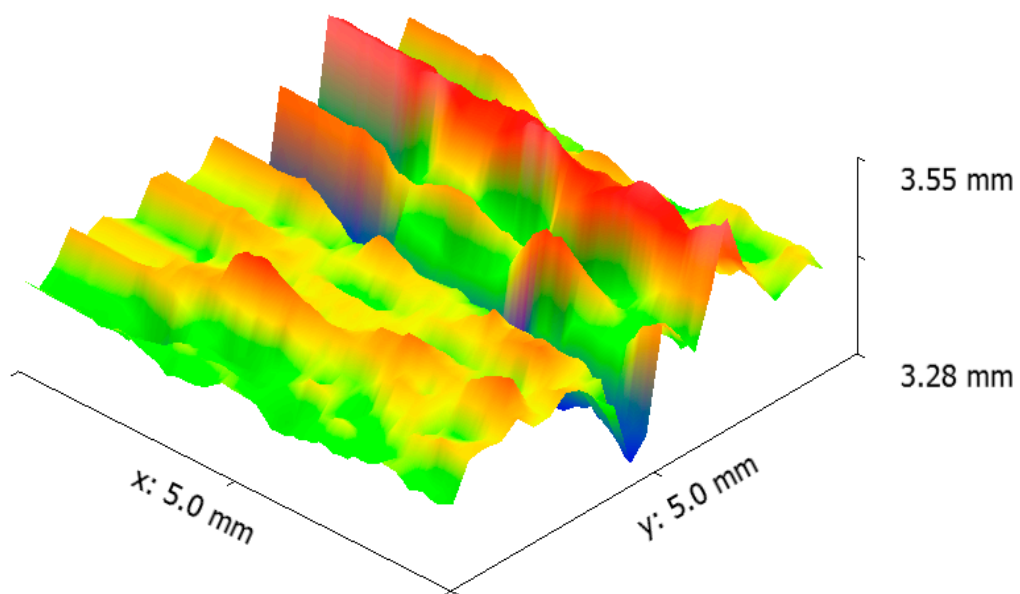
Figure 5. Laser profilometry of the disc brake surface in the vicinity of the crack.

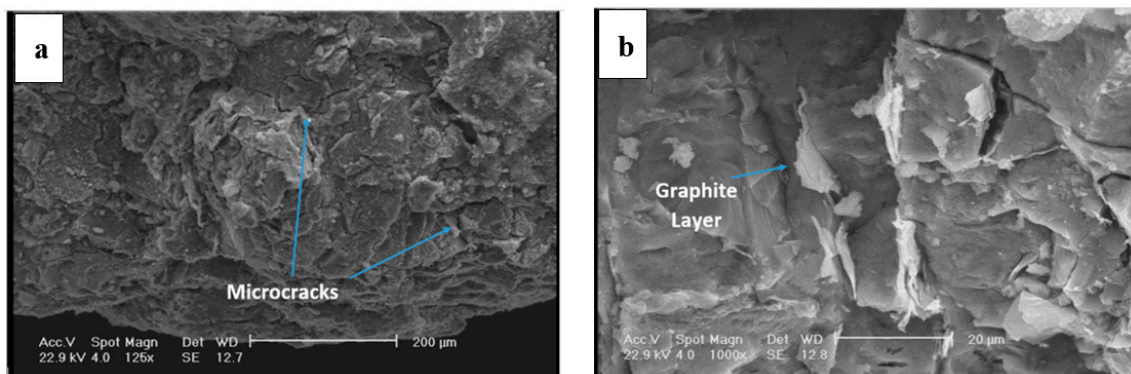
Figure 6 shows the fracture surface of the disc. Fracture is overall brittle with a layered structure (see Figure 6a). The fracture surface was covered with a network of fine microcracks. The interface of matrix-graphite, in which matrix is referred to pearlite, is a suitable place for crack initiation, given that the adhesion of graphite to the iron-based structure is rather weak. An example is depicted in Figure 6b. It appears that the fracture had mostly initiated from the graphite/matrix interface. Figure 7 shows that the fracture surface in some areas is covered with fine agglomerated particles. EDS results show that these particles were mostly Fe- and Si-containing oxide particles. These particles were formed during the wear of the surface and detachment of the particles. This is while the high temperature of the disc during the contact of the pad and the disc resulted in the diffusion of the oxygen atoms into the lattice and the oxidation of the particles. Fine oxide particles have relatively higher hardness compared to the matrix. These particles can cause severe abrasion in case they are entrapped between two moving components, which in this case for the brake pad and the disc. The formation of fine oxide particles between the brake pad and the disc had to do with localized temperature increase due to the excessive friction at local contact points between the pad and the disc.

Figure 6. (a,b) SEM images of the fracture surface in the brake disc.

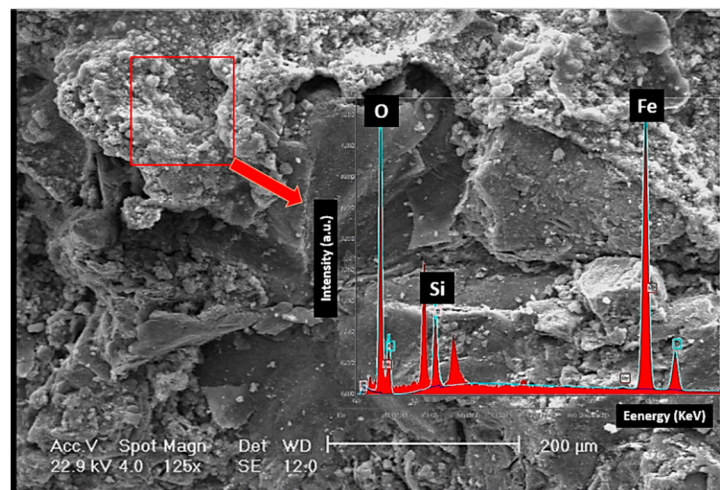
Figure 7. SEM/EDS analyses of the oxide particles.

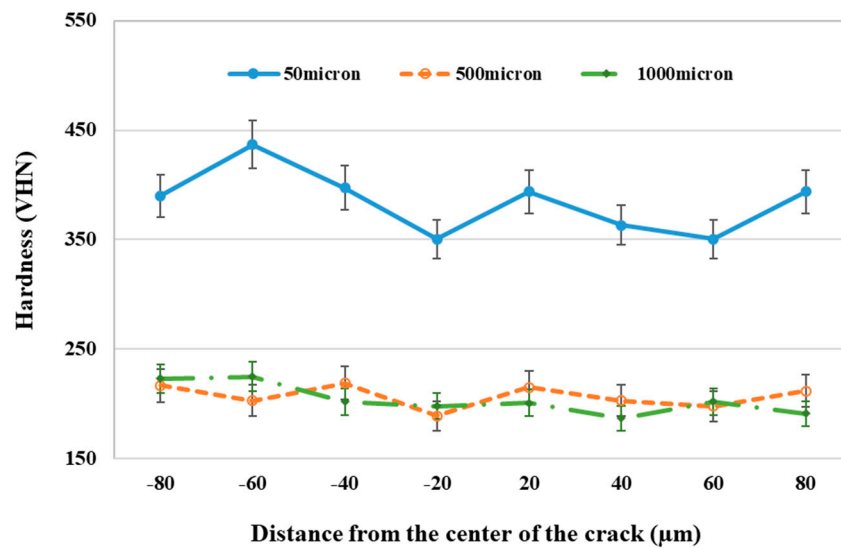
Results of microhardness profilometry across the crack at different depths from the surface are shown in Figure 8. Disc brakes experience large surface compression stresses due to exerted loads from the brake pad. This results in plastic deformation and work hardening at layers close to the surface. In this case, this resulted in an increase in the hardness from about 200 VHN at deep layers inside the brake disc to 400 VHN in layers close to the surface. This increase in the hardness confirmed the argument that the surface was heavily deformed and work-hardened during service. Prasad [4] also reported the occurrence of work hardening in gray cast iron discs during a wear test. The depth of the

work-hardened layer was dependent on the loading conditions, the sliding distance (service time), and the temperature increase at local contact points.

**Figure 8.** Hardness profilometry across the crack at different depths from the surface.

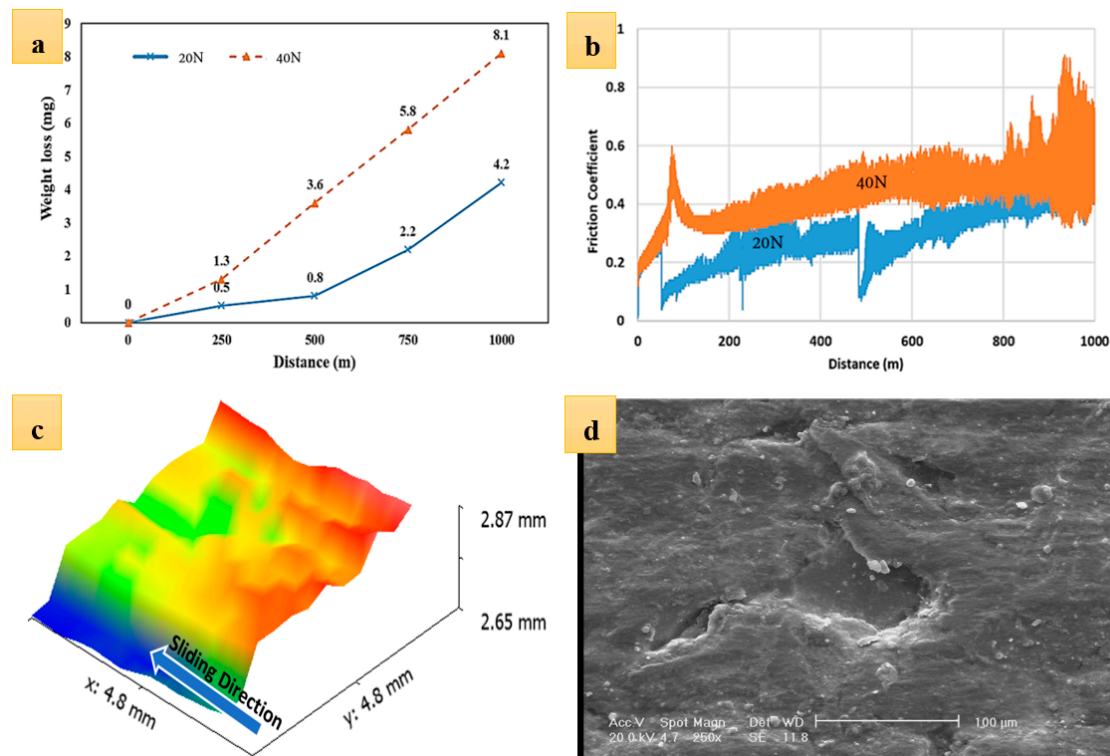
To further investigate wear mechanisms in gray cast iron, pin-on-disc wear tests were performed on discs of 50 mm diameter. The tests were conducted for 1000 m under 20 and 40 N loads. Figure 9 depicts the results of the wear tests. Figure 9a compares the weight loss during wear tests under 20 and 40 N loads. The higher the load, the higher the weight loss. In the case of a 40 N load, the weight loss linearly increased with the sliding distance. However, in the case of a 20 N load, it appeared that the weight loss had different kinetics during the test, in such a way that the kinetics of weight loss was much slower in the first 500 m of sliding. The kinetics of weight loss significantly increased from this point on. This could be due to the activation of a new wear mechanism. Given that oxide particles have a significant contribution to the wear [22], one can postulate that up to 500 m, not enough oxide particles were formed in between the pin and disc. This changed after 500 m of sliding. This argument follows the variation of the friction coefficient with sliding distance (see Figure 9b). We see that where the load was 20 N, the coefficient of friction increased with different kinetics after 500 m. Concerning the coefficient of friction, one can see that the coefficient of friction with a load of 40 N was comparatively larger than that with a load of 20 N. This had to do with the correlation of the applied load and the coefficient of friction. As the applied load increased during the wear test, the contact points between the asperities increased, which resulted in a higher coefficient of friction. The observed increase in the coefficient of friction with sliding distance in both cases could be attributed to the formation and fragmentation of oxide particles on the surface. More importantly, as the sliding distance increased, the chance of detachment and fragmentation of the graphite flakes increased. Given that graphite flakes have a self-lubricating effect, this detachment and fragmentation of graphite flakes can increase the coefficient of friction. Graphite detachment can also increase the surface roughness and this will have a negative implication on the coefficient of friction. Figure 9c,d show the laser profilometry of the surface topography and SEM image of the worn surface after 1000 m sliding under load 40 N. There were different features on the surface, with each being related to different wear mechanisms. First of all, there were some spots on the surface wherein the surface had clearly undergone severe plastic deformation. In some areas, this resulted in spallation on the surface (see Figure 9d). Other than that, there were some plowings on the surface related to the abrasion due to the relative movement of oxide particles on the surface. Moreover, some surface cutting was identified on the surface. Cutting was identified when there was material separating with negligible plastic deformation at the sides of the grooves.

**Figure 9.** Results of the wear test: (a) weight loss with sliding distance, (b) variation of friction coefficient with sliding distance, (c) laser profilometry of the sample after 1000 m wear test under 40 N load, and (d) SEM image of the same sample.
