Demonstration of the Structural Resiliency of Damaged Sentryglas Laminated Heat Strengthened Glass Fins in Full Scale Testing

Abstract: A unique structural design was made for the glass façade of the Co-Creation Center building in Delft. The roof is completely carried by the glass fins. The fins are laterally stabilized by being included in the triple glazed façade. To certify the safety of the design full scale tests on the fins were done at Delft University of Technology. Due to a transportation accident the fins were damaged at one end. This allowed an additional study into the effect of this pre-test damage on the residual compressive stresses induced by the tempering. It was found that the residual stresses were not significantly affected by the damage. During the compression tests no cracks developed at the damaged ends. A load of 200 kN, more than double the maximum design load did not produce failure in the prototypes. After intentionally seriously damaging all plies of the fins, the fins could still carry the 200 kN load for 30 min without buckling or other failures being noted. Measurement of the residual stress in the outer plies of the fins after damage showed that suf

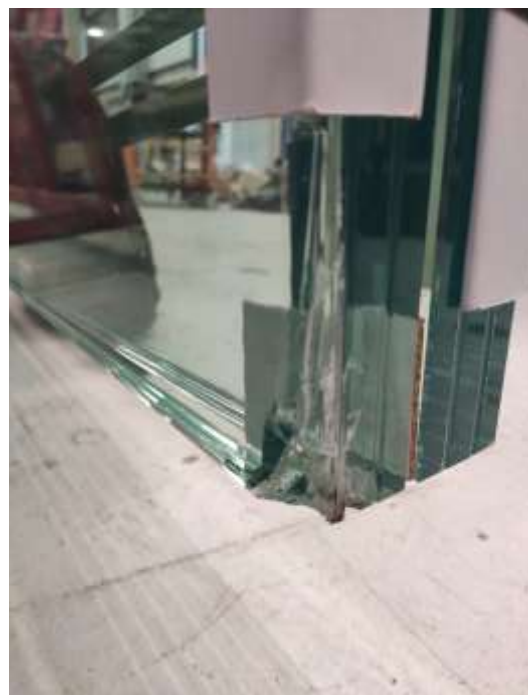
Unfortunately the glass fins were damaged at one end when they were moved into the laboratory by staff not specifically trained to handle glass. The damage is shown in Fig. 4. The damage was measured using a contour gauge as shown in Fig. 5 to determine the depth of the damage. Essentially at the bottom corners of the specimens a triangular bite was taken out of the outer ply over a length of some 24 mm as shown in Fig. 5. This

damage was about half of this some 40 mm up, over a 12 mm length the missing glass tapered from 12 to 6 mm. Above 100 mm from the lower longitudinal edge there was no visible damage. As getting new specimens would take two months and the damaged specimens were assumed to give a conservative test result the damaged specimens were used for testing.

Fig. 4: Transport damage to corner of fin before testing

Scalp measurements of the compressive surface pre-stress at the edge of the damage showed values of -60 ± 15 MPa. This is comparable to the values on the undamaged center line of the specimens. This indicates that the damage should have little effect on the glass strength in this case.

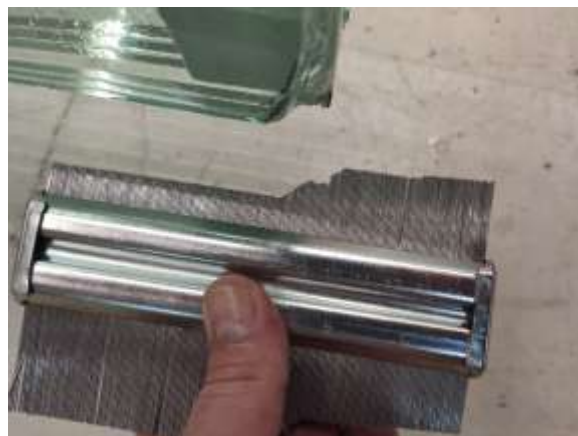
Fig. 5: Measurement of damage using a contour gauge

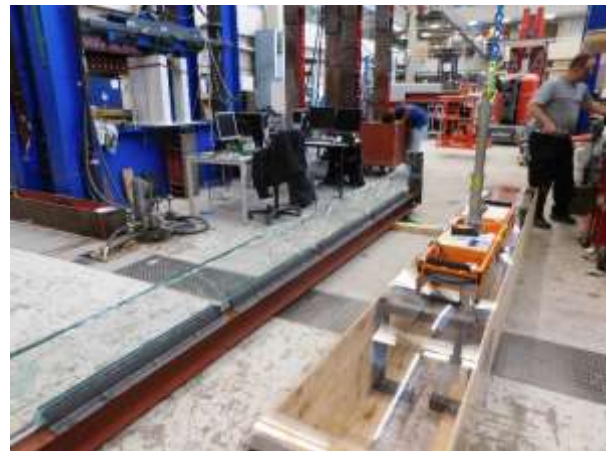
Fig. 6: Damaged specimen siliconed into steel profile which simulates the lateral support of the façade glazing in the real structure

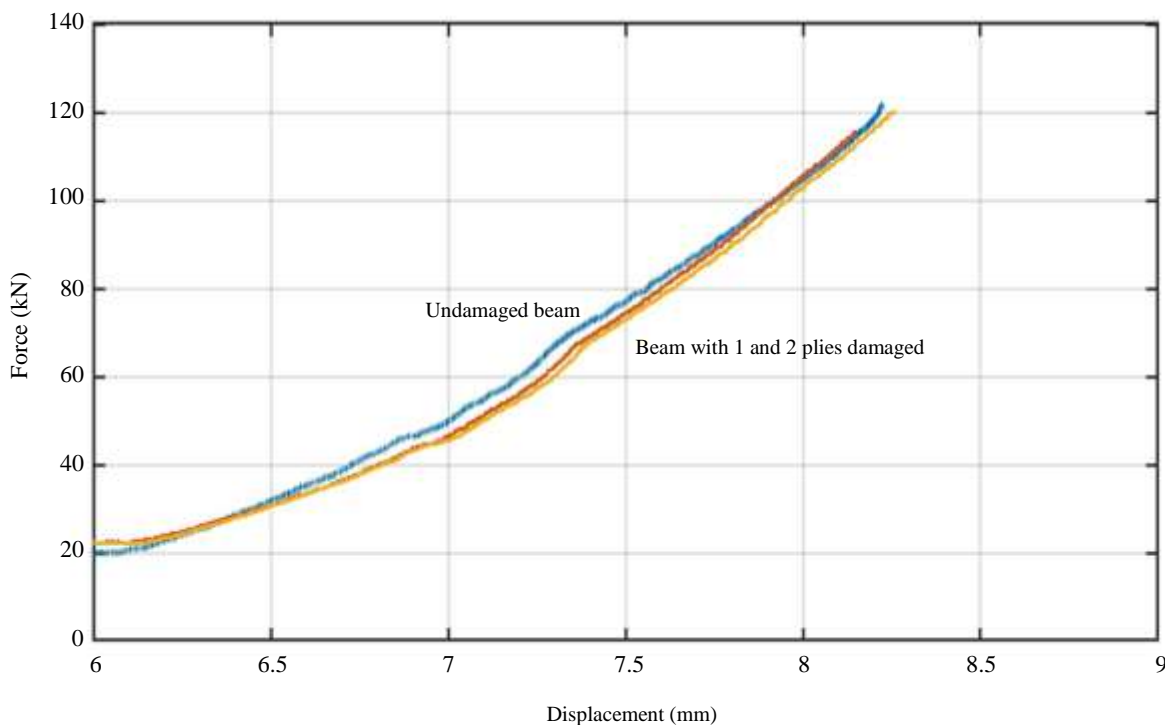
There was no failure of the glass fin under loading. Both the undamaged and damaged specimens were capable of dealing with a load at least double the maximum load expected in service. Figure 10 shows the load/displacement behaviour of the tests on specimen 1. Figure 11 shows the load displacement behaviour of specimen 2. The initial non-linearity of the load displacement curves in Fig. 10 and 11 is the result of movement in the steel top connection, which requires some displacement before the load is fully

Fig. 10: Load displacement behaviour of specimen 1

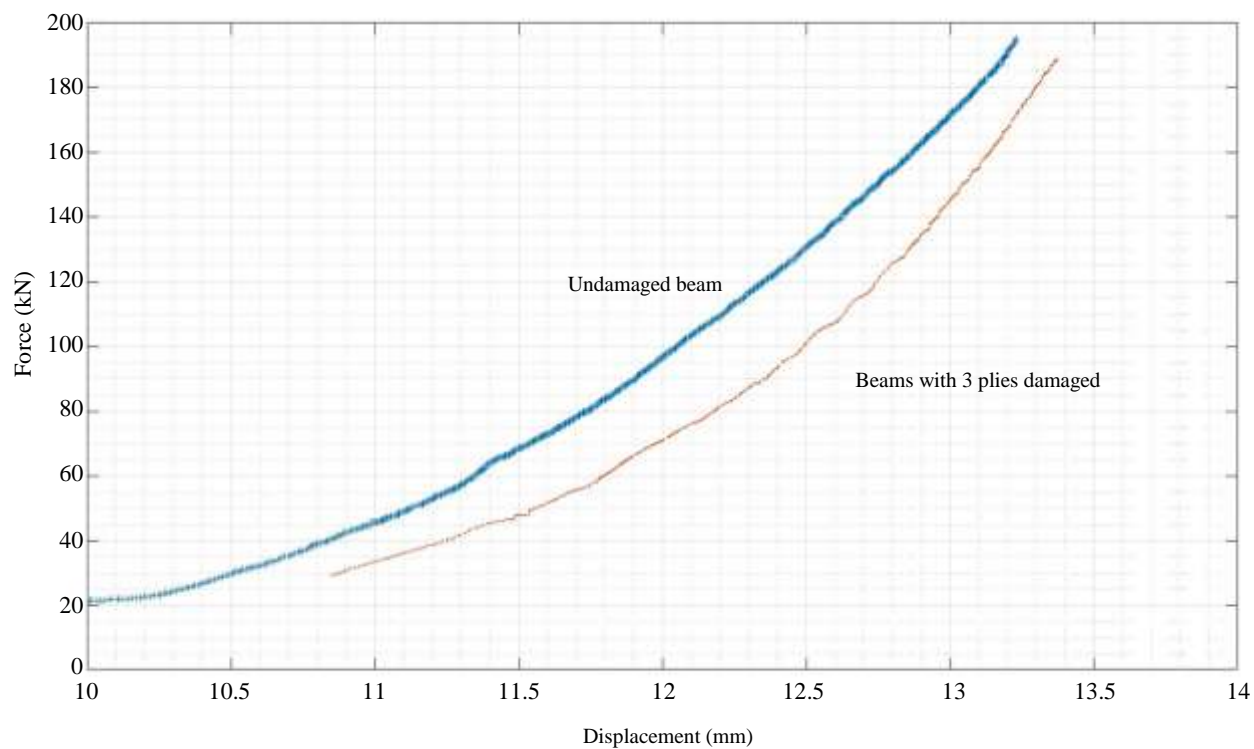
Fig. 11: Load displacement behaviour of specimen 2

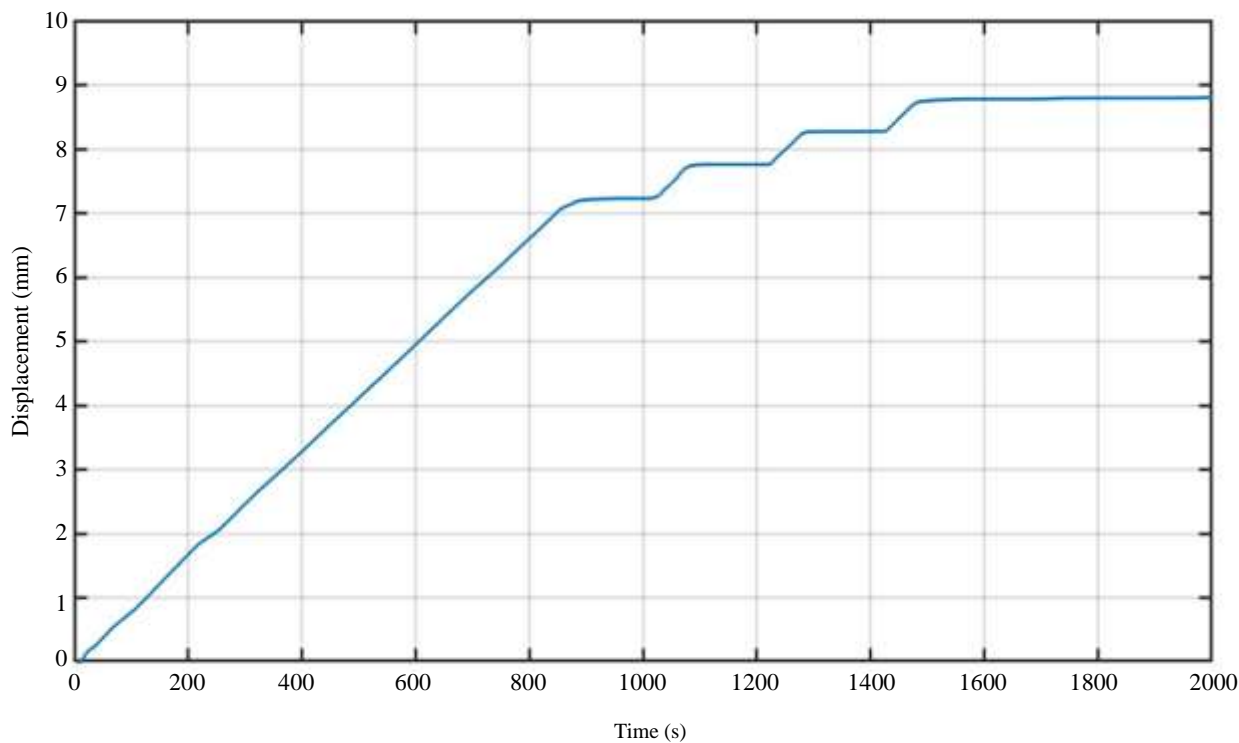
The damage did not result in short term creep, as is shown in Fig. 12, as holding the load constant did not result in additional displacement. Considering the significant levels of damage inflicted on the specimens, as shown in Fig. 13, this result is significant as the interlayer plays a significant role in transmitting forces in damaged specimen.

Fig. 12: Displacement time behaviour of the test on the 2 ply damaged specimen 1

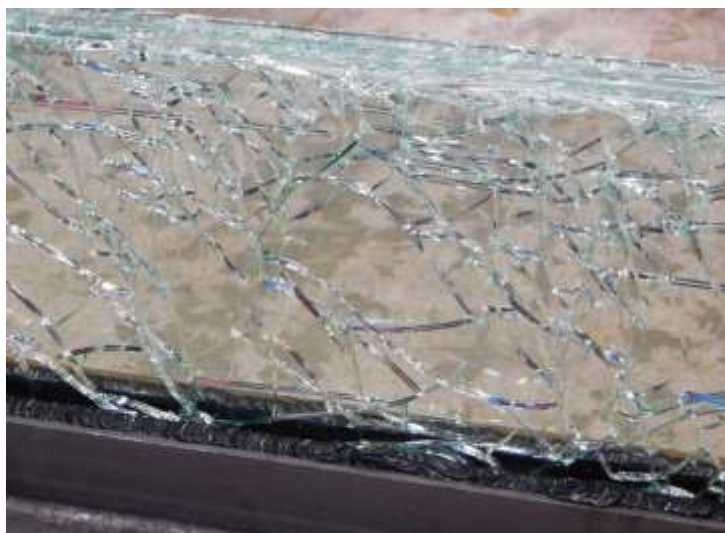
Fig. 13: Part of specimen 2 after having 3 plies damaged. Note the overlapping cracks in successive plies

- The use of heat strengthened glass which breaks into large fragments. These large fragments still maintain a level of compressive surface pre-stress after cracking of the glass and form an overlapping pattern allowing for stress transfer. In essence the cracking of the heat strengthened monolithic fin, turns it into a segmented spliced overlapping fin. As shown by (Trösch, 2015), this can be almost as efficient structurally as monolithic elements with proper lamination
- The use of Sentryglass foil as the laminating agent. The stiffer and stronger Sentryglass foil keeps the glass fragments together very well and the higher stiffness helps prevent buckling
