Some learning cases in the Port of Rotterdam

De Gijt, J. G.; Brassinga, H. E.; Roubos, A. A.

IOP Conference Series: Materials Science and Engineering

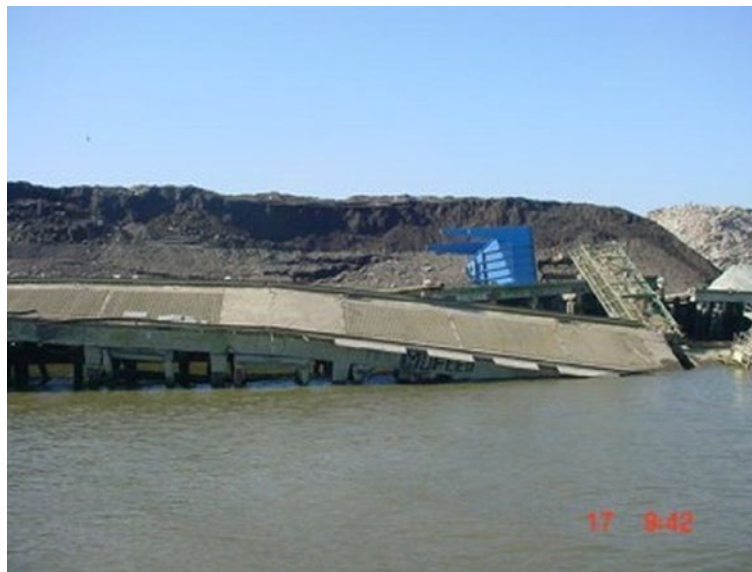
The jetty, figure 5, failed due to overloading. The acceptable loads were 20 kN/m², however the jetty was loaded up to 80 kN/m². This high load and the combination of bad soil conditions lead to this failure.

Figure 5. Failed jetty.

This jetty, figures 4 and figure 5, failed twice in three years time due to unsafe mooring maneuvers together with a relatively high current in the Meuse at that location [7]. Apparently it was very difficult when starting the mooring maneuver to adapt quickly to the high currents. So the front wall was damaged and the sand in caisson was washed out, creating a hole. This was a very dangerous situation as that area was used as parking area as well and high voltage electrical cables were present along the quay.

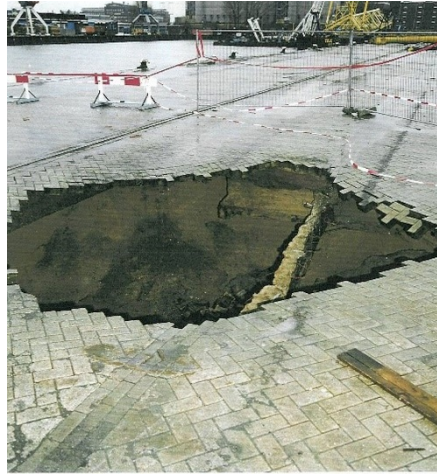
Figure 6. Hole in front wall of caisson quay wall.

damage was due to an failed mooring manoeuvre [7]. The captain of the ship could not get the machine in the reverse position in time. So the bulbous bow penetrated in the 0,25 m thick front wall of the caisson structure. So the front wall was damaged and the sand in caisson was washed out, creating a hole. This was a very dangerous situation as that area was used as parking area as well and high voltage electrical cables were present along the quay.

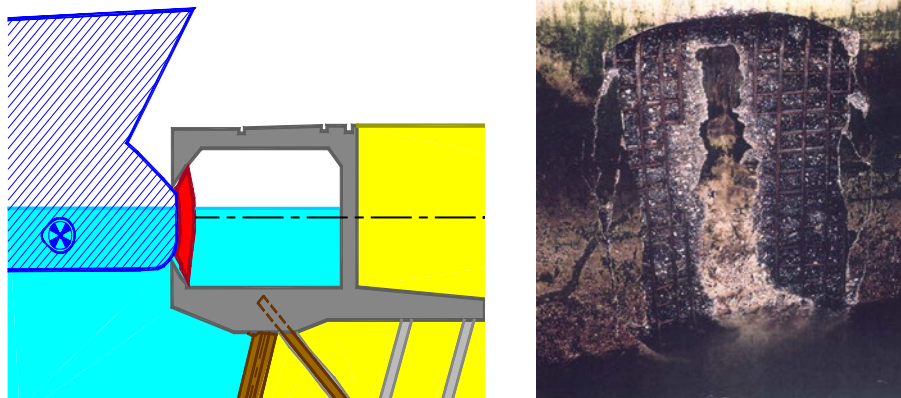
Figure 7. Damaged quay wall and impression of the damage of front of quay wall.

The ECT terminal on the Maasvlakte consists of a quay wall with a box structure founded on a comb wall and prefab concrete piles [7]. In 1992 a ship could not stop in time so the bulbous bow severely damaged the front wall. After inspection it was shown that only the front wall was displaced over ca 0,7 m. Due to the MV-piles the damage was limited to the front wall only. The rest of the structure remained intact.

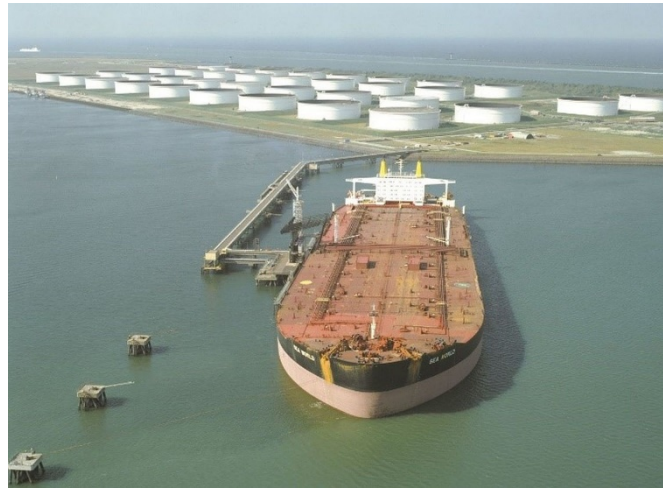
Figure 8. Damaged oil jetty.

The oil jetty at the Maasvlakte consists of a long concrete structure founded on steel piles, see figure 8 [7]. This jetty was severely damaged by a container ship which sailed through the jetty. The container ship was hardly damaged, however the jetty was severely damaged which is shown in figure 8. There was a considerable oil spill as well, which had to be cleaned up.

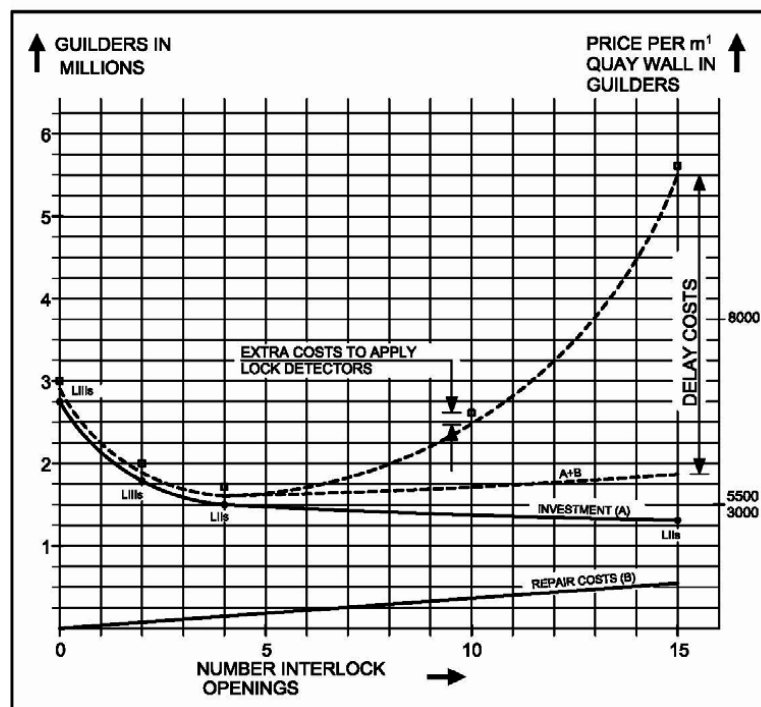
The maximum interlock openings that occurred were with Amazone harbour quay walls 80 and with the ECT quay wall 180. Of course this raised the question could we continue with this type of structures. Therefore also other types of quay wall structures have been considered like fe caisson quay and jetties. Then in 1992 it was decided to improve the installation method which includes no driving on the sheet pile elements. These must be installed by vibrating and jetting at the same time. This of installation method appears to be a good method. In 2003 this method was further improved by drilling with bentonite.

Figure 10. Investment in risk to prevent interlock openings.

Within the study conducted it was concluded that 2 interlock openings per 500 m quay wall is acceptable. The cost of repair of an interlock opening is approximately 30000 euro for each interlock damage.

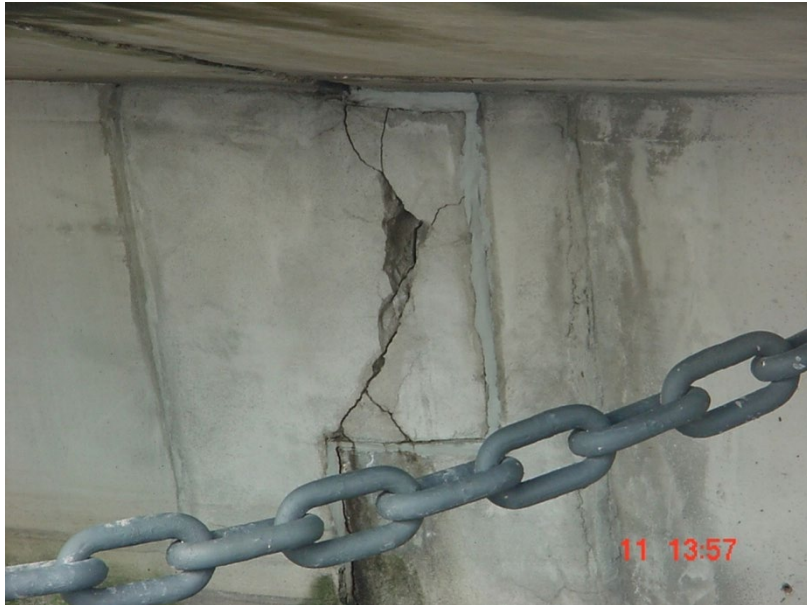
Figure 14. Cracking of concrete structure due to wrong connection.

This figure 14 shows a wrong connection of two sections of a quay wall in the Waalhaven [7]. Normally the sections of the super structure are only connected with teeth construction. However In this case the reinforcement was continued over the cross sections of the quay wall which initiated cracking due to uneven settlement.

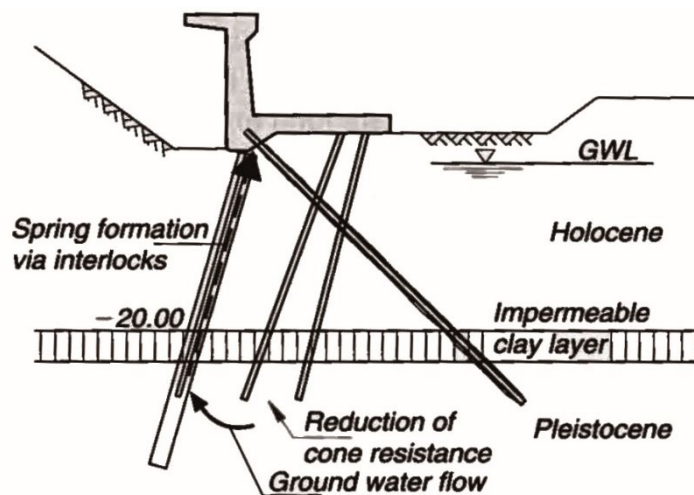
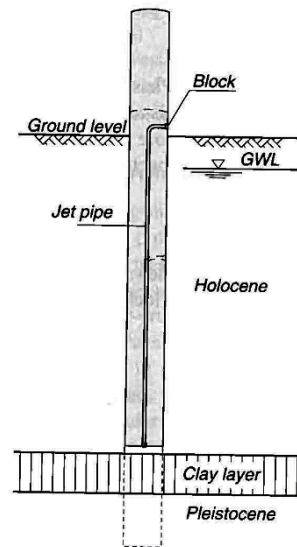
Figure 15. Building pit.

Figure 16. Pile jetting device.

Figure 15 and figure 16 show the cross section of quay wall with the building pit [8]. The concrete piles were installed with a jetting device for easier driving. However it occurred that the jetting pipes were not closed before driving started in the foundation layer. In that case the water flowed through the jetting pipe in the building pit and also reducing the bearing capacity of the piles.

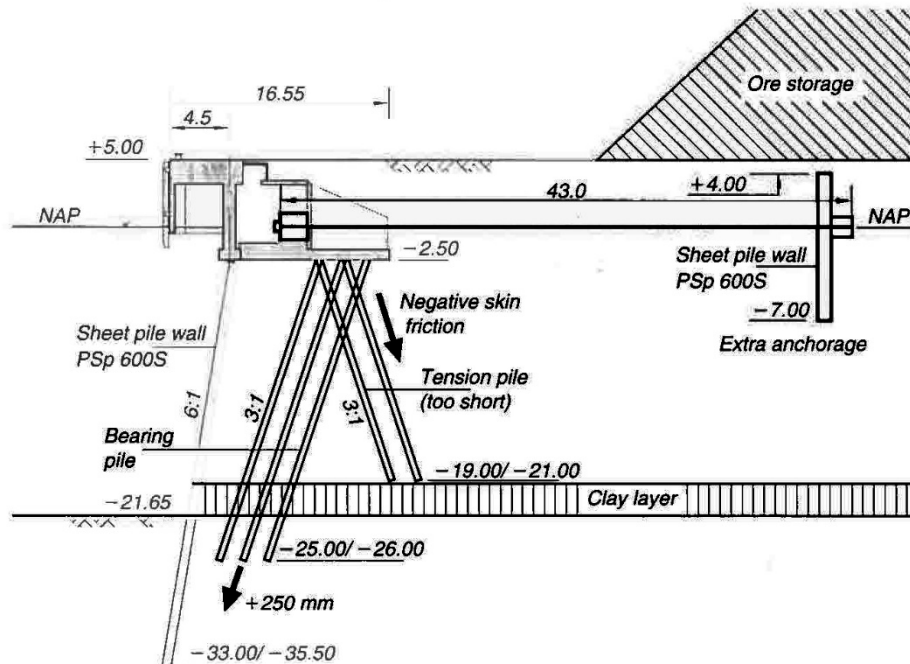
Figure 17. Quay wall with relieving floor.

Both figure 17 and figure 18 basically show the same structure [8]. However, in figure 17 the anchor force has to be taken by inclined concrete piles. However, they are so close together that the relieving floor in principle did not work. This caused a deformation of 30 cm in 20 years time. This required installation of an anchor screen.

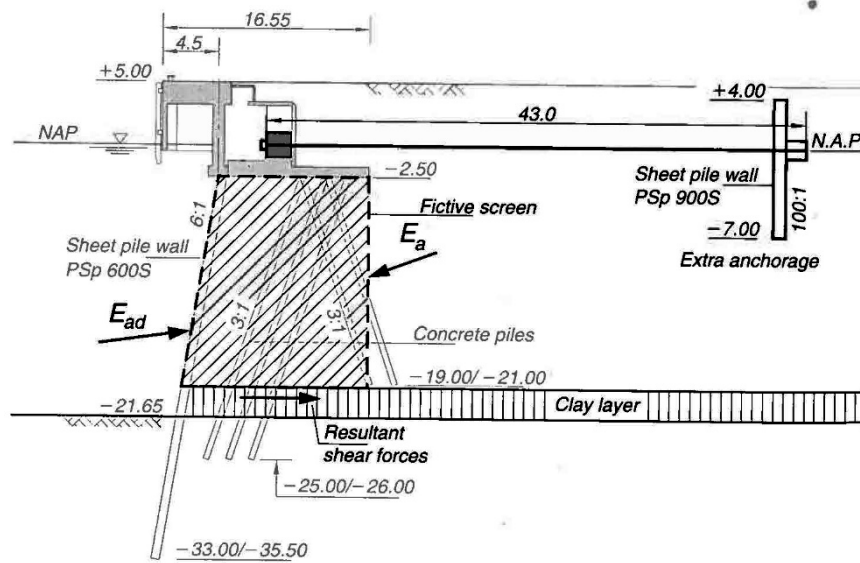
Figure 18. Quay wall with relieving floor.

The figure 18 shows the same structure. However, the concrete piles at the back site should have been driven deeper. As this was not realized due the very dense sand layer the structure showed too much deformation as well. It had to be anchored too with a horizontal anchor screen.

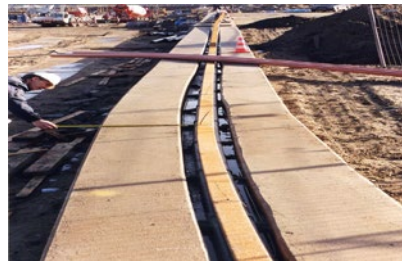
Figure 19. Deformed crane beam due too heavy densification of reclaimed sandfill.

This crane rail suffered too much deformation which was caused by too severe densification of the hydraulic fill [7]. Fortunately the crane could be properly installed without much extra work.
