Application of shearography with thermal loading for the structural inspection of Rembrandt's Night Watch

Nan Tao*¹, Andrei G. Anisimov¹, Esther van Duijn², Lisette Vos², Ilse Steeman²,
Katrien Keune^{2,3}, Petria Noble², Roger M. Groves¹

ABSTRACT

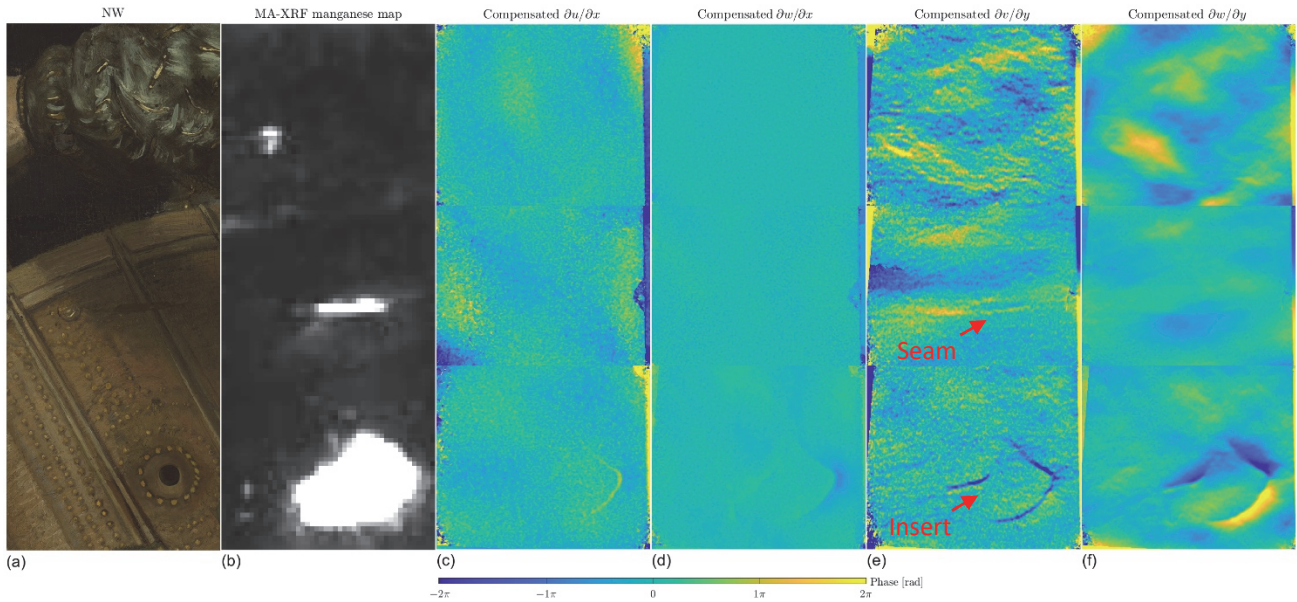
The inspected area of the drum with the canvas insert and the canvas seam in the original support is shown in Figure 3 (a). The seam and the canvas insert are detectable in the in-plane $\partial v/\partial y$ and the out-of-plane $\partial w/\partial y$ phase maps with the shear in the y -direction (Figure 3 (e, f)).

Figure 3. 3D shearography inspection results of the drum area with the canvas seam and insert (198×484 mm). (a) white light image with corrected intensity levels, (b) manganese (Mn-K) map, macro X-ray fluorescence scanning spectroscopy (MA-XRF) associated with the pigment umber used during the restoration, (c) the in-plane phase $\partial u/\partial x$ and (d) the out-of-plane phase $\partial w/\partial x$ with the shear in the x-direction (horizontal), (e) the in-plane phase $\partial v/\partial y$ and (f) the out-of-plane phase $\partial w/\partial y$ with the shear in the y-direction (vertical).

The inspection results of both investigated areas (Figures 3 and 4) show that known structural features can be reliably identified and mapped (viz. the seam and the insert in the drum, Figure 3). The overall pattern of the repaired slashes in the breeches area can be traced in the out-of-plane phase map with the shear in the x -direction ($\partial w/\partial x$, Figure 4 (d)). However, both the in-plane (Figure 4 (c, e)) and out-of-plane phase maps (Figure 4 (d, f)) do not have clear and significant local variations as compared to the area around the drum insert (Figure 3 (e, f)). The localised strain around the drum insert can be explained by the lower quality of the patched canvas compared to the repaired slashes in the breeches of Banninck Cocq.

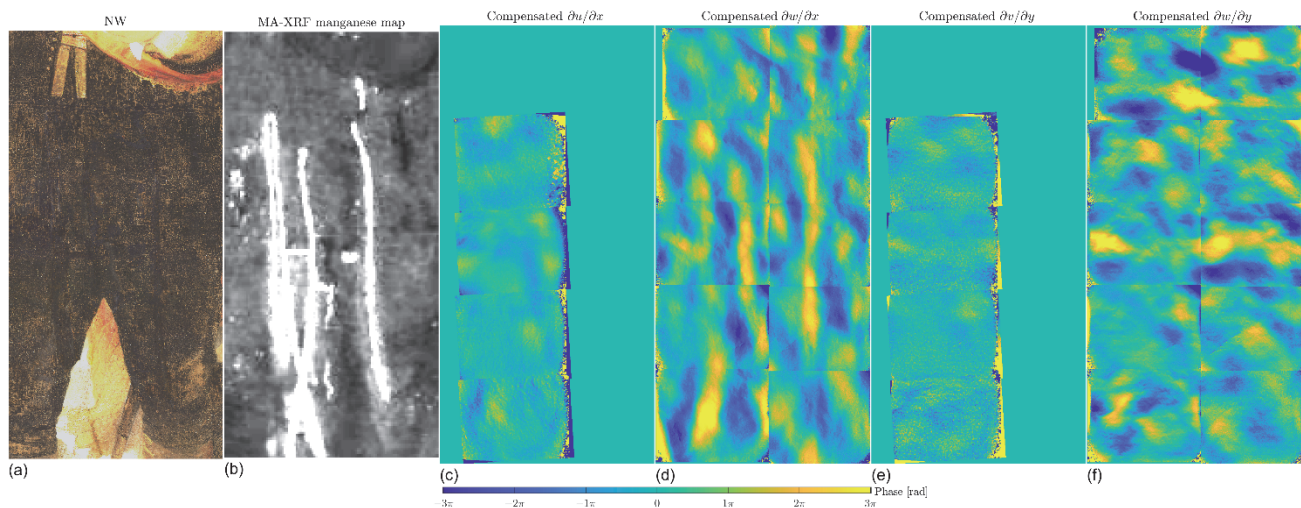
The area investigated in the breeches of Captain Banninck Cocq (445×909 mm) was significantly larger than the drum area (198×484 mm), therefore inspection of the full area with 3D shearography was found not to be efficient from the time and effort point of view. The entire breeches area was inspected with the out-of-plane configuration of the instrument (Figure 4 (d, f)) to identify possible delaminations between the original canvas and the lining canvas given the slashes incurred in 1975 in this area were the largest. A smaller area, which was considered the most critical was inspected with 3D shearography (Figure 4 (c, e)).

Figure 4. 3D shearography inspection results of the Captain Banninck Cocq's breeches area (445×909 mm). (a) white light image with corrected intensity levels, (b) manganese (Mn-K) map, macro X-ray fluorescence scanning spectroscopy (MA-XRF) associated with the pigment umber used for repairing the slashes during the 1975-76 restoration, (c) the in-plane phase $\partial u/\partial x$ and (d) the out-of-plane phase $\partial w/\partial x$ with the shear in the x-direction (horizontal), (e) the in-plane phase $\partial v/\partial y$ and (f) the out-of-plane phase $\partial w/\partial y$ with the shear in the y-direction (vertical).

In this paper, 3D shearography with thermal loading was used to inspect two areas with restored damage in *The Night Watch*, specifically the Captain Banninck Cocq's breeches and the drum. The results of the inspection from the reverse of the painting showed that the out-of-plane strain in the Captain's breeches does not show significant deviation that would indicate weakness in the adhesion between the repaired slashes and the lining canvas. The other repair, the canvas patch in the drum showed higher in- and out-of-plane strain variations. This was explained by the lower quality of the patched canvas compared to the repaired slashes in the breeches of Banninck Cocq.

Overall, 3D shearography provided valuable inspection results for assurances regarding the structural integrity of the 1975 repairs and the wax-resin lining in *The Night Watch*, reducing the risks and providing the confidence to proceed with the planned retensioning of the canvas.
