Buckling and failure assessment of curved butt-joint stiffened thermoplastic composite panels with roller boundary conditions

Composites Science and Technology

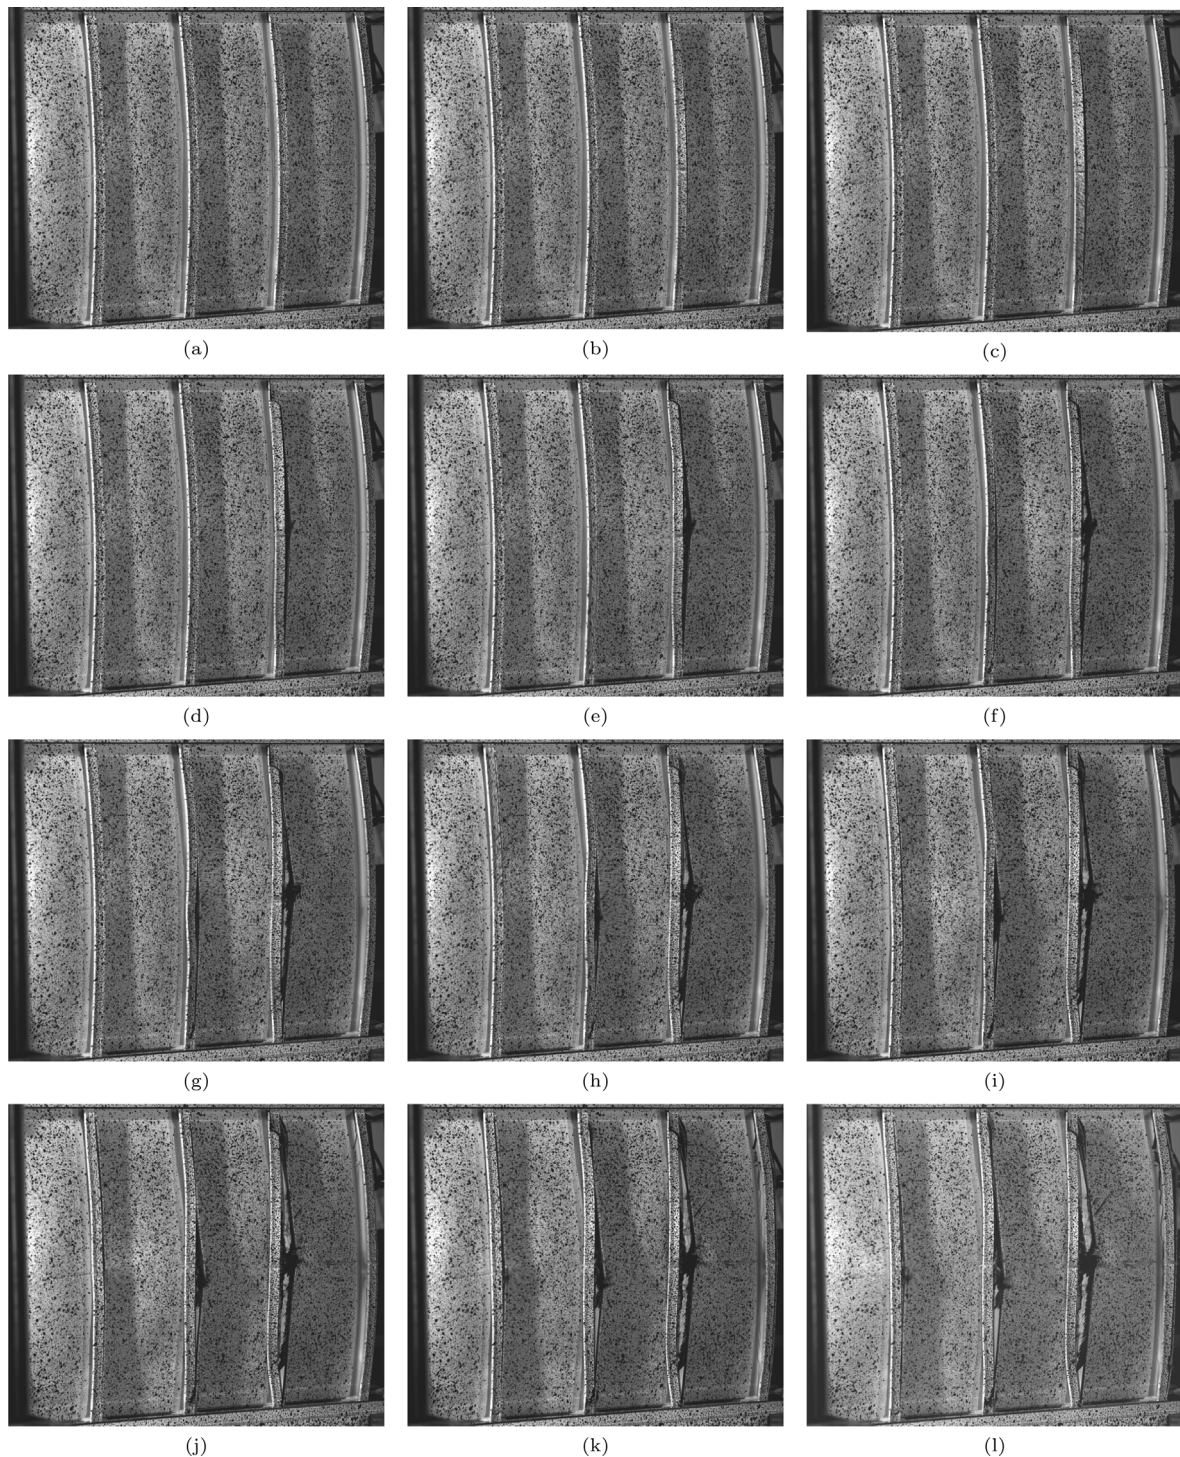
The panel collapse sequence of panel 1 is reported in Fig. 13 over a total time period of 1.1 ms. Panel collapse starts with the cap separating from the web of stringer 4 (a), the stringer with a BVID in the butt-joint skin–stringer interface. The cap completely separates in the following two frames and fractures at the top of the panel (b–c), followed by failure of the web (d). Then, the cap of stringer 3 separates from the web (e), and the cap fractures at the bottom of the panel (f). The web

Fig. 13. High-speed footage panel 1: (a–b–c) stringer 4 cap separation; (d) stringer 4 web fracture; (e–f) stringer 4 cap separation; (g) stringer 3 web fracture; (h) stringer 2 cap separation; (i) stringer 5 butt-joint failure; (j–k) stringer 2 web fracture, stringer 5 cap separation; (l) stringer 5 web failure.

of stringer 3 fails next, and the web of stringer 2 shows delaminated plies at the web-cap interface (g). The cap of stringer 2 then separates almost completely from the web within one frame (h). The butt-joint of stringer 5 is the first visible skin–stringer interface that shows failure (i), with the failure occurring at the top of the panel. Due to the separation of the caps from the webs, most butt-joints can no longer be seen. After the butt-joint failure, the cap of stringer 5 separates from the web, simultaneously with the web fracture of stringer 2 (j–k). Lastly, the web of stringer 5 fails (l).

The frames of the high-speed footage are further analysed. When the caps separate from the web, the caps displace towards the skin in the middle of the panel. The caps hit the skin once or multiple times, with the skin also displacing out-of-plane in waves. When web fracture occurs, a few caps detach further and pull partially out of the potting material. After failure is completed, the caps return close to their initial position.

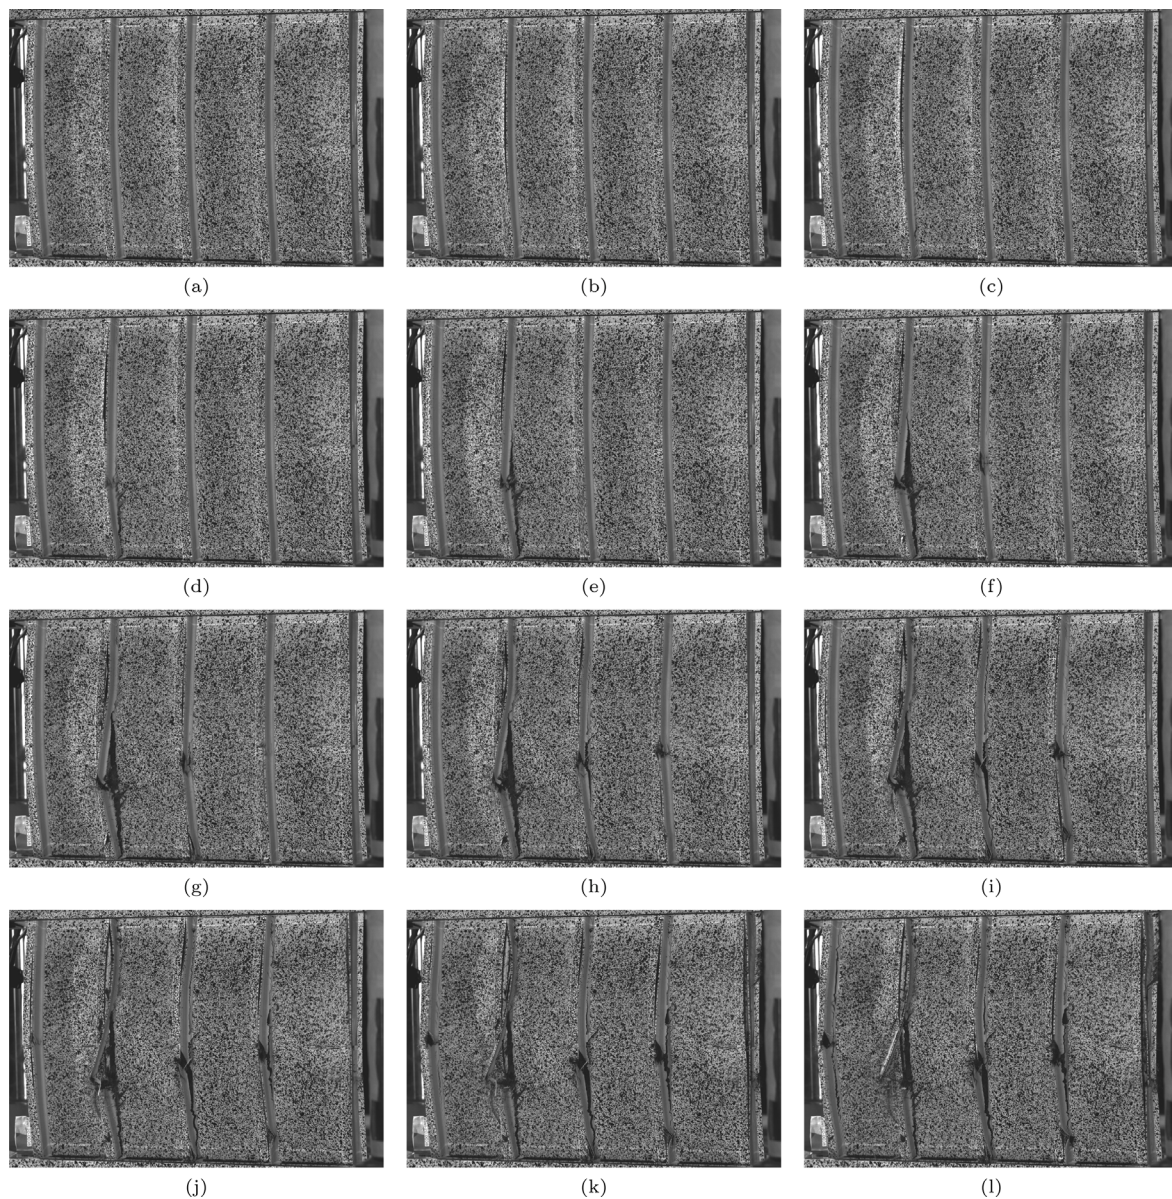
The panel collapse sequence of panel 2 is reported in Fig. 14 over a total time period of 2.3 ms, as every 2nd frame is reported. Panel collapse starts with the separation of the cap of stringer 2 in the middle

Fig. 14. High-speed footage panel 2: (a–b) stringer 2 cap separation; (c) stringer 2 butt-joint failure; (d) stringer 2 web fracture; (e) stringer 3 cap separation; (f) stringer 3 butt-joint and web failure, stringer 4 cap separation; (g) stringer 4 butt-joint failure; (h–i) stringer 4 fracture, stringer 1 cap separation; (j) stringer 5 cap separation, stringer 1 web fracture; (k) stringer 1 and 5 butt-joint failure; (l) stringer 5 web fracture.

of the panel (a–b), with a fracture in the cap at the bottom of the panel. The butt-joint of stringer 2 then separates from the skin at the bottom of the panel (c), which grows in an upward direction and is followed by fracture of the web (d). The cap of stringer 2 then separates from the web and fractures at the bottom of the panel (e). The butt-joint of stringer 2 fails at two locations, in the middle and bottom of the panel, and the web fractures (f). In the same frame, the cap of stringer 4 starts to separate, followed by further separation and fracture of the cap and failure in the butt-joint (g). The web of stringer 4 then separates, while the cap of stringer 1 also separates from the web (h–i). The web of stringer 1 then fails and the cap of stringer 5 separates from the web (j). The butt-joint of both stringer 1 and 5 then fails (k), and lastly, the web of stringer 5 fractures (l).

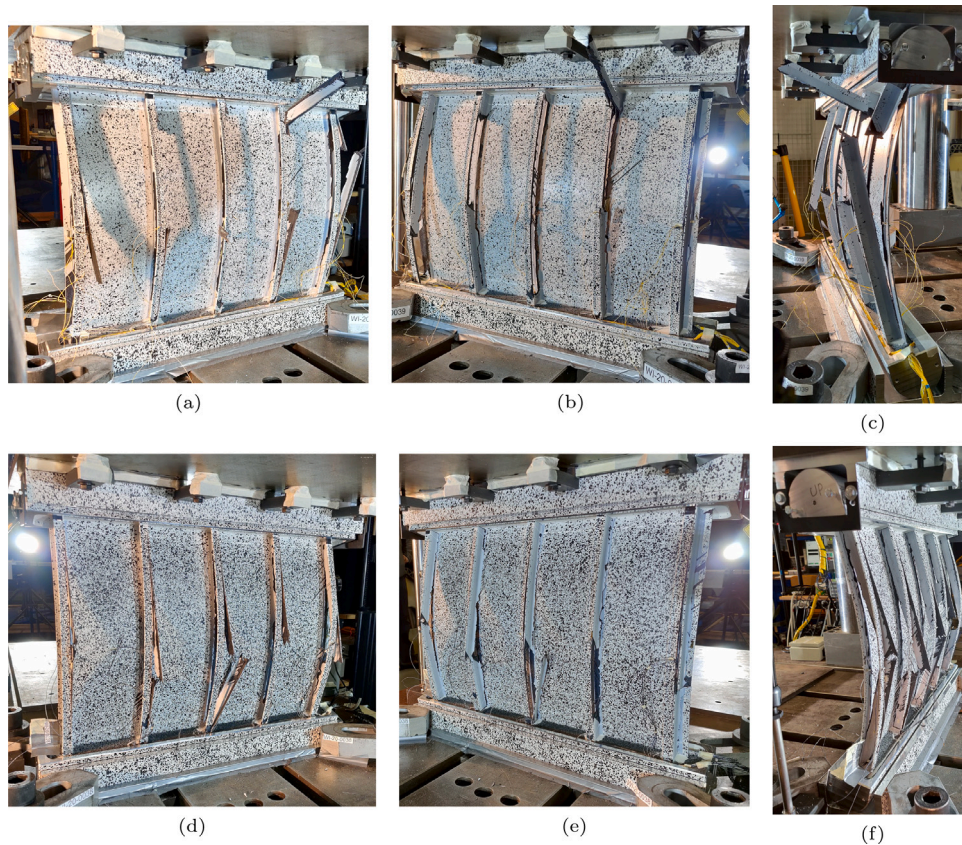
Photos of panel 1 after failure are reported in Fig. 15(a–c). The caps, once separated from the webs, show fractures in several locations.

The caps of stringers 1, 2 and 5 are also partially pulled out from the potting material. The failure between cap and web seems to occur in two different ways, with the top ply of the web being delaminated and pulled off partially, and with separation between the web and the short fibre filler. In the middle of the panel, it seems that failure and delamination of the web plies is more common, with small pieces of the ply still attached to the cap, while towards the top and bottom of the panel, failure occurs at the interface between the web and short fibre filler. All the webs separated from the skin at the butt-joint. The webs present one or more fractures in each web and parts of the web are no longer attached to the panel. The failure in the web and skin region is mostly in the butt-joint. Stringer 1 has a part of the ply delaminated from the skin at the bottom of the panel, and the remaining butt-joints only show minimal pulled-off fibres. Failure in the butt-joint can be roughly divided into three types of failure: failure at the interface between skin and butt-joint, failure in the short fibre filler and failure at the interface between web and butt-joint. There are no visible fractures in the skin, but there is likely damage inside the laminate. There are indications of damage at the back of the skin, with paint chipped off.

Fig. 15. Post-failure photos: (a) panel 1 left-view; (b) panel 1 right-view; (c) panel 1 side-view; (d) panel 2 left-view; (e) panel 2 right-view; (f) panel 2 side-view.

Photos of panel 2 after failure are reported in Fig. 15(d–f). The failure modes, that are initially visible, are similar to panel 1. Stringer 2 fails first and has considerable amounts of fibre pullout from the skin, especially towards the top of the panel. The biggest difference, however, is that the edge of the skin, on the side of stringer 5, shows a large fracture. A close-up picture of this fracture is reported in Fig. 16. The skin is fractured across the thickness of the laminate and has a visible length of approximately 60 mm as seen from the stringer-side of the panel. Further propagation is visible on the back side of the skin, with propagation in a downward direction, leading to a total visible length of approximately 100 mm.

Both panels show failure first in the web-cap joint area. The cap-web failure of panel 1 occurs in the stringer with a BVID in the butt-joint, but the BVID itself is not necessarily critical, with no indication of crack growth before panel collapse. From panel 1, a close-up of the stringer 4 cap and of the web is reported in Fig. 17(a–b). There are web plies still attached to the cap (Fig. 17(a)), both the -45 ply (blue arrow) and parts of the 90 ply (red arrow), and the 45 ply (purple arrow) is visible on the web (Fig. 17(b)). This indicates that the critical failure mode is a combination of both the failure of these plies and delamination. Panel 2 fails in stringer 2, and the criticality of this stringer out of the three middle stringers is most likely due to imperfections. The stringer 2 web of panel 2, as reported in Fig. 17(c), shows similar damage as stringer 4 of panel 1. The 45 ply (purple arrow) is visible at the top of the web, as the -45 ply (blue arrow) and 90 ply (red arrow) present failure as well as delamination, indicating the same failure mode as panel 1.

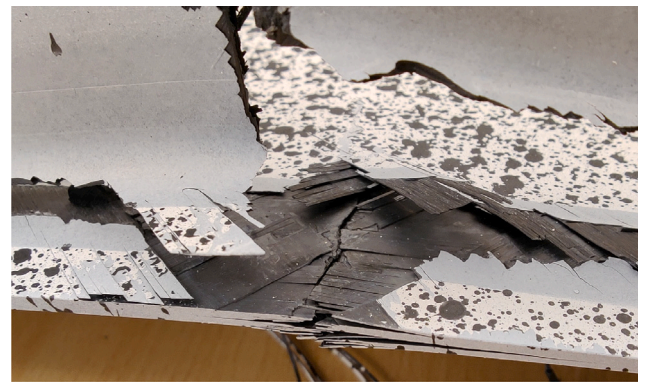
Fig. 16. Skin fracture of panel 2.

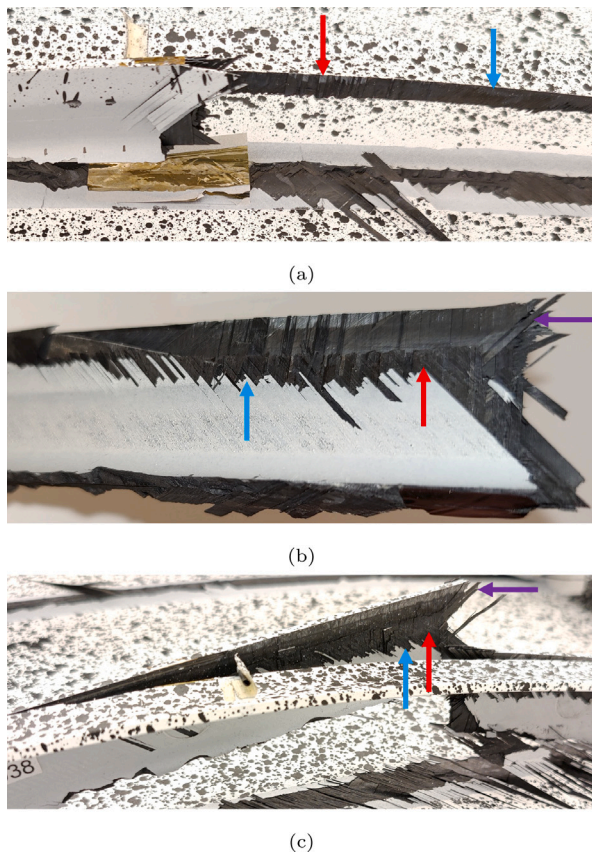
Fig. 17. Fracture photos: (a) panel 1 web and stringer; (b) panel 1 web; (c) panel 2 web and cap.
