## Combining Architectural Conservation and Seismic Strengthening in the Wood-Based Retrofitting of a Monumental Timber Roof

### The Case Study of St. Andrew's Church in Ceto, Brescia, Italy

Mirra, Michele; Gerardini, Andrea; Ghirardelli, Sergio; Ravenshorst, Geert; van de Kuilen, Jan-Willem

International Journal of Architectural Heritage

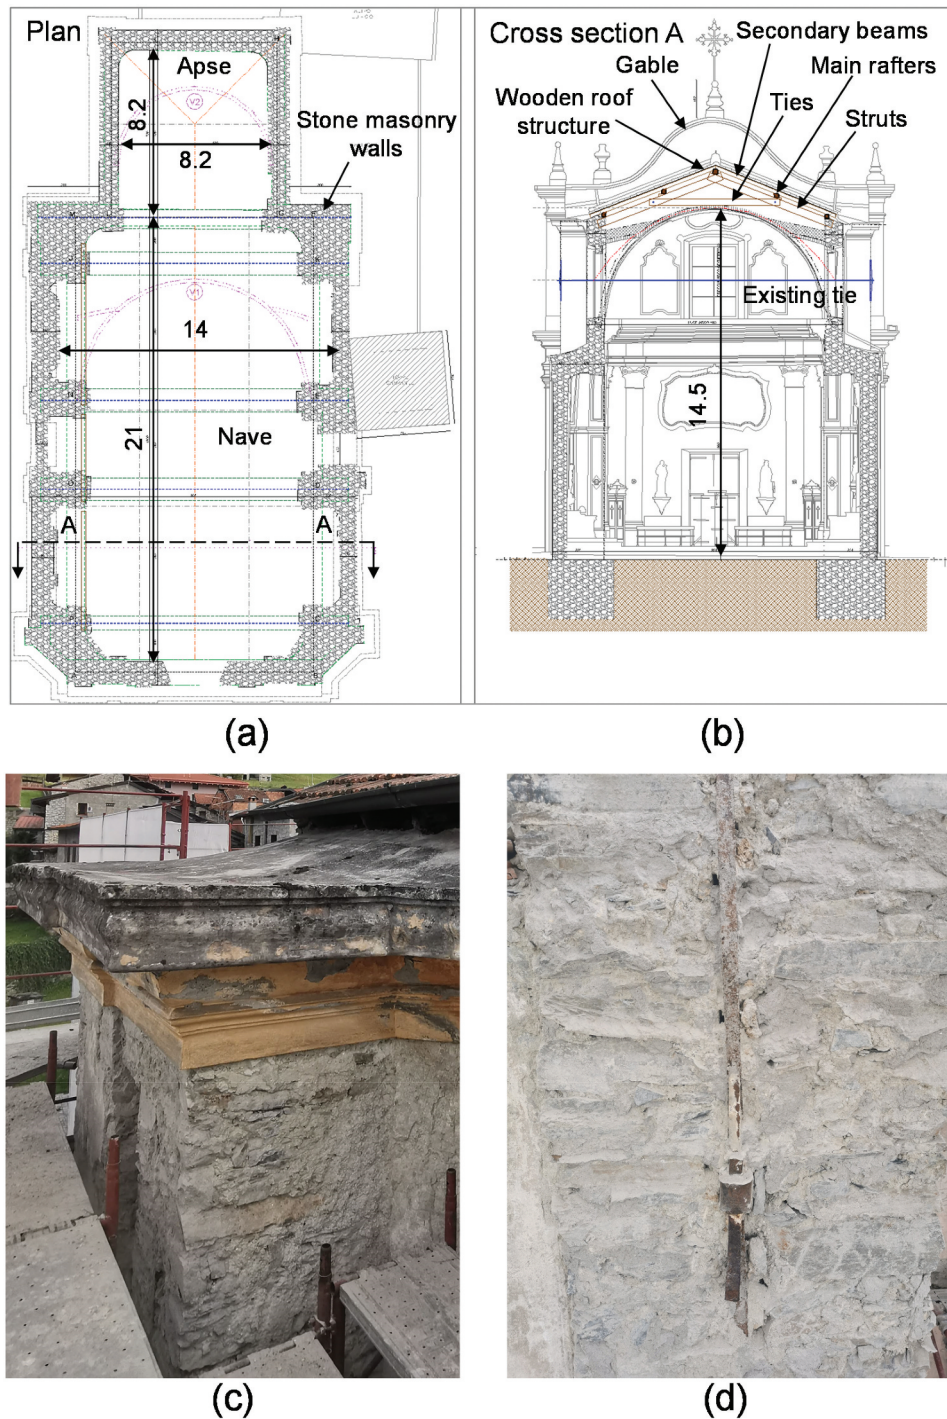
With regard to the main structural components of the church, all walls are composed of stone masonry (Figure 3c), reaching an average thickness of about 220 cm in the location of the buttresses, which also feature existing metal ties at the vault height (Figure 3d). Elsewhere, the thickness of the walls varies from 70 cm to 100 cm;

**Figure 3.** Plan (a) and cross section (b) of the case-study church (dimensions in m); particulars of a stone masonry wall (c) and of an existing metal tie (d).

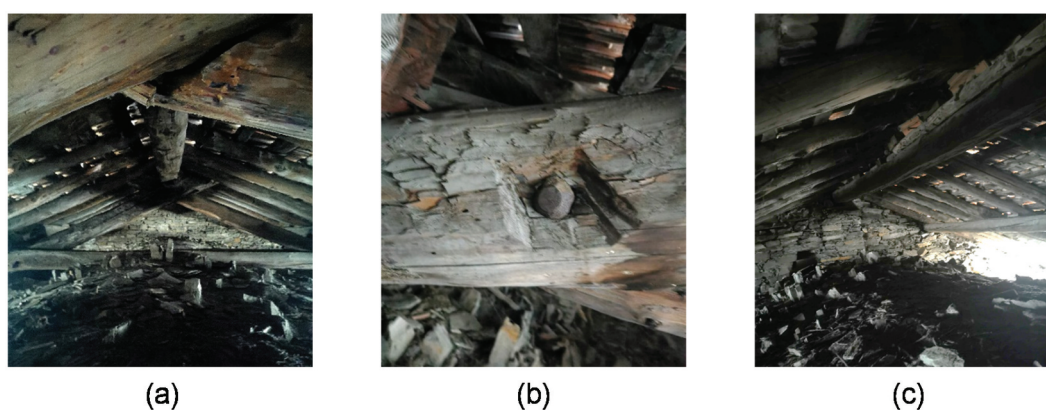
**Figure 4.** (a) Existing wooden roof structure; (b) existing metal pin between timber struts and ties; (c) ridge beam undergoing excessive deflection.

The wooden roof structure was found in fair state of conservation but was very difficult to inspect, as the attic of the nave and the apse is narrow and normally not accessible. The main rafters, including the ridge beam (Figure 4c), appeared to be very undersized, also considering the spans involved, up to 8 m: large deflections could be observed, which had been compensated over time by additional wooden blocks, to keep the support for the secondary beams as horizontal as possible. These secondary elements seemed better dimensioned and sound, but a small number of joists (approximately 15% of the total) were locally affected by biological degradation, caused by slight water infiltrations. The main wooden struts and ties were sound as well, and according to the static calculations performed, had adequate dimensions for their structural purpose. Yet, the existing connections with metal pins (Figure 4b) were not effective, because the holes in which they were located had become too large over time: thus, the ties could not fully absorb the horizontal thrusts induced by the struts, which seemed to be partly taken by the masonry buttresses.

The few joists and planks damaged by water infiltrations were integrated with newly supplied C24 joists, laid alongside the existing ones, and featuring their same geometry and wood species. Besides, the longitudinal rafters, which appeared to be very

undersized, were provided with an adequate flexural reinforcement, by placing additional C24 wooden beams clamped to the main ones by means of steel plates and threaded bars (Figure 8). These newly supplied beams had again the same geometrical

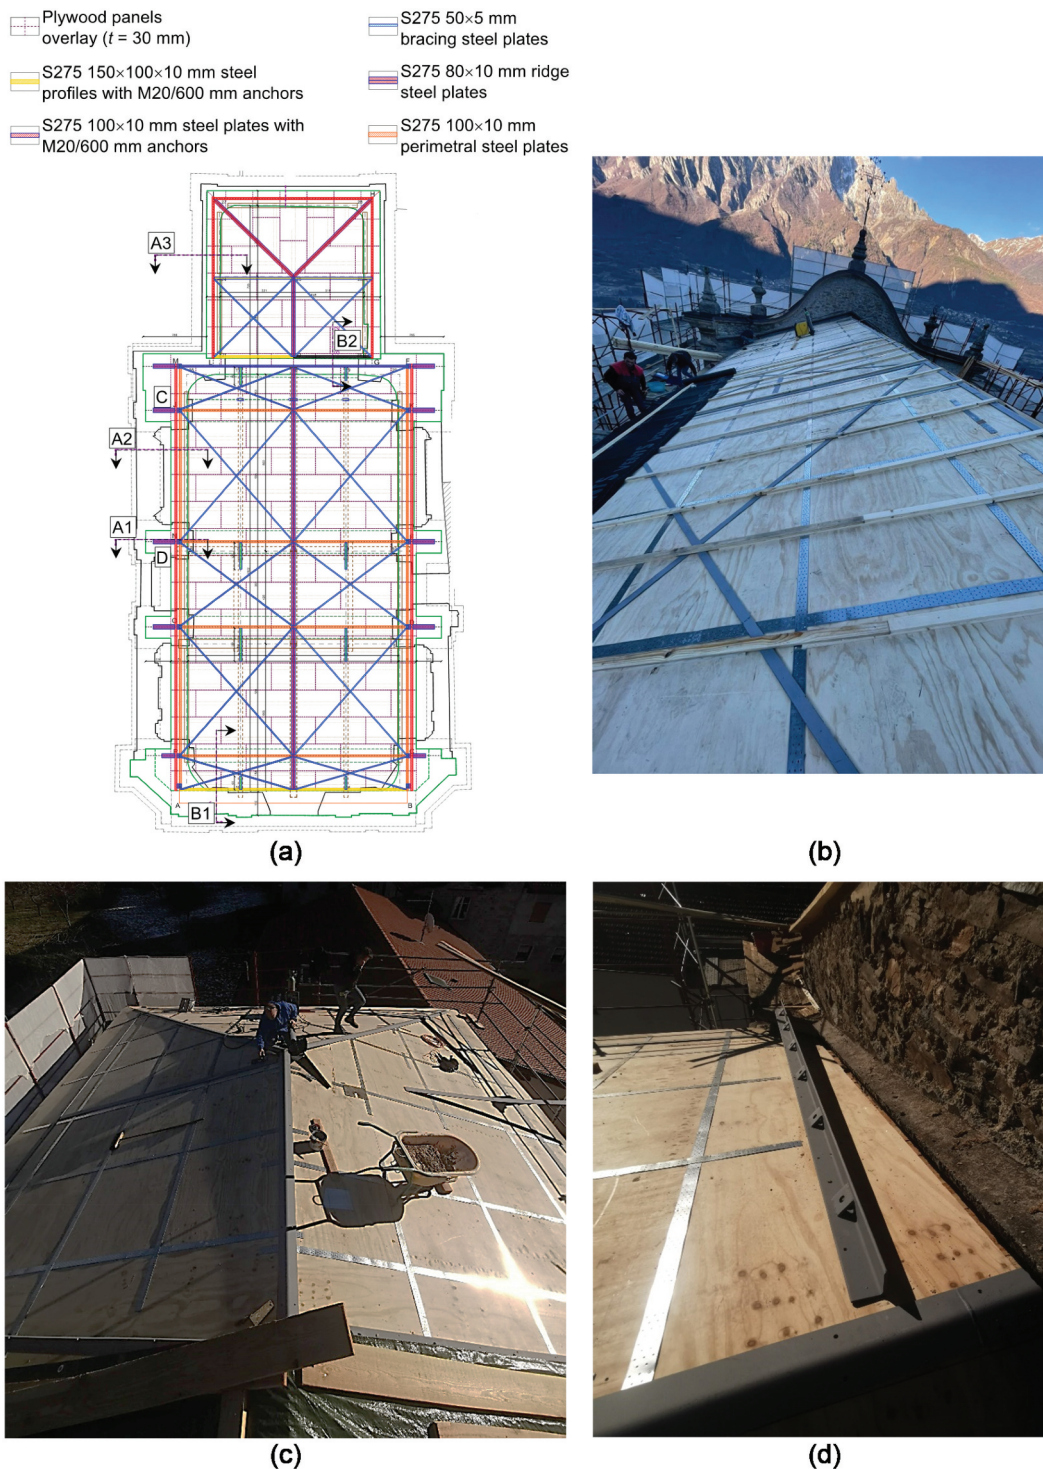
**Figure 5.** (a) Overview of the seismic retrofitting interventions; plywood panels overlay above the nave (b) and the apse (c); steel profile for the connection to masonry (d).

In order to meet the requirement of seismic improvement, retrofitting interventions were applied to the structural element responsible for most vulnerabilities, i.e. the wooden roof, seizing also the opportunity to combine both strengthening and architectural conservation. Taking into consideration the improvement of seismic shear transfer and redistribution of the existing roof, the main retrofitting intervention consisted of transforming it in a diaphragm. To this end, an overlay of 30-mm-thick C24 structural plywood panels fastened to the existing sheathing with  $4 \times 60 \text{ mm}$  Anker nails at 80 mm spacing, was realized (Figure 5). The plywood panels overlay was designed considering each roof pitch as a shear wall. Since the panels have a standard width of  $b_i = 1200 \text{ mm}$ , 15 nails were present on each panel's short side, following the adopted spacing  $s = 80 \text{ mm}$ . The long side of the roof above the barrel vault featured 16 rows of panels (see Figure 5), thus the total strength was derived as the design shear strength  $F_{v,Rd}$  of a single

On top of the plywood panels overlay, as an extra safety measure, an additional light bracing system consisting of  $5 \times 80 \text{ mm}$  S275 steel plates was designed, to promptly prevent local overturning mechanisms of the gable and the other walls, by directly transferring the pertaining shear forces to the buttresses (Figure 5). Besides, to enable an effective and distributed transfer of shear and tensile stresses, an adequate connection system between the new diaphragm and the wall had to be designed. Because the existing joists at the supports of the roof structure rested on the masonry for only 75% of their thickness (Section 2.2, Figures 6–7), the realization of anchors directly crossing them would not have been fully effective in preventing overturning mechanisms. Therefore, along the perimeter of the church, in correspondence to the eaves channels, a steel curb was realized in the position of the centre of mass of the wall (Figures 6–7). To allow the transfer of the shear and tensile forces between the plywood panels overlay and the curb, a connection with steel plates was created, in combination with a cable bracing system (Figure 6). The steel curb was then connected to the walls and the buttresses with M20 anchors (80–120 mm depth). The global seismic retrofitting intervention was particularly appreciated by the Superintendence for Architectural Heritage, since it allowed to avoid more invasive solutions and preserve at most the original wooden roof structure.

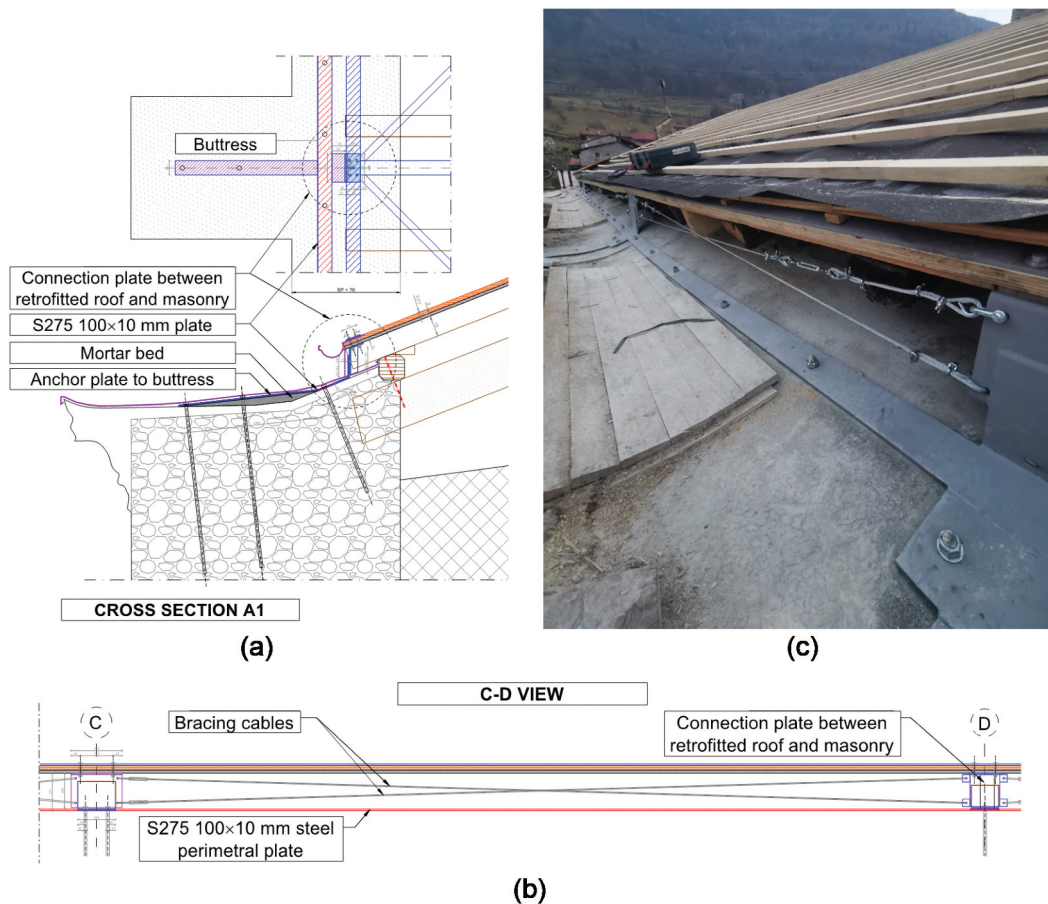
**Figure 6.** Connection between retrofitted roof diaphragm and masonry walls, with reference to the plan of figure 5: (a) cross section of the joint system in correspondence of the buttriss; (b) system of bracing cable between buttrisses; (c) realization of the intervention on site.

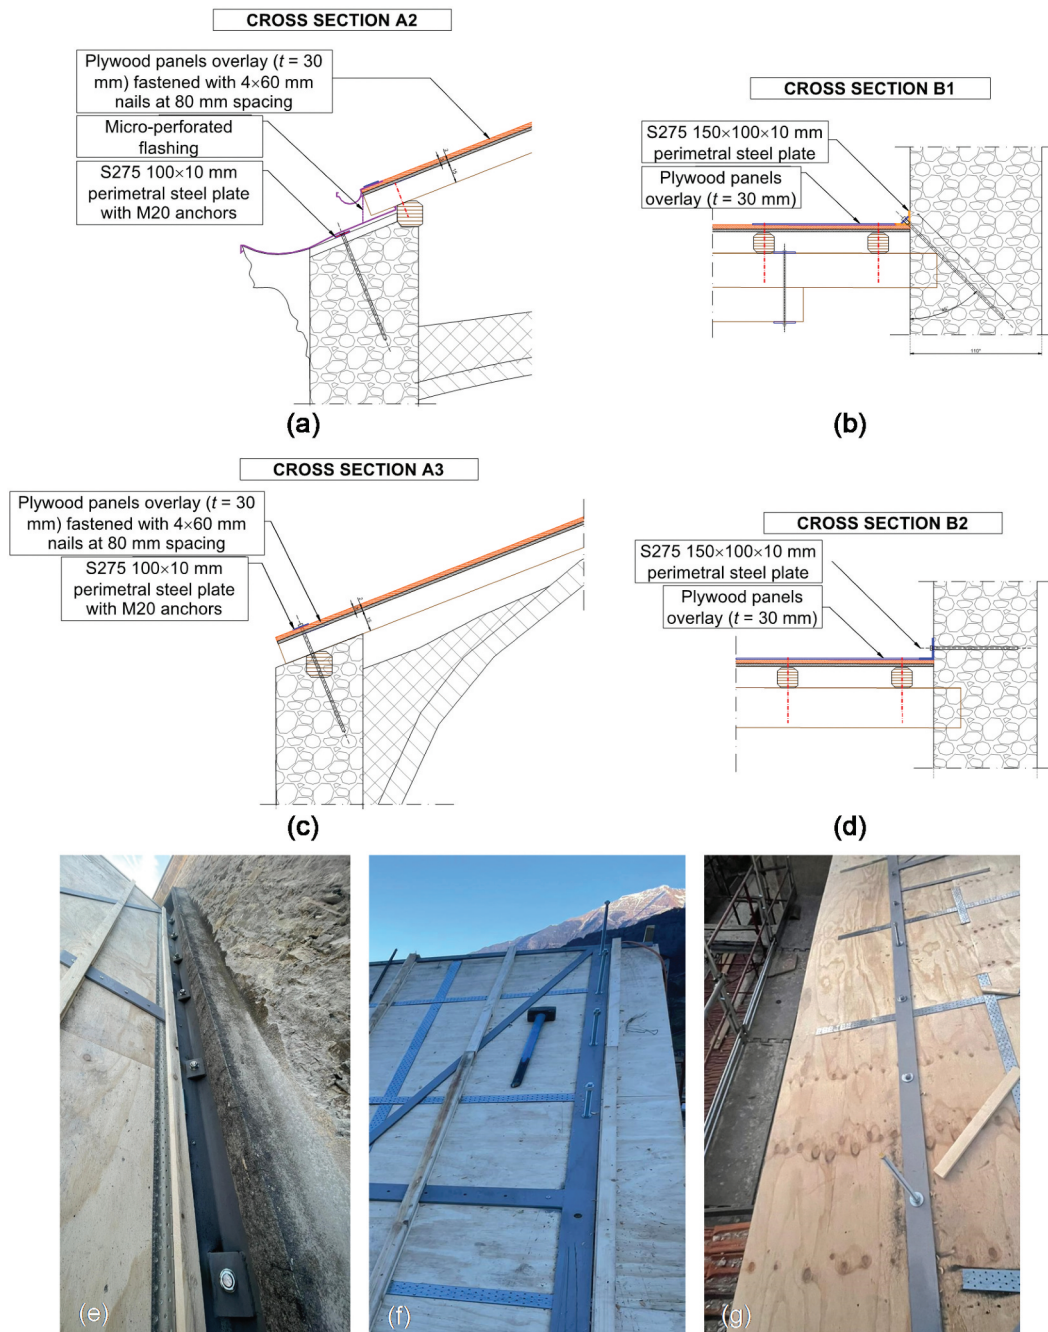
**Figure 7.** Connection between retrofitted roof diaphragm and masonry walls, with reference to the plan of figure 5: (a) cross section of connection system along the nave walls; (b) cross section of connection system in the main façade; (c) cross section of connection system along the apse walls; (d) cross section of connection system in the wall separating nave and apse; (e-g) examples of realized joints.

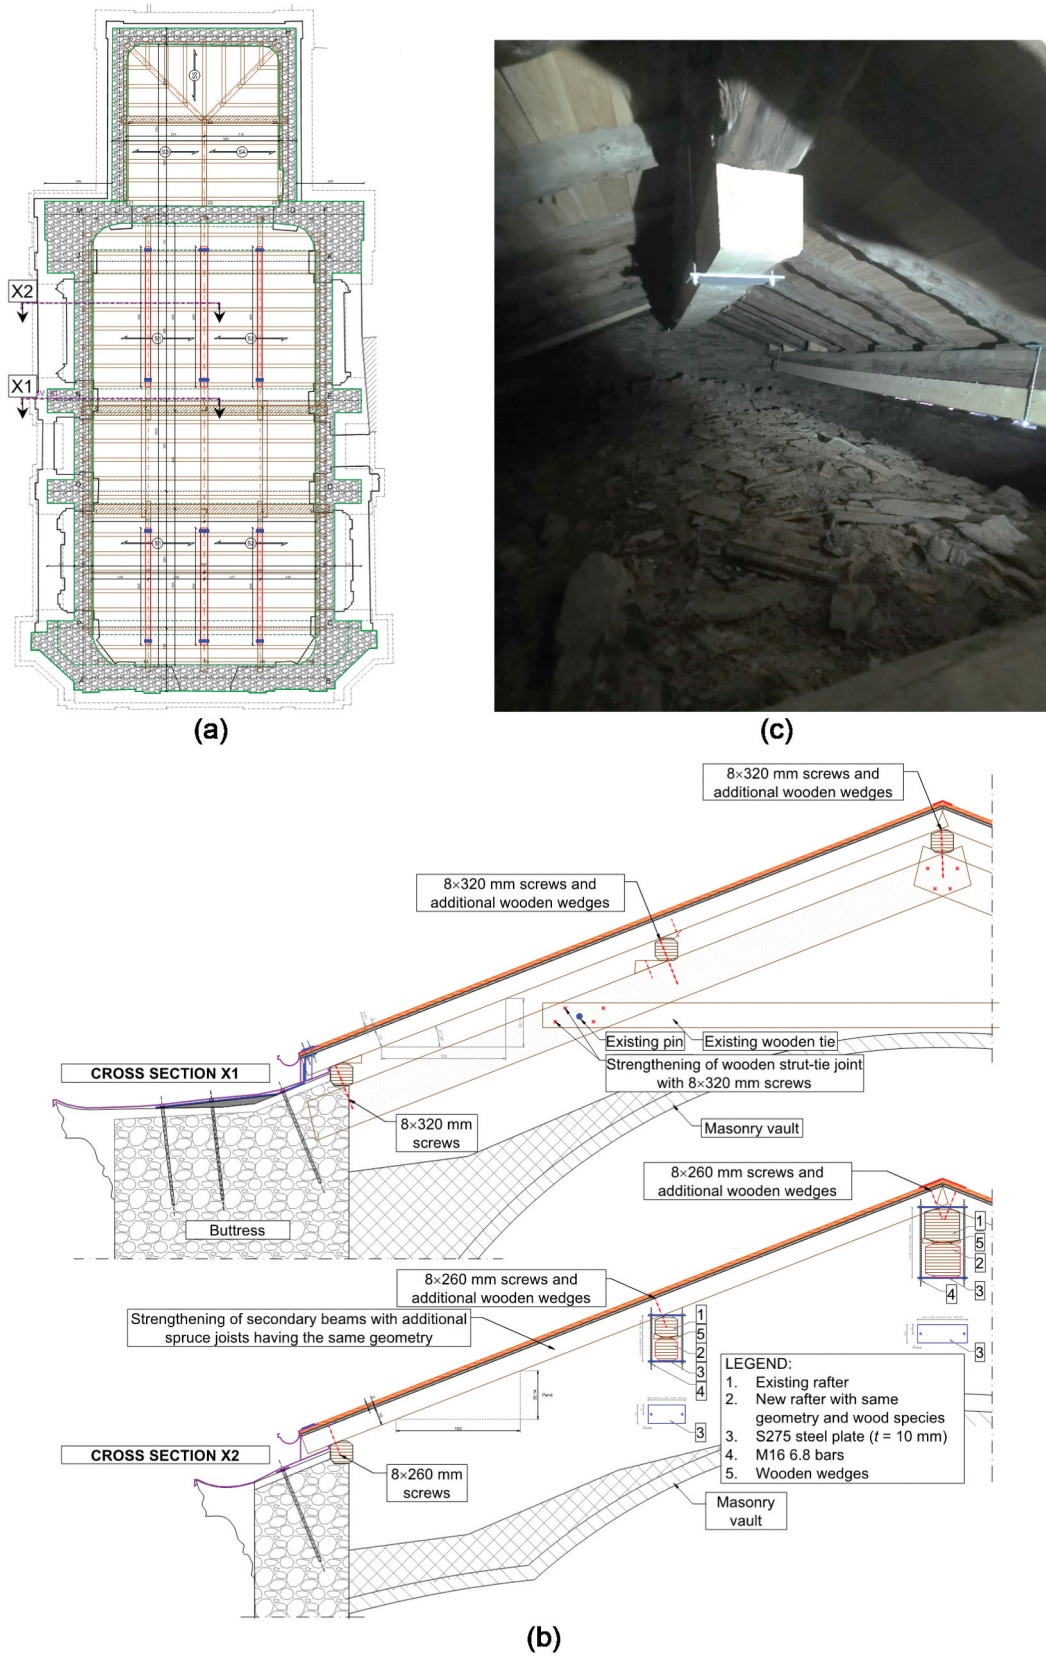
**Figure 8.** Plan (a) and cross sections (b) of the flexural reinforcement interventions on the roof; (c) realization of the interventions on site.

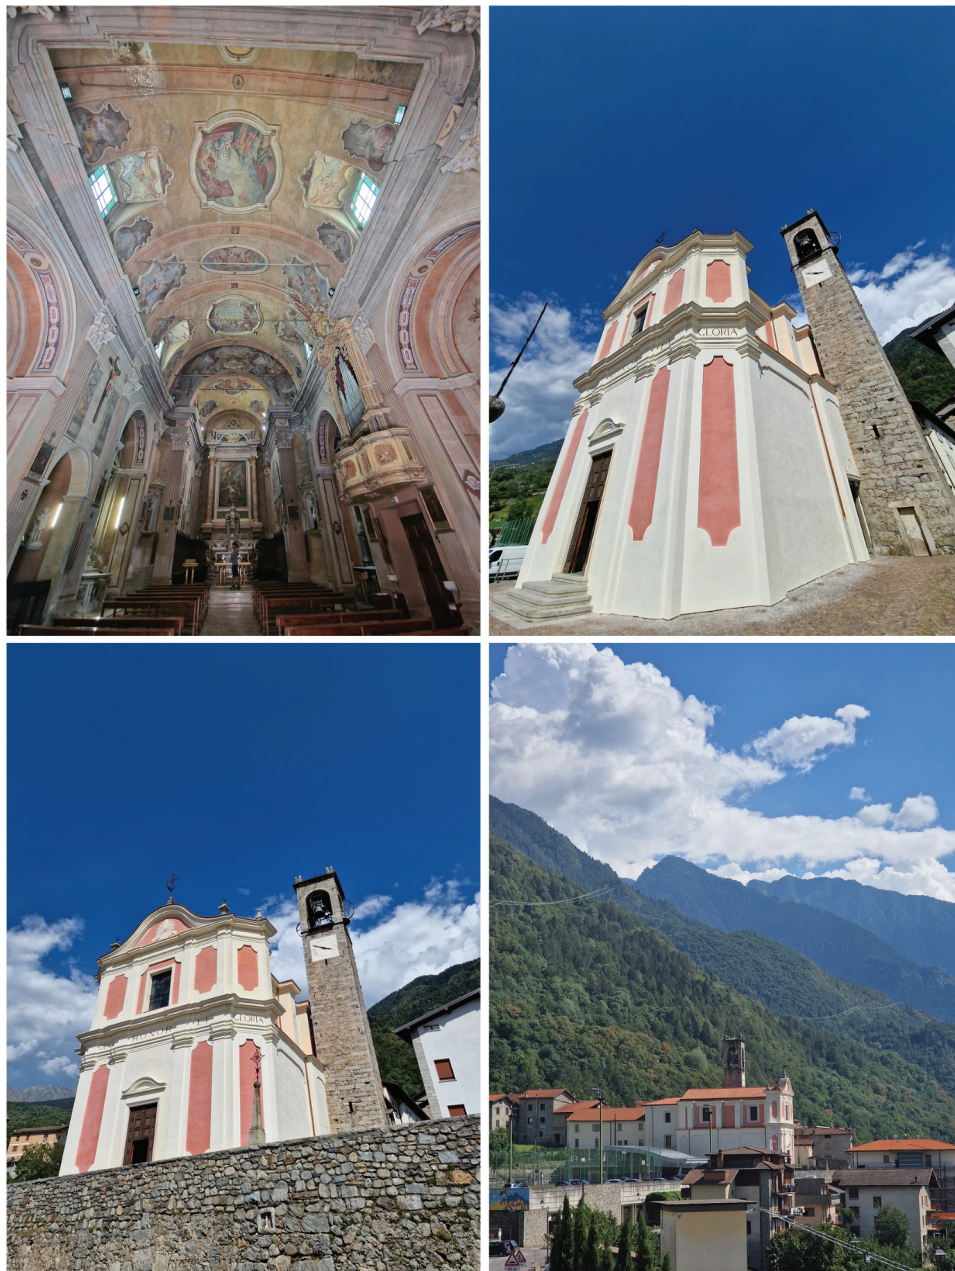
**Figure 9.** Views of the church of Ceto after the seismic retrofitting and restoration work.

The static and seismic retrofitting measures, as well as the whole restoration work on the church, were concluded in the second half of 2022: the building after these interventions is shown in Figure 9.
