Corrosion-fatigue damage identification in submerged mooring chain links using remote acoustic emission monitoring

Marine Structures

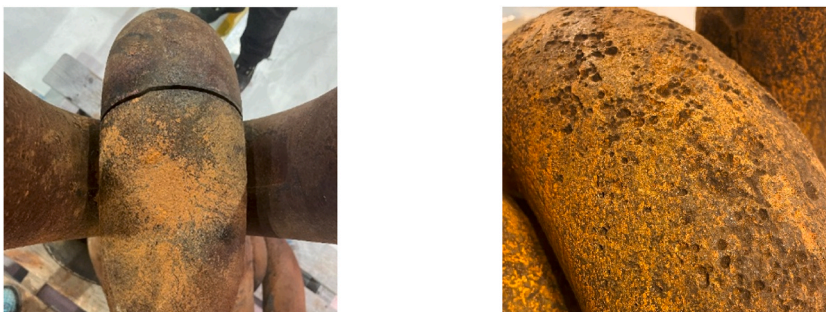
Fig. 1. Fatigue crack (left) and corrosion pits (right) in mooring chain links.

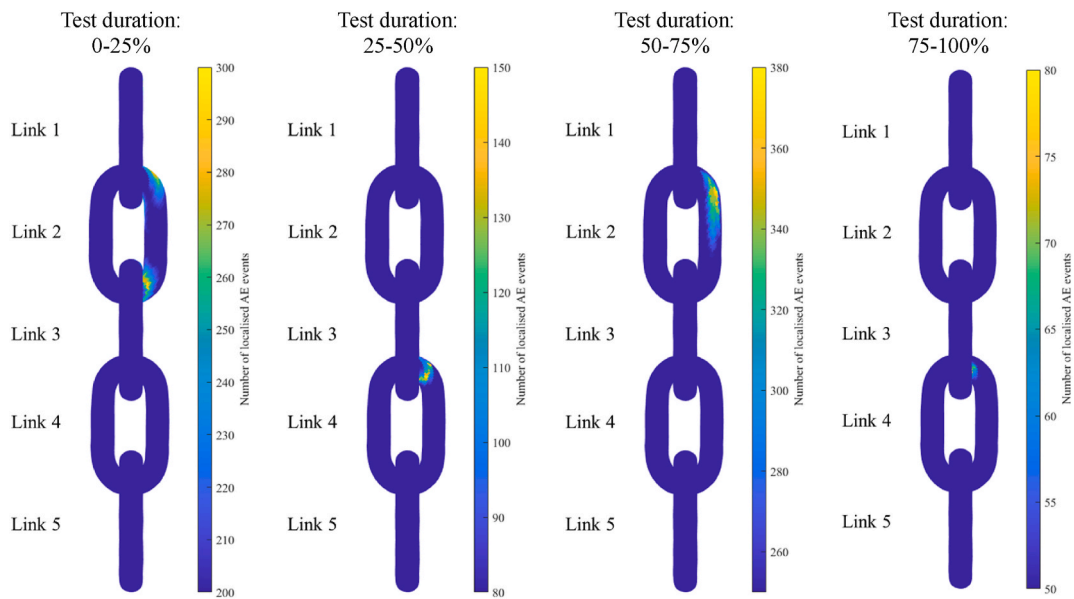
Fig. 8 shows the localisation map for four time periods of the test duration. Only from the AE source localisation maps, three damage zones can be identified. The damage zones are defined as the areas in the chain segment showing the highest number of localised AE events. These zones are located at the intersections of neighbouring links (i.e. Link 1–2, Link 2–3, and Link 3–4) and can generally be interpreted as the ‘crown areas’ (generally being the most susceptible to cracks, along with the welds). The first part of the test, 0–25 % of test duration, shows localised acoustic activity between Link 1–2 and Link 2–3. Both zones present a range of 250–300 localised AE events. In the second part of the test, 25–50 % of the test duration, the largest area of AE activity is located between Link 3–4, with 120–150 AE events. Between 50 and 75 % of the test duration, a relatively high number of AE events (in the order of 300–400) is localised around the crown area of Link 2, towards Link 1. The final part of the experiment, between 75 and 100 % of the test duration, shows acoustic activity in the upper crown of Link 4, with 50–80 AE events.

Fig. 8. Localisation map of AE sources for different periods of the test duration.

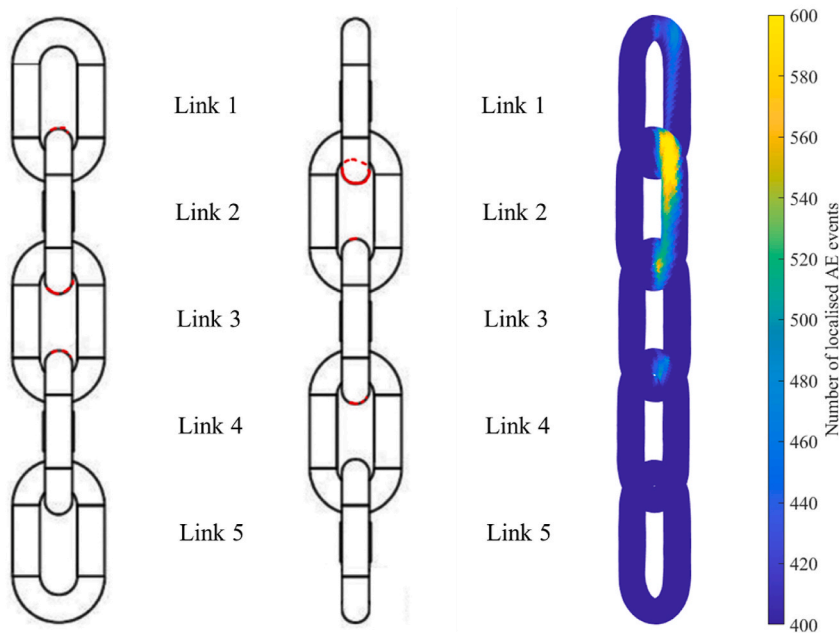
Fig. 9 shows the localisation map for the 100 h of measurements analysed. The AE source localisation map reveals three distinct zones of acoustic activity. Acoustic activity is expected to have been detected all over the chain segment due to the natural corrosion

process. However, highly localised AE activity can manifest the presence of fatigue cracks. The most prominent localised area is observed in Link 1–2. This is characterised by a number of localised AE events of approximately 600, spread between the crown and the weld area of Link 2. The second-largest area of AE activity is situated in the crown area of Link 2, towards Link 3, with 550–600 localised AE events. These initial observations suggest that Link 1–3 was the most acoustically active part of the chain, confirming early indications from the parametric analysis of AE. A third zone of activity is noted in the crown of Link 4, toward Link 3, accounting for a total of localised AE events ranging between 450 and 500. A few limitations and improvement points can be identified in the AE source localisation map. First, the localised areas seem to be biased against the middle part of the chain link crown (where fatigue crack is expected to grow). This bias may arise from potential masking effects on the damage-induced ultrasound signals and the limited number of sensors in play in the localisation. Possible improvements involve increasing the number of sensors in the movable arrays and accounting for masking issues in the AE source localisation algorithm. Second, the difference in AE events numbers may be related to the extent and stage of damage, but it is also influenced by the sensitivity of the sensors and the monitoring duration in each specific position (of the movable array). Future work will incorporate the normalisation of the AE source localisation map to enhance a more accurate comparison of the monitoring results.

Fig. 9. Total localisation map of AE sources and a sketch showing the main fracture and the observed indications (red circle and red lines respectively) during the post-failure inspection.

When combined with the insights in Fig. 9, it can be inferred that the main AE source localised in Link 1–2 correlates with the main fracture (and linear indications) in the chain segment. The entity of the secondary AE sources (i.e. the number of localised AE events) localised in Link 2–3 and Link 3–4 correlate with the indications observed in the respective areas. All the locations where indications were found through MP testing have been detected and localised using the remote AE technique. Furthermore, there are no indications by the AE that have not been found using MP testing. It can be concluded that a good correlation between the post-failure observation and the AE localisation has been found.

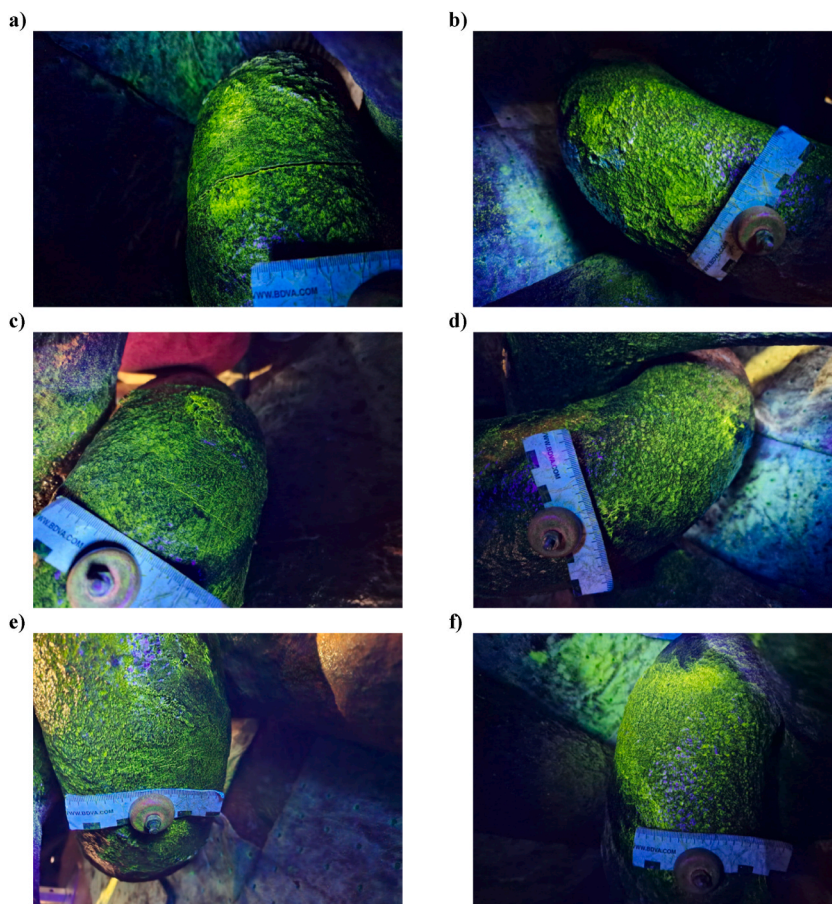
The condition of the chain segment was assessed at the end of the experiment through visual inspection and magnetic particle (MP) testing. All the links of the chain segment were tested. The positions in each link are labelled A, B, C, and D as shown in Fig. 10. The reported observations are located in the crown area of the chain links. The results of the post-failure inspection are shown in Fig. 11. The main fracture (Fig. 11a) was observed in Link 1 towards Link 2. The results of the post-failure inspection are summarised in Table 3.

Fig. 11. Results post-failure inspection. (a) Link 1, position D. (b) Link 2, position A. (c) Link 2, position D. (d) Link 3, position A. (e) Link 3, position D. (f) Link 4, position A.

Link	Region	Observations	Shown in Figure
Link 1	D	Fracture and linear indication measuring 12 mm.	Fig. 11a
Link 2	A	Linear indications measuring 6 mm, 4 mm, and several linear indications <2 mm.	Fig. 11b
	D	Linear indications measuring 40 mm, 15 mm, 10 mm, and multiple linear indications <5 mm.	Fig. 11c
Link 3	A	Linear indication measuring 10 mm.	Fig. 11d
	D	Linear indication measuring 10 mm, and multiple linear indications <3 mm.	Fig. 11e
Link 4	A	Linear indications measuring 6 mm, 5 mm, and multiple linear indications <3 mm.	Fig. 11f
