Metals

# Failure Mechanisms of Mechanically and Thermally Produced Holes in High-Strength Low-Alloy Steel Plates Subjected to Fatigue Loading

Carlos Jiménez-Peña <sup>1,\*</sup>, Constantinos Goulas <sup>2,3</sup>, Johannes Preußner <sup>4</sup> and Dimitri Debruyne <sup>1</sup>

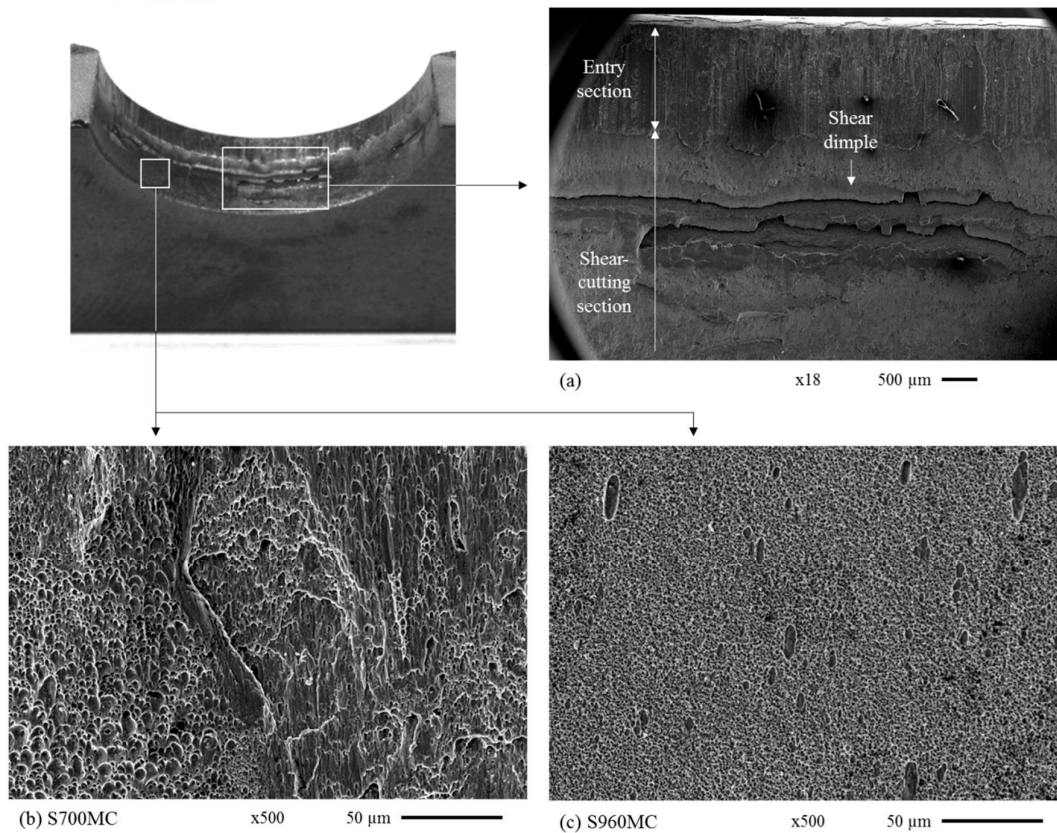
The optical analysis of the hole surfaces revealed significant differences between hole-making conditions. In Figure 4, the surface of the punched holes (flat punch) is shown. The shear-cutting section was formed by dimples elongated in the direction of the punch travel. A large amount of shear dimples was observed in the S700MC and S960MC steel grades, in which large sections of the hole surface were removed during punching. This phenomenon is displayed in Figure 4a for the S700MC and it was observed in all punching conditions. The dimples were much less present in the S500MC punched samples [13], where most of the surface was covered by smooth and highly deformed material. During the initial penetration of the punch in hole making process, the S500 formed coarse dimples when the hole began to form. However, the dimples were smeared away during the penetration of the punch. On the cutting surface of S700MC, Figure 4b, and S960MC,

Figure 4c, more dimples could be observed. This is because the microstructure in these grades was mostly of martensitic nature, therefore more difficult to smear away due to the increased hardness. The dimples in these cases were smaller, because the original microstructure was finer and contained carbides, which act as nucleation sites for the dimples. This fact makes the dimples more uniformly distributed in the higher strength grades than in the S500MC.

**Figure 4.** (a) SEM overview of entry and shear-cutting sections in punched holes. Below, a detailed view of the exit side is shown, where differences between (b) S700MC and (c) S960MC are evident.

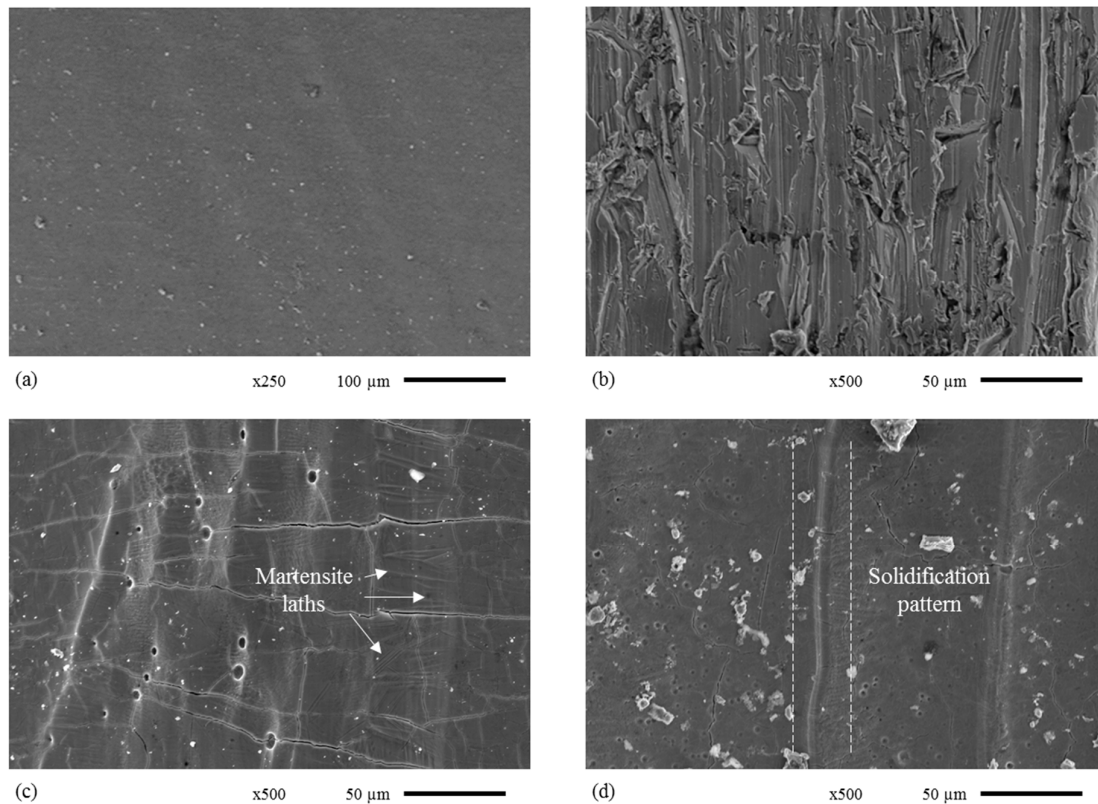
The remaining hole-making techniques produced hole surfaces with similar features, independently of the steel grade. Drilling always resulted in a smooth, feature-less surface, with no visible characteristics apart from the drill-traces in the direction of the drill rotation, noted in **Error! Reference source not found.a**. Drilling also produced a characteristic drill-chip, which is normally removed manually with a deburring tool. The chip was left intact, as in the previous research by the authors [13]. Waterjet-cutting produced highly abraded surfaces, with multiple dents at the locations in which the material was removed by the abrasive jet. A characteristic waterjet-cut surface is shown in **Error! Reference source not found.b**. Both laser-cut (**Error! Reference source not found.c**) and plasma-cut (**Error! Reference source not found.d**) surfaces were covered by a regular crack pattern. Cracks were very superficial and likely to be formed on a thin surface layer covering the hole surface. Plasma-cut surfaces additionally displayed traces in the direction of the hole, which indicate that the material at that location was extensively melted and resolidified. The location in which the plasma first entered the material was also characterized by the presence of a large blob of solidified material. In order to avoid any effect caused by this distinct surface condition, the plasma-cutting process was adjusted so the entry point of the plasma jet was not located at the expected fracture location (midsection of the hole) but at an angle of 45 degrees with respect of the axial loading. Similar observations for the drilled, waterjet-cut, laser-cut, and plasma-cut holes were made for the HSLA grade S500MC in [13], hinting at the independence of the hole surface from the microstructure of the

steel. In drilling and waterjet cutting, the surface was highly abraded and no distinct features were distinguishable between steel grades. In thermal cutting processes the surfaces were melt and resolidified into a new martensitic microstructure, which was also similar in all grades.

**Figure 5.** Hole surfaces produced by (a) drilling, (b) waterjet cutting, (c) laser cutting, and (d) plasma cutting.

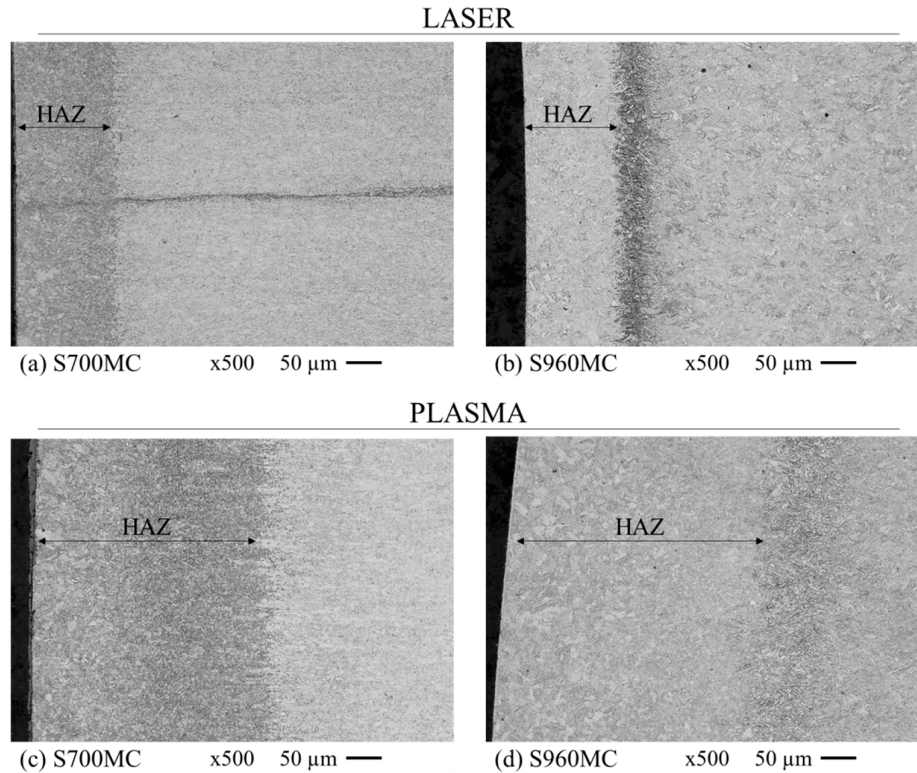
Similarly to [13], protruding acicular structures were observed in the laser cut of all HSLA grades, indicating the presence of martensite formation. These structures were also found in the plasma-cut surfaces but not as clearly and in the quantity observed in the laser-cut samples. The cross-section of the thermally cut specimens was further studied to evaluate the layer of transformed material. Cross-sections of the laser- (above) and plasma- (below) cut holes are displayed in **Error! Reference source not found.**. The analysis of the heat-affected zone (HAZ) revealed that there is a microstructurally affected layer surrounding the hole. This layer was characterized by martensitic microstructure. The dominant presence of martensite was a result of the large heat input from the cutting process and the subsequent fast cooling. The extension of the HAZ in the plasma-cut specimens was approximately three times larger than in the laser-cut specimens, in similarity with the S500MC grade [13].

**Figure 6.** Cross-section of thermal-cut holes: (a,b) Laser and (c,d) plasma.

Additionally, the cross-sectional analysis revealed the presence of centerline segregation indicated in Figure 6a, in the all three HSLA grades. This is related to the continuous casting production process. The centerline segregation can lead to local embrittlement [29].

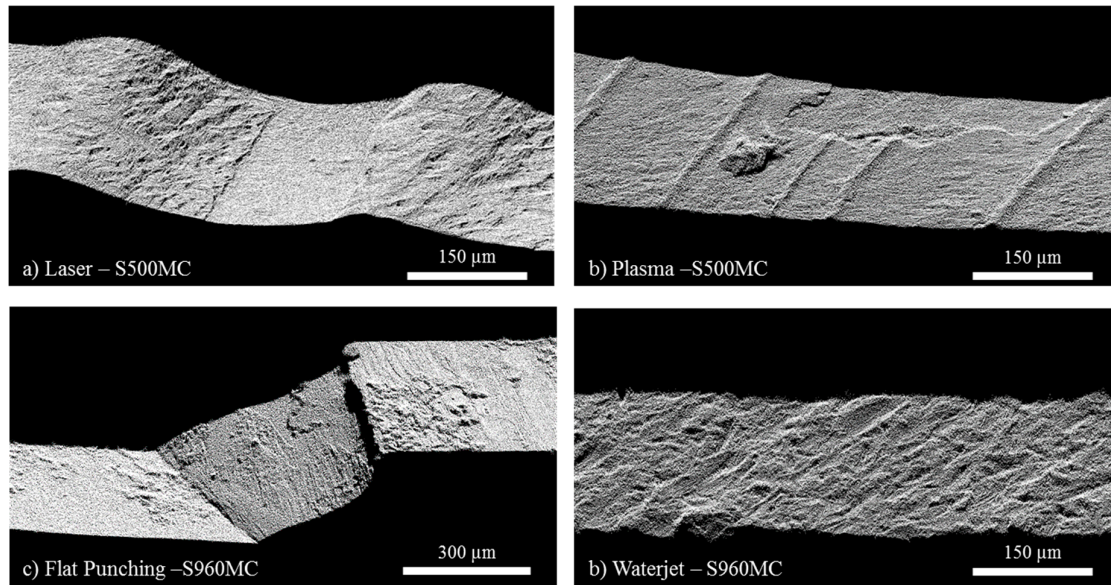
The surface profiles obtained by laser microscopy allowed to observe the predominant features that some of the hole-making techniques had in certain directions. A wavy pattern can be observed in laser-cut holes. This striation pattern is produced by the laser pulsations during the cutting process. This waviness was not observed in the plasma-cut surface, which appeared flat, but was also covered

by striations or ridges. These ridges were observed to be long and straight in the S500MC sample, see Figure 8b, and short and interconnected in the S960MC sample. They related with the solidification patterns previously discussed in Section 3.2. The analysis of the punched samples indicated that roughness differed locally in sections with a large amount of removed material (shear dimples). A distinct step was found in the punched S960MC sample (**Error! Reference source not found.c**), which indicated that the morphology of the hole is largely dependent on the presence of shear dimples. Finally, the waterjet-cut samples were found to have a granular surface topology caused by the abrasive cutting process, as shown in **Error! Reference source not found.d**.

**Figure 8.** Surface profile of (a) laser-cut hole (S500MC), (b) plasma-cut hole (S500MC), (c) flat punching (S960MC), and (d) waterjet-cut hole.

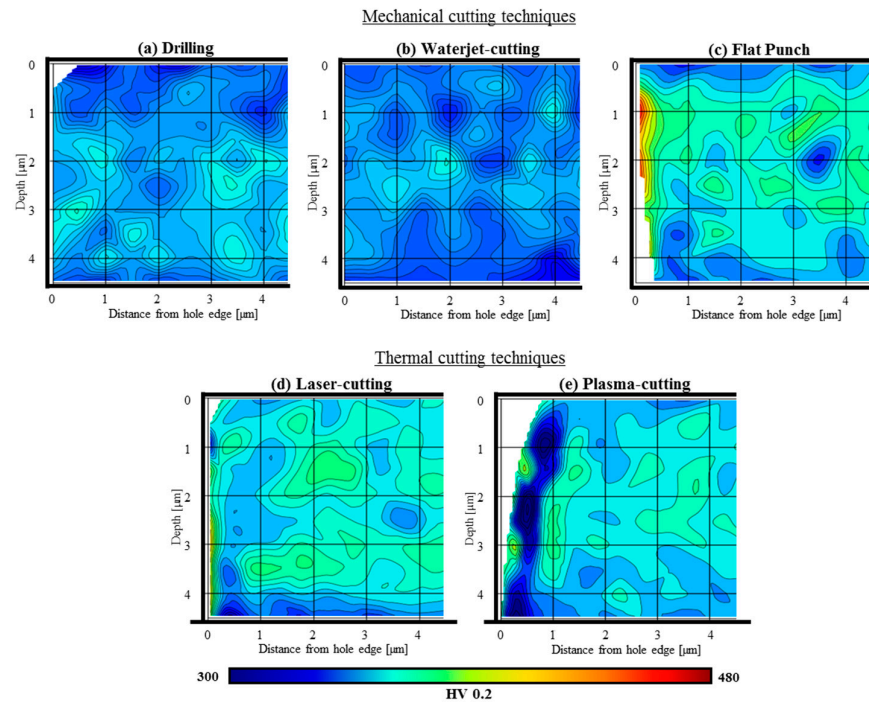
The produced hardening maps for the S700MC (**Error! Reference source not found.**) and S960MC (Figure 11) show a clear increase in the material hardness near the edge for punching and the thermal cutting processes, similarly to the S500MC in [13].

**Figure 11.** Hardness distribution near the hole edge in HSLA grade S960MC for various hole-making procedures: (a) drilling, (b) waterjet-cutting, (c) flat punching, (d) laser-cutting and (e) plasma-cutting. The hole edge is located on the left side of the images.

A notable hardness increase was also found in the laser-cut samples, but mainly in the S700MC HSLA grade. The phase transformation triggered during the thermal cutting processes resulted in a thin layer of martensitic microstructure surrounding the hole edge. The hardness of this layer was significantly higher than the mixed bainitic-tempered martensitic of S700MC base material and similar to the martensitic matrix of the S960MC microstructure. The martensite formation could explain the notable hardness increase in the S700MC grades while in the S960MC grade this increase was barely significant. A similar hardening was found in the S700MC plasma-cut samples. However, the hardening effect for the S960MC grade differed from the rest of HSLA grades as regions of softer material were found just after the initial hardened HAZ layer. This is because the martensitic matrix of the S960MC was tempered extensively by the heat provided by the plasma. A more detailed hardness analysis was performed near the hole edge, with less distance between indentations, shown in Figure 13. It was observed that although there was a notable hardening increase at the hole edge, there was a decrease in hardness near the end of the HAZ layer. The measured Vickers hardness values at this region was 300 HV 0.2, which represented an approximate decrease in hardness of 15% with respect to the base material hardness. The lower hardness of the layer adjacent to the plasma accounted for the softer regions observed in Figure 11.

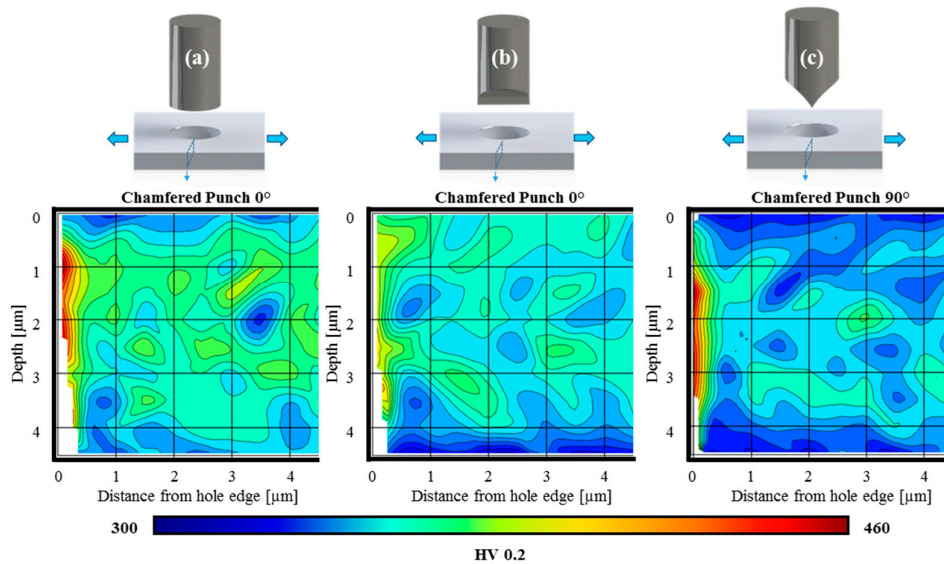
In the case of the punched samples, there was a clear hardness increase towards the hole edge. This phenomena has been already observed in punched specimens by Valtinat et al. [14] and can be

attributed to the effect of cold-work hardening. The increase of hardness in punched samples (flat punch) with respect to the base material hardness was found to be 62%, 50%, and 28% for the S500MC, S700MC, and S960MC HSLA grades, respectively. The hardness increase was in accordance with the differences in ductility of the HSLA grades. The punch shape and orientation also played a role in the final hardening distribution near the hole. As displayed in Figure 12, when the chamfered punch was employed and its sharp edges were not facing the measured surface ( $0^\circ$ ), the resulting hardening values were lower than when the other punching conditions were adopted. The chamfered punch at  $90^\circ$  and the flat punch yielded, however, similar hardening distributions. This effect was mostly appreciable in the HSLA S960MC, while in the other two HSLA grades the punching conditions yielded similar results. This was related to the lower ductility and formability of the HSLA 960MC, which resulted in a less uniform strain accommodation along the entire hole.

**Figure 12.** Hardness distribution produced in the S960MC by (a) flat punch, (b) chamfered punch at  $0^\circ$ , and (c) chamfered punch at  $90^\circ$ .

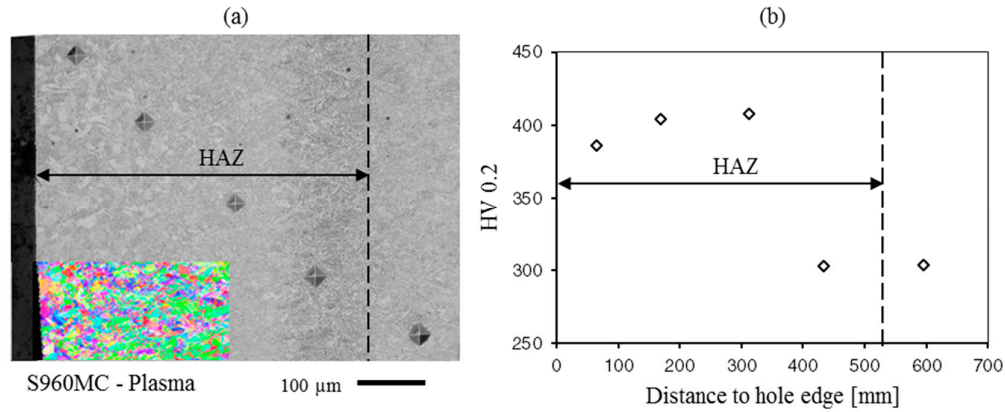
**Figure 13.** Hardness analysis near S960MC plasma layer: (a) micrograph displaying hardness measurements, (b) hardness values vs. distance to hole edge for each measurement.

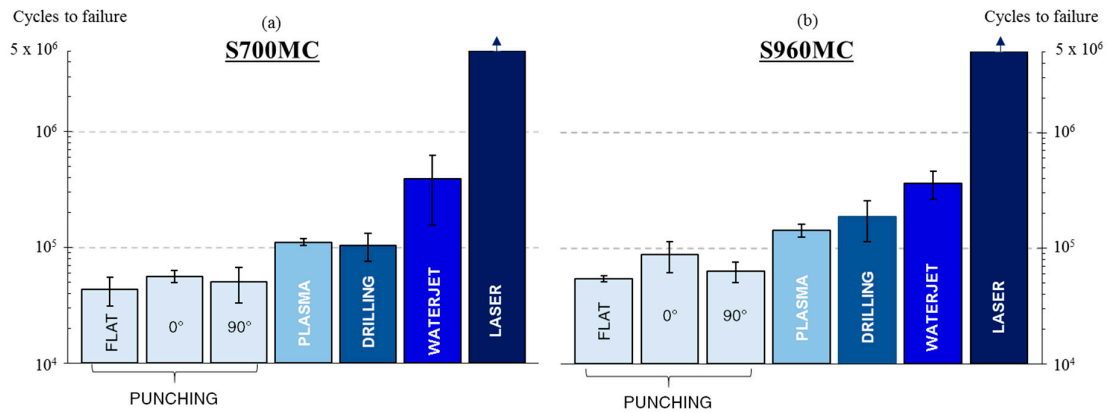
The fatigue results for the holed specimens, tested at a nominal stress range of 300 MPa, are presented in Figure 17. The S700MC and S960MC fatigue results followed the same trend as the S500MC in [13]. Punched samples displayed the lowest fatigue performance, whereas the chamfered punch aligned with loading (with the sharp edge not facing the failure location) performed best among the punched samples, followed by both plasma-cut and drilled specimens, which showed a similar fatigue life. A significantly better performance was observed for waterjet-cut holes. The best fatigue performance was achieved with the laser-cut specimens, where run-out tests were found.

The difference in fatigue life for the different punch geometries related with the hardness distribution results previously presented in Section 3.5, in which the chamfered punch aligned with the load yielded lower localized cold-work hardening near the hole edge.

As in [13], failure in plasma-cut samples took place predominantly at plasma-blob locations, which did not seem to affect the number of cycles to failure. It was also found for the drilled-cut sample that the drill chip had a strong influence in the failure mechanisms and its removal resulted in run-out fatigue tests.

When the fatigue results of both HSLA grades were compared it can be noted that, although both material followed the same trend in results, S960MC had a slightly better fatigue performance than S700MC, although scarce to be statistically significant without additional testing.

**Figure 17.** Fatigue results for (a) S700MC and (b) S960MC.

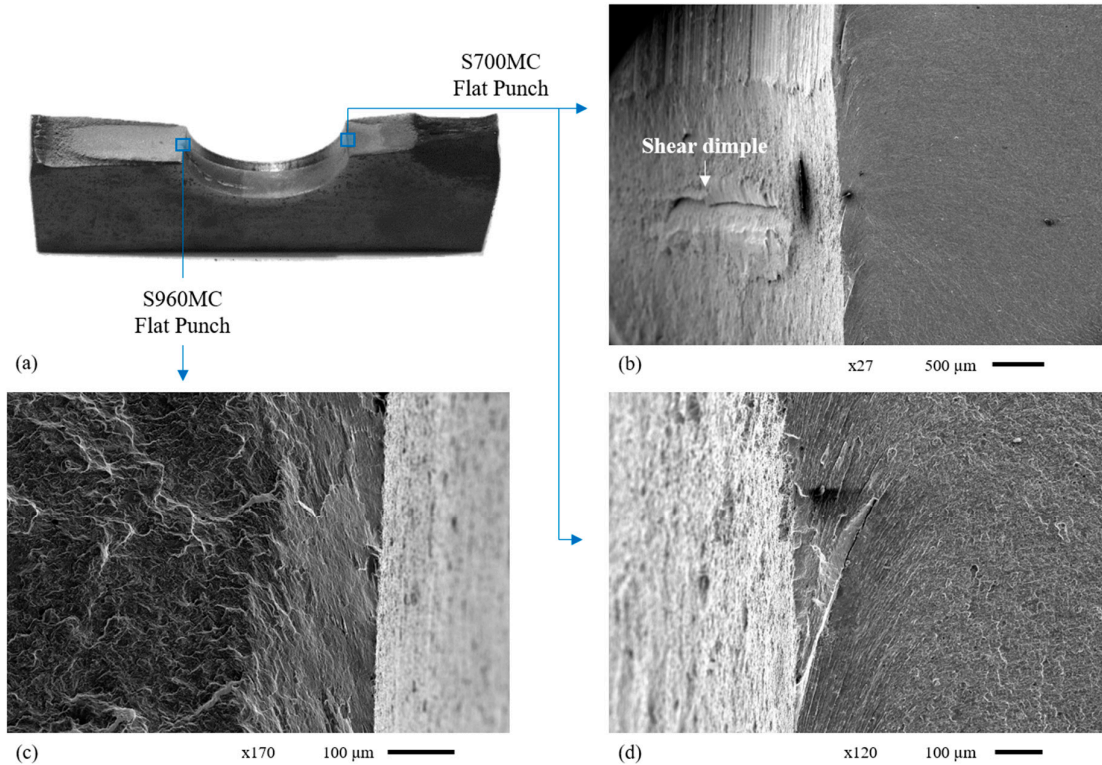
Fatigue failure typically occurred at the middle of the sample, starting from the hole edge. Fatigue cracks propagated perpendicular to the axial load direction. After a certain distance, when the cross-section was significantly reduced, ductile failure happened at the remaining connected material. The characteristic cup and cone shape produced by the shear deformation at 45° with respect to the tensile axis was observed at the ductile failure region for most specimens.

Both the entry section and the shear cutting section of the punched holes were evaluated by SEM. Although all fractured punched specimens presented cracks along the shear cutting section, there was a significant difference between the milder grade S500MC studied in [13] and the other two grades (S700MC and S960MC). In Figure 18, the characteristic crack formation location is shown for the S700MC and the S960MC grades punched with a flat punch. The results in [13] indicated that cracks were likely to initiate from the lower end of the shear-cutting section for the S500MC grade. However, the presence of larger cracks propagating from the middle of the shear-cutting section was noted for the S700MC and the S960MC grades. As previously commented in Section 3.2, shear dimples were more frequent in the S700MC and S960MC grades, which may suggest larger damage and cracks produced during the punching process. These cracks, just as the shear dimples, would be located at the middle of the shear-cutting section and would further propagate due to the action of the induced cyclic loading. This middle area contained segregation of alloying elements, such as Mn. The alloying element segregation resulted in reduced ductility and toughness in this area, making it

prone to cracking. The punched S500MC samples showed fewer dimples, which might explain why cracks tended to propagate from the lower region of the shear-cutting section.

**Figure 18.** (a) Overview of fractured punched specimen. Fracture surfaces of flat-punched specimens: (b)(d) S700MC and (c) S960MC.

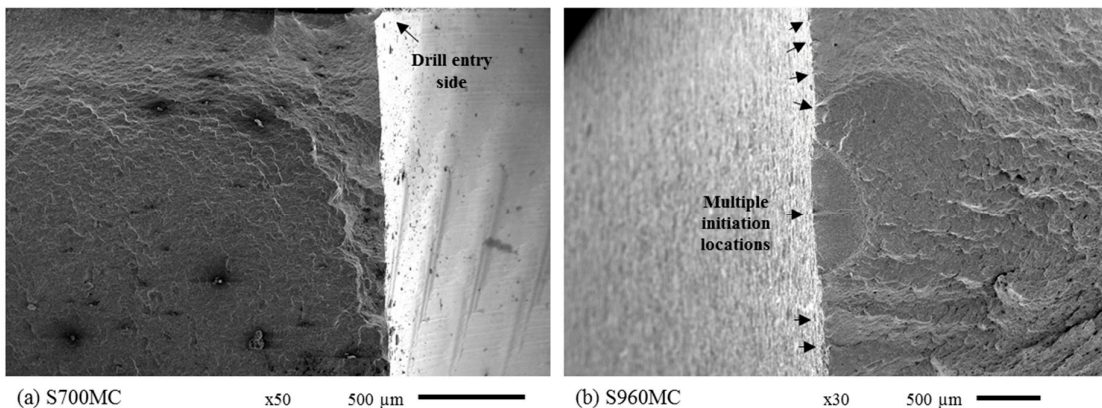
The SEM evaluation of drilled samples revealed that fracture in drilled specimens originated at the edges (top or bottom) of the hole. Both edges presented multiple sharp edges that acted as a notch during the fatigue cycles for cracks to originate and propagate. This can be observed in Figure 19a, where a crack propagated from the drill entry site to the rest of the cross-section in a S700MC specimen. The sharp edges at the entry and exit of the drill were the origin of cracks in all tested specimen and HSLA grades. Due to the high notch sensitivity of the HSLA grades, the deburring of the drilled edges was a necessary step to make the most of the smooth surface and the absence of hardening produced during drilling.

**Figure 19.** Fracture details of (a) entry drill chip (S760MC) and (b) waterjet-cut mid-hole surface (S960MC).

All observed waterjet-cut fractured samples were similar for all studied grades. A characteristic fractured section is shown in Figure 19b (S960MC). The waterjet-cut fractured surfaces presented multiple crack initiation sites along the hole depth, which originated from the geometrical features produced by the rough waterjet-cut surface finish, previously discussed in Section 3.2. A significant difference between waterjet-cut and punched specimens is that in the case of the first, cracks initiated from the geometrical features produced by the abrasive material while for punched specimens, cracks that were already introduced during the punching process propagated during the fatigue cycles.

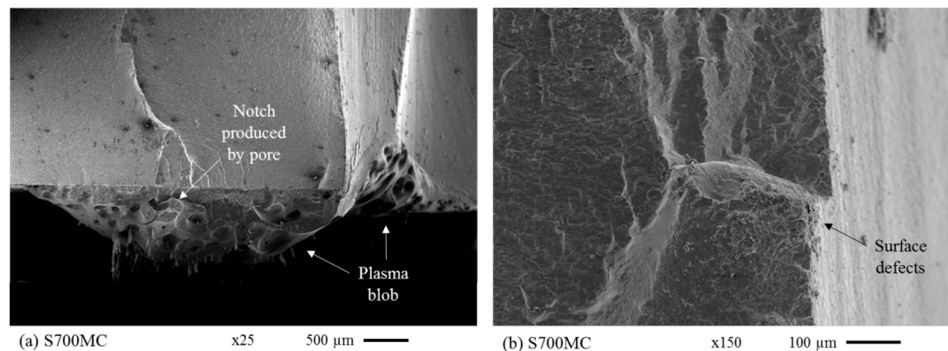
The plasma blob was found to be responsible for the initiation of many of the fractured samples. As discussed in Section 3.2, the plasma blob was located at 45 degrees with respect of the hole section in which failure was expected to happen. However, due to the multiple notches induced by the plasma blob, failure occurred in this region in many of the tested specimens. As shown in Figure 20a, the plasma blob extended into the material and the pores present in the blob acted as notches for crack initiation. The surface defects produced during the plasma-cutting process were responsible for the remaining crack initiation locations. These defects were distributed along the entirety of the hole depth and their size was relatively large if compared with the defects induced during waterjet cutting, which could explain the lower performance of plasma-cut samples. An example of cracks originating from a plasma surface defect is shown in Figure 20b.

**Figure 20.** Fracture surfaces at (a) plasma blob and (b) mid-hole surface (S700MC).
