Field survey assessment of flood loads and related building damage from the July 2021 event in the Ahr Valley (Germany)

2024

Journal of Flood Risk Management

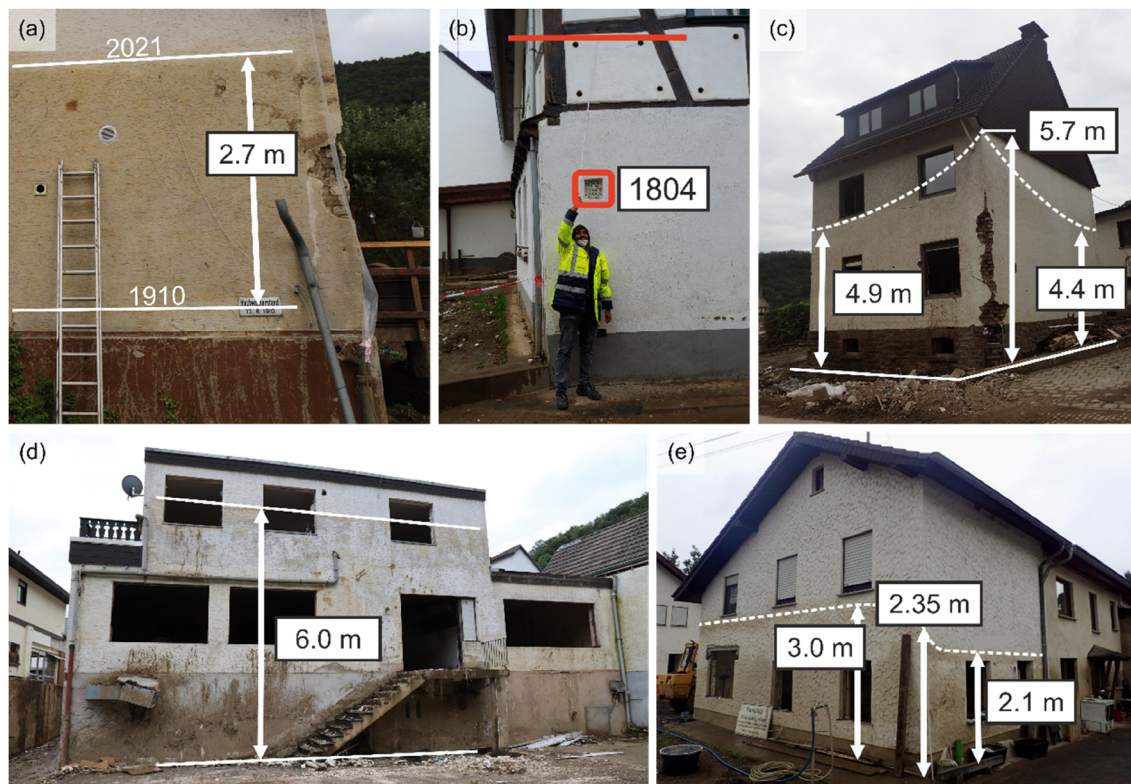
Spatial variability of the water depths was also associated with the local hydrodynamic behaviour of the flood. In particular, it was noted in several buildings that the distribution of the water marks was uneven around the four sides, as shown in Figure 3. For instance, a house in Altenahr (Figure 3c) showed a water depth of ~ 4.9 m on the downstream side, while the corner on the upstream side revealed marks up to 5.7 m. This corresponded to a ratio of 1.16, which is slightly higher than previous laboratory observations for steady flows around buildings with various geometries by Wüthrich, Pfister, et al. (2020). Similar results were also observed in Schuld, where a building in the centre of the village showed that a façade frontally exposed to the flow showed water marks at 3.0 m, while the sides had marks at 2.1 m (Figure 3e). This showed a ratio between the front and side of 1.4, which was higher than the house in Altenahr, thus suggesting a slightly high velocity flow. These data confirmed the spatial variability of the flow conditions during the flood, as well as the non-uniform distribution of loads acting on buildings, further addressed in Section 4.

FIGURE 3 Watermarks in the Ahr Valley: (a) Ahrbrück; (b) Walporzheim; (c) Altenahr; (d) Altenahr; (e) Schuld; (c) and (e) have a non-uniform distribution of water marks on buildings during floods; (a) provides a comparison of the 2021 flood with the extreme event of 13 June 1910, while (b) shows the difference between the 1804 and 2021 floods.

Figure 3c showcases a debris impact on a building, suggesting that the affected corner corresponded to the most upstream edge. The building also shows small impacts near the window openings on the ground floor. Presumably, repeated collisions progressively dislodged the old concrete masonry units and failure was exacerbated by the flow erosion of the joints, which led to the

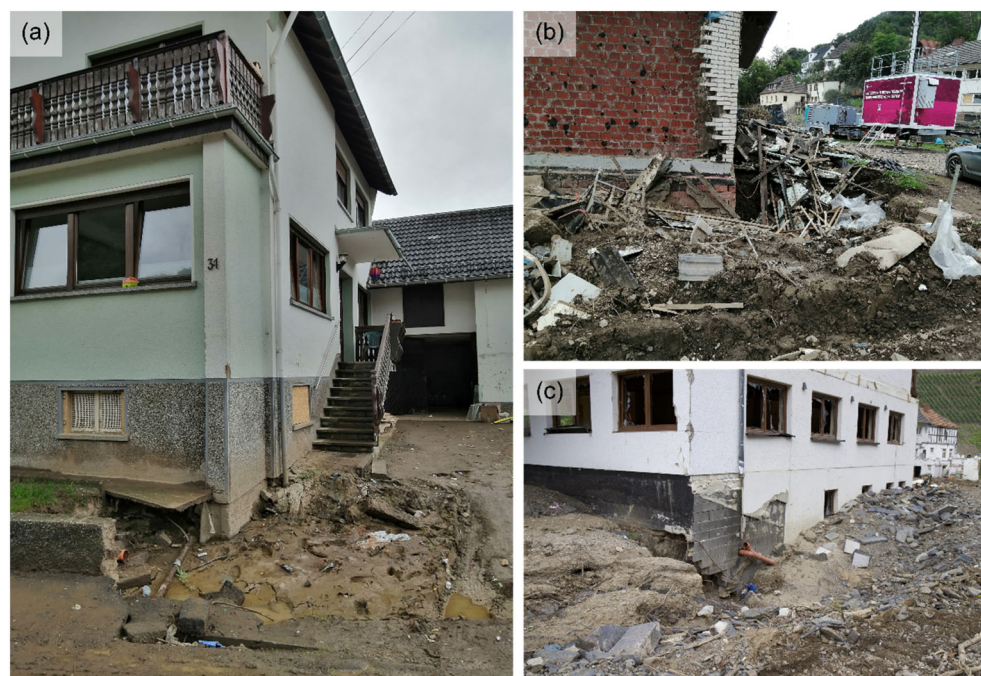
FIGURE 4 Scour at various buildings corners in: (a) Schuld; (b) Altenahr; (c) Marienthal.

Nevertheless, it was observed that in most cases, the scour at the corners did not affect the building's stability since it was not deep enough to reach the foundation (Figure 4). However, the spatial variation of the depth of the scour holes also confirmed the uneven distribution of pressures and increased flood loads on buildings (ASCE 7, 2017; FEMA, 2007), as shown in Section 4.2. For shallow slab or strip foundations, in some cases, the scour depth exceeded the foundation depth (Figure 5). Thus, once the scour reached the foundation, the continuous high-velocity flow likely started undermining the soil under the foundation slab, resulting in an overhanging or a partially supported slab. Nevertheless, the buildings remained stable despite the flood heavily damaging the upper timber storey (Figure 5b).

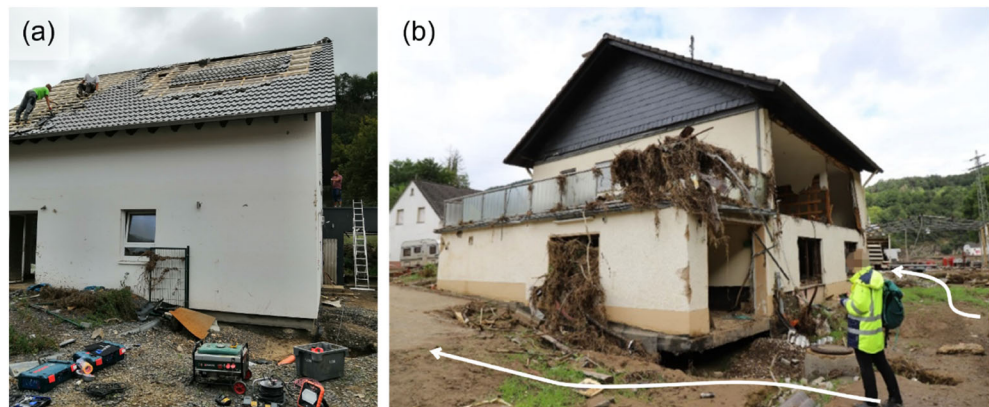
FIGURE 5 Damaged building in (a) Kreuzberg and (b) Brück, where scour at the corner reached the foundation. In (b) debris accumulation can also be observed.

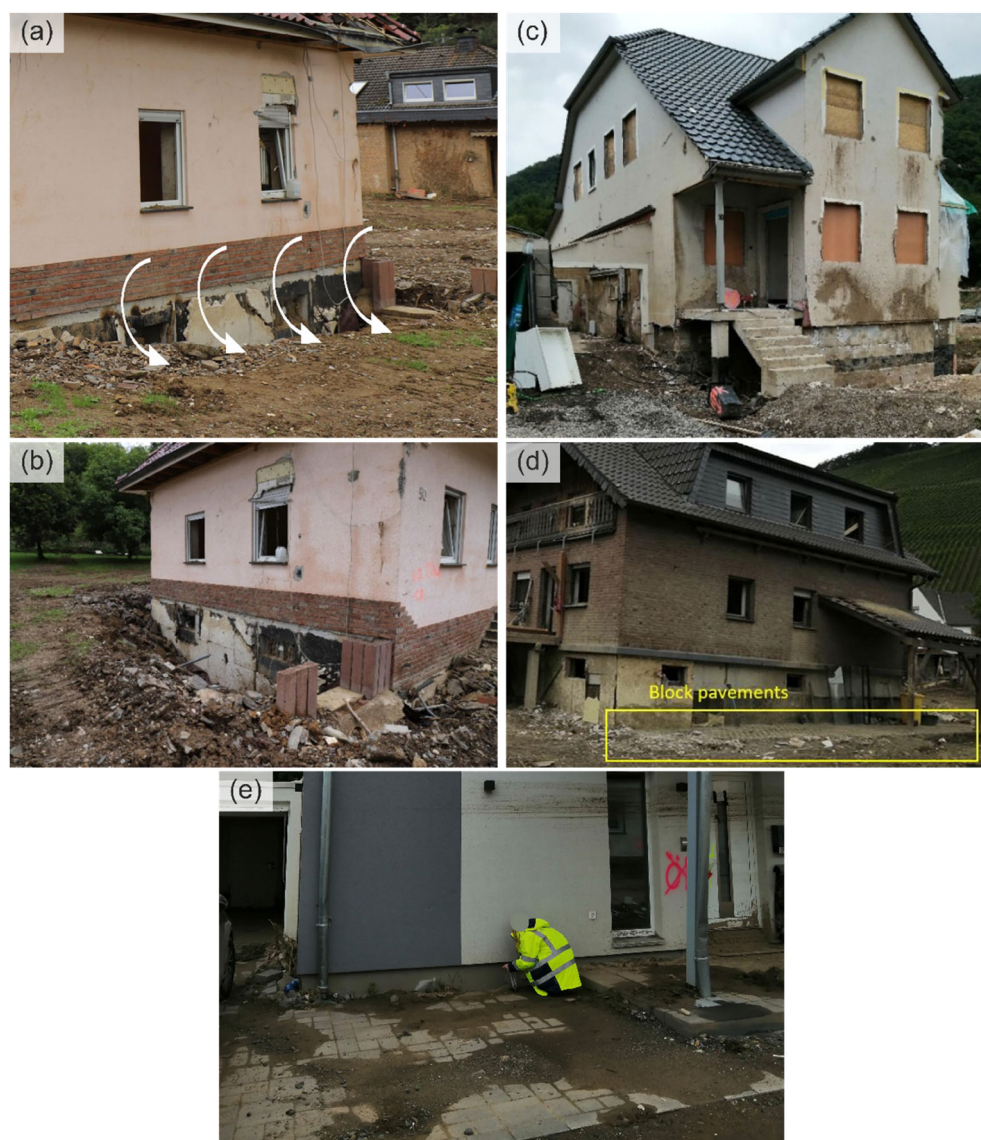
At a few locations, the scour occurred at the front of the building, where the upstream recirculation dug a large amount of material, with a comparatively smaller soil removal along the sides (Figure 6). This pattern aligns with the experimental observation of tsunamis interacting with squared buildings (see figs. 7 and 11 in Mehrzad et al., 2022). This type of scour was found in front of buildings that are un-sheltered (or partially sheltered) by upstream elements, and this pattern is known to depend on the ratio between building width and flow

FIGURE 6 Examples of scour around buildings due to the formation of horseshoe vortex. Figures (a) and (b) were taken in Brück (same building, front and side view), Figures (c) and (d) were taken in Marienthal with (d) and (e) showing scour protection by block pavement; Figure (e) was taken in Kreuzberg.

Figure 6d shows a building on the Marienthal flood plain, where scour would be expected, in line with neighbouring buildings. However, observations revealed no scour-hole around this building, where block pavements likely prevented soil removal. Similar observations were made at several locations (e.g., Figure 6e). Although the pavements were partially broken at a few sites, they still protected the buildings against scour and served as a first layer of protection. The use of revetments for scour and riverbank protection is not new, and deep-routed grass and block pavements have been widely suggested in the past (Gray & Barker, 2004; Julien, 2002). However, these field observations confirmed the effectiveness of these scour protection measures during floods, stressing their importance for flood protection and risk mitigation.

- Revetment and pavements proved to be effective scour protection measures (Julien, 2002). These should be combined with deeper or piled foundations for buildings located near the river to combat bank erosion. Green infrastructures (i.e., grass and trees) were insufficient to prevent damage during this extreme event. Buildings at the extrados and intrados of river bends deserve particular attention.

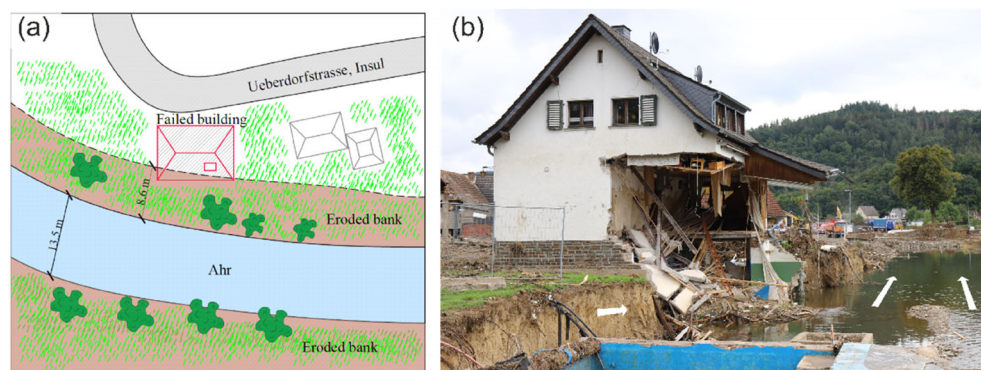
Buildings adjacent to the river suffered largely from bank erosion. The sustained water levels and high velocities removed a significant portion of the river bank, which could not be prevented despite the protection with natural vegetation, including grass and trees (Abernethy & Rutherford, 1998; Gray & Barker, 2004). Locals reported that after the flood the river had doubled its regular width at many locations. In addition, bank erosion reached many buildings adjacent to the river, compromising their foundations. Since most buildings in the Ahr Valley have one or two storeys, the common type of foundation observed was shallow foundation,³ including isolated footings, strip footings or slabs. Shallow foundations transfer building loads to the earth near the surface rather than deeper soil or rock strata. This means that bank erosion often daylighted these shallow foundations, resulting in sizeable structural failures. A typical example is shown in Figure 7b, where a concrete strip footing of approximately 1.2 m was exposed below the basement, triggering the failure of part of the building (Korswagen et al., 2022). Note that despite the grass protection, the bank erosion extended inland for approximately 8.6 m, based on pre-event satellite imagery on

FIGURE 7 Bank erosion-related failure in Insul. Sketch (a) is based on satellite imagery from Google Earth on 24 March 2020; (b) image taken during the survey.

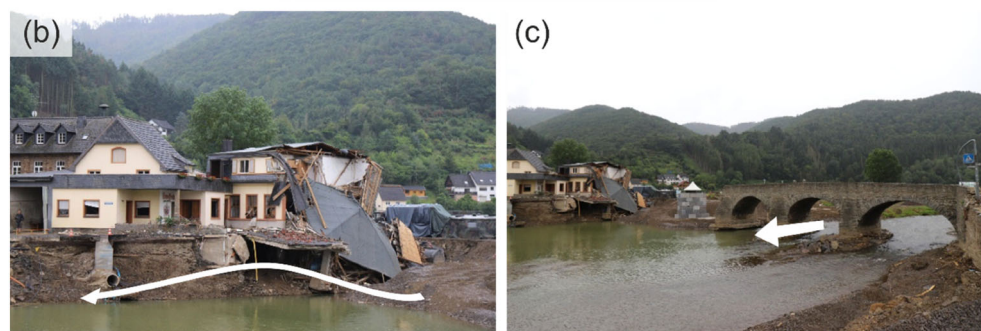
During the survey, some bank erosion at the intrados (inside) of river bends was also observed, also affecting building stability. The example in Figure 9 revealed an eroded depth of around 1.5–1.8 m, exposing the shallow foundation (square columns) of the building. However, the footing remained grounded, ensuring the stability of the building, contrary to Figure 8b.

FIGURE 9 Bank erosion at the intrados (inside) of the river bend in Mayschoß. Sketch (a) is based on satellite imagery from Google Earth on 24 March 2020. Please note that photo (b) was taken on 17 August 2021, whilst photo (c) on 30 March 2022.

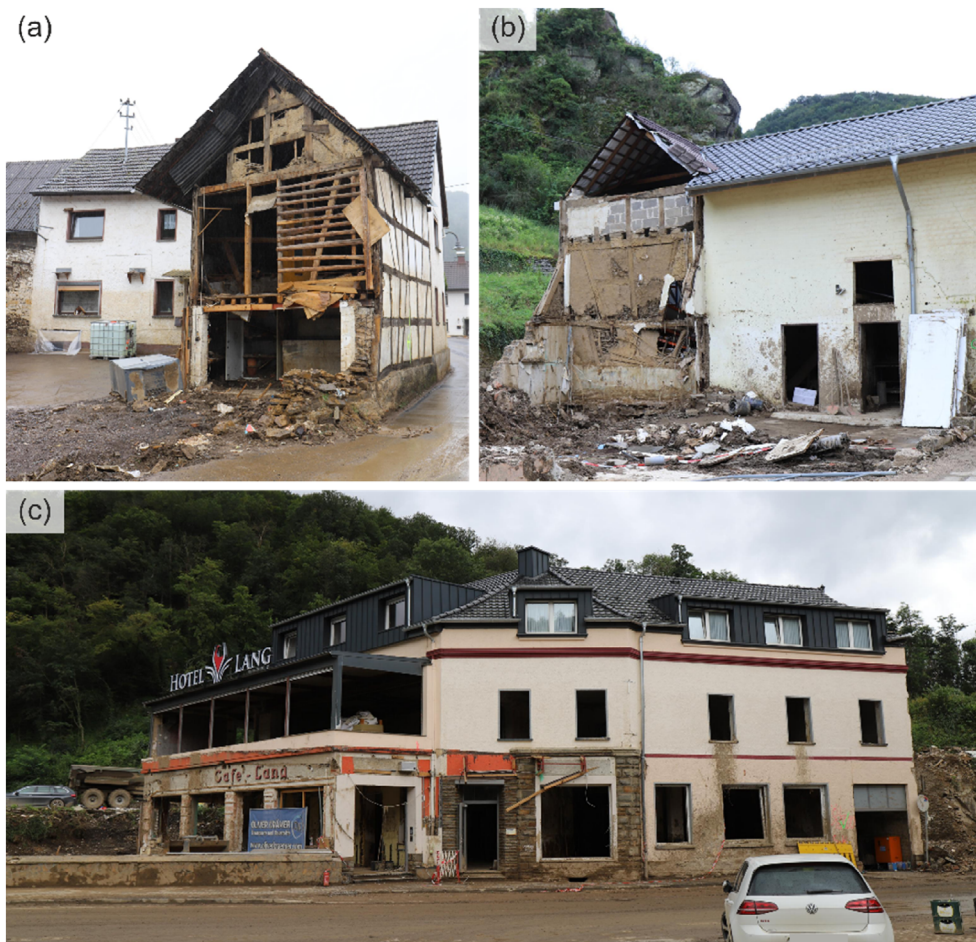
FIGURE 11 Figures (a, b) show a failure due to buoyancy and horizontal loads in Marienthal, and the floor plan layout; (a) before flood; (b) after the flood. Figures (c, d) show the failure of the L-shaped floor plan layout; (c) before flood; (d) after the flood [Source: (a, b) Photographs by Moni Körtgen, house owner. (c) Google photos; photo courtesy of Heidi Möller on August 2020. Date accessed: 30 August 2022] (Möller, 2020). Arrows indicate presumed flow direction.

A critical load during floods is buoyancy, which tends to uplift and destabilise structures. Many buildings in the Ahr Valley are constructed with timber and lightweight materials, which were particularly affected by the buoyancy-induced vertical loads associated with the high water levels. Figure 11a,b presents an example that occurred to the first ‘un-sheltered’ building upstream of Marienthal. An eyewitness reported that part of the building was initially sheared-off from the foundation and turned over by the water. This detachment could be linked to the large buoyancy force resulting from the rapid water level rise, while the movement of the building was likely associated with the strong momentum of the flow. Nevertheless, many buildings sustained the initial buoyancy loads since water entering the structures added weight to the building, inducing a stabilising effect. Such buoyancy effects can be threatening for buildings with large enclosed areas, facilitating uplift. Similar observations were also observed during tsunamis (Chock et al., 2013; Sundar et al., 2007) and in laboratory experiments by Wüthrich et al. (2018) and Harish et al. (2022a, 2022b).

Interestingly, the building in Figure 11a was built with an ‘L-shaped’ plan, which was severely damaged during the flood. Similar observations were made for other buildings (e.g., Figure 11d), suggesting that the L-shape layout generates large loads at the junction, due to flow accumulation and recirculation (Figure 11a). A specific analysis of pressure distribution for such layouts would be of interest to better understand the physical processes involved.

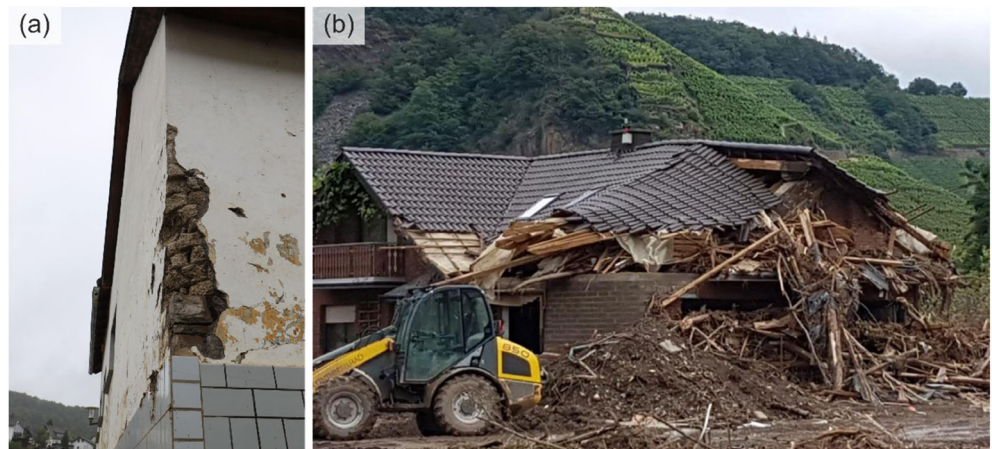
FIGURE 12 Damage associated with debris (a) marks on buildings by debris impact (Schuld); (b) debris damming around a building (Dernau).

located upstream of each village, which were often the most damaged (e.g., Figures 11b, 12b, and 15d,e) and the most affected by debris accumulation (e.g., Figure 12b). Similar observations were provided for tsunamis, where unshielded buildings near the shore are the most damaged (Moris et al., 2021; Pringgana et al., 2021). Similarly, for floods, Maiwald and Schwarz (2015) pointed out that the location of the building relative to the flow velocity vector (flow direction) and the urban integration had an influence on the structural damage, providing a simplified characterisation based on the arrangement of surrounding housing and flow characteristic. This highlights the importance of considering spatial planning as a tool to achieve community resilience and to limit building damage.

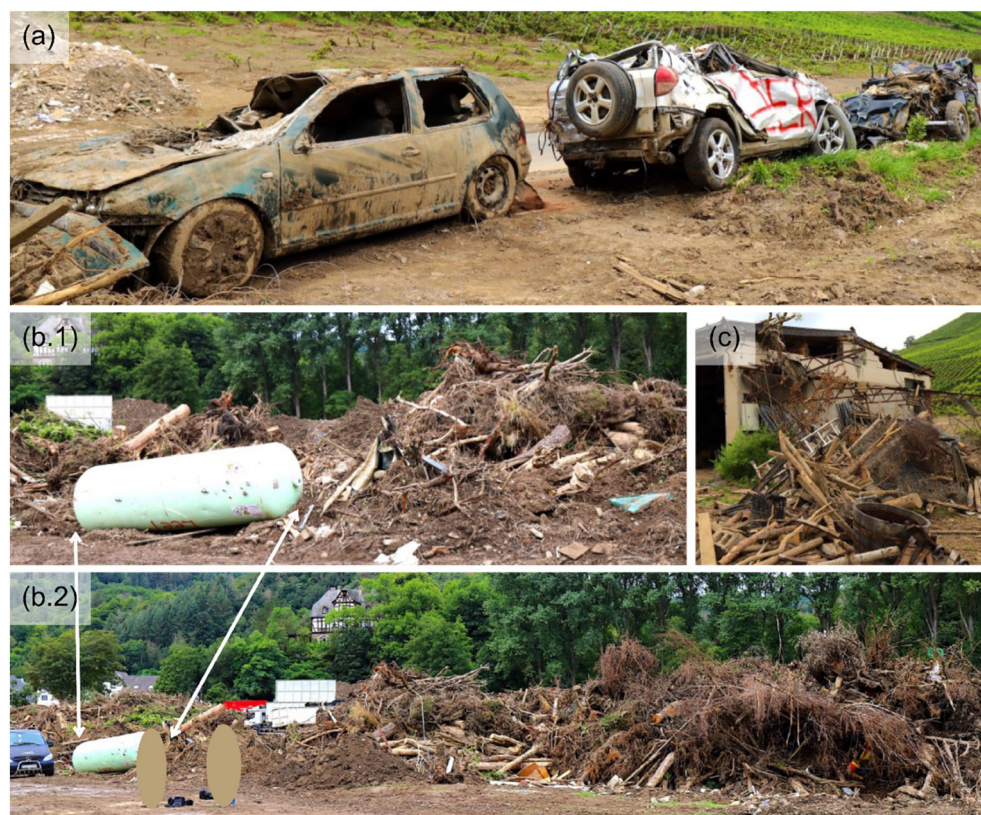
to damages to upstream buildings. Similarly, household and city appliances such as washing machines, (oil) tanks and furniture were often seen, together with benches and (farm or garden) fences. Additional large floating debris included vehicles such as bicycles, motorcycles, cars, motorhomes and caravans. Altogether, this man-made debris became entangled with the wooden debris (Figure 13), increasing the accumulation volumes.

FIGURE 13 Various types of debris: (a) cars dragged and rolled by the flood (Dernau); (b.1, b.2) car-sized tank among a large pile of woody debris (Kreuzberg); and (c) several timber items collected in front of a house (Kreuzberg).

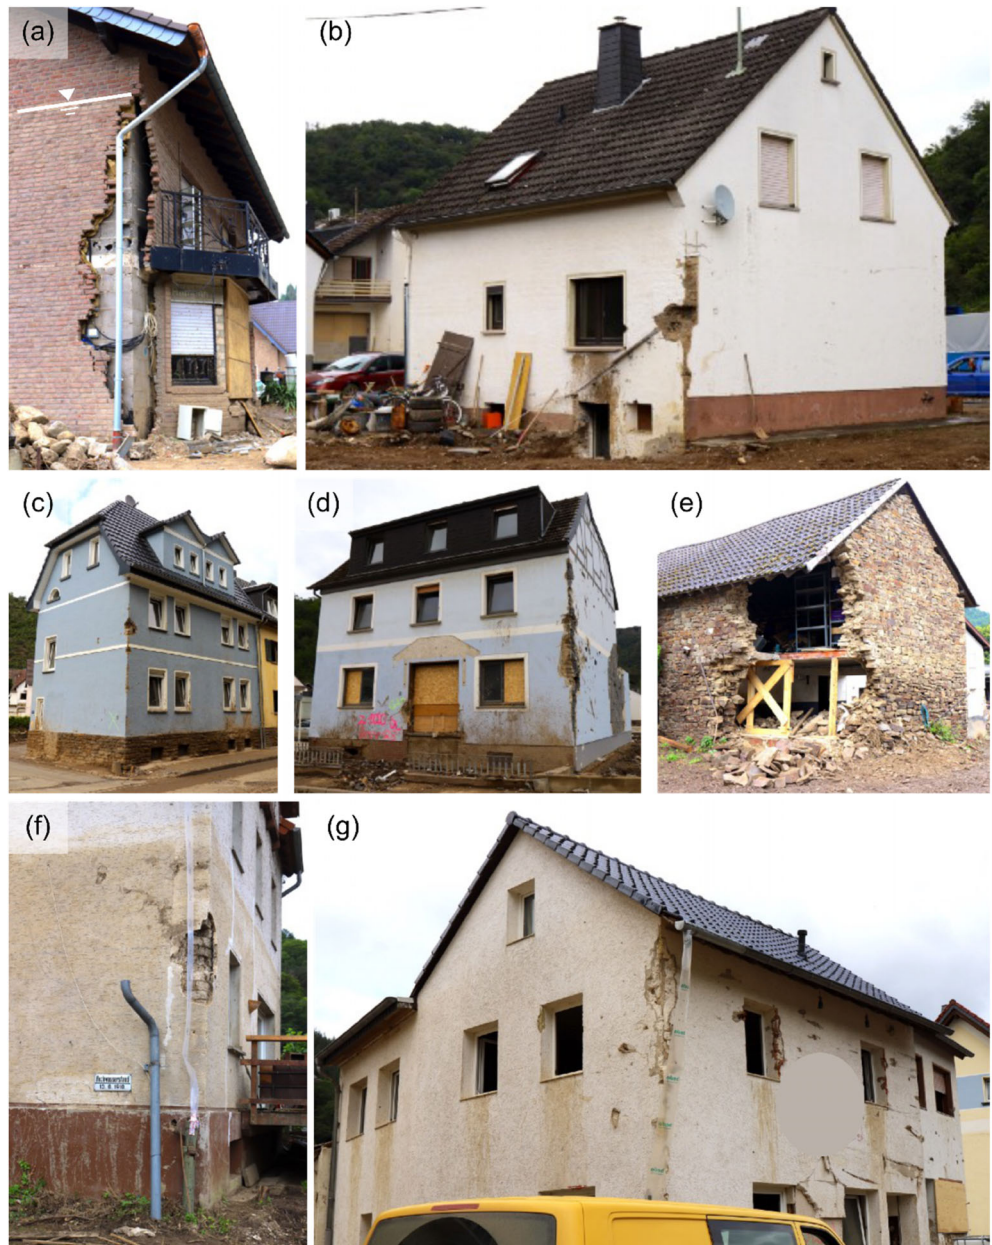
observed corner failure. Similarly, Figure 14a depicts a house with an outer veneer of fired-clay brick masonry which failed in the corner, presumably due to the impact of floating debris. The veneer was insufficiently supported by the inner structural walls of concrete blocks and floors; the ties, connecting both leaves of the cavity wall through the air or insulation chamber, are designed to provide stability and withstand wind loads. The examples provided in Figure 14c,d,f present traces of similar debris collisions on buildings edges, while Figure 14g shows additional impacts at window corners on the first storey. Finally, Figure 14e shows a traditional rubble stone masonry building, also revealing a structural failure, likely due to debris impact.

FIGURE 14 Damage and partial failures caused by the impact of floating debris, below the water-mark. (a) Dernau; (b) Altenahr; (c, d) Kreuzberg; (e) Schuld; (f) Brück; (g) Kreuzberg.

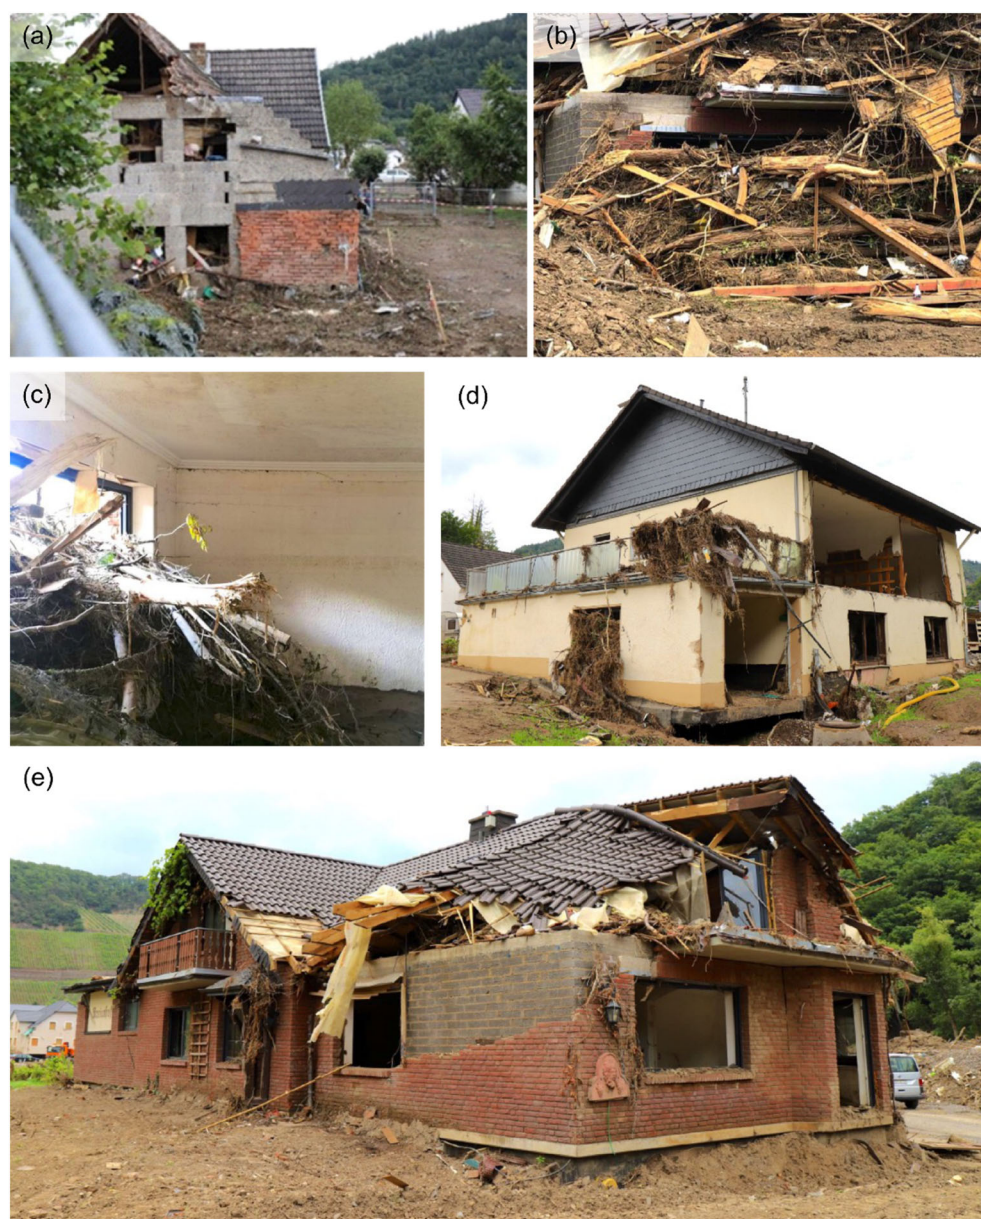
structure. This was shown in laboratory experiments by Stolle et al. (2018) and Wüthrich, Ylla Arbós, et al. (2020), confirming that woody debris forms a more compact and entangled dam, which blocks the flow more effectively in comparison with other debris, thus leading to a higher backwater effect. This resulting force may be sufficient to cause serious structural damage to the buildings, especially when the debris-dam pushes the roof, typically constructed of timber frames. Figure 15 shows locations, where debris around buildings had not yet been removed, visualising potential configurations of these dams. Figure 15e shows the damaged building after the debris was removed. Figure 15d depicts the debris accumulated in front and partly through an opening.

FIGURE 15 Photographs of remains of debris-dams accumulated at buildings. (a) Insul; (b, c, e) Dernau (same building); (d) Brück.

The survey showed that the structures most affected by debris-dams were located on the upstream end of each town. This is understandable since these structures acted as local debris collectors, therefore providing shelter to buildings located further downstream.

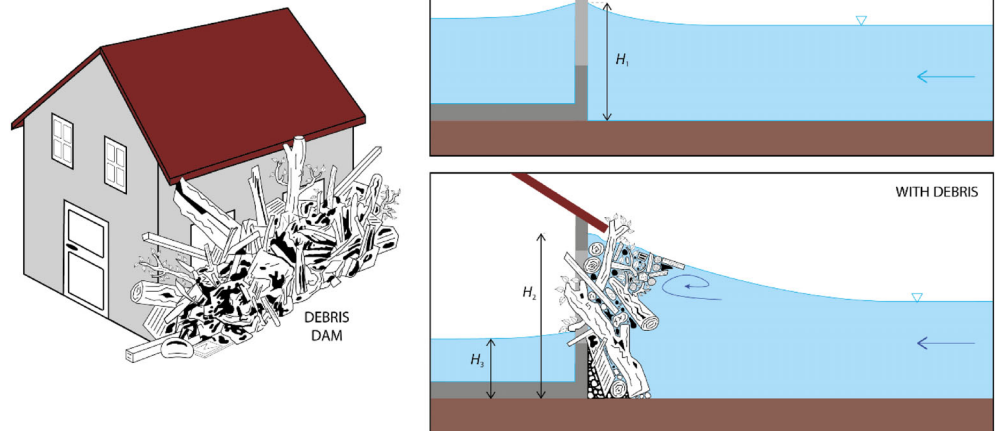
As an overly simplified example, Figure 16 shows the sketch of a house with its upstream side completely covered by debris, similar to those observed during the survey. Assume that the wall is 3 m tall, 6 m wide and that two windows of $1.5 \text{ m} \times 2 \text{ m}$ are present at a height of 0.75 m. If the flood depth is 2 m and water flows through the openings, the area exposed to the flood is 8.25 m^2 , which corresponds to a resultant hydrostatic pressure of 10γ (where γ is the specific weight of the water in N/m^3 ; Kelman & Spence, 2004). If the flow velocity is 1 m/s, the resultant hydrodynamic pressure, assuming a uniform

distribution over the depth and a drag coefficient of 1.0 (Jansen et al., 2020), would be 8.25γ . When a debris dam builds up against the house, water can no longer flow freely through the openings, increasing the area exposed to the flow (Wüthrich et al., 2018). Moreover, the dam may also span out on the sides of the building, which further increases the obstructed area and therefore the loads. Besides, the reduced flow area may lead to a constriction of the flow depending on the neighbouring buildings and obstructions. This may lead to an increased water level in front of the house. For this example, the increase in water level is considered 10% and the additional area covered by the debris-dam on the sides of the building is assumed as 10% in total. This is an optimistic assumption since experiments have shown increases in water depth of up to 20%–25% depending on the flow

FIGURE 16 Sketch of 'debris-dam' resting on a building. Comparison of water levels with and without the dam.

conditions (Wüthrich, Ylla Arbós, et al., 2020). Ten percent increase means that the exposed area becomes 14 m^2 and corresponds to a resultant hydrostatic pressure of 16γ . If the flow velocity and drag coefficient remain unchanged, the hydrodynamic drag would amount to 14.5γ . Consequently, in this simple example, the debris dam leads to a 75% increase in the resultant hydrodynamic force exerted by the flood. Furthermore, the hydrostatic pressure is often equalised on both sides of the wall if water can enter the structure (Figure 16); but in the case of a debris dam, the water level inside could be lower than outside, which would add a hydrostatic component to this value.

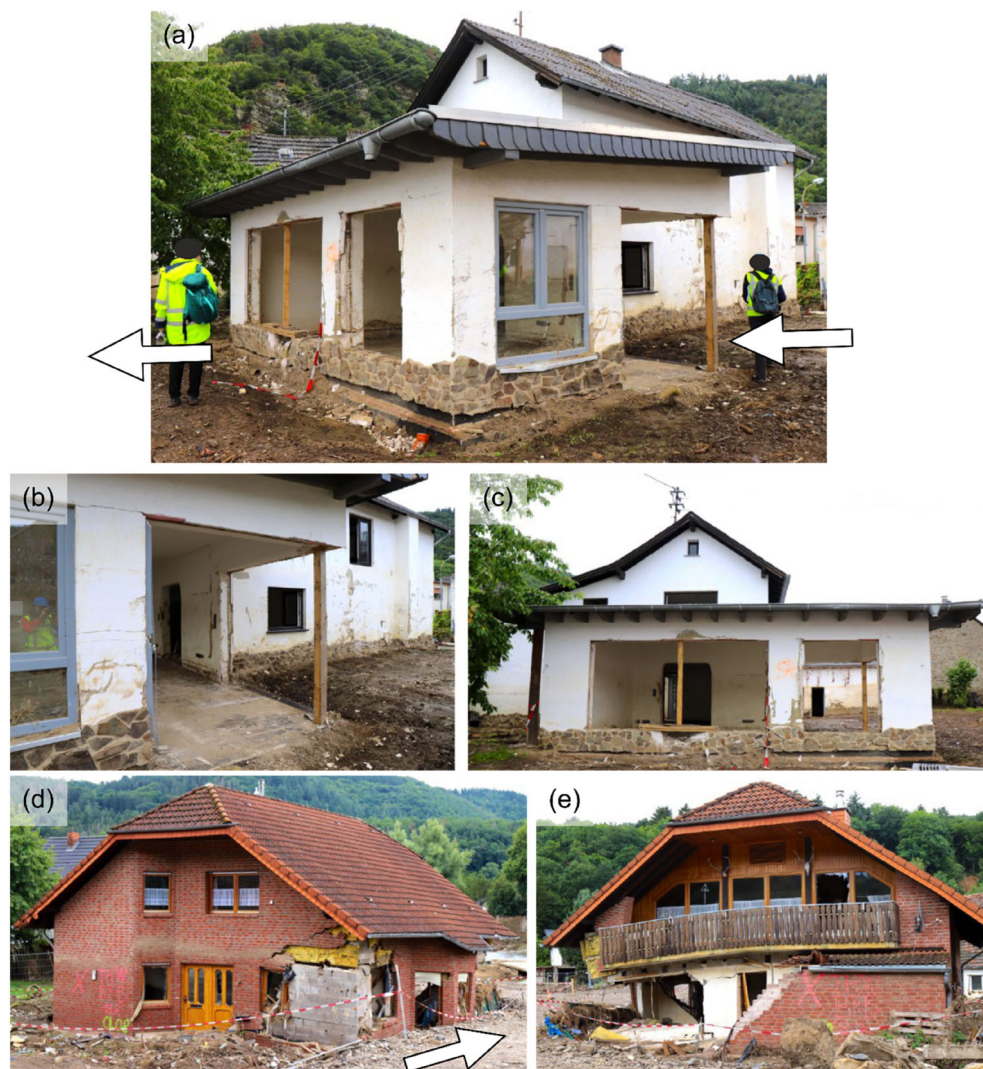
The survey showed that some structures suffered from inwardly collapsed columns or walls. Discussions with local witnesses revealed that large amounts of debris had accumulated against these structures. At the time of the survey, many (partly) collapsed buildings had already been removed, so it is not possible to comment on the flood action that led to failure. However, Figure 17 presents two examples where flood loads, presumably related to debris, affected columns. The first case (Figure 17a–c), shows two missing columns temporarily supported with timber poles. The column on the leading edge (Figure 17b) was surrounded by flowing water which favoured debris collision. After the failure of the column, the debris accumulated inside the structure and pressed against the other two (Figure 17c), with the left one collapsing. The remaining column showed outwards out-of-plane deformation, while in Figure 17b the remaining column showed an inwards deformation. Similarly, in Figure 17d, the flood led to the partial collapse of a masonry wall, which tilted forward due to the flood actions acting primarily near its base. At the back of

FIGURE 17 Building damage associated with the failure of single elements: (a–c) failure of a pillar in Schuld, likely associated with the debris reported inside the structure (removed, hence not visible in the picture); (d) wall tilting forward and (e) column missing at the corner in Insul. Red arrows indicate the suspected flow direction.
