Contributing human and organizational factors to the collapse of the FC Twente stadium roof

Karel Terwel

Abstract

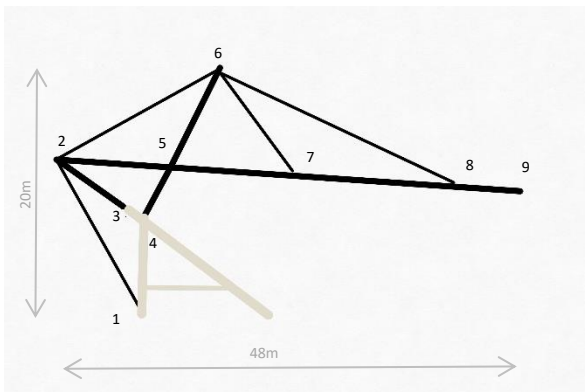
Figure 1: Schematic overview of bearing frame (Based on [2]).

The structure for the L-extension of the roof consisted of 11 bearing frames. Each bearing frame had a length of approximately 48m and a height of approximately 20m (see fig. 1). The bearing frame was constructed out of steel tubes. These were mounted on the concrete grandstand structure.

The engineers created stability out of plane by coupling bars and braces at the positions of 2,5,6,7 and 8. The roof, a steel structure with steel sheeting, was positioned below position 2,5,7,8 and 9.

However, the structure appeared not to be fully mounted at the moment of collapse. One coupling bar between the nodes 6 of two frames was lacking. Furthermore, several couplings between nodes 2 of various frames were missing to enable easier construction with the tower cranes. Temporary braces were removed to apply safety nets. Part of the steel roofing was already assembled.

- The main cause of failure was out-of-plane buckling of the outer parts of two frames where the connecting bar at position 2 was missing

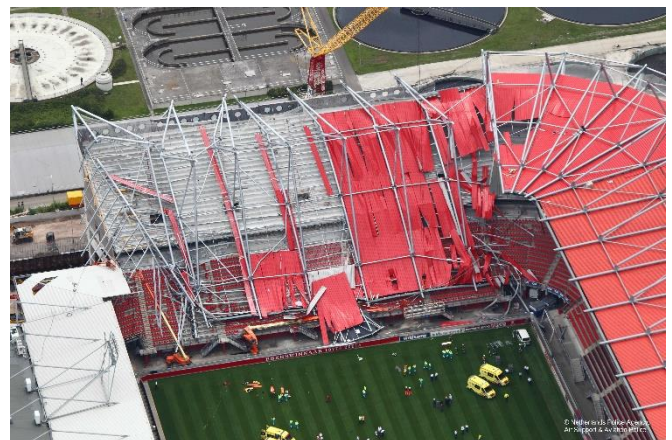
- The frame where the video-wall was connected collapsed first

Figure 2. Roof of FC Twente stadium after collapse. Reproduced by permission of Netherlands Police Agency; Air support and Aviation Police
