**A global safety deficiency
False glide slope capture affecting aircraft**

Schuurman, Michiel

Journal of Aviation Management

Schuurman, M. (2016). A global safety deficiency: False glide slope capture affecting aircraft. *Journal of Aviation Management*, 2016, 93-100.

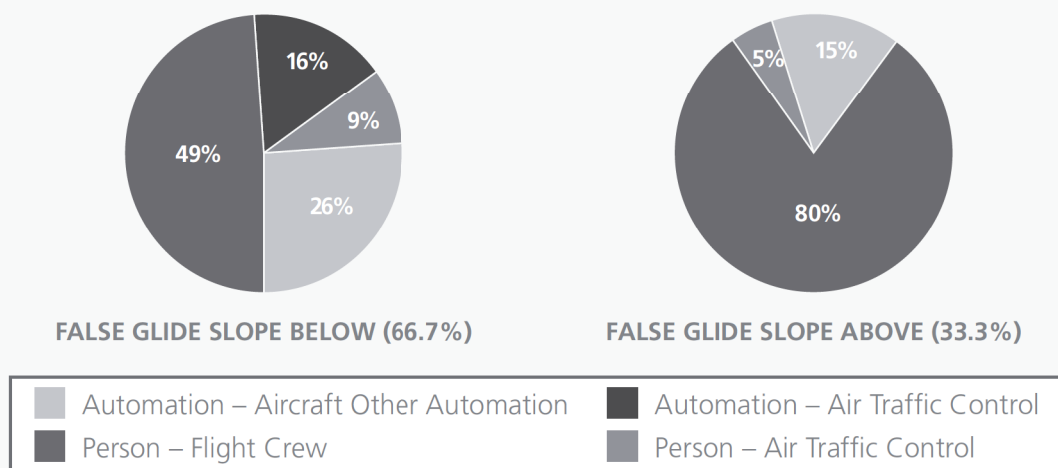
Figure 1 - ASRS Database Overview Problem Description Above and Below Glide Slope

For statistical purposes, ASRS attributed a problem to each event. The ASRS assessment of these events is not definitive, but the database suggests that human factors and navigation facility equipment played a major part. For the investigation, DSB analysed these ASRS events in more detail, and found that a distinction could be made between glide slope events from "Above" and "Below" the 3-degree glide slope (See Figure 1). The analysis shows a difference in assessment of the contributing factors. In cases of "Above" 3-degree glide slope events, the database suggests the problem is mostly related to the flight crew. But does this reflect what is really going on? What do we know about the ILS glide slope antenna?

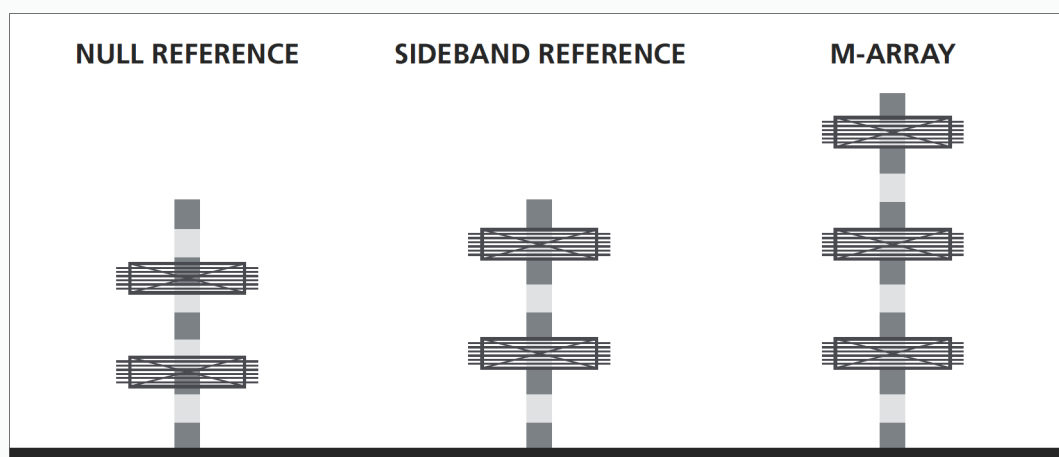
Figure 2 - ILS Glide Slope Imaging Type Antennas

Five types of glide slope antenna systems are used worldwide. Three of which are imaging type antennas referred to as Null Reference, Sideband Reference, and Capture Effect or M-array (See Figure 2). The two non-imaging type antennas are the Endfire and Waveguide. The non-imaging type antennas were excluded from the investigation because they are infrequently used. The M-array antenna is most frequently used at airports worldwide.

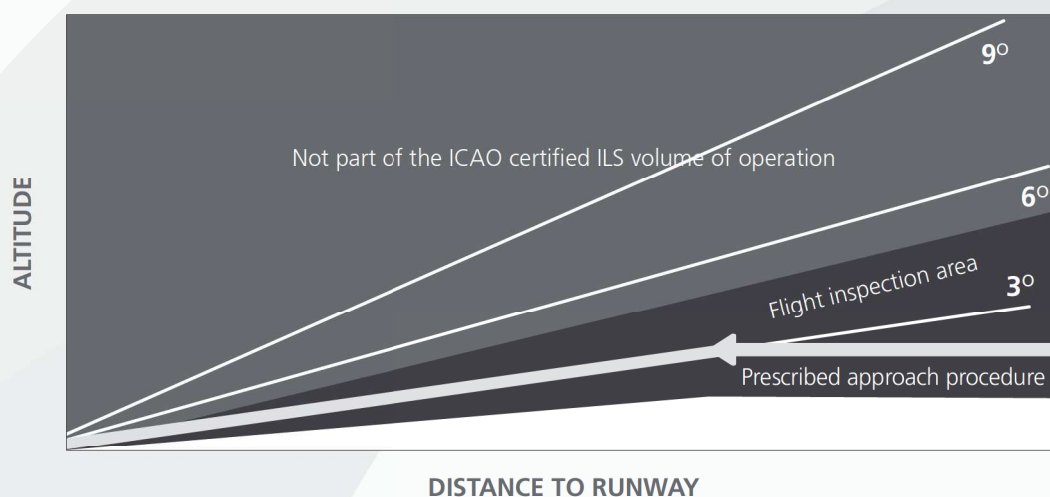
Figure 3 - ILS Glide Slope Certified Volume of Operation

The measurements to determine the glide slope field as performed in DSB investigation were not part of a normal flight inspection, which is performed on the 3-degree glide path. Above an angle of 5.25 degrees, the glide slope field characteristic is not required by ICAO regulations to be inspected (See Figure 3). This means that when flying above the 5.25-degree glide path, the aircraft is flying beyond the reliability threshold, which is certified and periodically checked by flight inspection. The pitch-up upset events were all flying in the area above the 5.25-degree glide path.

Despite SMS methodologies and previous investigations, the reported pitch-up upset incidents occurred in airspace, which is not part of the ICAO certified ILS volume of operation. None of the parties identified this latent safety deficiency.
