Monitoring Pilot Study of Temporary Permeable Structures for Mangrove Restoration

Keywords: mangrove restoration; brushwood structures; temporary permeable structures; nature-based solutions; building with nature

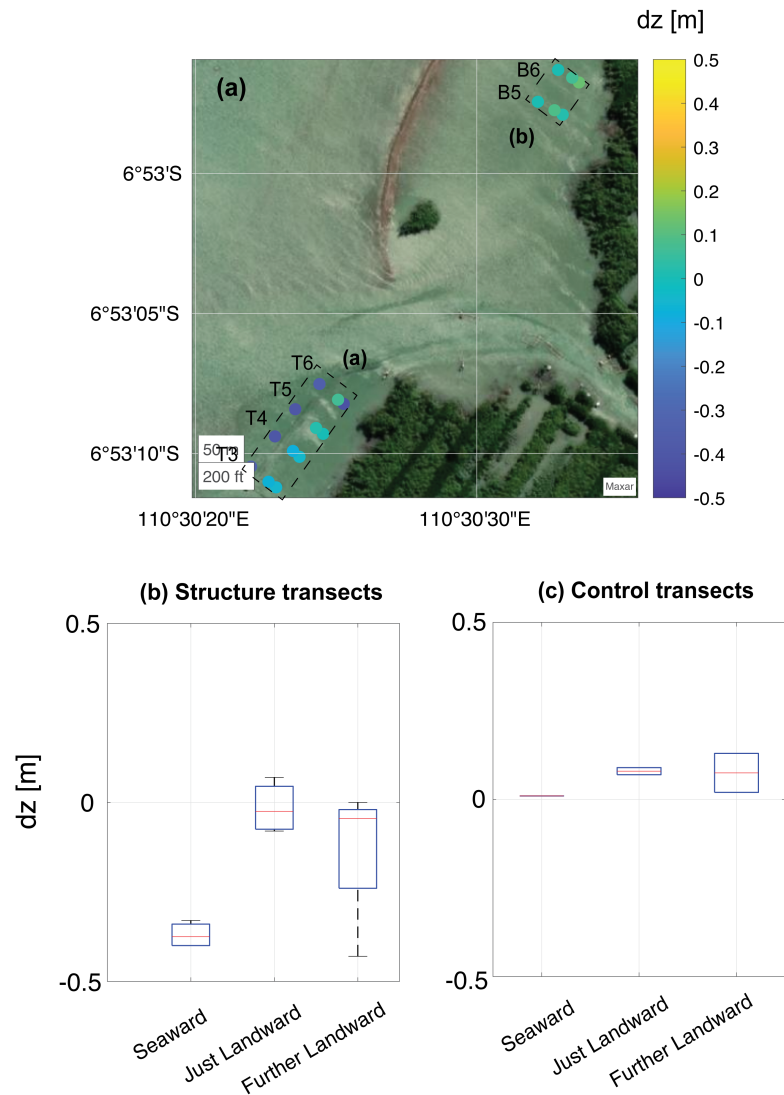
The comparison of average bed level changes at monitoring poles between December 2021 and December 2022, from structure and control transects is shown in Figure 7. At the control transects (no structures), monitoring poles showed consistent sediment accretion. Mean bed level changes between both control transects reached accretion values of 0.01 m on the most seaward pole, 0.08 m landward, and 0.13 m further landward. At the structure transects, on average, considerable erosion is measured seaward from the structures (mean change = -0.38 m), with slight erosion just landward of the structure (mean change = -0.03 m), and larger erosion further landward (mean change = -0.05 m). Standard deviations at these points were relatively high, particularly further landward (standard deviation = 0.2 m), indicating substantial spatial variability in sediment dynamics within the structured area, as also shown in Figure 7b.

Erosion seaward of the structures likely resulted from a combination of processes, including creek development along the structures, sediment stirring and scouring caused by wave reflection [26], as well as landward sediment influx due to wave height reductions across the structures [27]. Wave reflection and transmission likely varied for different structures, considering variations in designs [26] and differing levels of damage during the northwest monsoon (Figure 3), with T3 and T4 heavily damaged by mid-January, while T5 and T6 remained intact. Despite differences in structure stability, and possibly in performance, during storms, the relatively uniform erosion observed along all sections suggests that creek development may have played a significant role in driving erosion on the seaward side of structures. Landward of the structures, responses varied: T3 and T4 experienced erosion, T5 remained stable, and T6—adjacent to a creek—showed initial accretion near the structure (0.07 m) but substantial erosion (-0.43 m) farther landward (Figure 7).

Figure 7. (a) Map depicting bed level changes (denoted as dz , in meters) between December 2021 and December 2022 for both structure and control transects. (b) Boxplot illustrating bed level changes at structure transects for monitoring poles located 10 m seaward, 10 m (just) landward, and 20 m (further) landward from the structure. (c) Boxplot for control transects, showing bed level changes at poles placed at equivalent distances from the shore.

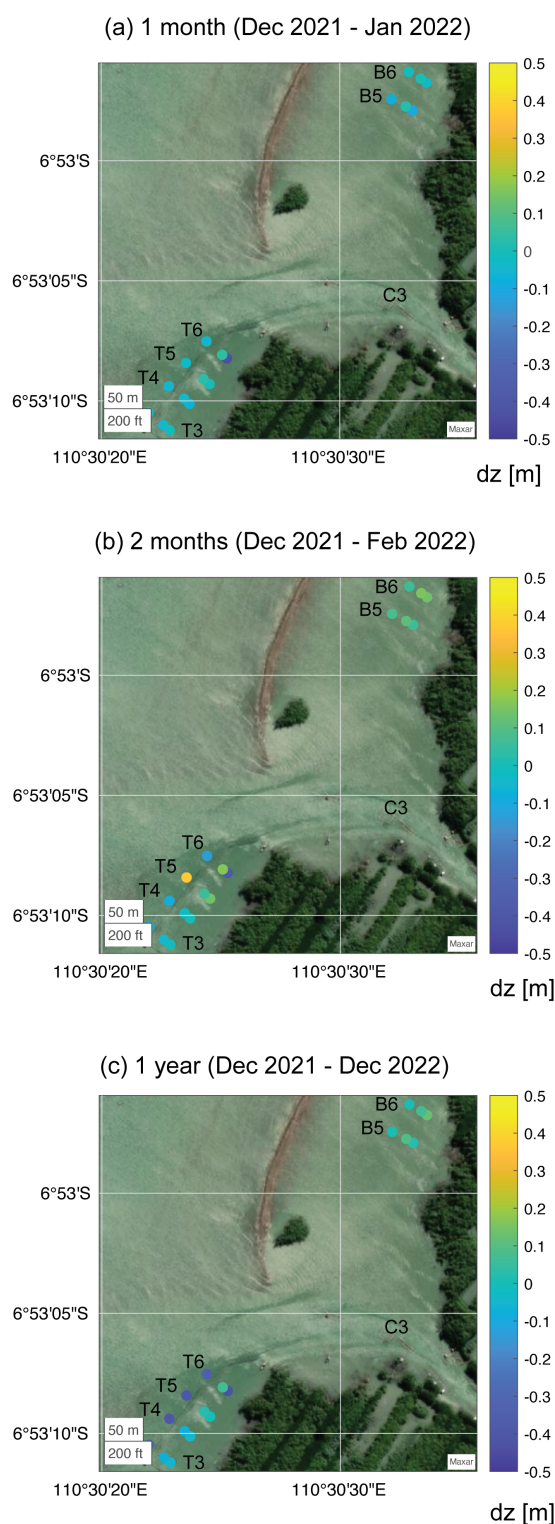
Seaward erosion occurred mainly within the first two months (Figure 8a,b), continuing into subsequent months as the area deepened significantly by June (Figure 8c) before stabilizing between June and December (see Figure 9). Behind T3 and T4, mild erosion persisted throughout the year. At T5, the bed level raised by 0.1 m between January and February 2022, perhaps due to sedimentation during storms within this period (see consecutive storms in January in Figure 3) but this sediment had eroded again by June. At T6, significant erosion occurred at the most landward point during the first month (Figure 8a), while bed level changes elsewhere were minor. The severe erosion observed at the seaward pole of T6 appears influenced by creek development, supported by the deepening of creek C3 in December 2021 (Figure 5e).

Figure 8. Bed level changes measured at monitoring poles across structure transects (T3–T6) and control locations (B5–B6). (a) Changes observed between 9 December 2021, and 11 January 2022, highlighting erosion and localized accretion patterns. (b) Bed level changes between 9 December 2021, and 9 February 2022, showing continued accretion near structures and minimal changes at control sites. (c) Bed level changes over the longer term, from 9 December 2021, to 10 December 2022, illustrating overall erosion in front of the structures and variable accretion and erosion behind them.

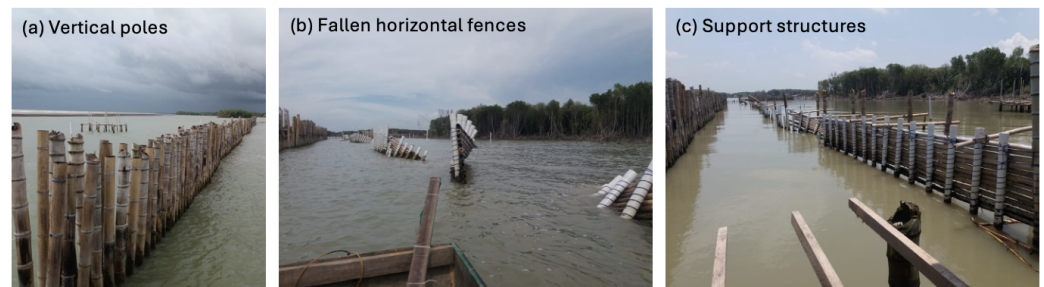
A field survey revealed that the landward rows of T3 and T4 had collapsed due to storms by mid January 2022 (see Figure 10b). The damaged sections consisted of horizontal bamboo beams attached to vertical poles, which were destabilized and tilted by wave loads. The damaged sections included 12 m (~30%) of the back row of T3 and the entire back row of T4. The greater damage observed in T3/T4 compared to T5/T6 may be attributed to higher wave exposure, though variations in construction quality and soil conditions cannot be ruled out. In contrast, the front (seaward) rows, made of vertical bamboo poles embedded in the seabed, remained stable (see Figure 10a). Repairs were carried out in March–April 2022, involving the retrieval of the fallen section from the seabed and the construction of additional support structures behind the fences (see Figure 10c). The delay between the collapse and repair indicates that the structure’s performance at T3 and T4

could have been compromised for two months, which could have contributed to the higher erosion measured landward of the structures at these two transects, compared to T5. Our observations indicate that ensuring structural stability requires reinforcing horizontally beamed fences with support structures to prevent tilting. Additionally, structures built using only vertical bamboo poles proved to be more stable, as all elements were securely drilled into the soil. To further enhance future implementations, stability models for bamboo structures should be developed.

Figure 10. Photographs documenting the repair process of the damaged temporary permeable structure during early 2022: (a) the first row, consisting of vertical bamboo poles embedded in the muddy seabed, remained stable throughout the storm season; (b) the second row, originally constructed with horizontal bamboo poles supported by vertical poles, collapsed in January 2022 due to insufficient stability to withstand wave loads. The damaged sections had a length of 12 m (~30% of the back row) of T3 and 35 m (entire back row) of T4; (c) the structure was repaired between March and April 2022, with the collapsed components lifted and additional support structures added to enhance stability.

The costs of the construction of the pilot in 2021 were equal to 27,000 euros or 429,330,000 IDR for 466 m of structures, with costs between 30–60 euros per meter of structure (500,000–1,000,000 IDR per meter of structure). Transects were monitored monthly, corresponding to costs of 230 euro/month or 3,847,900 IDR/month (2760 euro/year or 46,174,800 IDR/year). During this pilot, several lessons learned from previous projects were applied to reduce maintenance costs, such as avoiding using brushwood filled nets (which often broke or floated away) and protecting bamboo poles to avoid shipworm damage (which increases their lifetime from less than a year to two years). However, by using dense horizontal arrangements of bamboo, the high forces acting on the poles resulted in partial collapse of one section of the structure during the NW monsoon season. For subsequent years, support structures were added behind the bamboo poles, but fixing the

damages of the first NW monsoon of 2022 was as expensive as building the structures from scratch. Damages from waves impact, combined with shipworm damage in locations where brushwood structures are submerged for a long time, have also resulted in large damage in Vietnam [10]. In the structures of this pilot, the structures were -0.7 to -0.9 m with respect to MSL, or -1.2 to -1.4 m with respect to MHW, exceeding the recommendation that the bed level should not be lower than MHW -0.70 to -0.80 m, based on experiences in Vietnam [10], which could have led to excessive wave exposure and wood submergence. Nevertheless, due to the considerable erosion experienced by this region, it was difficult to find shallow foreshores fronting vegetation stands.
