Journal of Archaeological Science: Reports

A case study for scientific research prior to conservation of marine metal artefacts

A rare find of a high-status 17th century oval box, retrieved from a shipwreck, provided a unique opportunity to research the construction and finishing layers of an object that is untouched for 350 years. This case study was used to demonstrate the extent of data that can be gained from analytical techniques prior to conservation. The amalgam-gilt brass object was studied by optical and electron microscopy, X-radiography, micro-computed X-ray tomography, neutron tomography, X-ray fluorescence, X-ray diffraction, Rutherford backscattering spectrometry, proton-induced X-ray emission and gas chromatography. The results have led to a characterisation of the manufacturing methods used on the box and to a better understanding of the practicality of modern analytical methods and techniques in (maritime) archaeological research.

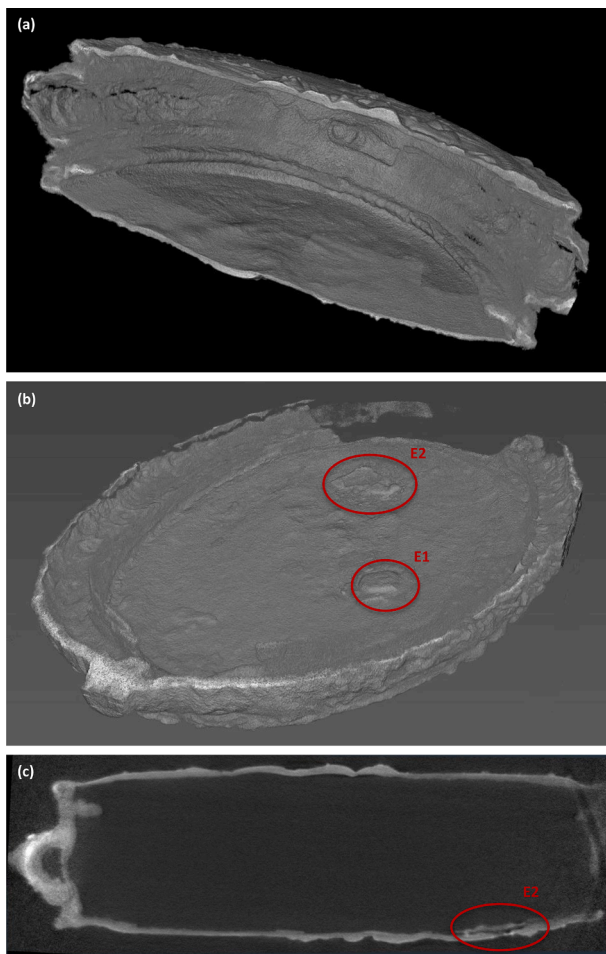
Fig. 7. Reconstructions made from neutron tomography. (a) Interior of the box showing the possible opening mechanism with the Venus-side on top; (b) the bottom side of the Venus-plaquette, showing a smooth outline, indicative of casting. Two old deformations can be seen as well (areas E1 and E2, see Fig. 6); (c) virtual section along the longitudinal axis of the box, with the Venus-plaquette shown on top and the one with Leda on the bottom.

Fig. 7a shows that the possible opening mechanism is now incomplete, with the knob (see Fig. 6) located at the left of the rectangular opening. This shape suggests perhaps the use of a spring system with the steel spring now completely disappeared, probably due to corrosion.

From the reconstructions made from NT, it can be deduced that the backs of the plaquettes roughly follow the form of the decoration (Fig. 7b), and the thickness measures about 2–3 mm, consistent with manufacturing by casting. The gadrooning and other sheet metal structures are embossed, based on their shape and thickness (~1 mm). This is in agreement with the observation of different corrosion morphologies on the different box components (section 4.2).
