Case Studies on Failure Investigations in Structural and Geotechnical Engineering

Balconies in Maastricht

Karel C. Terwel

This chapter focuses on human and organisational factors that are usually behind the technical cause of failure. This is illustrated by a case of the collapse of five balconies in 2003 in Maastricht (The Netherlands) resulting in two fatalities.

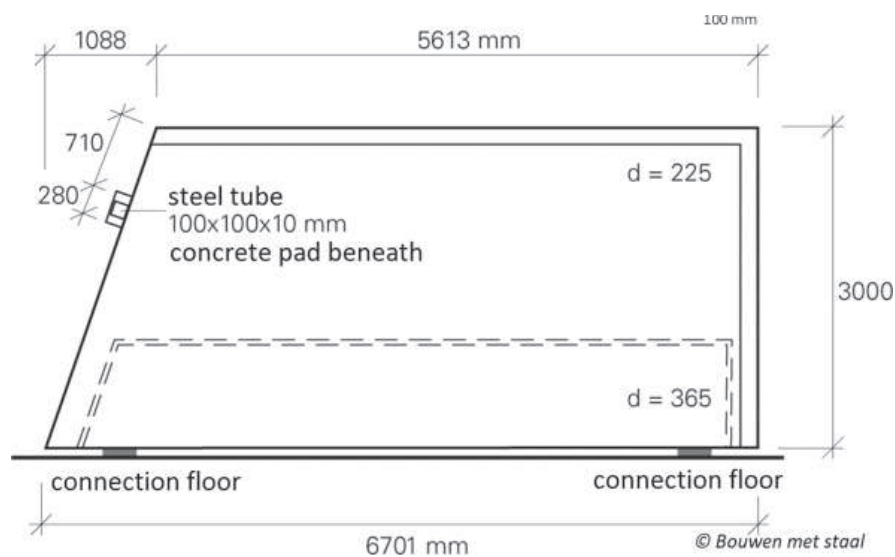
To provide a stable structure a steel column, 100 mm * 100 mm was added as third support. This column was supported by a foundation wall beneath (see Figure 4.1 for a top view of the standard balconies).

Figure 4.1 Top view of standard balcony with the position of the steel tube column (adapted from [11, 13] with permission). Mind that balcony slab level 1-5 is thicker than slab on ground level (Figure 4.3).

First, the column was repositioned towards the boundaries of the slab, to be able to integrate the column with the finishing structure (aesthetical reason [11]). Figure 4.1 clarifies the final, changed position of the column. To be able to support the balcony on a pad at the side of the balcony a slab is required (see also figure 4.1). Second, during preliminary design the engineer designed two moment-resisting connections, between the apartment floor and the balcony slab. During the technical design phase, this was changed by a supplier into two hinged connections [6]. These changes resulted in a less robust solution that was more vulnerable to failure.

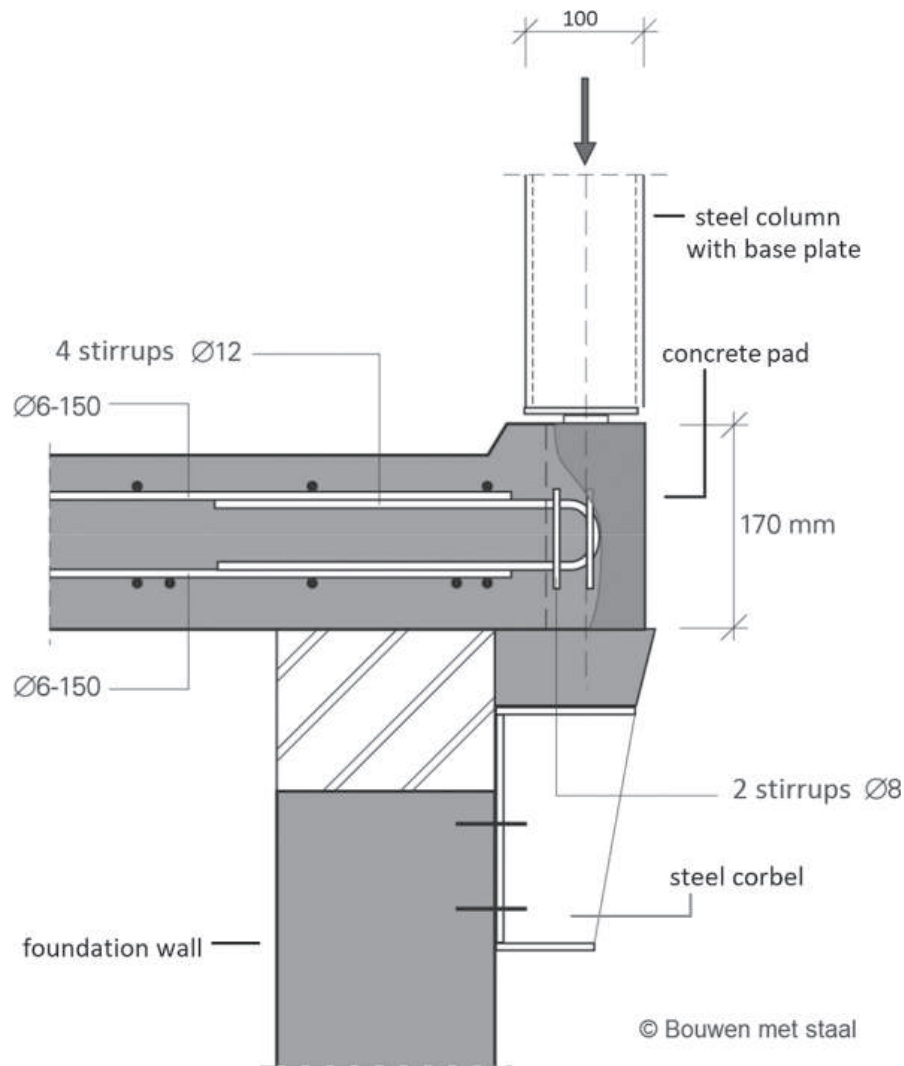
Various parts of the structure were subject to the forensic investigations. Experts agreed that detailing of the reinforcement of the pad at ground floor was inadequate and not according to the codes. Furthermore, the bolted connection of the steel corbel on the foundation wall was not properly constructed and the connection between the steel corbel and the concrete pad was suboptimal.

Finally, it was concluded by experts and court that the combination of a bending moment and a concentrated force on the small pad resulted in failure of the pad at ground

Figure 4.2 Detail of solution with steel corbel ground floor (adapted from [11, 13] with permission).

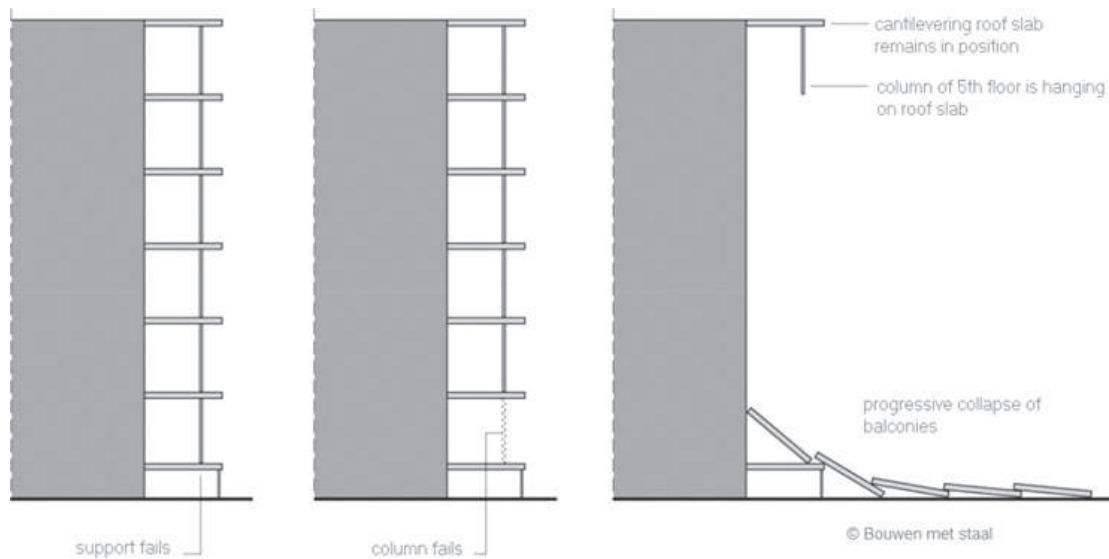
floor level. This resulted in a progressive collapse of the other balconies (see Figure 4.3) as the columns lacked support [3]. The triggering event was not evident; it was suggested that a relatively warm day resulted in lengthening of the steel columns, or that creep effects of the roof slab might have played a role [4].

Figure 4.3 Side view of building: initial failure leading to progressive collapse (adapted from [11], with permission).
