Small Hard Body Impact on Annealed, Heat Strengthened and Fully Tempered Laminated Glass

Keywords: Structural Glass, Small Hard Body Impact on Glass, Glass Sound Screens

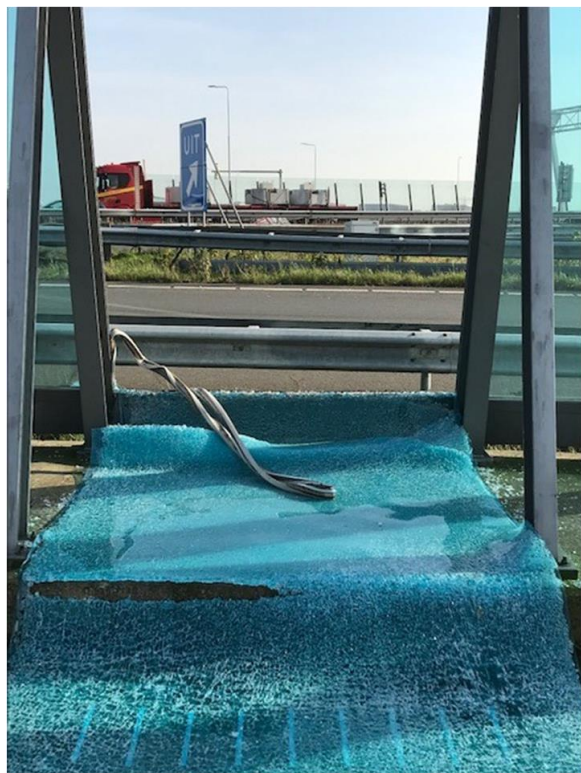
Fig. 1: Failed tempered laminated glass sound screen panel

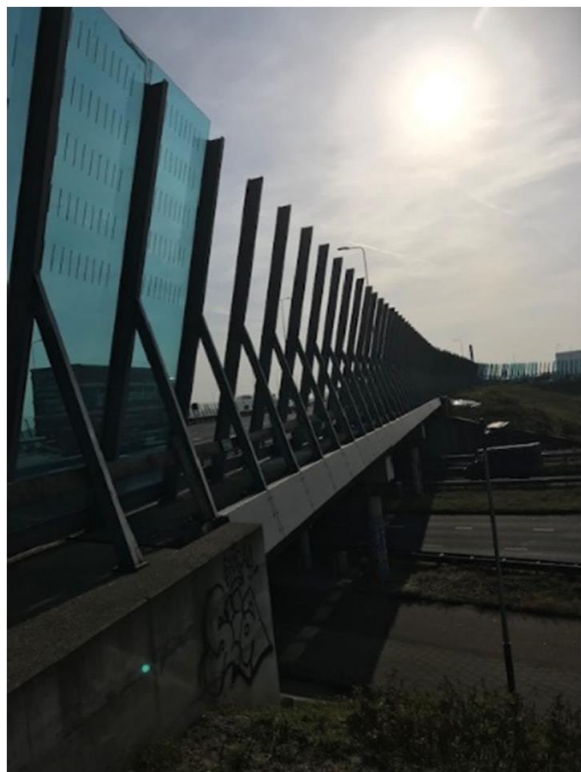
Impacts on architectural glass are infrequent and only the single case of a stone launched by a snow blower hitting a fully tempered laminated glass panel of the apple cube in New York, (Quirk, 2021), is in the open literature. In the field of car windows and glass sound screens impact problems are however a real concern. Figure 1 shows an actual example of a fully tempered laminated glass sound screen panel after both glass plies failed. In certain cases, such as shown in Fig. 2, where a glass sound screen leans over a by-pass, safety concerns can lead to immediate removal of damaged glass.

Fig. 2: Sound screen panels leaning over a by-pass removed after safety concerns

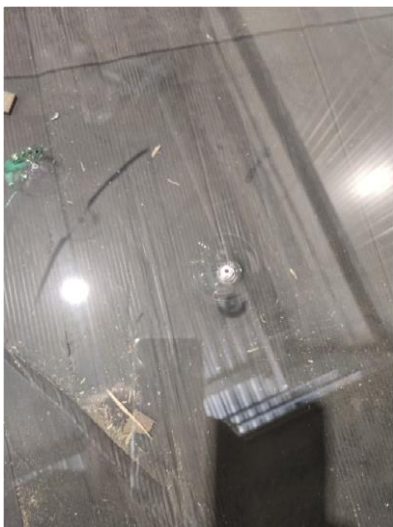
The results are given in Table 3. In annealed glass small hard body impact has no visible effect. Impacting spherical impactors of 14 or 15 mm diameter caused a cone crack, similar to those described by Chaudhri (1989; 2015). Larger impactors cause larger cone cracks, shown in Fig. 5. Cracking from the cone crack region is not caused by the actual impact. Cracks grow from the cone crack zone later due to stress fields from later impacts close to the original damage zone.

Fig. 5: Cone crack in the annealed glass after critical impact

The annealed glass has good impact resistance in the sense that impacts only cause cone crack damage. However, any tensile stress from subsequent impact, or presumably wind or other out-of-plane loading, will cause cracks to grow from the cone crack. In that sense the annealed glass is the worst choice in that non-critical damage quickly becomes critical damage. So there is effectively no residual strength after impact.

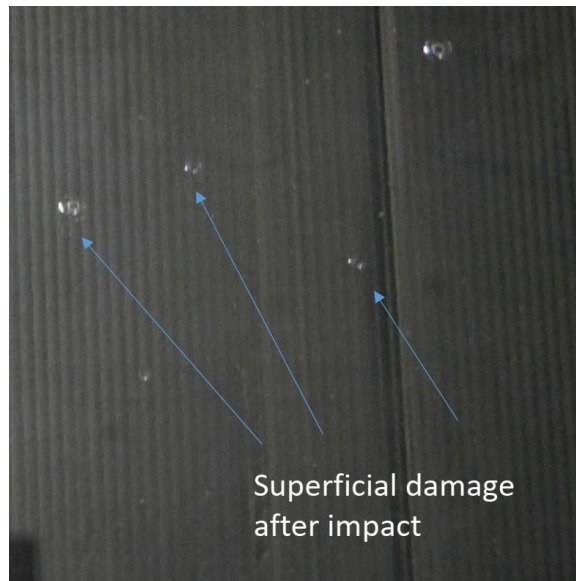
In fully tempered glass with sub-critical impactors slight chipping of the surface, as shown in Fig. 8 is observed. This is not noticeable in annealed and heat-strengthened glass. Larger impactors of 20 mm diameter or more cause total failure of the top layer. An example is shown in Fig. 9. Additional impact of a 25 mm diameter spherical impactors caused failure of the bottom plate also in some cases, leading to total structural failure of the fully tempered panel, as shown in Fig. 10.

Fig. 8: Superficial damage to fully tempered glass by non-critical impacts

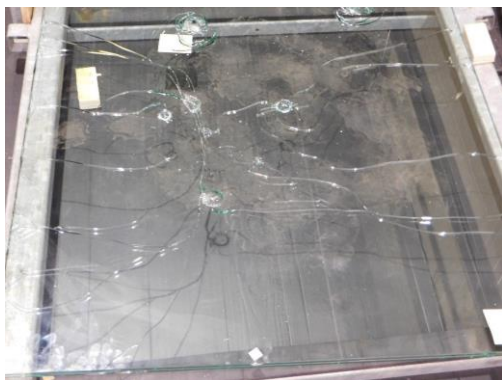
In heat-strengthened glass, the impact of a 16 to 18 mm diameter spherical impactor causes a cone crack with immediate cracking extending from it as shown in Fig. 6. Additional impacts by larger impactors cause more damage. In most specimens after 3 or 4 large cracks have been made, larger impactors do not cause extra damage, presumably as the decreased stiffness reduced the impact stress. One specimen was turned upside down after testing, with the back face being tested also. This specimen could, even after multiple impacts on both sides, still carry a large static load safely as is shown in Fig. 7. As shown by Veer *et al.* (2021), heat-strengthened glass retains at significant fraction of its residual surface compressive strength after fracture, so this is not surprising.

Fig. 6: Cone cracks with cracks extending from them in the heat-strengthened glass after multiple impacts

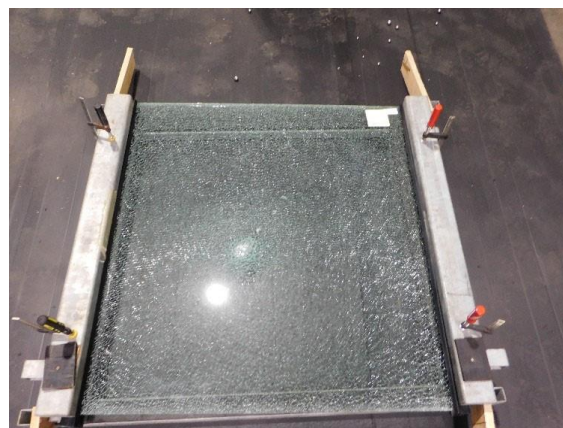
Fig. 9: Disintegrated fully tempered glass top-layer

Looking at the 1×1 m specimens the results show that fully tempered glass is the most resistant to impact damage. However, if the threshold for impact damage is exceeded the pane completely disintegrates. The tests however also show that a large impact on the fragmented pane can still cause the back pane to fragment also. In that case, as is clear from Fig. 9, there is no residual safety and the damaged panel will not be retained within its frame.

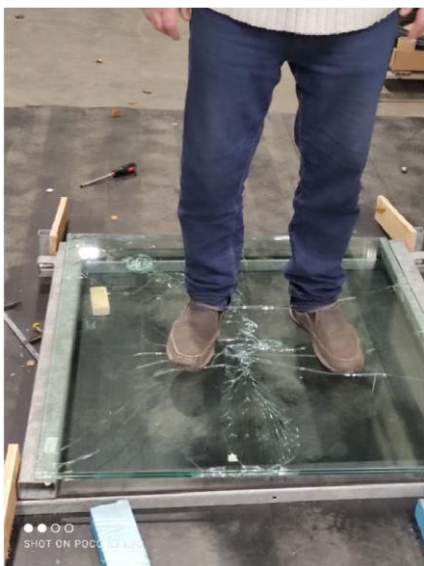
Fig. 7: Demonstration of the residual stability of heat-strengthened panel after multiple impacts on both sides

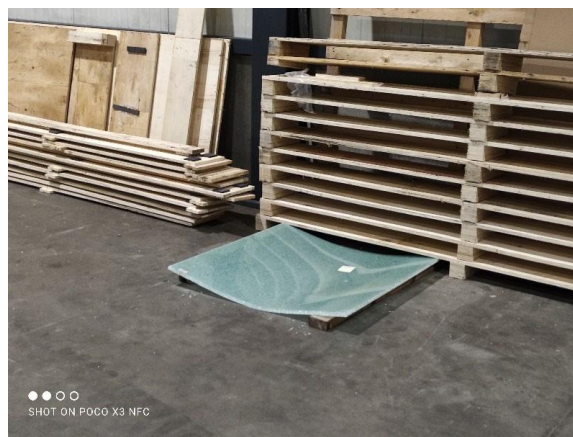
Fig. 10: Loss of structural integrity of fully tempered panel after additional impacts caused the failure of the bottom layer

The heat-strengthened glass is demonstrably the most safe. Impact with an energy above the threshold for impact damage causes a cone crack to form which immediately cracks further, presumably due to the tensile stress in the middle of the glass. However multiple impacts, even on both sides, do not impair the safety as the damaged panel can still sustain a significant load as Fig. 10 shows.

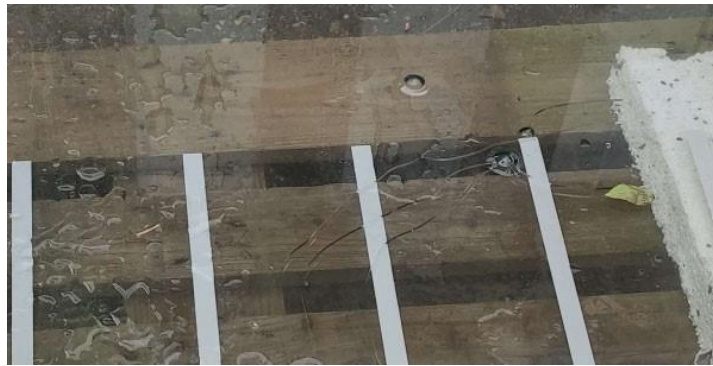
Fig. 11: Results of tests on location 1

Tests were done at 6 different locations of the panel, varying in support and aiming at the middle or edge of the panel. The results are described for each location in Table 4 and Fig. 11, 12 and 13 show the impact damage.

The results from the tests on the full-scale panel are more complex. The glass is thinner and the average surface compression stress is lower than in the 1×1 m panels. Where the glass impacted is locally supported by the foam supports the critical energy for impact damage exceeds that found for the 1×1 m panels. Where the glass is impacted between the foam supports the critical energy for impact damage is lower. As the 66.2 panel has about half the bending stiffness of the 88.2. Panels, apparently the increased flexure decreases the critical energy for impact damage. The reasons for this requires further research to elucidate. The most critical finding is however that the full-scale glass panel is very resilient to impact damage and has enough residual strength to maintain both structural safety and its sound screen function even after multiple impacts, even though the architectural function is partially lost.

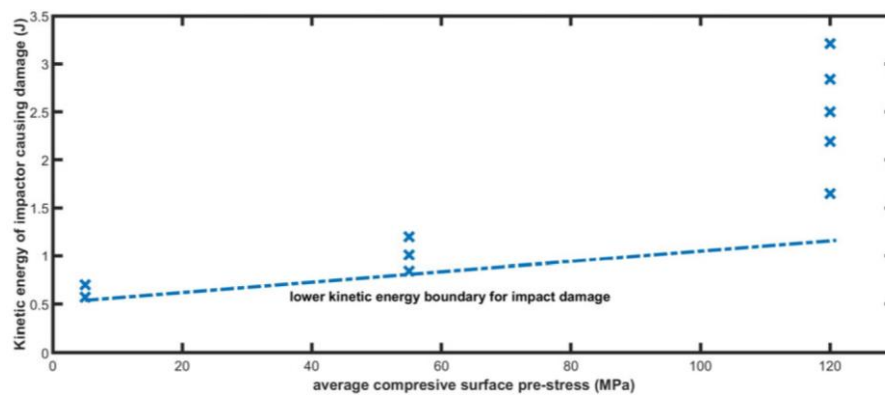
Fig. 14: Relation between average pre-stress and critical energy for impact damage

Figure 14 shows a plot of pre-stress against impact energy causing damage for all tests, with a lower and upper boundary. Although the scatter is considerable it is clear that higher surface compression pre-stress causes a significant increase in the critical kinetic energy to cause impact damage. This however is outweighed for practical purposes by the lack of residual strength caused by the total fragmentation of fully tempered glass.
