# Application of shearography with thermal loading for structural inspection of Rembrandt's *Night Watch*

The assessment of the structural condition of cultural heritage objects is important for conservation interventions and their long-term preservation. This investigation concerns *The Night Watch* (1642), a large-format 17<sup>th</sup>-century canvas painting by Rembrandt van Rijn that is on display in the Rijksmuseum, Amsterdam. This painting, which has a complex treatment history, has various damaged areas and has undergone three wax-resin relinings. In 1975 the canvas was slashed twelve times with a serrated dinner knife, including several long slashes in the area of Captain Frans Banninck Cocq's breeches. In 2021, prior to a proposed new structural intervention involving retensioning of the canvas, it was important to evaluate the structural condition of the repaired slashes and of another repair, specifically an old canvas insert in the drum. For this, an in-situ inspection was carried out in the Rijksmuseum as a part of Operation Nightwatch. 3D shearography instrument with thermal loading was used to inspect these two areas of interest on the reverse of *The Night Watch*.

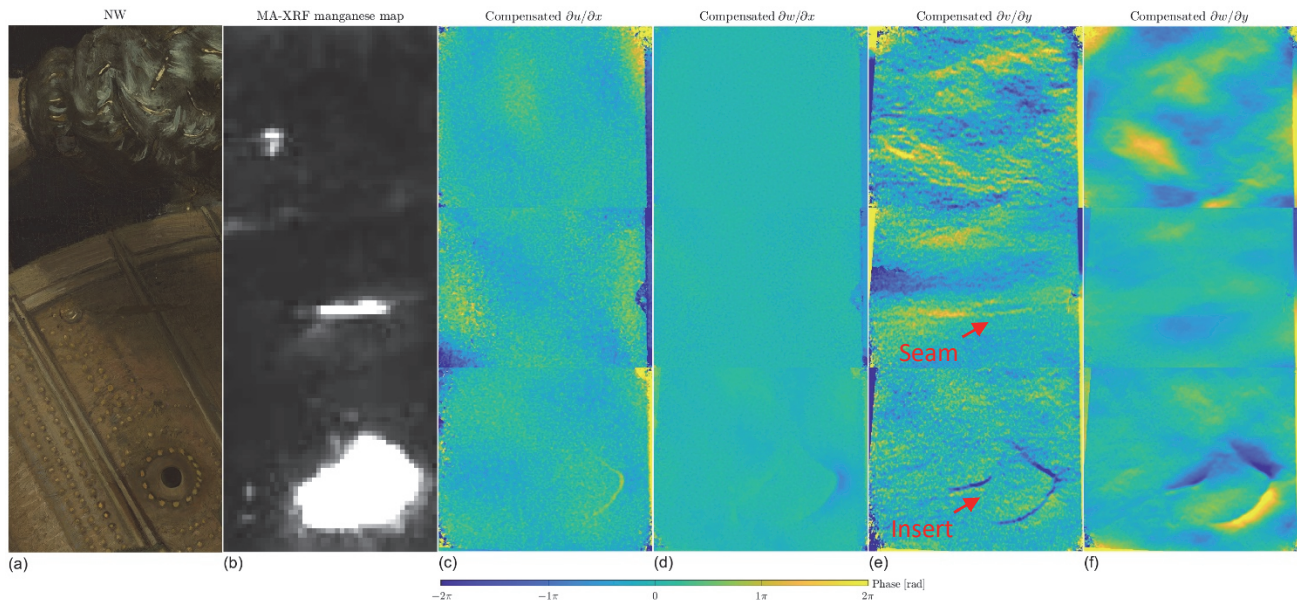
The inspected area of the drum with the canvas insert and the canvas seam in the original support is shown in Figure 3 (a). The seam and the canvas insert are detectable in the in-plane  $\partial v/\partial y$  and the out-of-plane  $\partial w/\partial y$  phase maps with the shear in the  $y$ -direction (Figure 3 (e, f)).

Figure 3. 3D shearography inspection results of the drum area with the canvas seam and insert (198×484 mm). (a) white light image with corrected intensity levels, (b) manganese (Mn-K) map, macro X-ray fluorescence scanning spectroscopy (MA-XRF) associated with the pigment umber used during the restoration, (c) the in-plane phase  $\partial u/\partial x$  and (d) the out-of-plane phase  $\partial w/\partial x$  with the shear in the x-direction (horizontal), (e) the in-plane phase  $\partial v/\partial y$  and (f) the out-of-plane phase  $\partial w/\partial y$  with the shear in the y-direction (vertical).

The inspection results of both investigated areas (Figures 3 and 4) show that known structural features can be reliably identified and mapped (viz. the seam and the insert in the drum, Figure 3). The overall pattern of the repaired slashes in the breeches area can be traced in the out-of-plane phase map with the shear in the  $x$ -direction ( $\partial w/\partial x$ , Figure 4 (d)). However, both the in-plane (Figure 4 (c, e)) and out-of-plane phase maps (Figure 4 (d, f)) do not have clear and significant local variations as compared to the area around the drum insert (Figure 3 (e, f)). The localised strain around the drum insert can be explained by the lower quality of the patched canvas compared to the repaired slashes in the breeches of Banninck Cocq.

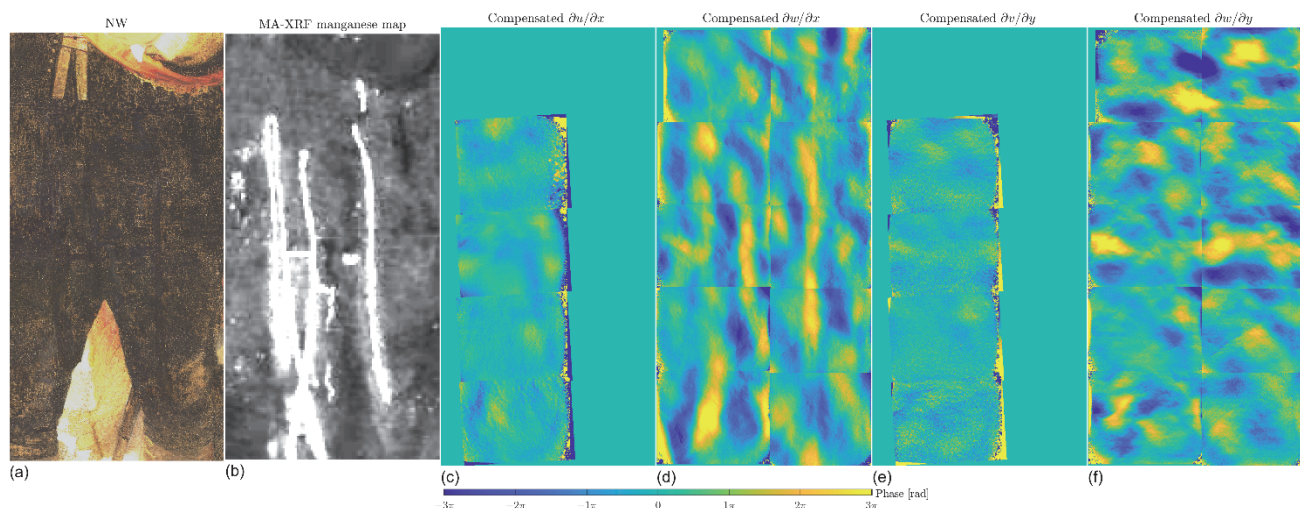
The area investigated in the breeches of Captain Banninck Cocq (445×909 mm) was significantly larger than the drum area (198×484 mm), therefore inspection of the full area with 3D shearography was found not to be efficient from the time and effort point of view. The entire breeches area was inspected with the out-of-plane configuration of the instrument (Figure 4 (d, f)) to identify possible delaminations between the original canvas and the lining canvas given the slashes incurred in 1975 in this area were the largest. A smaller area, which was considered the most critical was inspected with 3D shearography (Figure 4 (c, e)).

Figure 4. 3D shearography inspection results of the Captain Banninck Cocq's breeches area (445×909 mm). (a) white light image with corrected intensity levels, (b) manganese (Mn-K) map, macro X-ray fluorescence scanning spectroscopy (MA-XRF) associated with the pigment umber used for repairing the slashes during the 1975-76 restoration, (c) the in-plane phase  $\partial u/\partial x$  and (d) the out-of-plane phase  $\partial w/\partial x$  with the shear in the x-direction (horizontal), (e) the in-plane phase  $\partial v/\partial y$  and (f) the out-of-plane phase  $\partial w/\partial y$  with the shear in the y-direction (vertical).
