Data verification for "Empirical fragility and ROC curves for masonry buildings subjected to settlements"

*Data verification for "Empirical fragility and ROC
curves for masonry buildings subjected to
settlements"*

Report

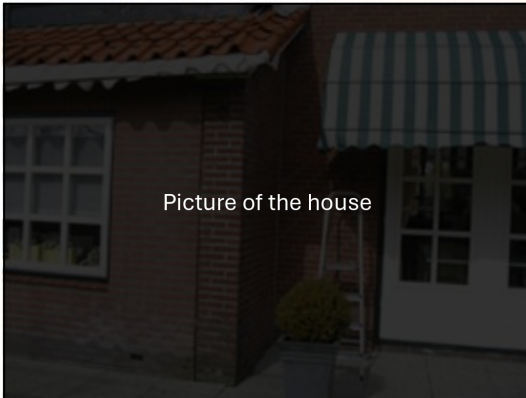
3435 naad voorhuis - schuur.JPG

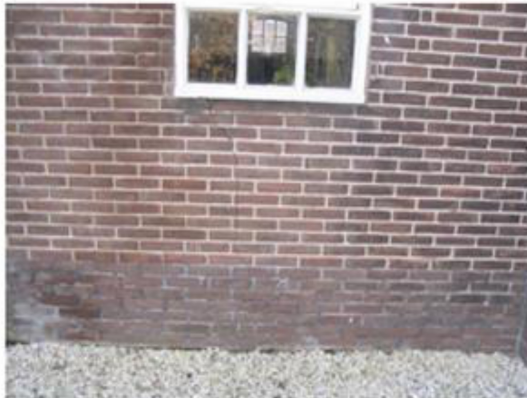
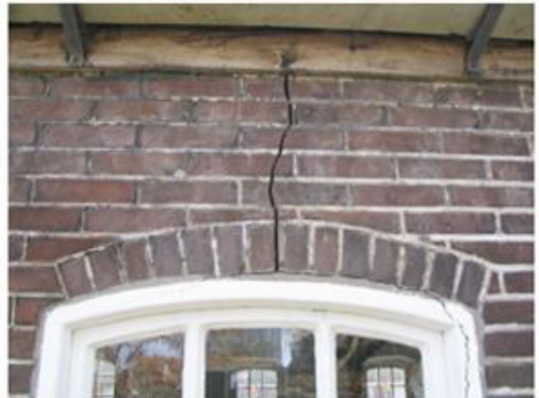
3439 scheur zijgevel schuur.JPG

3440 scheur zijgevel schuur.JPG

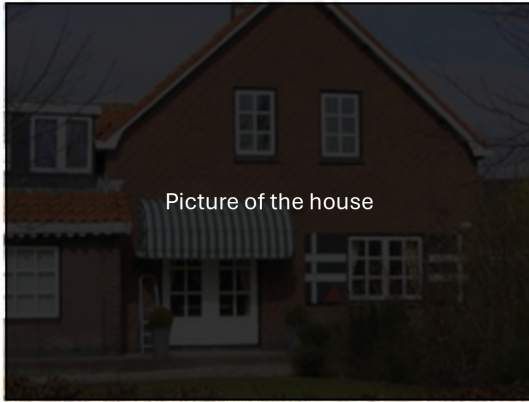
3445 linkerzijgevel voorhuis.JPG

- huidige scheefstand van het voorhuis zodanig dat criterium voor schadecategorie 3 (zettingsgradiënt > 1:100) nu al wordt overschreden
- vermoedelijk wordt de scheefstand van het voorhuis veroorzaakt door negatieve kleeft en/of paalmoment
- op dit moment nog geen schade zichtbaar aan voorhuis doordat pand in zijn geheel is geroteerd
- schuur vertoont aan zijde kade slechts beperkte rotaties, vooral aan achterzijde; desondanks wel scheurvorming zichtbaar aan zijde kade
- scheefstand voorhuis is op dit moment kritisch; verdere toename scheefstand leidt tot onveilige situatie; geadviseerd wordt e.e.a. met eigenaar te bespreken

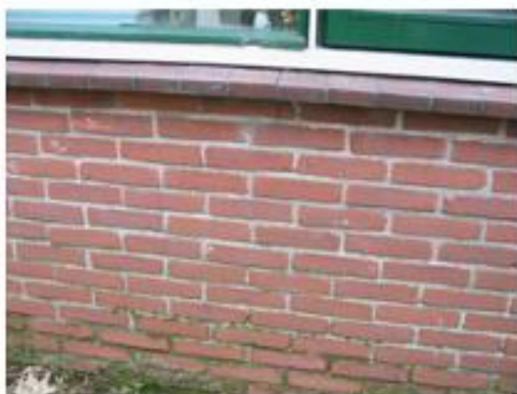
- pand is constructief in redelijke conditie
- ter plaatse van linkerzijgevel enige scheurvorming zichtbaar in voorhuis
waarschijnlijk als gevolg van rotatieverschil tussen voorhuis en stal
- ter plaatse van aanhechting plantenbak - woonhuis enige scheurvorming zichtbaar.

gebrek: scheurvorming linkerzijgevel

4983 scheurvorming linkerzijgevel voorhuis

type schade	herstetechniek	hoeveelheid (m / m2 / st)	prijs/eenheid	kostenpost
lichte scheefstand	herstel niet nodig			PM
lichte scheurvorming links	inboeten, voegen	2,00 m2	€ 75	€ 150
scheurvorming plantenbak	inboeten, voegen	4,00	€ 75	€ 300
totaal excl. btw				€ 450

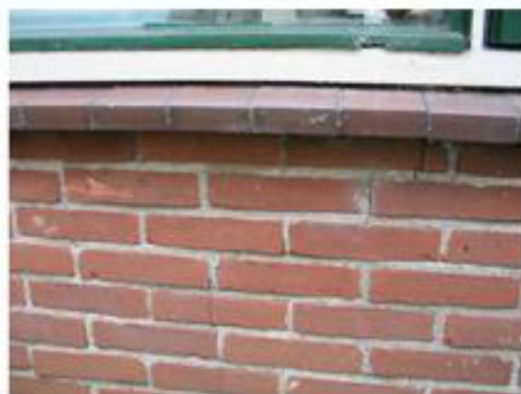
4984 idem detail

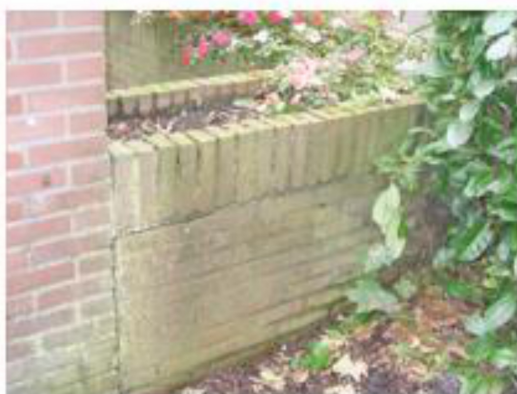
4985 plantenbak
