# A Study on the Failure of AISI 304 Stainless Steel Tubes in a Gas Heater Unit

**Abstract:** This paper investigates a failure in convection section tubes of a gas heater unit in a petrochemical plant. Tubes are made of AISI 304 stainless steel. The failure is reported after 5 years of service at working temperature 500 °C. The failure is in the form of circumferential cracks in the vicinity of the weld. Various characterization techniques, including optical and electron microscopes as well as energy-dispersive X-ray spectroscopy (EDS), were used to study the failure. Results showed that the damage has initiated in the heat affected zone (HAZ) area parallel to the weld/base metal interface. Cracks have propagated alongside grain boundaries, resulting in an intergranular fracture. The main cause of failure was concluded to be attributable to the grain boundary sensitization and intergranular grain boundary attack due to improper welding and long time exposure of tubes to high temperature. Possible mitigation strategies to minimize similar failures will be discussed.

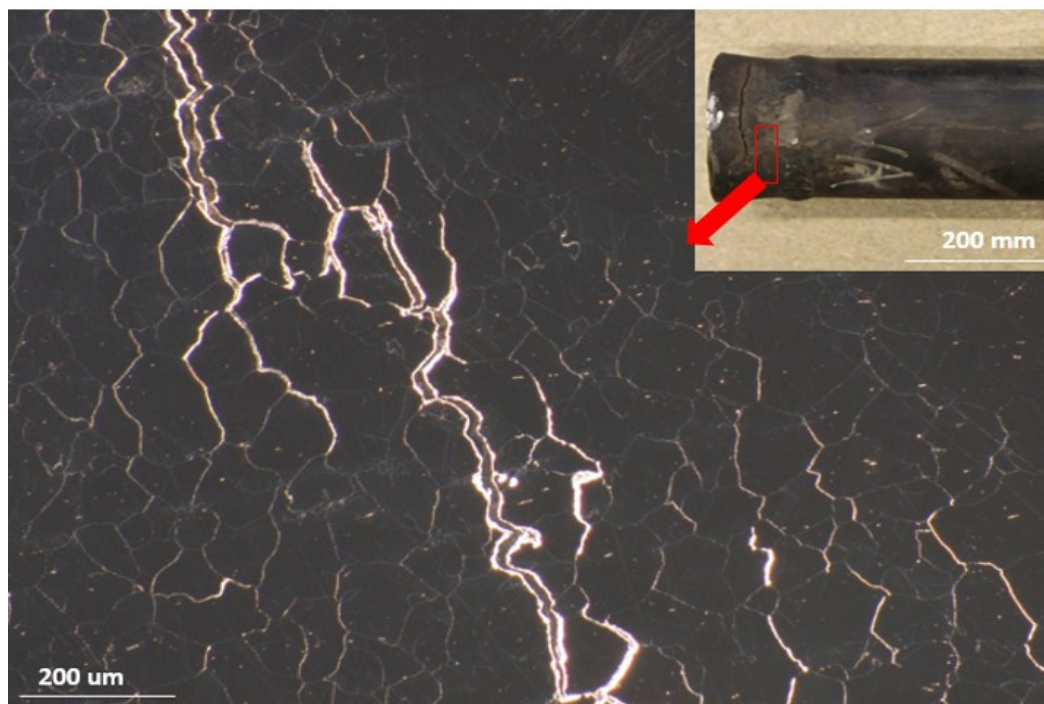
Figure 1 shows an example of a failed tube together with stereomicroscopic image of crack. As can be seen, the crack has propagated circumferentially parallel to the welding line. The crack has propagated in HAZ area in the vicinity of the weld. stereomicroscopic image shows that the crack has propagated alongside grain boundaries. There is no defect in the form of crack or cavities inside the weld, inferring that the weld itself has a perfect quality. In some areas there are some deposits on the surface. Other than these mentioned features, there is hardly any other abnormality in the form of bulging, thinning, or localized deformation in any form. The fact that there is no bulging or localized deformation infers that creep is not a major issue.

Figure 1. Macro and stereomicroscopic images of failed specimen.

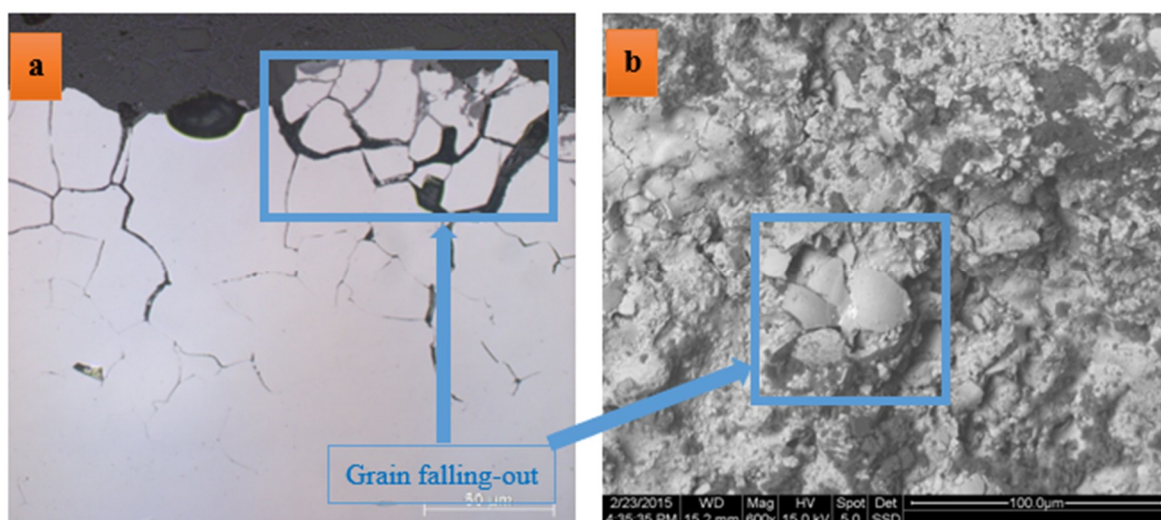
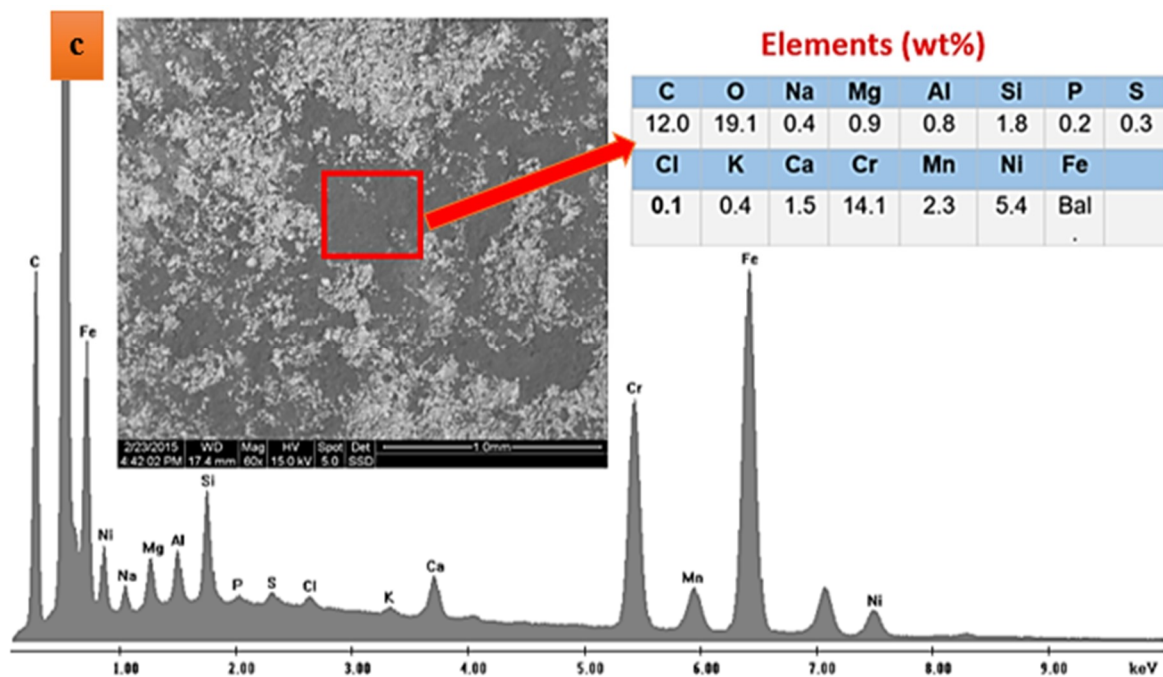
**Figure 2.** Cont.

Figure 2 shows grain structure and deposits on the surface of the tube near the damaged area. Two main features are noteworthy to mention. The first noticeable observation is the so-called “grain falling-out” phenomenon (see Figure 2a). It appears that grain boundaries at the surface are heavily oxidized, resulting in the weakening of grain boundary and detachment of a whole grain from the surface. This is also confirmed by the SEM image (Figure 2b). It is also noticeable that some areas on the surface are covered a black deposit. The EDS analysis of these deposits are given in Figure 2c, showing that elements like C, Cl, Mg, Na, and Ca are present in the composition of these deposits. Given that the outer surface of the tube is the fire-side, one can conclude that these deposits are typical fly ashes, coming from the fuel. In this case fly ash corrosion appears to have a significant attribution to the observed failure. Fly ash is a residue generated due to coal combustion and contains fine particles. In this case ash is brought to the system via flue gas. The composition of fly ash depends on the coal and the combustion condition. In most cases, fly ash contains ferric oxide, aluminum oxide, silicon dioxide, and calcium oxide [18]. Fly ash particles are normally collected by filter bags and/or electrostatic filter. Yet, there is a chance that very small residues are not captured by filters. These residues are then precipitated on the outer surface of the tube. Fly ash residues can accelerate surface corrosions. Elements like Ca and Na can diffuse into grain boundaries, resulting in the weakening of grain boundaries and ultimately grain detachment on the surface. Needless to mention that elements like Cl can also severely corrode stainless steels.

**Figure 2.** (a) Optical microscope image of grain falling-out at the surface, (b) SEM image of grain falling-out at the surface, and (c) SEM/energy-dispersive X-ray spectroscopy (EDS) analyses of deposits on the surface.

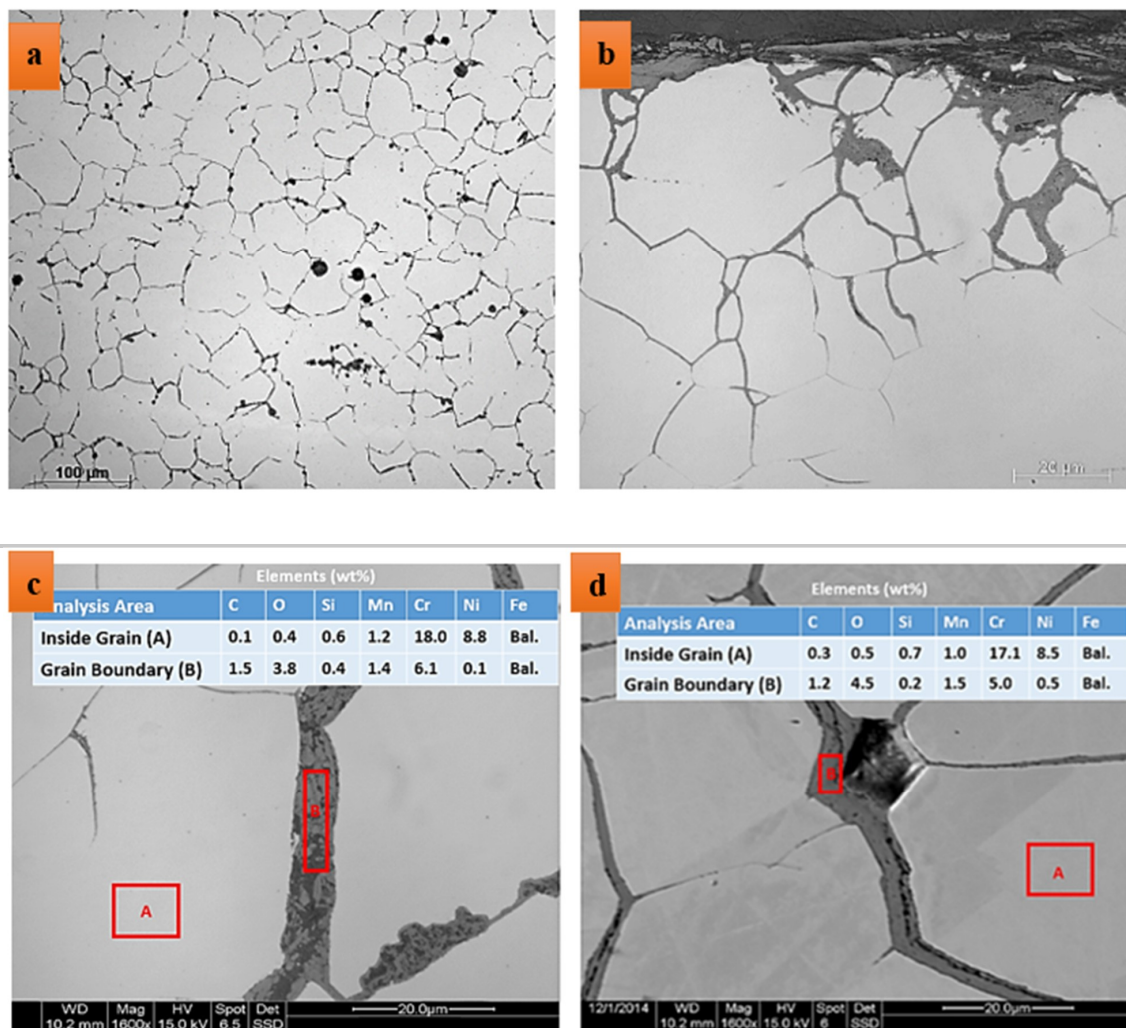
Figure 3 shows optical microscope and SEM images of HAZ structure in the as-polished condition. Figure 3a,b show that grain boundaries are mostly covered with a rather thick black phase layer. Figure 3c,d depict that the thickness of the grain boundary phase layer can be as high as 10  $\mu\text{m}$ . The grain boundary phase appears to be rather brittle. This is clearly seen in Figure 3c in which the grain boundary phase is broken. The EDS analyses of grain boundary, given in Figure 3c,d, show that the grain boundary phase is rich in oxygen, carbon, and chromium. It appears that grain boundaries are sensitized and are heavily oxidized. Grain boundary sensitization takes place when chromium carbide precipitates at grain boundaries. Chromium carbide precipitation at grain boundary creates a chromium-depleted zone in the vicinity of sensitized grain boundaries. Given that chromium is the major element when it comes to the corrosion resistance in stainless steels, this narrow chromium-depleted region adjacent to the grain boundaries makes grain boundaries preferential corrosion spots. A continuous network of carbides on grain boundaries and intergranular corrosion makes grain boundaries weak and brittle. Cracks can therefore more easily propagate alongside sensitized grain boundaries. Sensitization of grain boundaries of austenitic stainless steels takes place in temperature range 510 to 780  $^{\circ}\text{C}$  [19]. Any thermal exposure into this temperature range during welding or service could potentially result in the sensitization of grain boundaries in stainless steels. The temperature and time required to cause sensitization and intergranular corrosion depends on the chemistry of the alloy, and more specifically on the carbon content of the alloy. Obviously, the higher the carbon content of the alloy, the higher is the risk of sensitization. For this reason, low carbon stainless steel grades such as AISI 304L and AISI 316L alloys are known to have an excellent resistance against sensitization during welding. In higher alloyed stainless steels such as alloys AISI 904L, grain boundary susceptibility to sensitization is also essentially not a concern [19]. In this case, the observed sensitization has possibly its root in the welding practice. The service temperature is on the lower side of the sensitization temperature range and service exposure has possibly not the major contribution to the sensitization. If sensitization was due to the service exposure, one should have seen sensitization in the base metal as well, which obviously is not the case.

**Figure 3.** Optical microscope images of grain structure in the heat affected zone (HAZ) area of failed specimens; (a,b) an overall view, and (c,d) SEM/EDS analyses of grain boundary phase and inside grains.

- Carbon content has a very decisive influence on the susceptibility of grain boundaries. Superior resistance to grain boundary susceptibility can be achieved by reducing the carbon content values less than 0.03 wt%. It is highly recommended to use AISI 304L or other low-carbon stainless steel grades instead of AISI 304.

- Stabilizing elements like Nb and Ti can also enhance the resistance to sensitization. These elements form stable carbides at high temperature. This way less carbon is available for the formation of chromium carbides at grain boundaries. Commonly used stabilized austenitic stainless steel grades are AISI 321 and AISI 347. Replacement of currently used AISI 304 alloy with stabilized grades is also highly recommended.

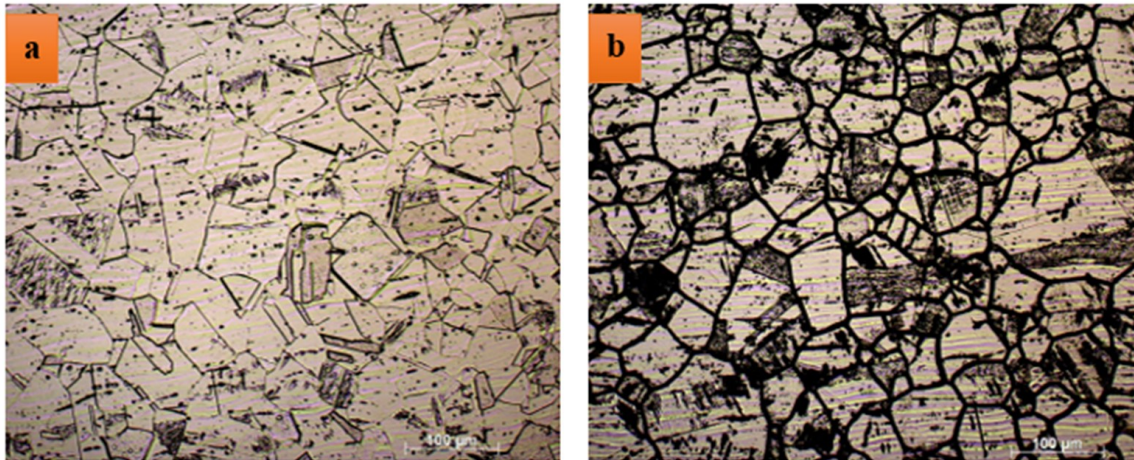
The formation of the latter etch structure is an indication of grain boundary sensitization. Figure 4 shows the etch structure of AISI 304 stainless steel in the base metal (Figure 4a) and in the HAZ (Figure 4b). A clear difference is observed between these structures. While the former is a typical step

structure, the latter is a clear ditch structure, inferring that HAZ has become severely sensitized during welding and service exposure.

**Figure 4.** Optical microscope images of grain structure in (a) base metal and (b) HAZ area of failed specimen, etched according to standard ASTM A262, Practice A.
