Damage Diagnostics of a Composite Single-Stiffener Panel Under Fatigue Loading Utilizing SHM Data Fusion

European Workshop on Structural Health Monitoring - Special Collection of 2020 Papers - Volume 1

Agnes A. R. Broer¹(✉), Georgios Galanopoulos², Dimitrios Zarouchas¹,
Theodoros Loutas², and Rinze Benedictus¹

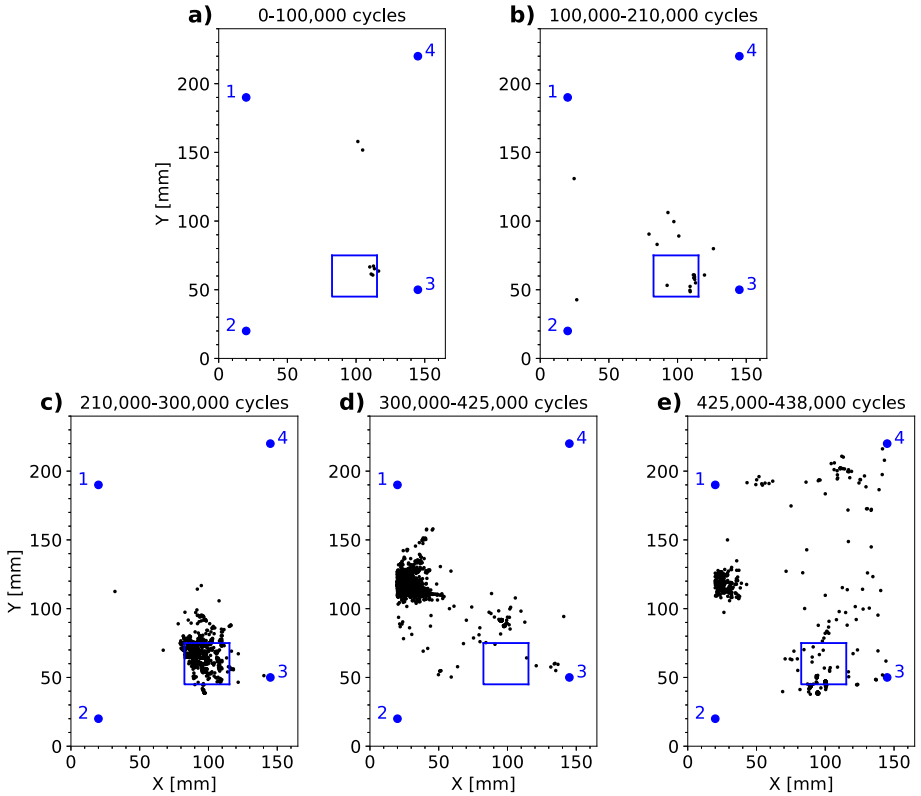
Fig. 2. Localized acoustic emission hits for specified cycle periods. The initial disbond location is indicated by a blue square and the AE sensors by blue circles.

all locations: the bottom region below a height of 90 mm shows a smaller absolute compressive strain reduction than the region above 90 mm. Evaluating the localized AE events for this cycle period (Fig. 2b), it is seen that some hits are localized around the disbond region. Figure 3 shows a further increase in cumulative energy, although it is a slightly steeper increase than in the previous cycle period. These results are an indication that, besides stiffness degradation, activity is present near the disbond resulting in disbond growth.

210,000–300,000 Cycles. Between 210,000 and 300,000 cycles, many AE events are localized, which are centered in the initial disbond area and above it (Fig. 2c). Furthermore, the cumulative energy curve (Fig. 3) has an increased slope and increases continuously throughout the considered period. The distributed strain measurements along the stiffener feet for 210,500 and 300,500 cycles are shown in Fig. 4a and b. Similar to the previous cycle period, the left stiffener foot experiences only minimal changes in strain values while the right stiffener foot shows larger differences: a small strain reduction is seen between 80 mm and 110 mm, while the region above 110 mm displays larger reductions in strain. Based on the results from both SHM techniques, it can be concluded that the disbond has grown during the considered cycle period. In addition, the direction of disbond growth can be derived from the results and it is believed to have grown upward along the length of the right stiffener. This is based on the concentration of AE events in the upper region and above the initial disbond area, as well as the minimal strain reduction on the right stiffener foot between

Nevertheless, it needs to be recognized that a large number of AE events is localized in the center height of the left skin. Moreover, the cumulative energy increases rapidly after 300,000 cycles. Evaluating the left stiffener foot, only a minimal compressive strain reduction is noted in the lower half, thereby providing little clarification on the cause of these AE events. Therefore, data from two additional SHM techniques was evaluated, namely the DIC system and LWDS. Neither provided indications of damage initiation and propagation. Given that a PZT of the LWDS is located at $[x, y] = [25.0, 120.0]$ mm, it is therefore argued by the authors that these AE hits do not indicate a damage process but that these were instead caused by an external source. A further investigation is required to establish the actual cause; however, it is hypothesized to be either a faulty PZT or a mechanical process such as the cable of the PZT hitting the panel during fatigue loading.

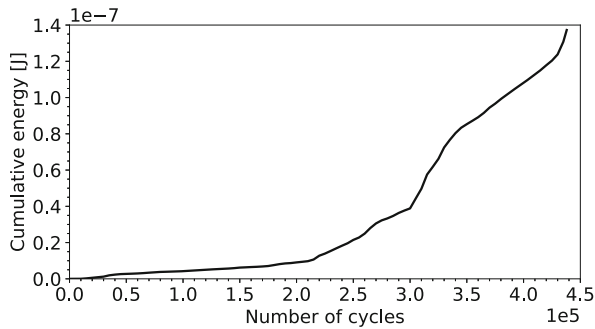
Fig. 3. AE cumulative energy versus number of cycles, with bins of 5000 cycles.

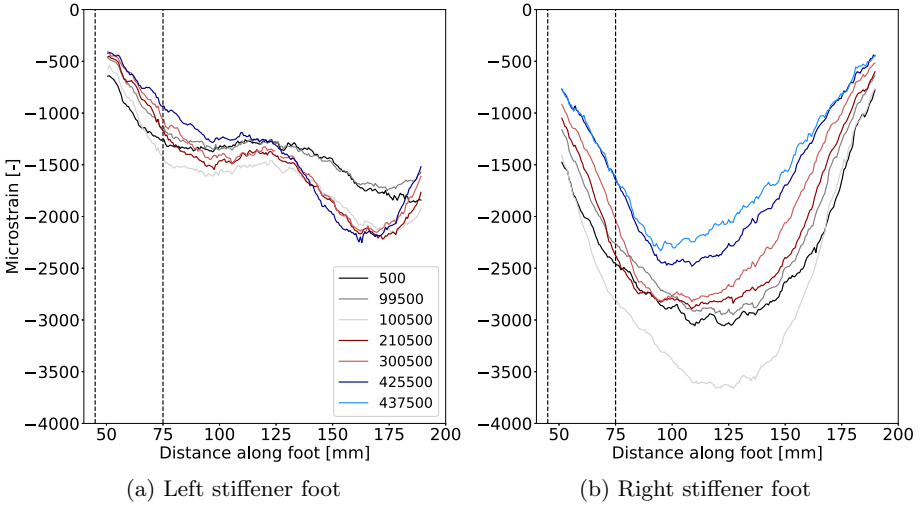
100,000–210,000 Cycles. Figure 4a and b show comparisons between the strain measurements on the stiffener feet at 100,500 and 210,500 cycles. The compressive strain in both feet has increased at 100,500 with respect to 99,500 cycles due to the increased maximum load (–50 kN to –60 kN). Comparing the

strain measurements at 100,500 and 210,500 cycles, little change is detected on the left foot, while the right foot shows a larger reduction in compressive strain. However, this reduction in strain does not occur with a similar rate at

Fig. 4. Surface strain measurements along the stiffener feet. The disbond is located in the right stiffener foot and its initial location is indicated in both graphs using black dashed lines. Legend is similar for both figures.

425,000–438,000 Cycles. Evaluating results closer to final failure, it is seen that the strain distribution in the lower half of the right stiffener foot remains close to constant, while the region above 90 mm shows a further strain reduction. Simultaneously, the left stiffener shows a reduction in compressive strain between approximately 100 mm and 130 mm while the strain in the lower and upper regions remains close to constant. The latter might be caused by either a disbond growth upward along the right stiffener or by a disbond growth from the right stiffener foot to the left stiffener foot. This reasoning can be further substantiated when evaluating the localized AE events (Fig. 2e); events are localized both below and above the initial disbond region. Additionally, around a height of $y = 60$ mm, multiple AE events are localized left of the disbond area. The growth of the disbond across the length of the stiffener as well as along its width is believed to have resulted in the final failure of the panel. The panel failed after 438,000 cycles during QS loading.
