## Restoration of the Interior

van Thoor, M.-T. (2019). Restoration of the Interior. In M.-T. van Thoor (Ed.), *Colour, Form and Space: Rietveld Schröder House Challenging the Future* (pp. 34-53). Delft University of Technology.

# 3 / RESTORATION OF THE INTERIOR

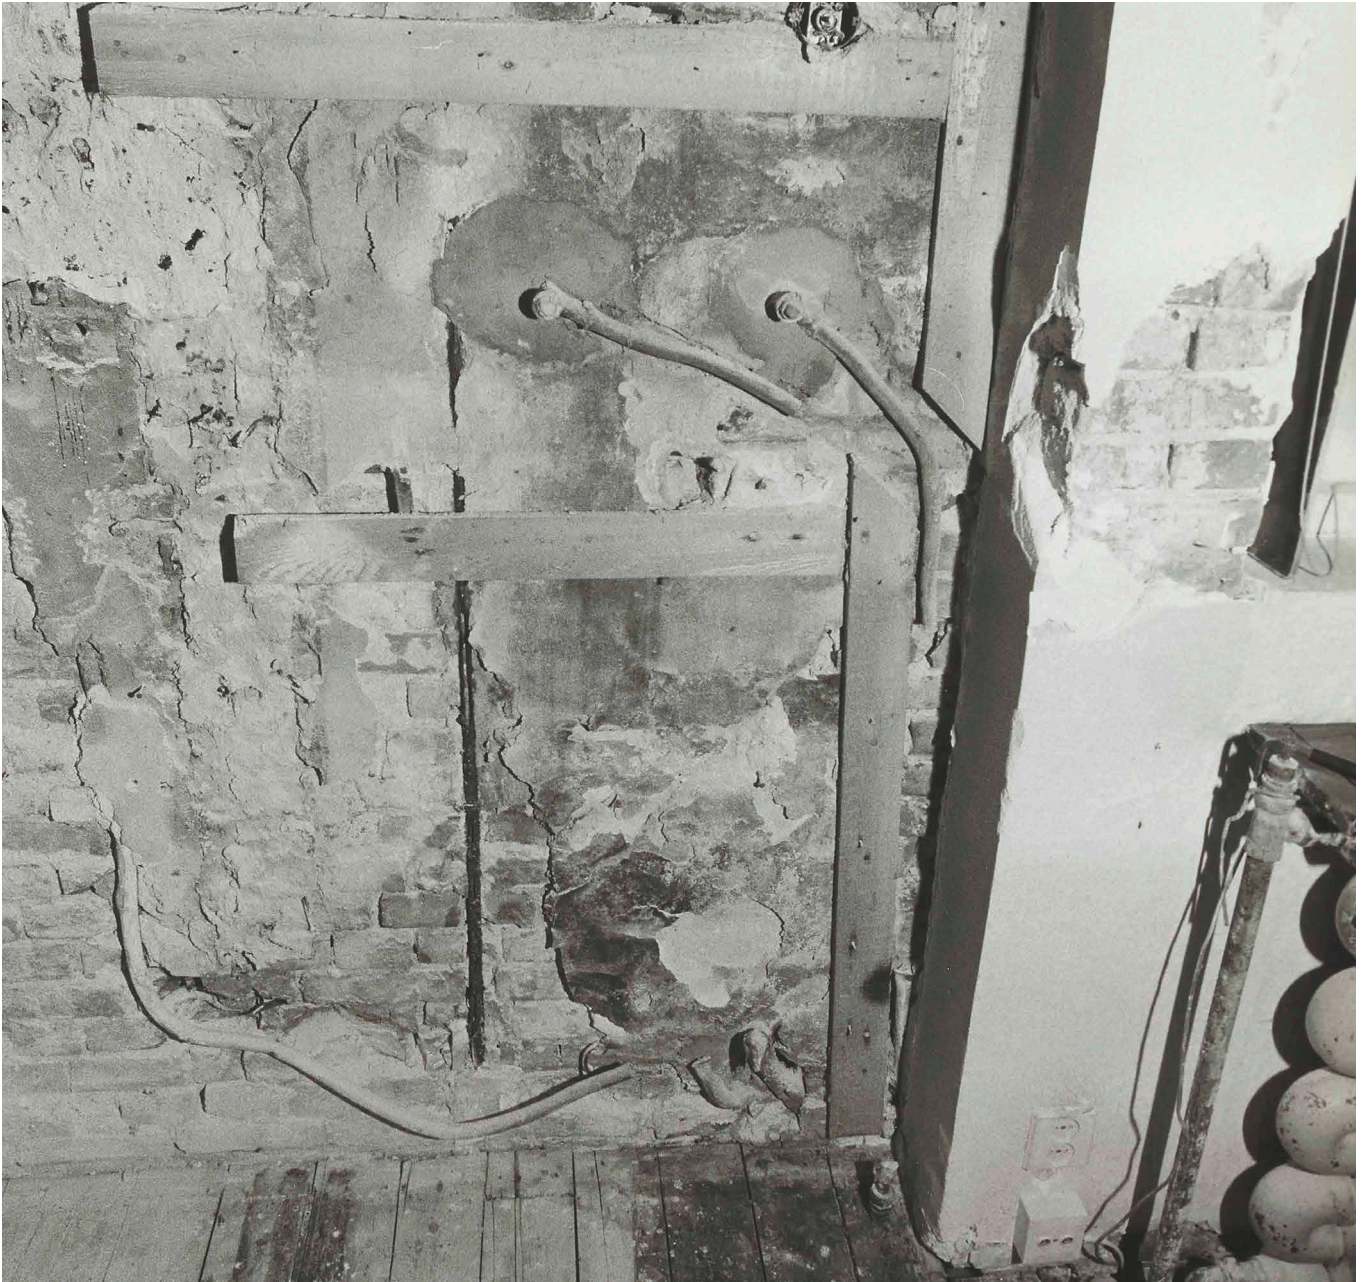
FIG. 3.1 The dismantling of wall, floors and ceiling yielded a lot of information about pipes, connection points and the attachment of furniture

The survey of the now stripped-back house yielded a lot of new information [FIG. 3.1].<sup>21</sup> For example, pencilled lines and painted and stained areas were discovered on the floors, which provided insight into the division of the floor surface and the position and size of the beds [FIG. 3.2]. Holes in the walls indicated where cupboards and other items of furniture had been fixed to the walls. Mulder also recovered original parts of the former kitchen. And during the inspection of the electrical services, a 'strangely insulated hot water system' was discovered under the floor.

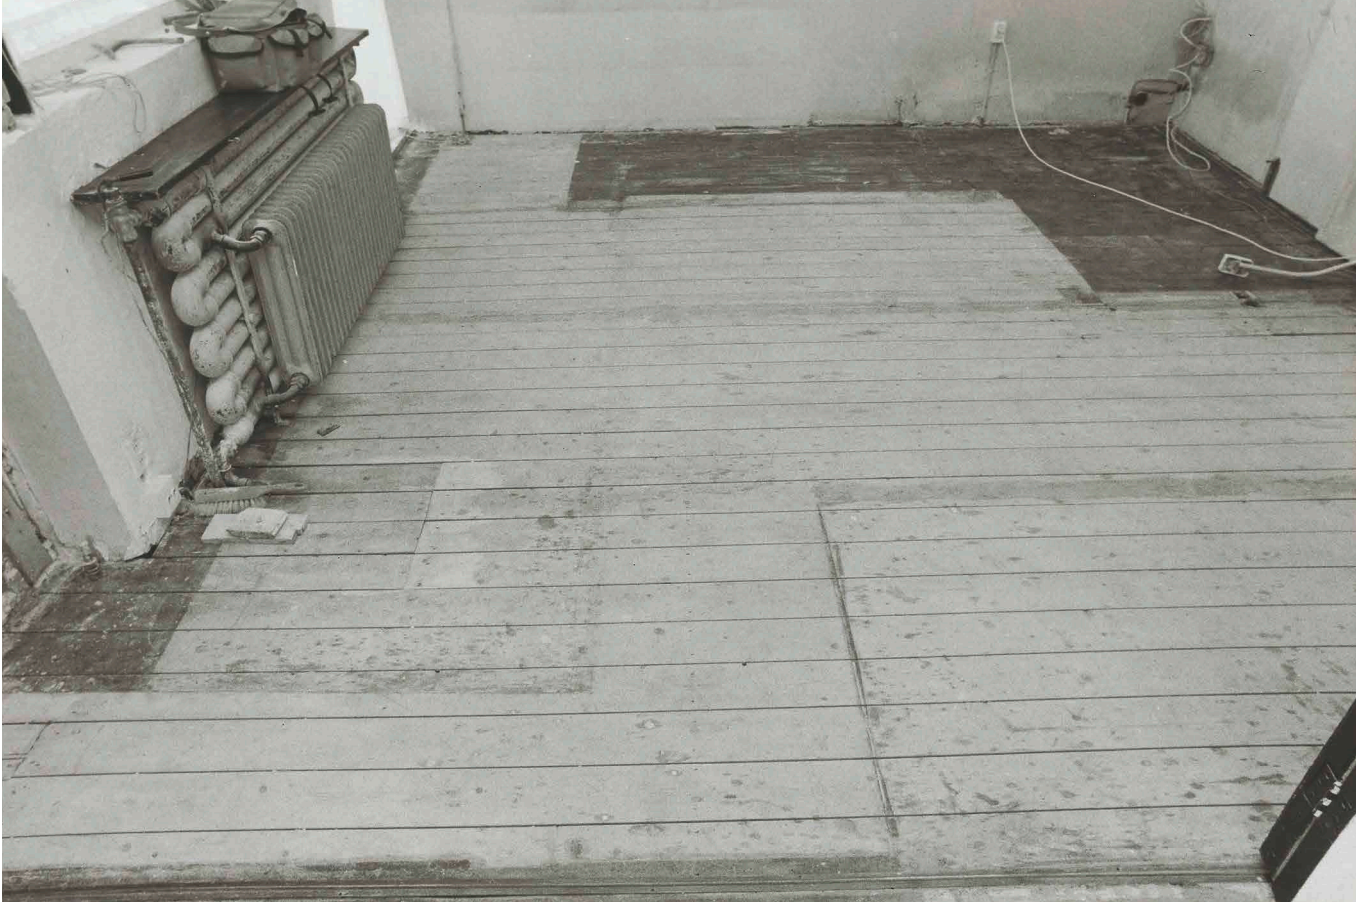
FIG. 3.2 The floor gave an indication of the division of the floor surface and the position of the beds

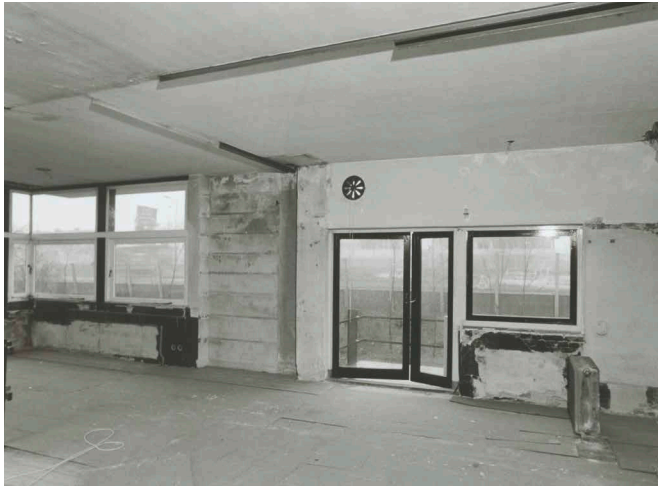
FIG. 3.3 The partially dismantled upper floor

The most visible and radical aspect of the restoration of the upper floor was the stripping of the walls and ceiling, the elements that were so crucial to the spatial picture [FIG. 3.3/3.4]. Stripped back they revealed only 'bare brickwork' and a bare soffit [FIG. 3.5/3.6/3.7]. 'The [foundation] and I were of the opinion that we would only be able to make the original spatial picture clearly and definitely tangible if the delimiting surfaces that determine that picture were once more of impeccable texture and colour,' Mulder later wrote. Even the possible withdrawal of the RDMZ's grant did not persuade the foundation to change its mind according to Mulder.<sup>23</sup> In 2016 Mulder still recalled a visit to his office by Ida van Zijl and Wim Denslagen. There was further discussion of the rigorous approach, which according to Denslagen did not correspond to what RDMZ was used to. Mulder explained once more that for him the original spatial experience went hand in hand with the restoration of space and surfaces. 'Denslagen disappeared, and that was the end of it'.<sup>24</sup> And so Mulder proceeded to reprise the reconstructive approach he had previously applied to the exterior.

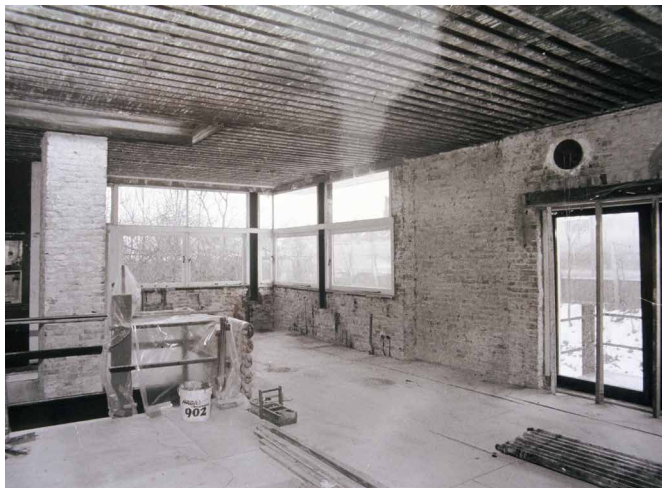
FIG. 3.5 The upper floor of the Rietveld Schröder House in dismantled state

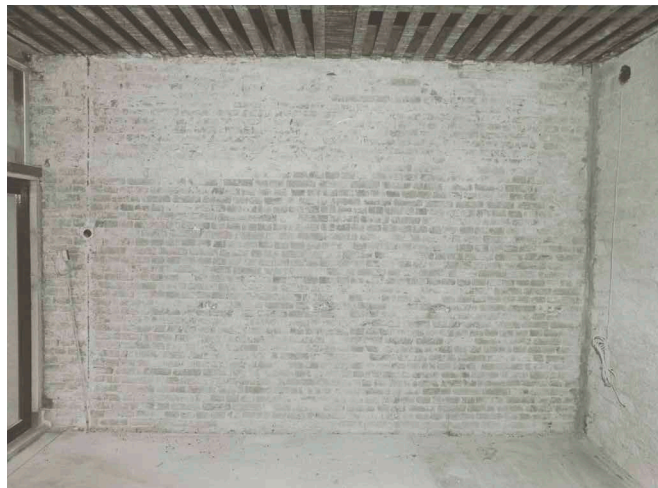
FIG. 3.6 Bare brick wall and stripped ceiling

Before the walls were replastered, the cracks in the brickwork were, like those in the exterior, filled with synthetic mortar. The new metal lath ceiling was suspended from the joists using a (floating) steel network in order to minimize the chance of cracks.<sup>27</sup> The plastering was carried out by the firm of H. van de Kant Afbouwbedrijf Zeist B.V. H. van de Kant recalled that the existing plaster had to be carefully removed and placed in bags in plastic trays, sorted according to wall area and colour. This enabled Mulder to carefully examine the plaster and layers of paint on top of it.<sup>28</sup> After that examination the old plaster was carried away and destroyed. Although the abovementioned memos from 1984 and 1985 refer to a specific plaster mix, Mulder and Van de Kant stated, when asked, that the exact proportions of cement, sand and lime were decided on site. Ultimately, it was the plasterer who determined this, just as in Rietveld's day. After applying the plaster, the plasterers had to sand the base coat 'with jute on a wooden board', to achieve the same effect as under Rietveld. It resulted in a smooth surface with here and there a stray grain of sand, but without any traces of repair work or restoration.

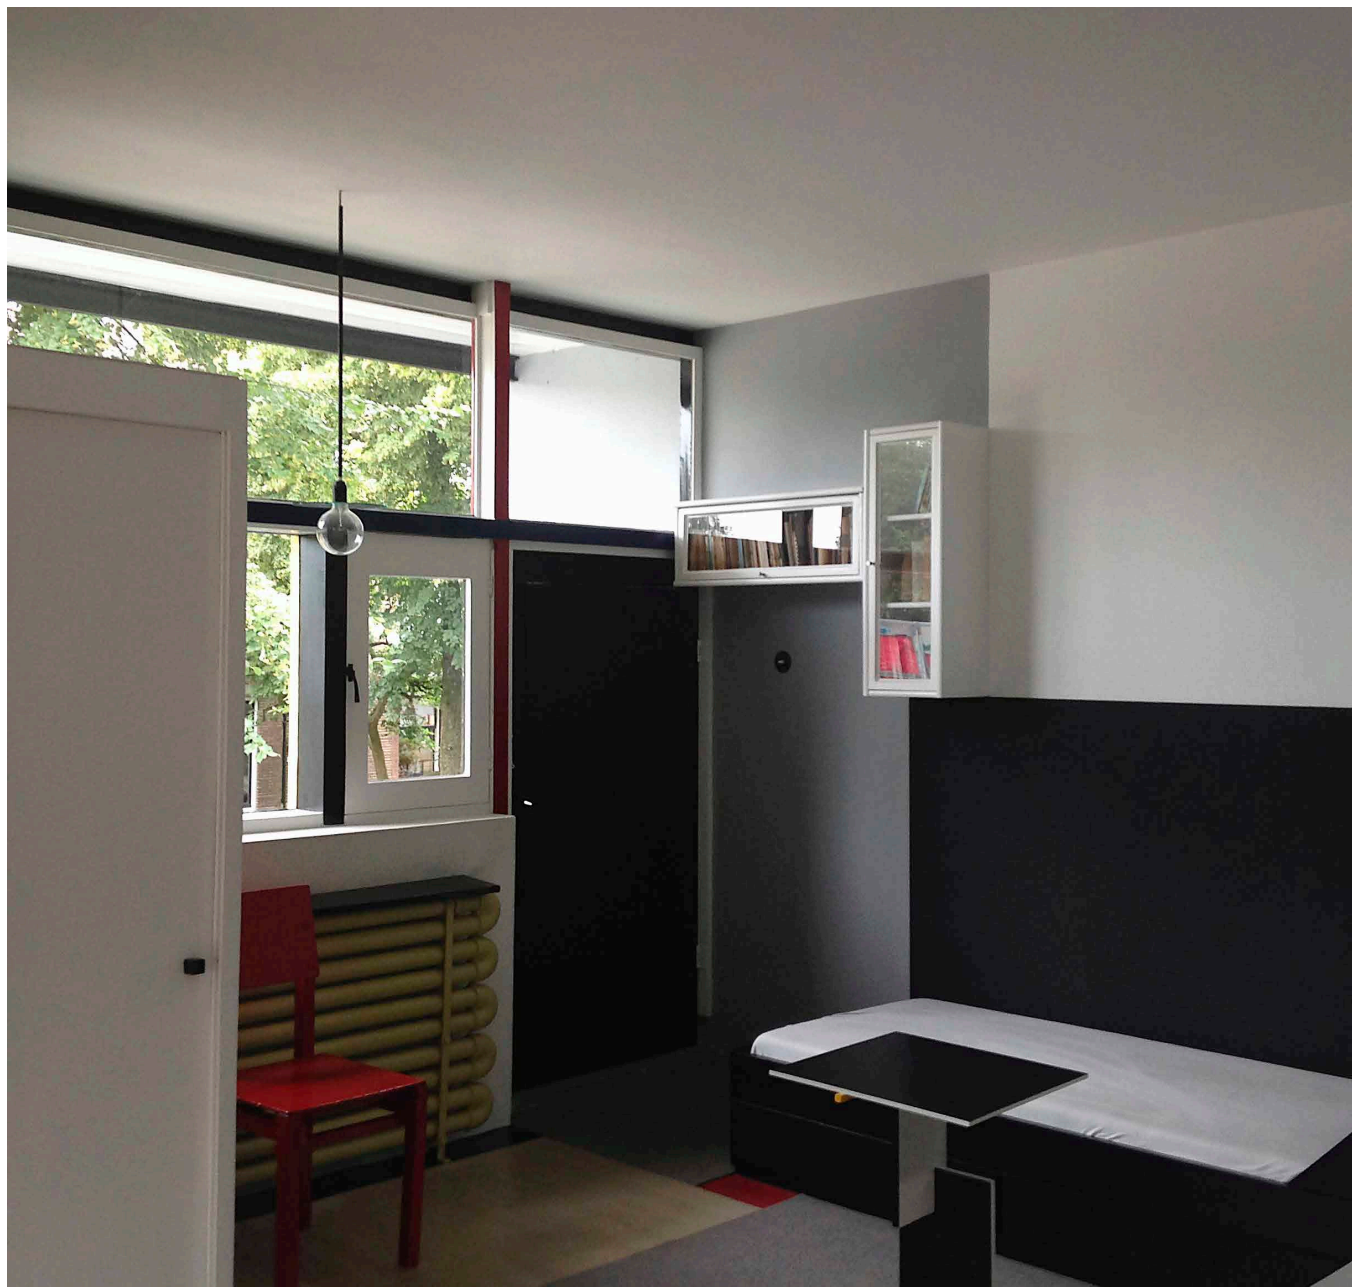
What mattered was the entire composition of colours and surfaces, which was supposed to restore the original spatial experience. During the removal of the plasterwork in the girls' bedroom, Mulder had discovered a grey that matched the compositional image of the space. The wall, which ran from inside to outside, had been white on the inside back when Mulder had devised the colour scheme of the exterior in the 1970s. When the painting of the interior was completed, however, it turned out that the grey on the inside of this wall was different from the grey of the exterior section. Because it was important for the overall image

FIG. 3.9 The wall in the girls' room runs from inside to outside, so B. Mulder had both the inner and outer sides of the wall painted in the same shade of grey, 2015

that the wall should be the same colour inside and out, Mulder had the exterior repainted [FIG. 3.9]. But it didn't end with the repainting of the balcony wall on Prins Hendriklaan; the entire composition of greys on the exterior had to be determined all over again.

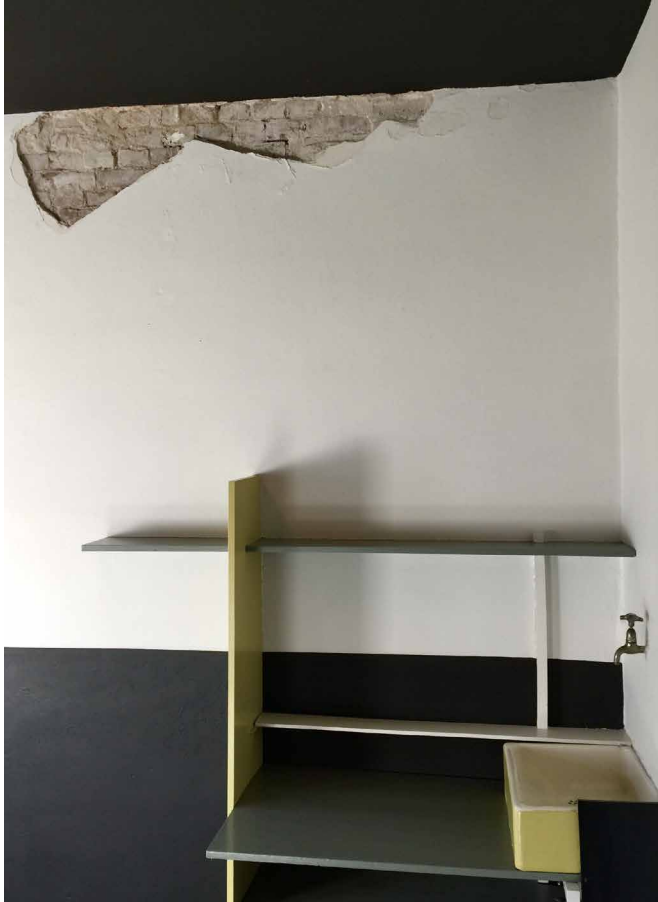
FIG. 3.13 The plasterwork at the top of the south wall of the study was damaged and came loose in October 2016

In October 2016 a piece of plaster came loose at the top of the south wall of the study [FIG. 3.13]. This provided an opportunity to have both the cause of the loosening and the composition of the plaster investigated by, respectively, TU Delft and TNO.<sup>36</sup> Quite by chance it was possible to show a sample of this plaster to Hans Geerken, who had been involved in the restoration of the exterior. He thought it looked as if it had been composed of coarse sharp sand from Buslo with putty lime and cement; he thought the sand dated from the 1970s. In addition, the top layer of paint was probably Alfatex IQ latex.<sup>37</sup> Thus it looked as if the plasterwork on this wall had been renewed. However, TNO's petrographic analysis indicated that the sample did not contain any cement and consisted of lime mortar base coats, lime mortar finishing coats plus two top coats. 'It's possible the sample was a fragment of the original plaster,' was TNO's conclusion.<sup>38</sup>

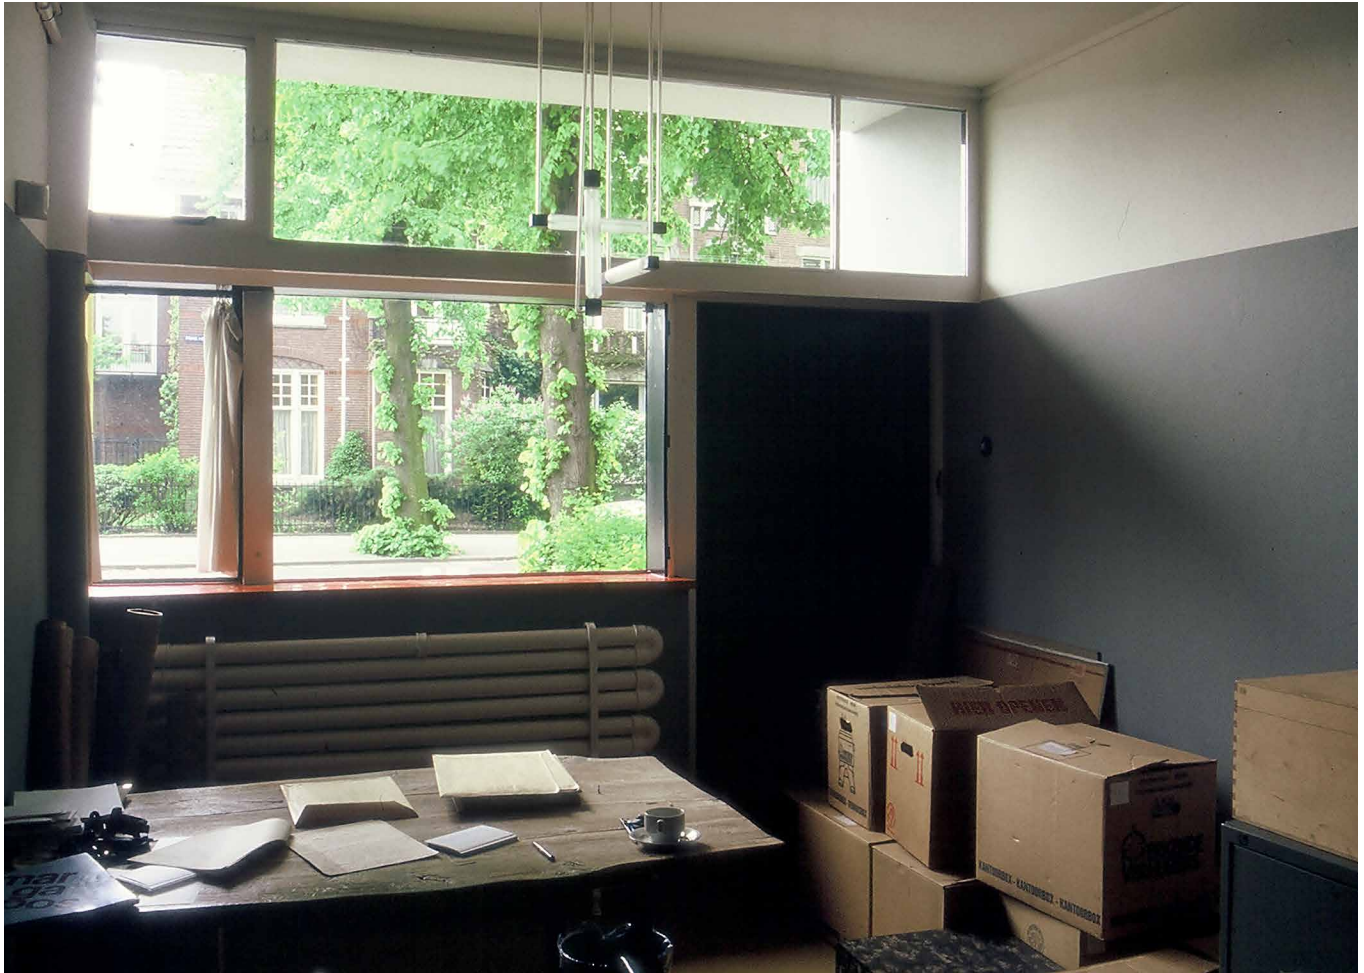
FIG. 3.15 In 1985 the lower sections of the studio walls are grey; the inner side of the door to Prins Hendriklaan is painted black

However, a photo taken in April 1985 shows the lower sections of the walls painted grey, and the inside of the door onto Prins Hendriklaan in black rather than white [FIG. 3.15]. Upon inquiry Mulder recalled that he had based the colour scheme of the ground floor on what he had encountered there.<sup>40</sup> The studio was therefore repainted in the colours of the top coat, without searching for traces of the original colours and also without

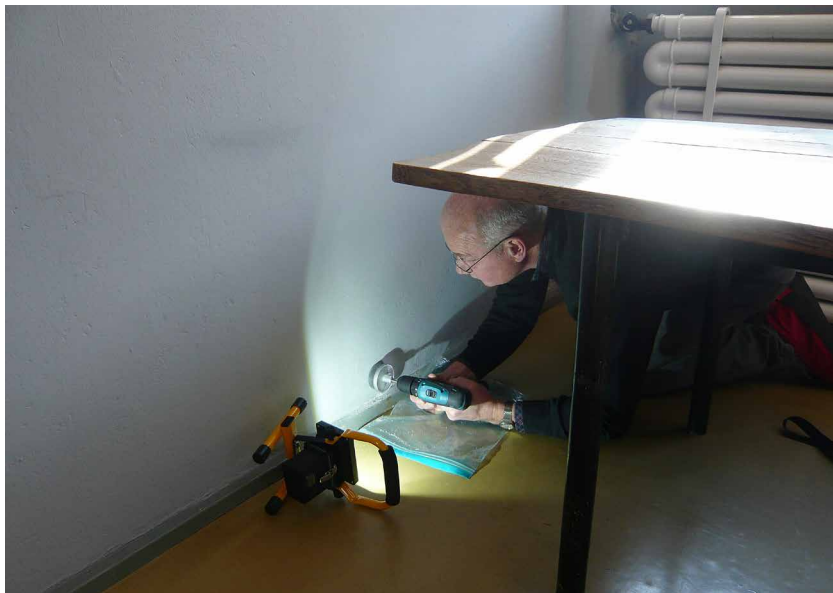
FIG. 3.18 SRAL specialist taking a sample from the east wall of the studio

Samples were taken on the ground floor from the south wall of the study and from the east wall of the studio, and on the upper floor from the south wall of the girls' room. These provided insight into the possible differences in composition and finishing of the plasterwork, which turned out to be definitely not (upper floor), and possibly (ground floor) original. The TNO analysis produced one unexpected result: the two plaster samples proved to have the same stratigraphy, which would seem to indicate that both are instances of renovation plaster.

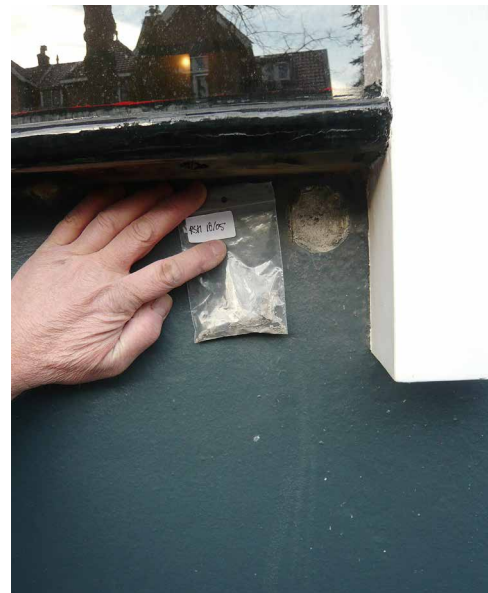
FIG. 3.19 Plaster sample from the wall below the studio window on Prins Hendriklaan
