## A case study of apparently spontaneous fracture

Veer, Fred; Bristogianni, T; Baardolf, Gerardus

Glass Structures and Engineering

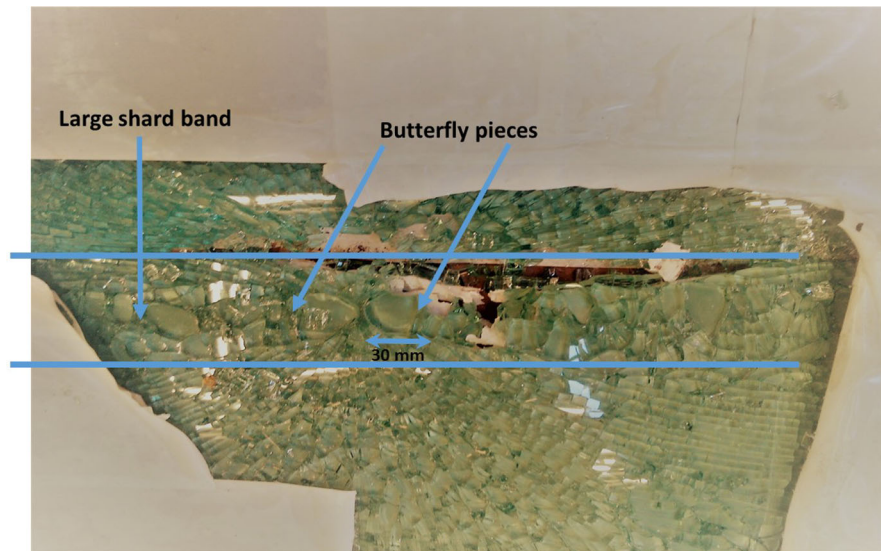
**Fig. 1** Band of large shards and butterfly in spontaneously failed vehicle roof window supplied to authors after in service failure. Length of butterfly fragment around 30 mm, width of small shards about 4 mm

The spontaneously broken windows showed two clear characteristic features. Firstly, there were alternating bands of large and small shards, illustrated in Fig. 1, indicating uneven tempering. Secondly there were pairs of shards that looked like a butterfly pattern at what looked like the initial point of failure from the radiating fragmentation pattern centred on the butterfly, as is shown in Fig. 2. It should be noted that as the glass was monolithic and only held together by the foil, the butterfly shards were slightly displaced, showing a gap between them. The butterfly shards were carefully removed and fractographically examined.

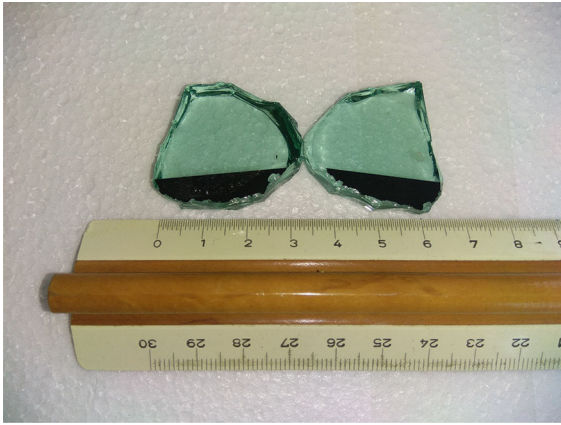
**Fig. 2** Butterfly fragments removed from “spontaneously” failed window

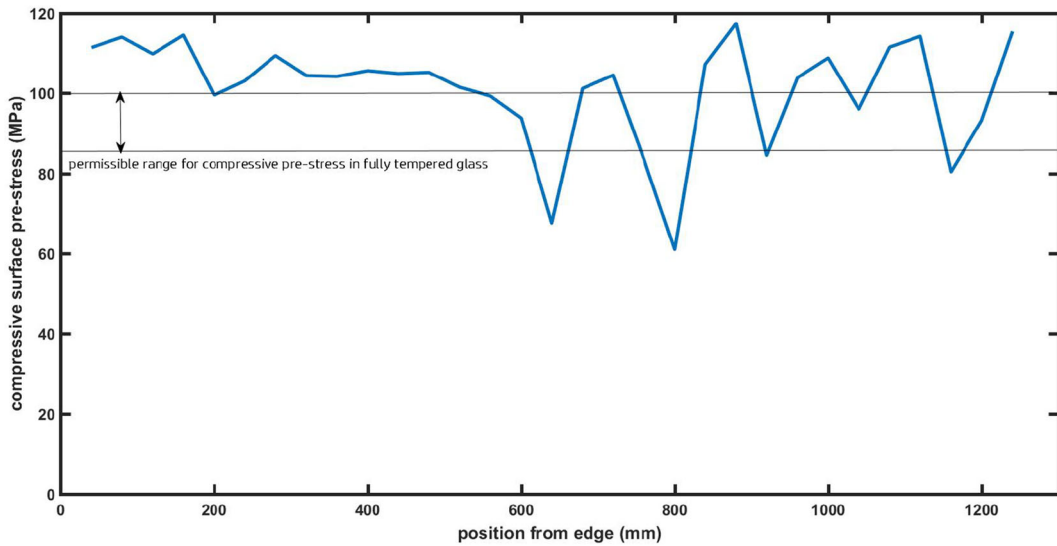
**Fig. 3** Measured compressive surface pre-stress at the centre of the length of the window, measured across the width of the window from left edge to right edge for specimen 1

The compressive surface pre-stress was found to vary considerably across the width of the window forming bands similar to the bands of shards visible in the spontaneously failed specimens. As the variation is far greater than the 5% measuring error, the differences must be assumed to represent physical differences in the compressive surface pre-stress.

Figure 3 shows a typical variation in compressive pre-stress as measured with the SCALP 5 device. It should be noted that at the centre of the specimen, where the highest bending stresses occur, the compressive surface pre-stress is significantly lower. Depending

on the specimen, local values for the compressive surface pre-stress as low as 20 MPa were measured. This is in sharp contrast with the values of 100 MPa measured in the properly thermally toughened zones.

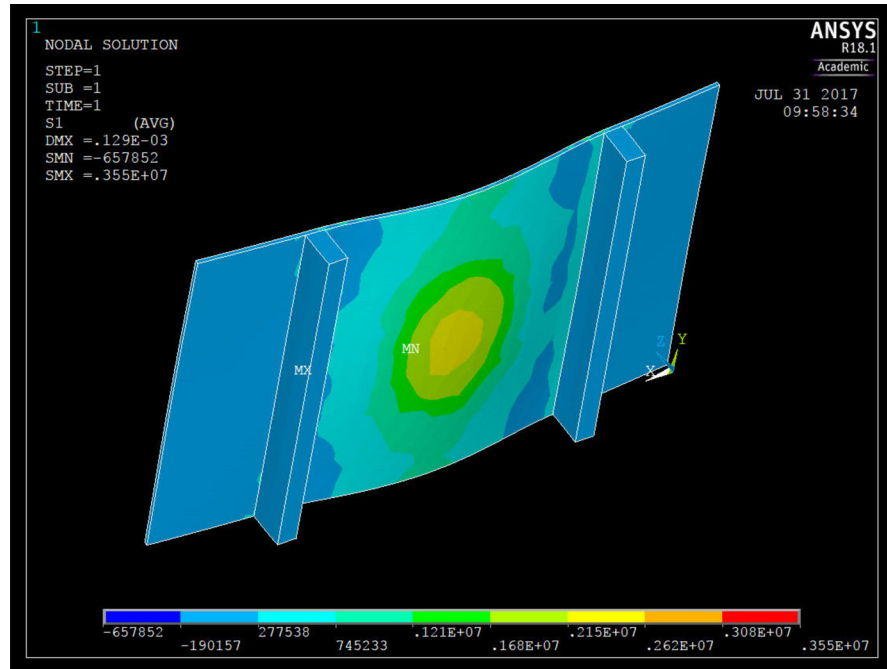
**Fig. 6** Stress distribution according to ANSYS model

and illustrated in Fig. 7. All failures originated in the area with the highest applied stress shown in Fig. 6. The bands of large and small shards visible in Fig. 7 corresponded to the bands of lower and higher compressive surface pre-stress measured with the SCALP 5 device.

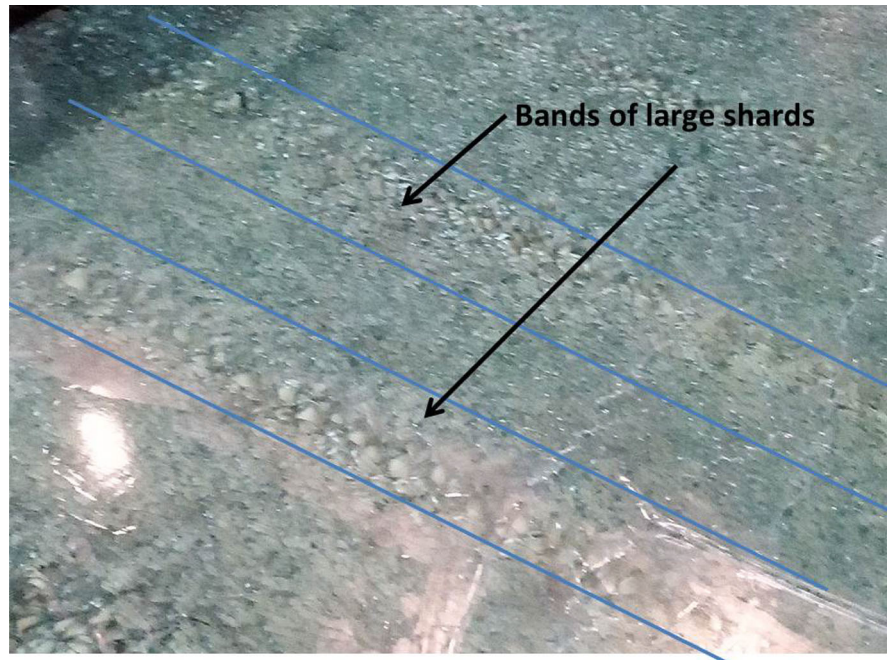
The loading rate was 250 N/min. Table 3 gives the calculated failure stresses. After failure, all specimens showed the same pattern of bands of small and large shards as observed in the spontaneously failed windows

**Fig. 7** Specimen after failure, drawn bands are approximately 40 mm wide

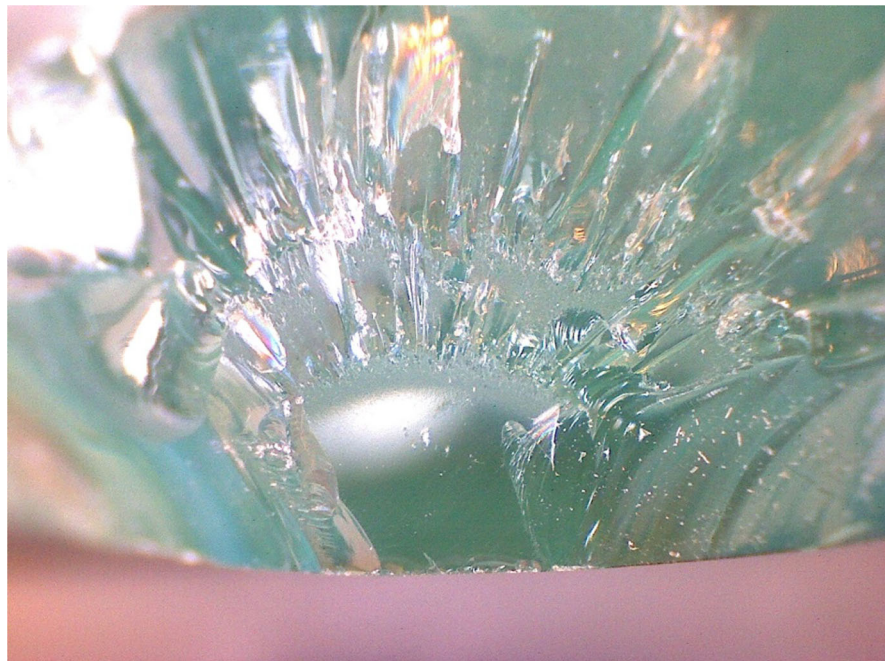
**Fig. 8** Fractography of butterfly piece, typical mist, mirror, hackle zones

The second set of butterfly pieces showed a clear fractographic pattern under a microscope. This is shown in Fig. 8. The source of failure is clearly at the surface of the specimen and not in the interior, where a NiS failure would originate. The failure pattern is simi-

lar to that for an overload as given by Ono (2004), showing the typical mist, mirror and hackle pattern. This pattern alone makes it clear that no inclusion caused the original “spontaneous” failure.
