Collapse of the Grimburgwal, a historic quay in Amsterdam, the Netherlands

A quay wall directly next to a building, both dating from around 1870, collapsed along the Grimburgwal in Amsterdam, the Netherlands, on 1 September 2020. The historic quay wall consisted of a masonry wall, built of a timber deck supported by several rows of timber piles of about 12 m long. As over 200 km of such quays exists in Amsterdam and streets are usually very busy, the collapse triggered the question of the safety of the remaining quay walls in the city. A forensic investigation was carried out to determine the failure mechanisms and factors that contributed to the collapse. The investigation aimed to learn from this event and to prevent similar failures in the future. The main failure mechanisms and contributing factors were identified and confirmed using an integrated model of the quay, which is both simple and robust. The model was used to perform a sensitivity study taking all relevant uncertain factors into account. This work provided valuable insight into the main collapse mechanisms of the wall. Based on the results of this forensic study, it is possible to assess other historic quays.

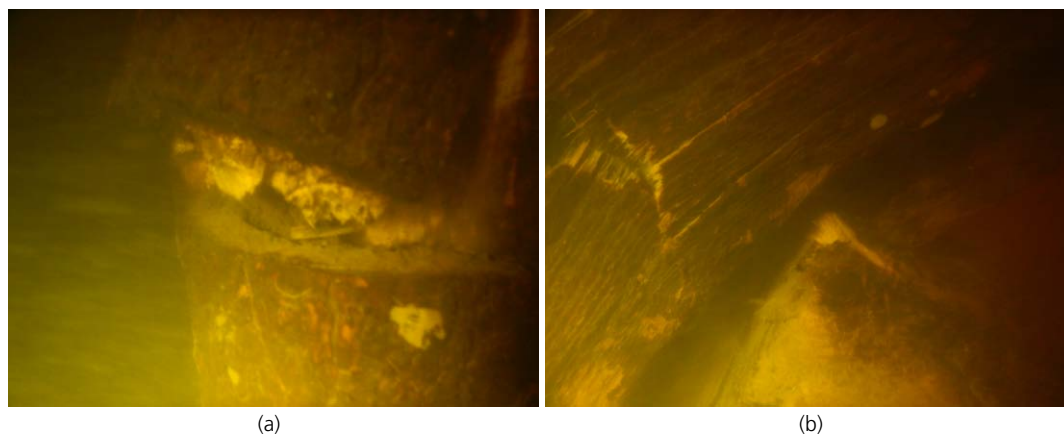
Figure 5. Pictures of the collapsed foundation under water by Van Gellecum (2021): (a) broken pile; (b) broken cross-beam

From Figure 11, it can be seen that for the two-row pile system, the bending stress in both pile rows exceeded the timber capacity (in green) for the smaller piles even for small increases in canal bed depths. For larger pile diameters, this was not the case nor for quays with three pile rows. Comparing the results of the bending of the piles with the initial horizontal movement of the quay as seen in Figure 1 and the deformations of the satellite measurements in Figure 6, as well as the broken foundation parts in Figure 5, leads to a consistent collapse mechanism.

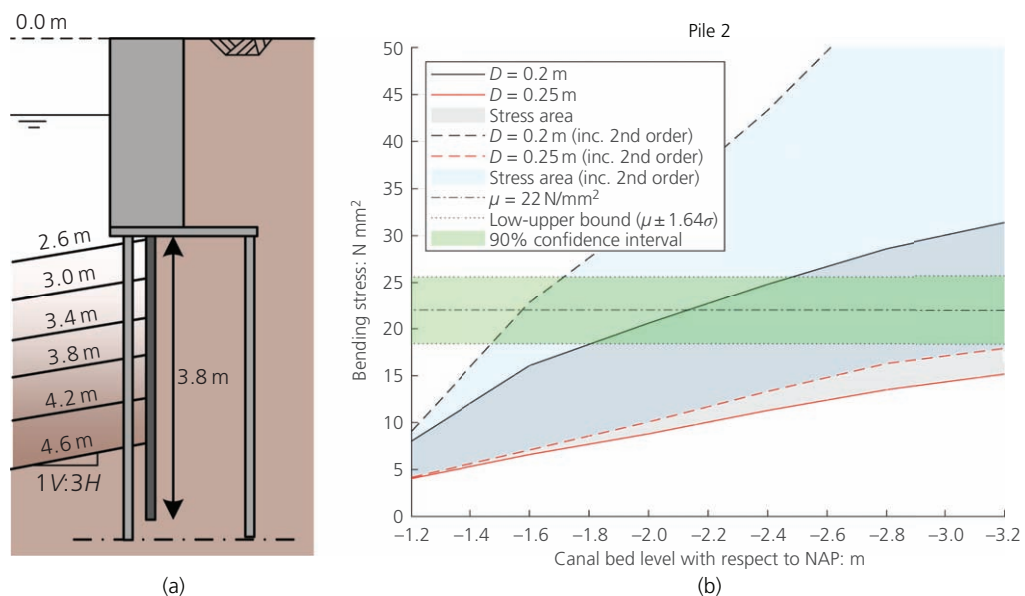
Figure 11. Results of the bending stress in the piles (a) depending on the depth of the canal and (b) for different pile diameters, first- and second-order calculations and strength of the timber

This assessment has shown that the geometry of the quay played an important role in the sensitivity of the quay to the deepening of the canal. This resulted in measures/follow-up actions being recommended related to stress testing the historic quays in Amsterdam. The main recommendations are to check other places with soil erosion of the canal bottom, quays that have only two rows of piles as foundation and/or quays with damage of the masonry in the form of cracks.
