Extensive testing on PVC sewer pipes towards identifying the factors that affect their operational lifetime

Konstantinos F. Makris, Jeroen G. Langeveld & François H. L. R. Clemens

ABSTRACT

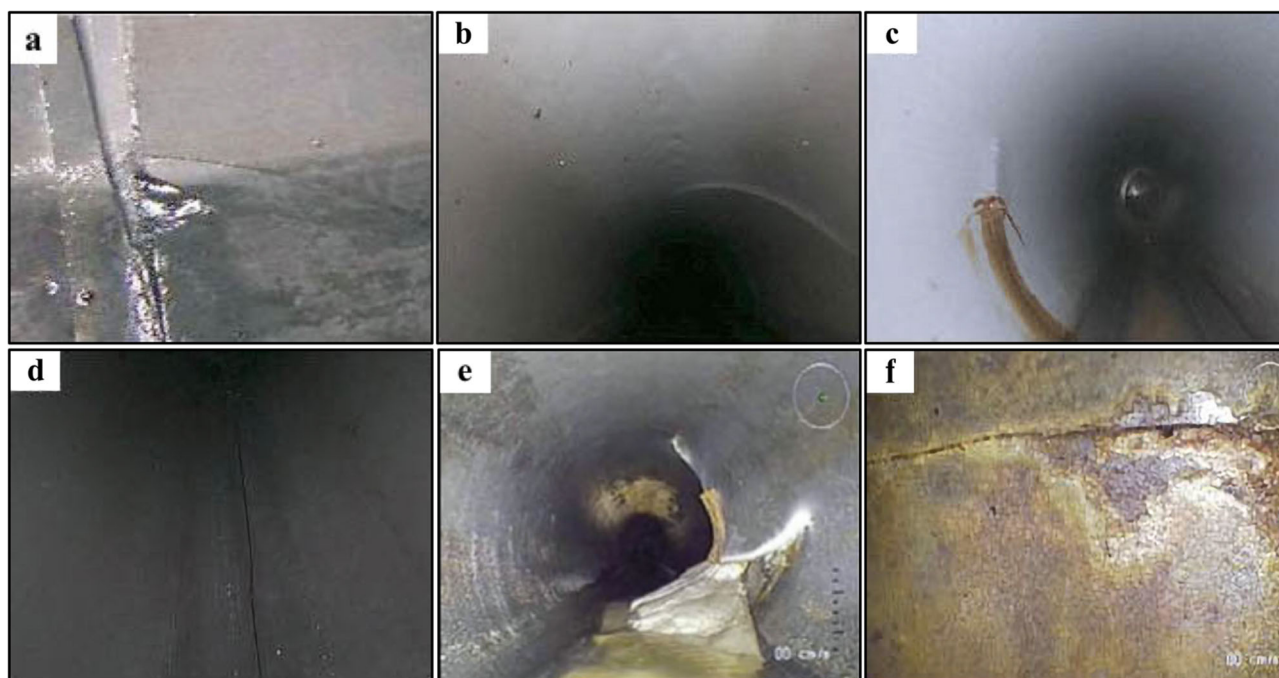
Figure 1. CCTV or Panoramio® footage of: (a) Exhumed pipe A-1 (DN 200, 43 years old) with crack at the connection. (b) Exhumed pipe A-2 (DN 200, 42 years old) with deformed top. (c) Exhumed pipe A-3 (DN 200, 41 years old) with pointy break at the side. (d) Exhumed pipe A-4 (DN 250, 39 years old) with crack at the bottom. (e) Exhumed pipe B-2 (DN 250, 39 years old) with break. (f) Exhumed pipe B-3 (DN 200, 23 years old) with complicated crack.

Investigation of material properties provided sufficient information about the structural integrity of the affected pipes, without justifying the origins of the occurred failures. The actual causes were exposed either during excavation or via careful interpretation of inspection data. The cause of failure of pipe A-1 could be attributed to joint bending. Inspection footage clearly indicated angular bending at the joint (Figure 1(a)) leading to the development of contact

Settling conditions and/or poor soil compaction are considered as a plausible justification also for the deformed top observed in pipe A-2. This pipe was also installed approximately 0.8m deeper in the ground compared to the other

tested pipes and under a paved street, increasing the vertical load at the crown of the pipe. The combined effect of soil conditions and the low bending stiffness of plastic pipes could lead to such pre-buckling conditions (Stein, 2001).

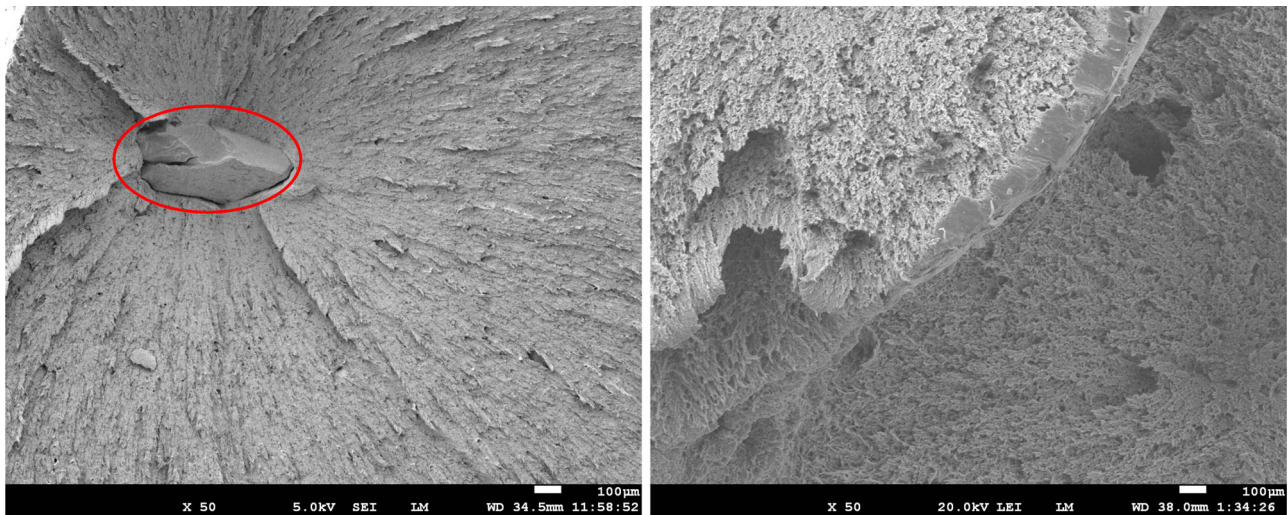
In the explored specimens, two cases of premature failure during tensile testing, samples B-1 and B-3 at 53.4% and 23.4% elongation respectively, were analyzed with SEM. Magnification of the cross-sections at break revealed that both failures were initiated due to cavities within the structure (Figure 7). Especially concerning sample B-3, numerous cavities were found in the recycled core and, in particular, near the interface between virgin and recycled PVC (Figure 7, right). Chemical analysis via EDS indicated that no foreign elements were traced at the inspected areas.

Figure 7. Images obtained via Scanning Electron Microscope at prematurely failed cross-sections during tensile testing for samples of B-1 (left) and B-3 (right). The cavity found in B-1 sample (within red circle) is covered with the coating material needed for this analysis.

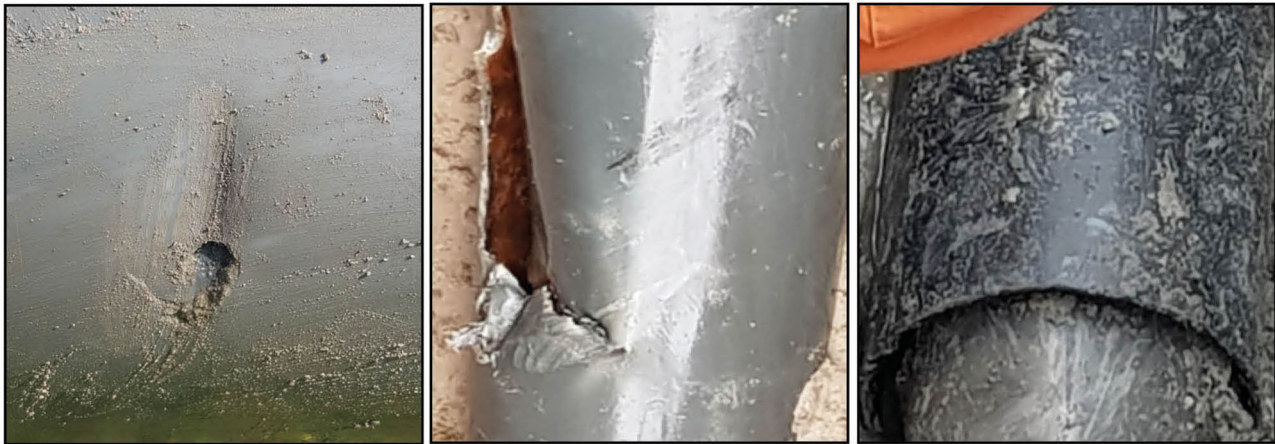
Figure 9. In-situ footage after excavation of pipes A-3 (left) and B-2 (middle) with break due to third party impact, and pipe B-3 (right) with crack due to poor installation quality.

In case of pipe A-3, no sharp object (e.g. rock) was found to be in contact with the pipe near the break, while deep scratches were observed in the deformed area above the defect (Figure 9, left). Based on this fact, it can be safely assumed that this defect is caused by human activity, conceivably third-party impact. A more evident indication of a similar situation was provided via visual examination of the break at pipe B-2, as the footprint of an excavator's bucket was recognized on the pipe (Figure 9, middle). The likelihood of such a failure cause was increased by the existence of several installed pipes destined for other purposes close to the affected one, hinting at extensive digging activity during the service life of the pipe under consideration.

The source of pipe B-3 failure could be traced back to the installation of the pipe. The crack detected via the inspection was found to be initiated at the contact point between the affected pipe and the concrete protection of a warm water distribution pipe. Nonetheless, the interaction of these two types of infrastructure was trivial compared to the installation practice, as an extra piece of pipe was found around the cracked part of the pipe (Figure 9, right). This fact revealed the human interference regarding the failure and the poor installation quality.

This study identified that the most important cause of failure for the examined pipes is related to poor installation quality and human activities. Such activities include excavation in the surroundings of the pipe, most likely due to installation or maintenance of other underground infrastructure. Therefore, it is inadequate to develop sewer asset management strategies based only on the age of the pipe and the pipe material properties. Incorporation of detailed protocols for handling and construction, close supervision during construction and measures against third party impacts are a precondition for long-lasting sewer pipelines.
