Safety and Health Concerns for the Users of a Playground, Built with Reused Rotor Blades from a Dismantled Wind Turbine

Abstract: This paper analyses the user safety of a playground built out of reused blades from a dismantled wind turbine. Located in Rotterdam and designed by the Netherlands architecture firm Superuse Studios, the playground, called “Wikado”, represents an example of the circular economy applied to the built environment. With reused materials, Wikado represents a saving in resources and energy, when compared to a standard playground built with primary materials. Furthermore, the playground creates a unique design experience for its users, who can still recognise the original rotor blades following their transformation into slides, platforms, and tunnels. However, the safety of the playground could be questioned. This paper will analyse the materials and products used in the playground and their condition some years after opening. The analysis focuses on the risks of human health during the use of the playground. It considers the shape and the sharpness of the rotor blades, its components such as glass fibres and epoxy resin. As a result of the analysis, two risk

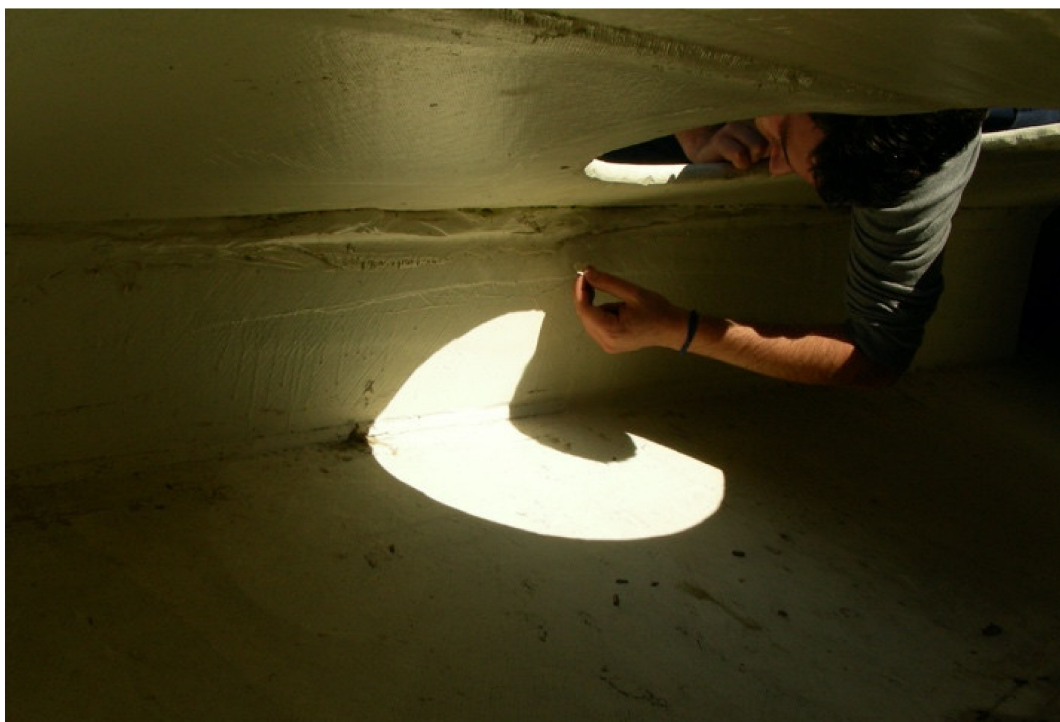
Figure 4. Interior of a rotor blade where finishes are cut and brittle as a consequence of the use by children. The interior of the blade is accessible; some parts are more than a metre high, where a young child can stand and walk. (Photo by Piero Medici, 2011).

The second location, where the glass fibres and the epoxy resin were exposed, was inside one of the hollow blades (Figures 4 and 6). These glass fibres belonged to the finishes by Maropol. It was established that this part was quite sharp and that it should have been smoothed out. A small piece was removed as a sample for investigation. It was sharp at the touch, and the glass fibres, the epoxy resin, and the white paint coating (Figure 5) were apparent.

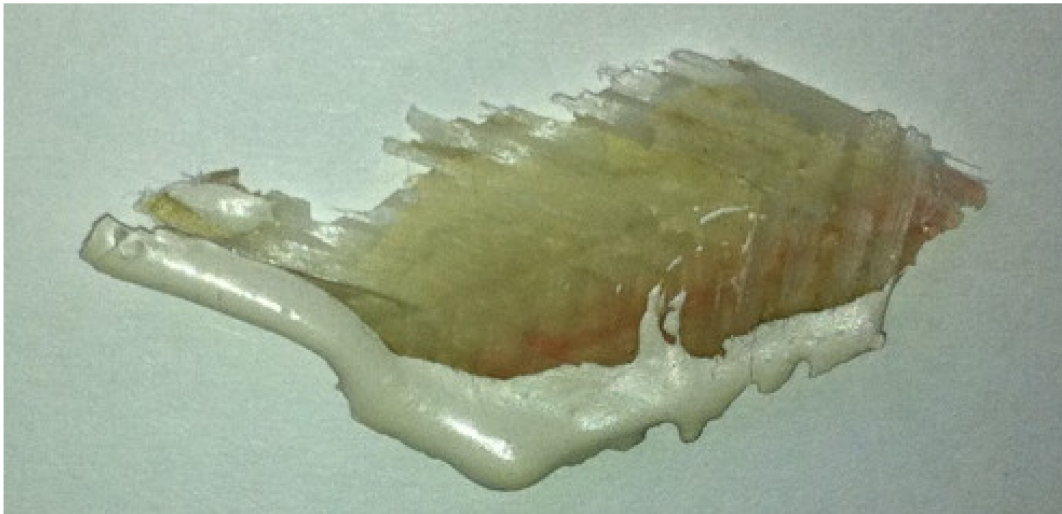
Figure 5. Piece of sharp finish of glass fibre, epoxy and white paint coating, a sample from the location illustrated in Figure 4 (Photo by Piero Medici, 2011).

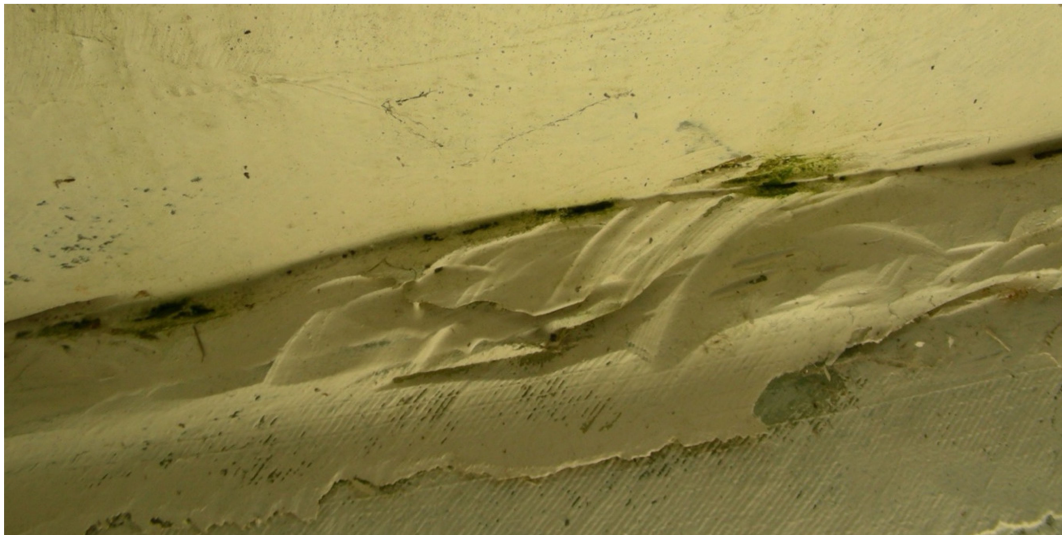
Figure 6. Close-up of finishes with epoxy resin, glass fibres and white paint coating. In the right part of this picture the spot is visible where the piece of Figure 5 was removed (Photo by Piero Medici, 2011).

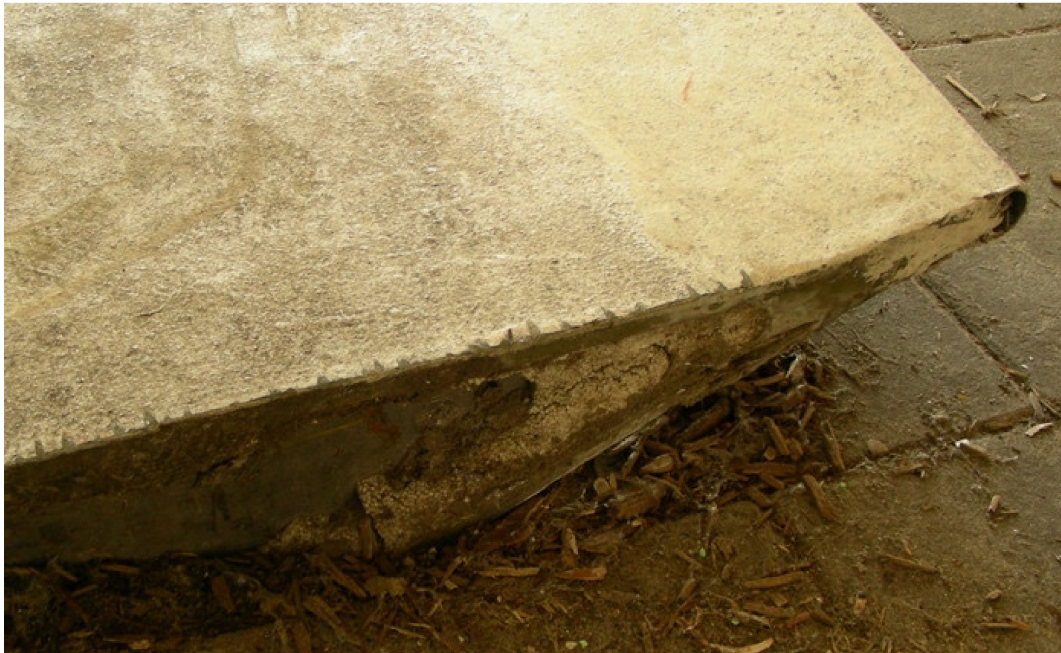
At the time of the site visits, which was three years after Wikado's opening, some parts of the blades were already brittle (Figures 4–12) and some parts of the glass fibres were exposed, sharp, and with the potential to cut the skin when being touched on site. Both glass fibres of the rotor blades by NGup and glass fibres used by Maropol were used for the finishes. During the visits to Wikado, it was observed that the glass fibres had the potential to come into contact with the users, especially on two locations of the blades. The first location faced the entrance of the playground in the street called Tochtstraat, and it had a height of a typical step (Figures 7 and 8). The glass fibres were exposed, most likely because users often stepped on the edge of the blade. These glass fibres probably belonged to both the finishes by Maropol and the blades manufactured by NGup. In the same location (Figure 7), some polystyrene had also detached from the edge.

Figure 7. Edge of the rotor blade already brittle with polystyrene coming out, as a consequence of the users walking on it (Photo by Piero Medici, 2011).

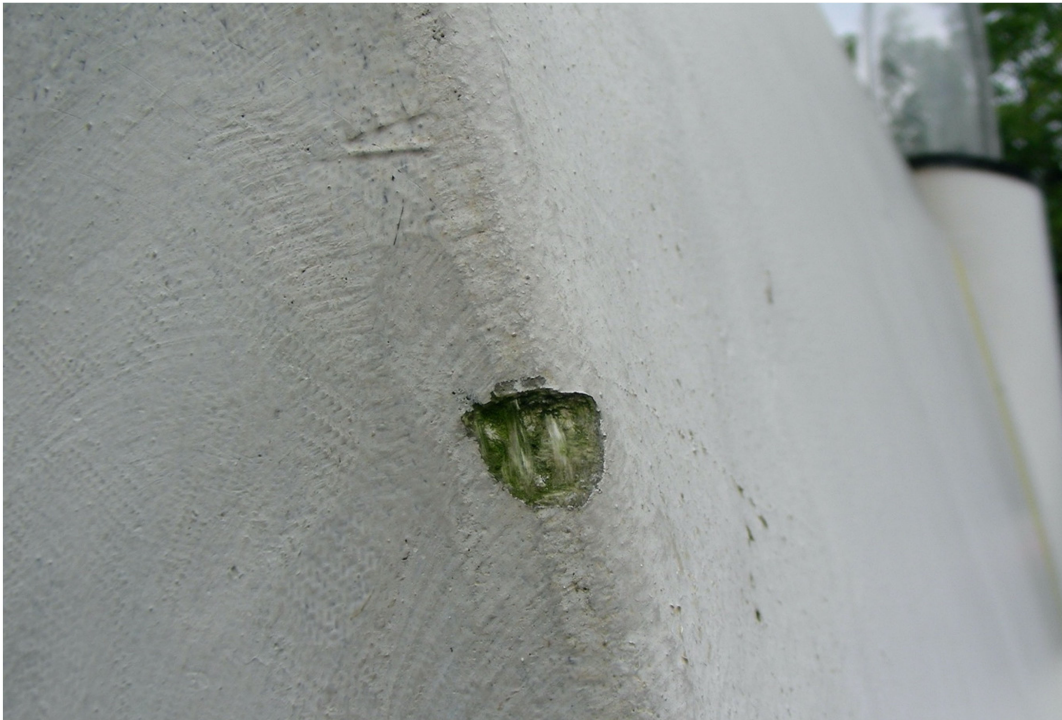
Figure 9. Damaged finish by Maropol, with glass fibres exposed, as a consequence of use damage (Photo by Piero Medici, 2011).

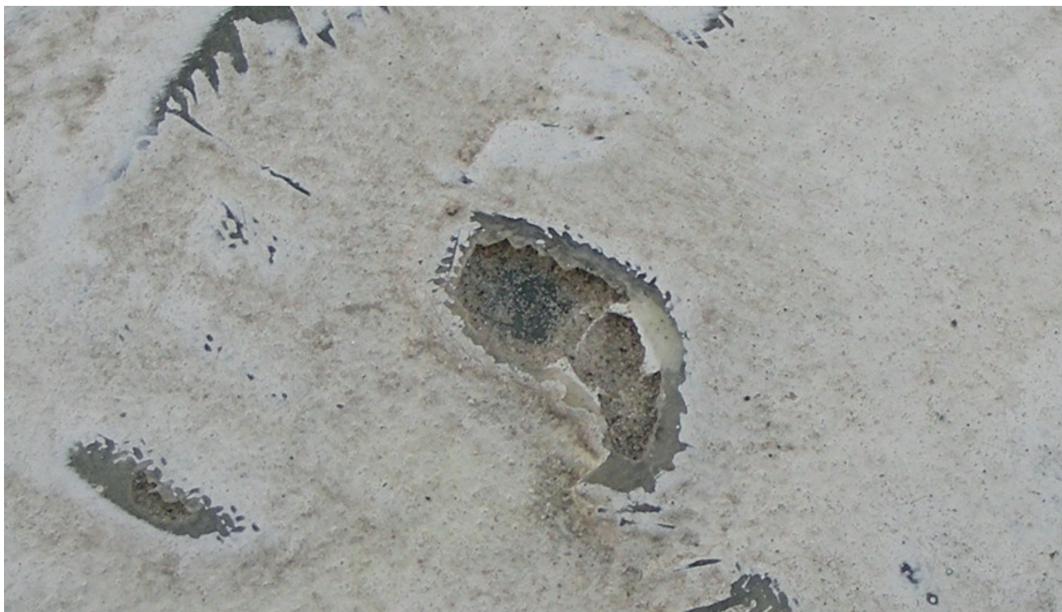
Figure 10. Damaged and sharp surface of a blade, as a consequence of the users walking and playing on it (Photo by Piero Medici, 2011).

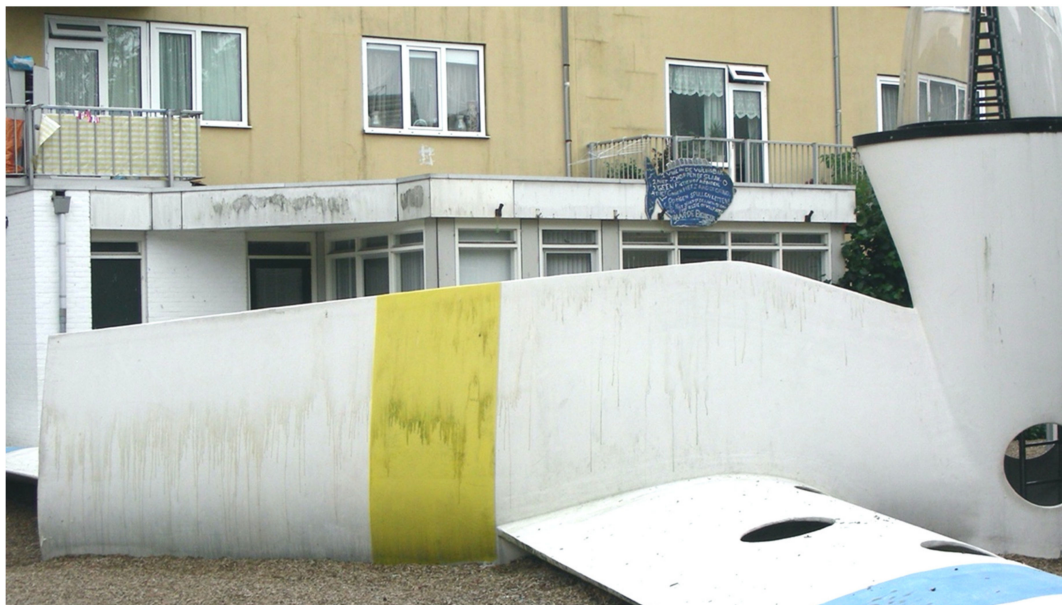
Figure 14. Leaching on the surface facing north-west of the blade standing on the long side (Photo by Piero Medici, 2011).

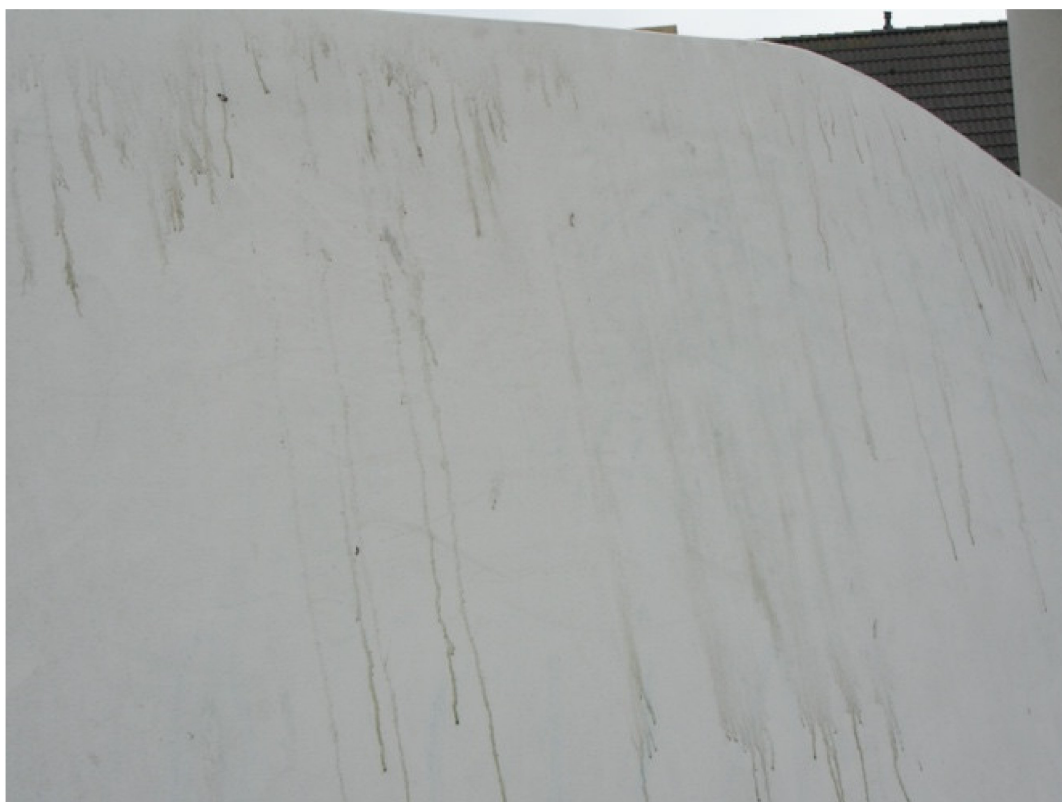
Figure 15. Drops leaching along the north-west surface of the blade standing on the long side (Photo by Piero Medici, 2011).

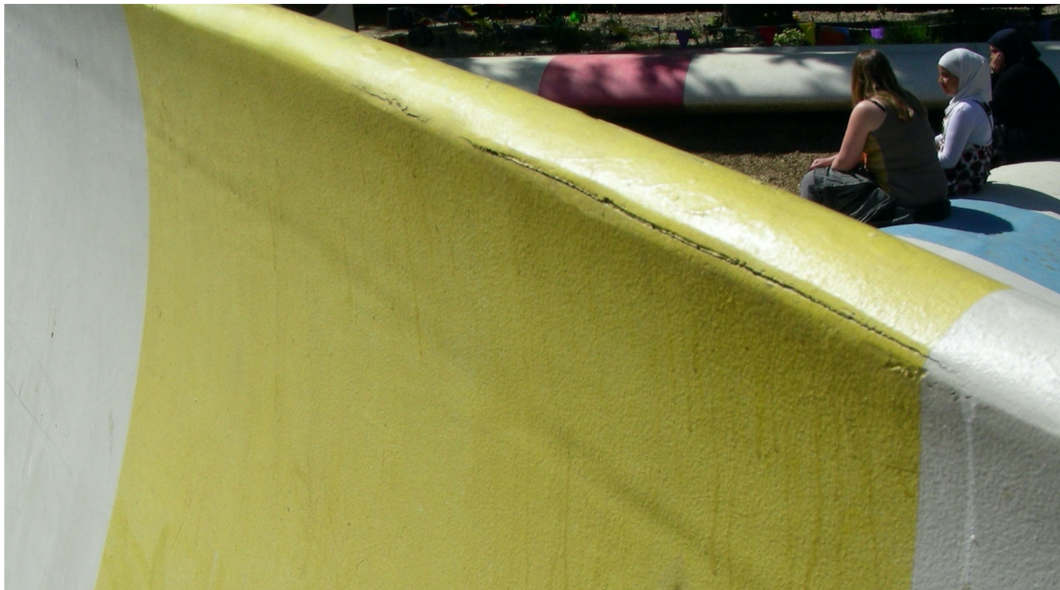
Figure 16. Leaching on the surface facing south-east of the blade standing on the long side. Drops seemingly coming out from an opening of the coating by Maropol (Photo by Piero Medici, 2011).

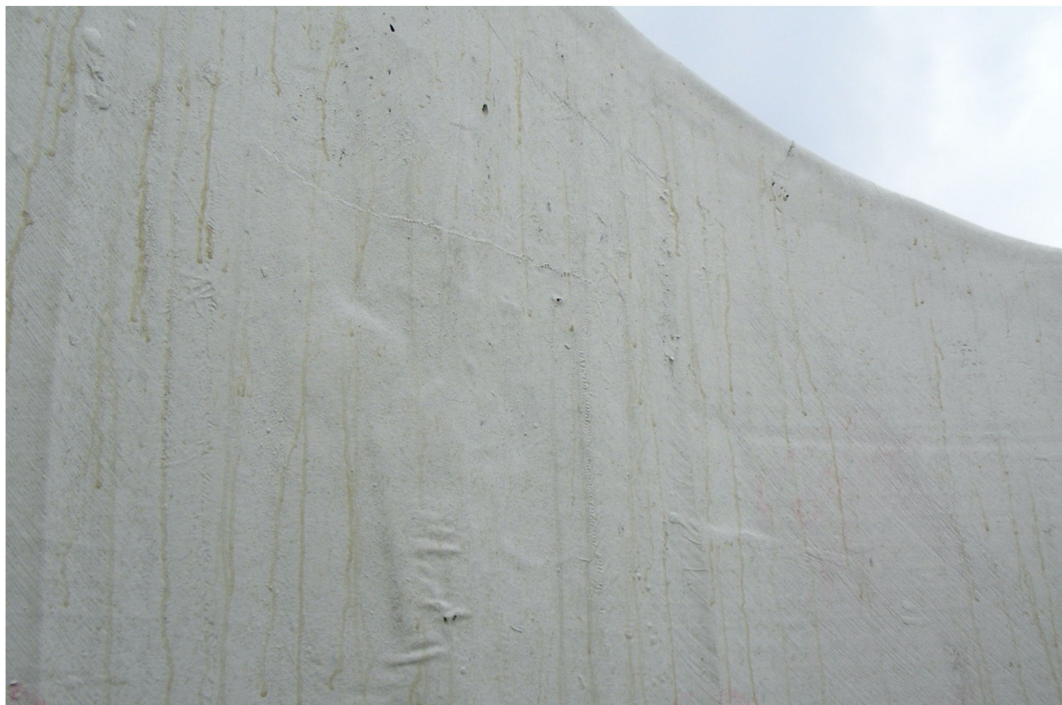
Figure 17. Leaching from the top of a tower (Photo by Piero Medici, 2011).

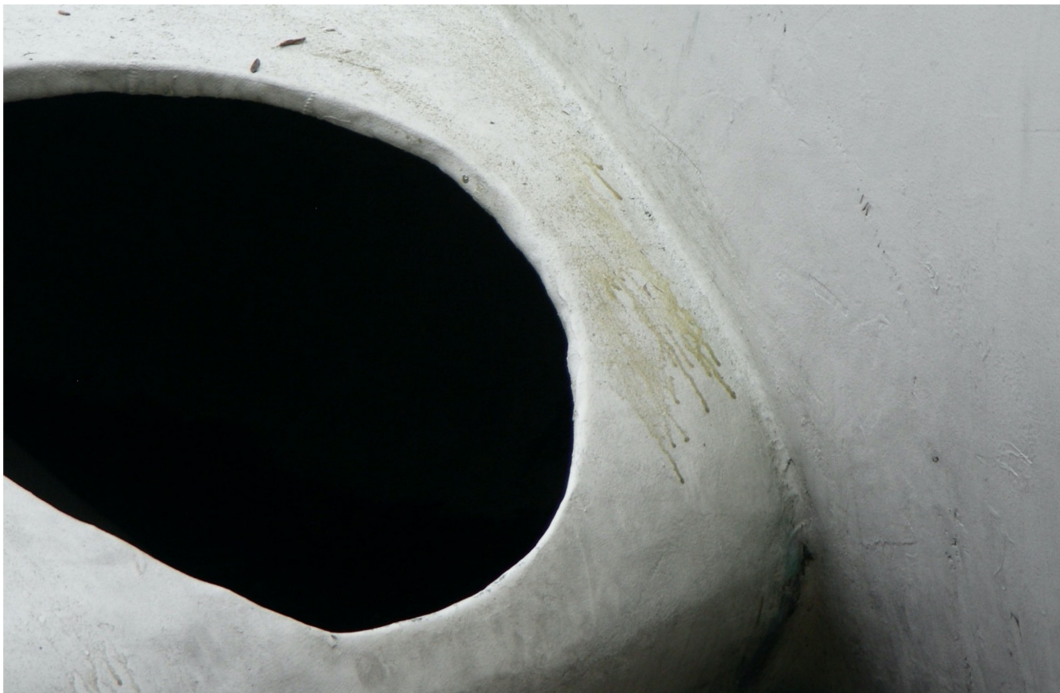
Figure 18. Leaching next to the joints by Maropol (Photo by Piero Medici, 2011).

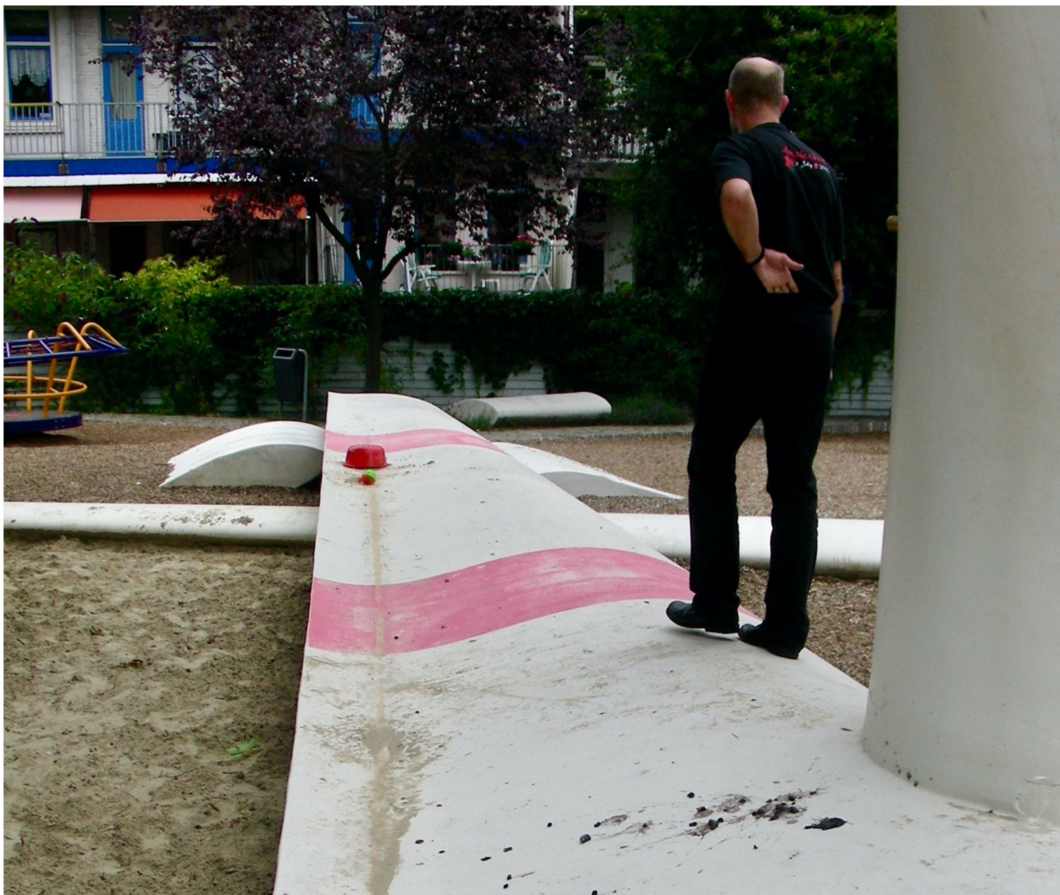
Figure 19. Trace along the blade working as a rain gutter. A red toy bucket is located on the blade and on the left bottom part of the picture a tea cup is visible (Photo by Piero Medici, 2011).

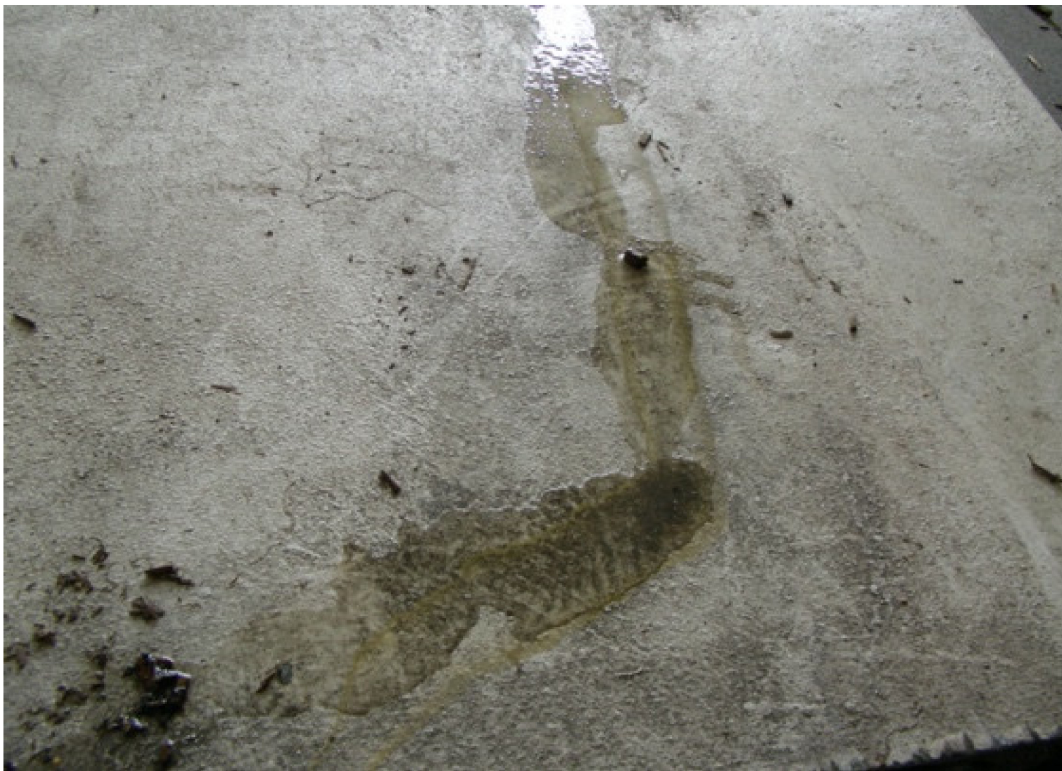
Figure 20. Blade lying horizontally working as a rain gutter, a yellow leach is visible (Photo by Piero Medici, 2011).

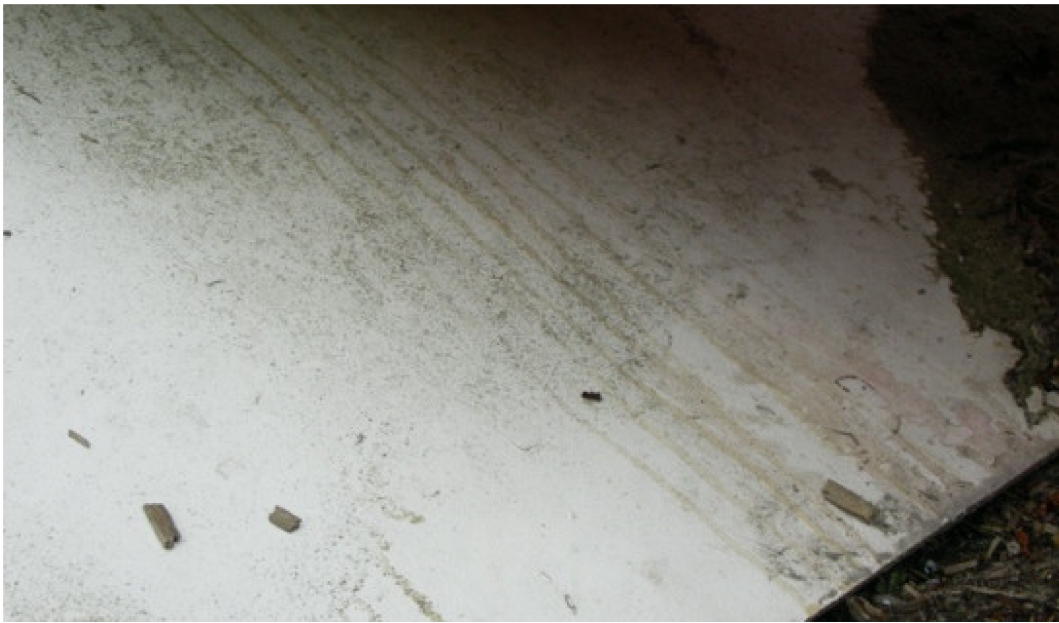
Figure 22. Close-up of the drops, on a blade lying horizontally (Photo by Piero Medici, 2011).

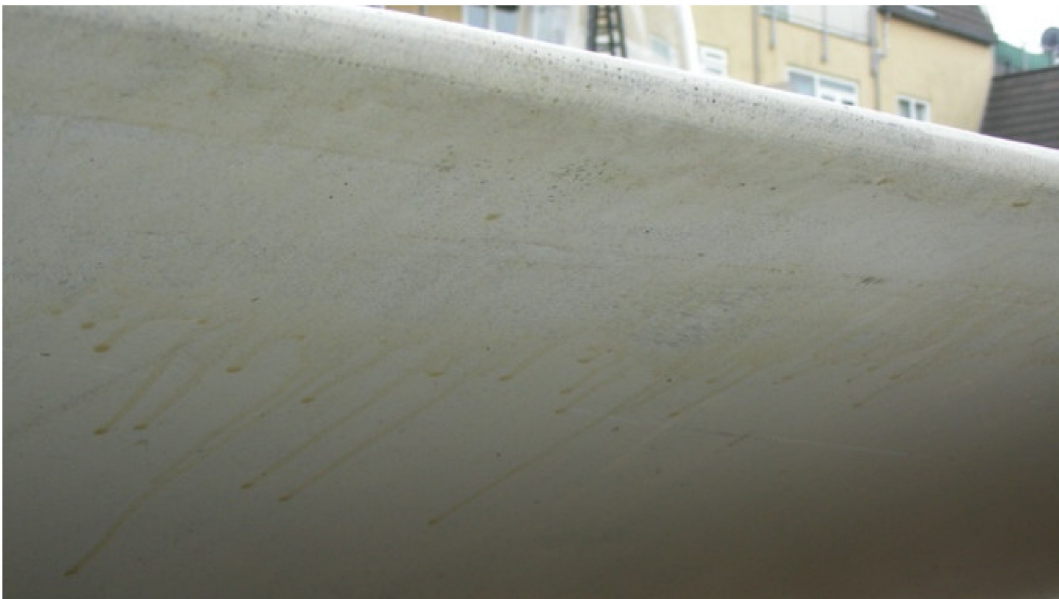
Figure 23. Leaching below a blade lying horizontally (Photo by Piero Medici, 2011).

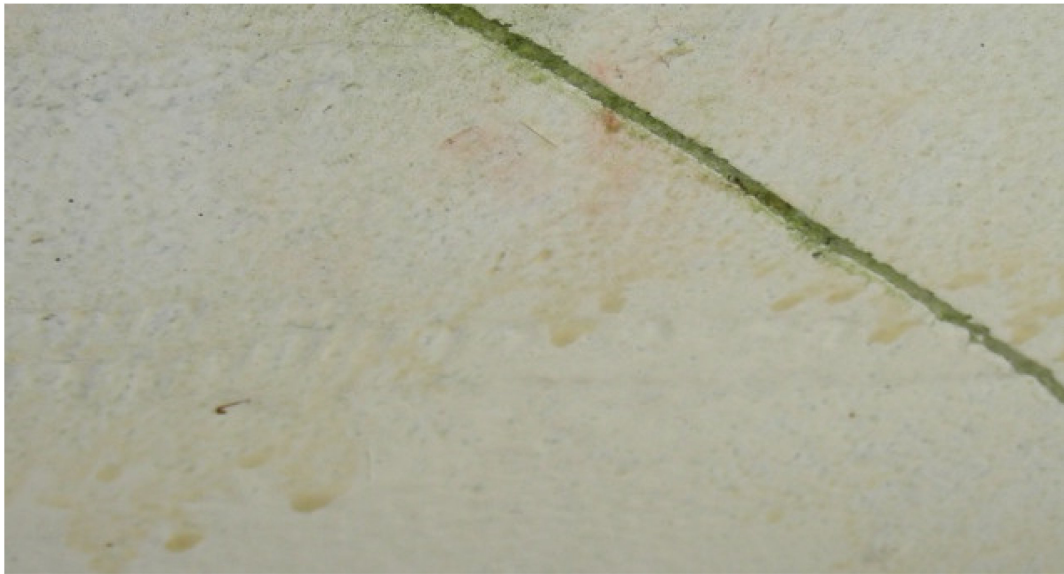
Figure 24. Close-up of the drops next to a surface opening (Photo by Piero Medici, 2011).

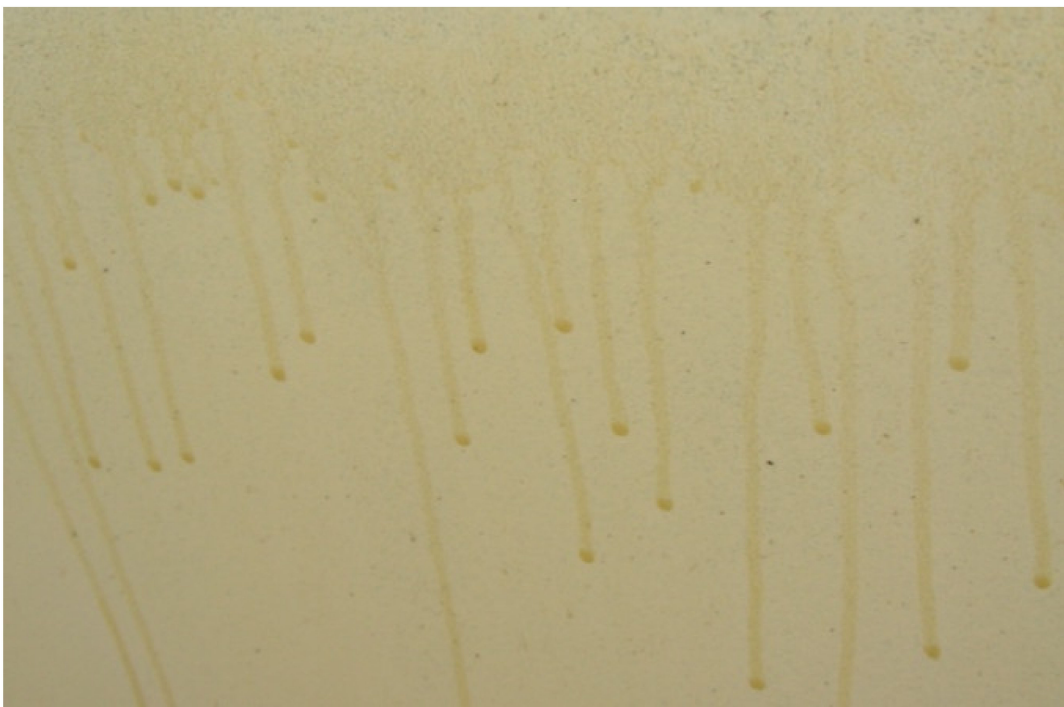
Figure 25. Drops leaching down, close-up (Photo by Piero Medici, 2011).

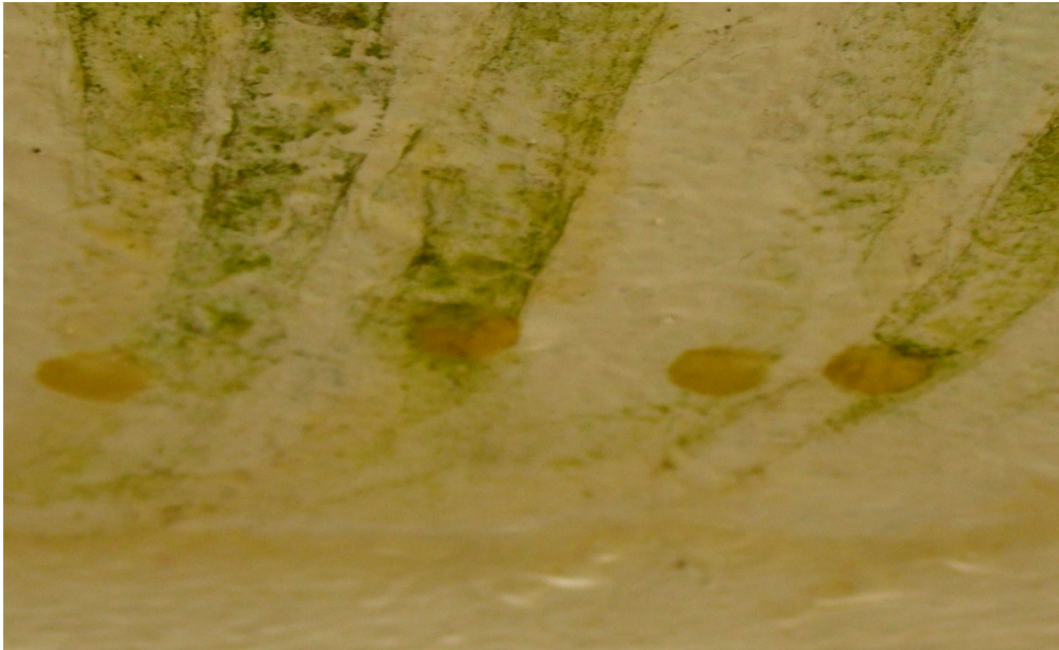
Figure 26. Drops leaching below the blade, close-up (Photo by Piero Medici, 2011).

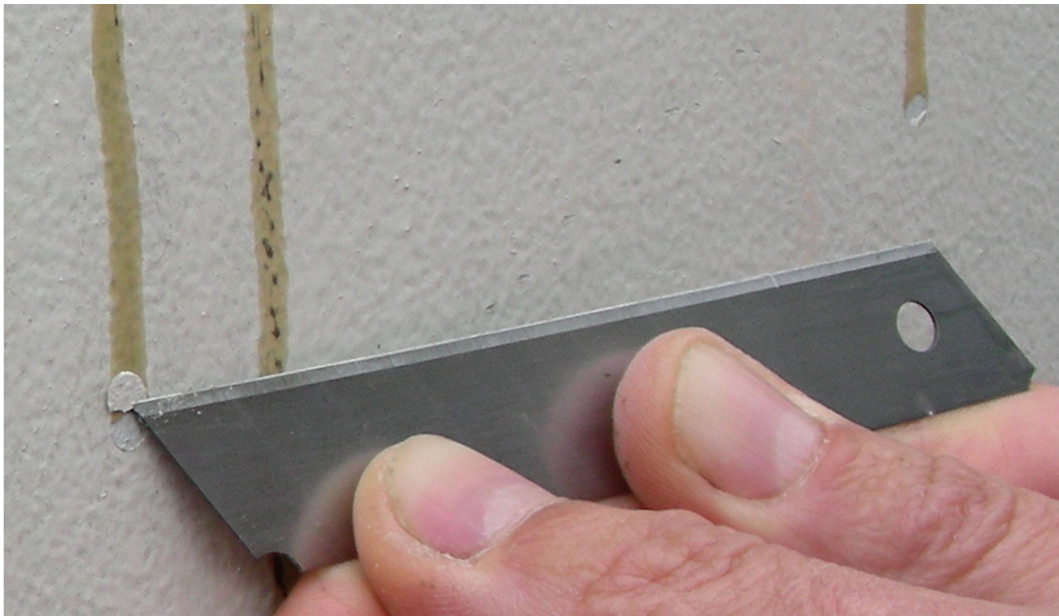
Figure 27. Test with the cutter on the surface of the blade standing on the short side; some paint is attached to the detached drop (Photo by Piero Medici, 2011).

Since the inspections took place during the summer months, the temperature was approximately 20 degrees Celsius, and the weather was cloudy but not raining. The drops were quite dry and solid to the touch. During one of the visits, a cutter was used to test the consistency of the drops (Figure 27). On the blade standing on the short side, the drops were quite solid, dry, and sometimes slightly sticky. Drops were removed using the cutter and they were found to be firmly attached to the white paint, with a thin layer of paint sticking to the detached drops. In another part of the playground, with two blades stacked on top of each other, the drops were less dry, but still quite firm (Figures 24–26). In the playground, the drops were generally quite solid and only sometimes slightly sticky. The inspecting group agreed that it could have been useful to test the consistency of the drops on the wet playground after a day of heavy rain and after a warm sunny day. If, under these conditions, the leaching would be more liquid, the users could accidentally touch and ingest the drops through hand to mouth behaviour or even direct licking.
