Microbiologically influenced corrosion of a pipeline in a petrochemical plant

Microbiologically Influenced Corrosion of a Pipeline in a Petrochemical Plant

Abstract: This paper investigates a severe microbiologically influenced failure in the elbows of a buried amine pipeline in a petrochemical plant. Pipelines can experience different corrosion mechanisms, including microbiologically influenced corrosion (MIC). MIC, a form of biodeterioration initiated by microorganisms, can have a devastating impact on the reliability and lifetime of buried installations. This paper provides a systematic investigation of a severe MIC-related failure in a buried amine pipeline and includes a detailed microstructural analysis, corrosion products/biofilm analyses, and monitoring of the presence of causative microorganisms. Conclusions were drawn based on experimental data, obtained from visual observations, optical/electron microscopy, and Energy-dispersive X-ray spectroscopy (EDS)/X-Ray Diffraction (XRD) analyses. Additionally, monitoring the presence of causative microorganisms, especially sulfate-reducing bacteria which play the main role in corrosion, was performed. The results confirmed that

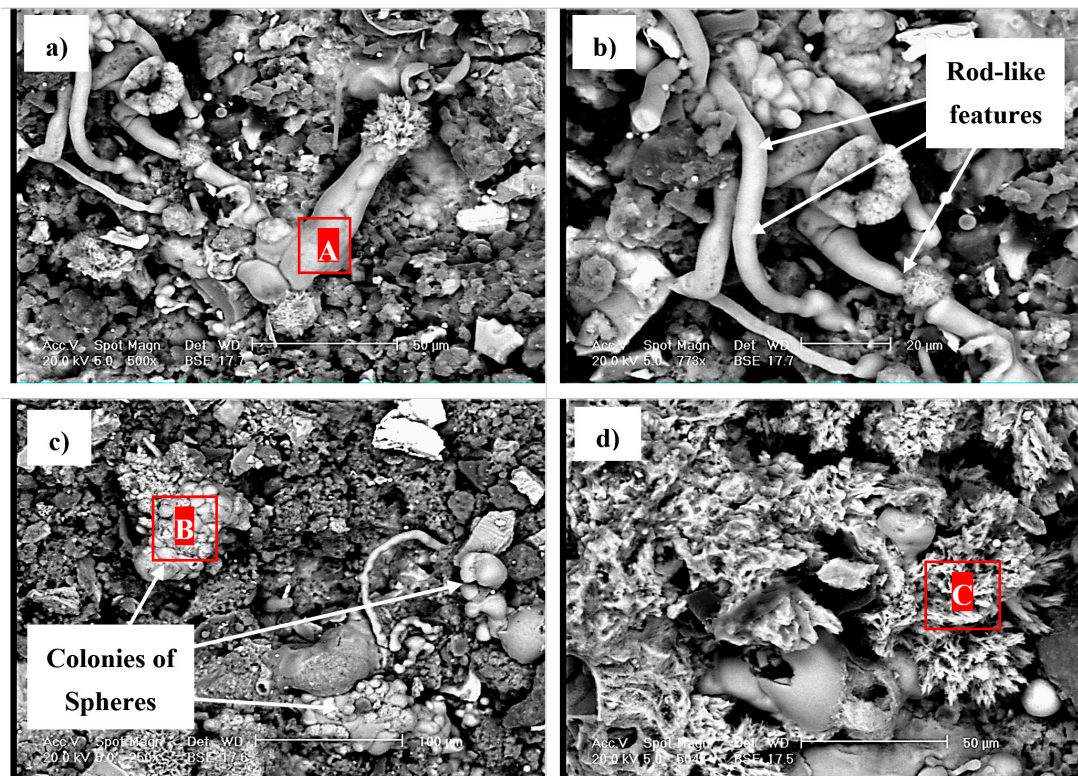
Figure 5 shows the typical features found inside pits at the outer surface. This figure clearly shows that the surface was covered with a biofilm. Biofilms, consisting of complex communities/colonies of microorganisms and EPS, can dissolve oxygen and create gradients of pH, resulting in localized forms of corrosion, such as crevice corrosion and pitting [10]. Three noticeable features were seen in the biofilm:

- (i) Rod-shaped products, with approximate length of 50 μm ;
- (ii) Colonies of spheres, with their size ranging from 10 to 100 μm ;
- (iii) Flower-like surface features, all shown in Figure 5.

Rod-like features were, statistically, more frequently seen than the other two morphologies. The distributions of all the mentioned morphologies were rather homogeneous, i.e., all features were seen in each and every pit.

Figure 5. Scanning Electron Microscope (SEM) photomicrographs showing biofilms (or surface deposit) and features inside biofilms, i.e., (a) and (b) rod-like features, (c) colonies of spheres, and (d) flower-like features.

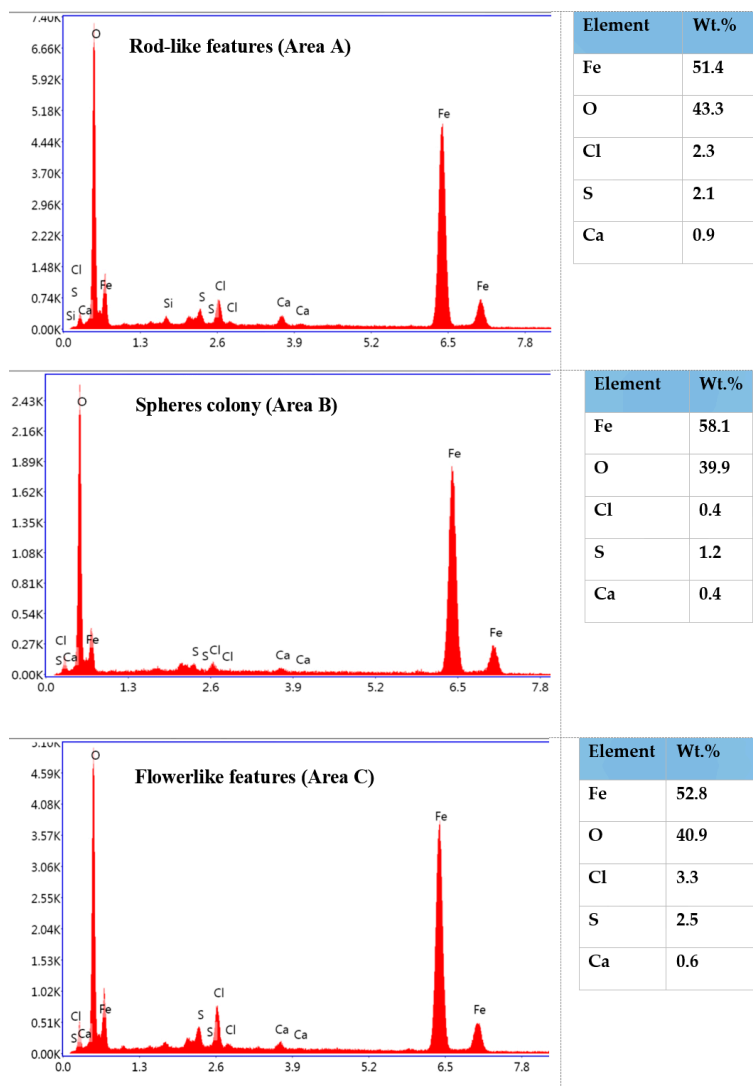
Figure 6 shows the results of EDS analyses of rod-like, spherical, and flowerlike corrosion products. In terms of the chemistry, there was no meaningful difference between these features, inferring that the difference between these features is only morphological. The presence of sulfur in all the EDS spectra is an indication that the observed features are SRB, which is an anaerobic bacterium. SRB is known to be the primary factor of MIC. Organic compounds attracted to the surface of steel make it an ideal environment for the colonization of microorganisms [2]. Amongst different microorganisms, SRB is known to have excellent adaptability to extreme conditions. Biochemical energy for the growth of SRB is obtained by reducing sulfate (SO_4^{-2}) to sulfide (S^{-2}) in the presence of natural organic compounds. At the same time, with the absorption of atomic hydrogen (H) on the surface of iron, it will gradually disappear [16]. Overall, the major detrimental metabolic activities of SRB are mostly related to its ability to:

Figure 6. Energy dispersive X-ray spectroscopy (EDS) analyses of areas shown in Figure 5, related to rod-like, spherical, and flower-like features (x -axis: Energy (KeV), y -axis: a.u.).

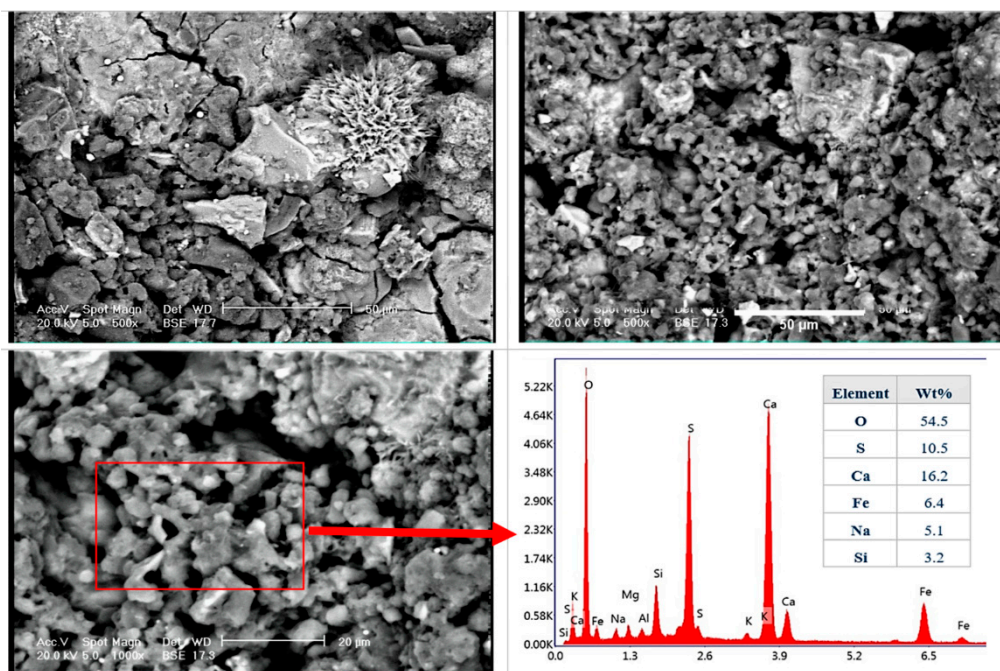
Figure 7 represents a closer look at the biofilm in the outer surface in which microorganisms are distributed. Biofilm is a self-produced firmly-attached EPS surface layer. In fact, the stability of microorganisms is dependent on the biofilm, given that the biofilm provides structural support for microorganisms and, to a great extent, protects them from environmental, physical, and chemical stresses. Biofilms could host a variety of different microorganisms including fungi, bacteria, eukaryotes, and archaea, with each having a different metabolic ability [2]. The SRB, in particular, has a vigorous metabolism, producing a certain amount of EPS (in fact, often there are also other microorganisms present that are mainly responsible for EPS production), which rapidly adhere to the surface of the metal and build a biofilm [14,18]. The biofilm, in this case, has a porous nature, making the ion/nutrition exchange much easier. EPS are composed of charged polymers and can significantly contribute to the accumulation of different chemical species inside EPS. In the case where organic acids are produced by microbial species, mineral dissolution rates are expected to increase [19,20]. The results of EDS analysis show that elements oxygen, sulfur, calcium, chloride, and iron were present in the biofilm. Figure 8 shows typical XRD patterns of corrosion products, taken from the surface of the pipe. The results confirmed the formation of a significant amount of oxide-hydroxide (FeOOH), iron oxide, and iron sulfide. The latter is a typical corrosion product when SRB is the controlling microorganism.

Figure 7. Examples of SEM images of biofilms together with EDS analysis.

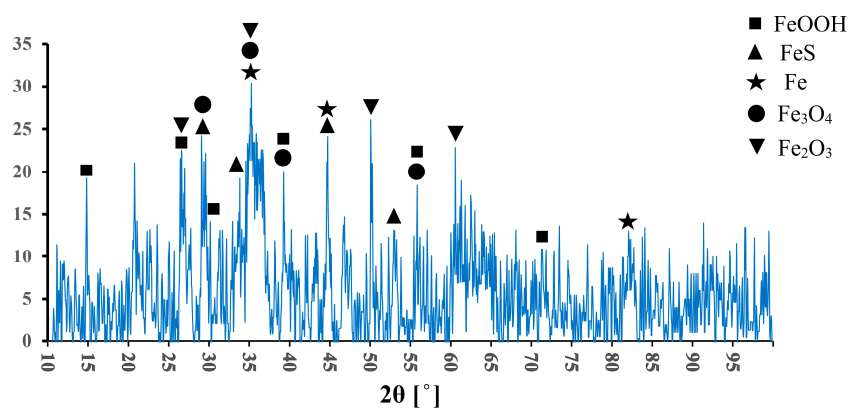
Figure 8. An X-ray diffraction analysis of the surface of the pipe.

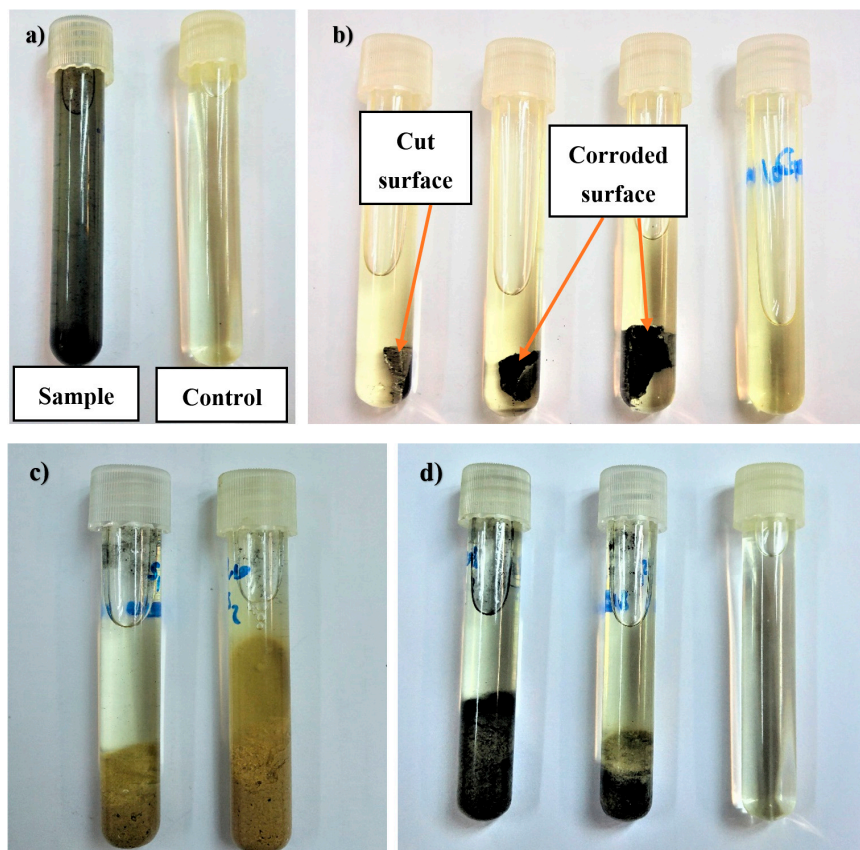
Surface scratches from the corroded elbows and samples of soil from the corrosion area were inoculated in SRB-specific media and incubated in anaerobic conditions for 20 days. As shown in Figure 11, the black precipitation is created due to SRB growth and H_2S and FeS production in the media. It is noticeable that the SRB-induced black precipitation was only created on the corroded surface of the failed elbow, and there was no sign of black precipitation on the cut surface, see Figure 11b. The formation of SRB cells was confirmed by SEM images, see Figure 12, and EDS spectra, see Figure 13. SRB is resistant to environmental stresses such as pH and temperature variations, chloride concentration, and high values of pressure. They form biofilms and create massive corrosion products by deteriorative mechanisms [21,22].

Figure 11. SRB growth monitoring in specific media after 20 days. Control: The specific medium without inoculation. (a) Surface scratch from corrosion tube, (b) the corrosion tube cuts (c) the soil samples of corrosion area after five days, and (d) after 20 days.

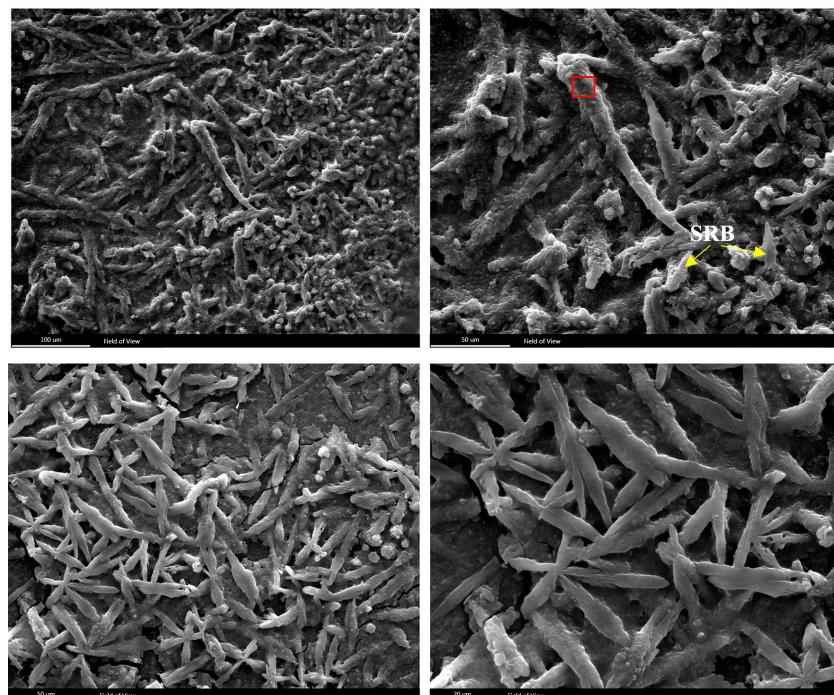
Figure 12. SEM images of SRB growth in specific media inoculated by the surface scratches of the corroded sample (all pictures are from similar features with different magnifications).

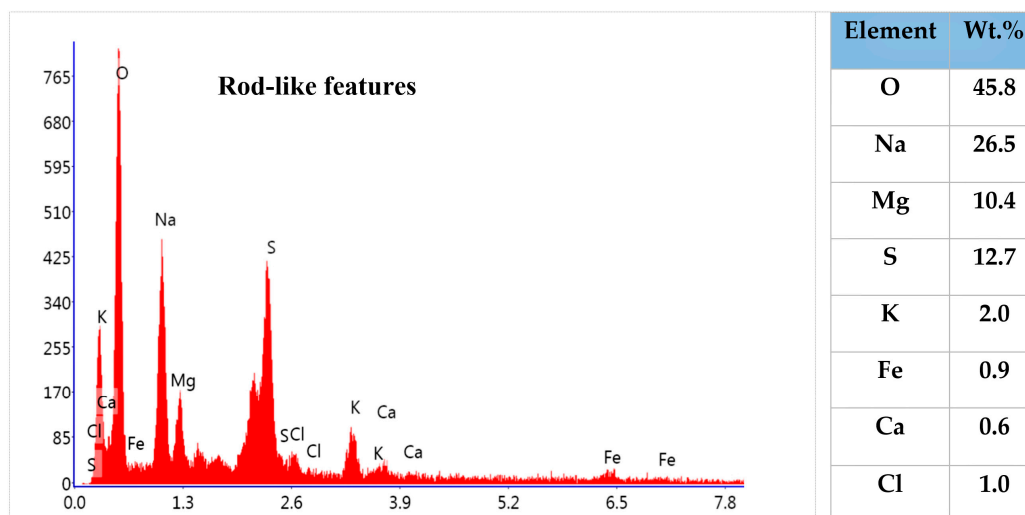
Figure 13. An EDS analysis of area shown in Figure 12 (*x*-axis: Energy (KeV), *y*-axis: a.u.).
