Health Condition Monitoring of Insulated Joints based on Axle Box Acceleration Measurements

Maria Molodova, Maider Oregui, Alfredo Núñez, Zili Li*, and Rolf Dollevoet

Section of Railway Engineering, Faculty of Civil Engineering and Geosciences, Delft University of Technology, Stevinweg 1, 2628 CN Delft, The Netherlands

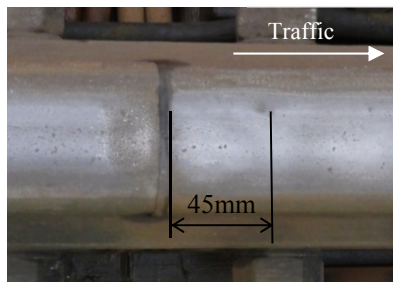
(a) IRJ number 1 with light surface deformation.

In this section, four IRJs from the track Eindhoven – Weert (E-W) were investigated, IRJ number 1 and 2 with light plastic deformation (Figure 5a-b) and the IRJ number 3 and 4 with severe plastic deformation of the rail surface (Figure 5c-d). The plastic deformation is caused by the impact occurring after the gap and has a typical wavelength of about 35-50 mm (Oregui et al, 2015b). Since IRJ number 2 with light surface deformation did not have any other visible damage at the fastener and insulation layer, it will also be used for comparison in the next sections as a reference IRJ in normal condition.

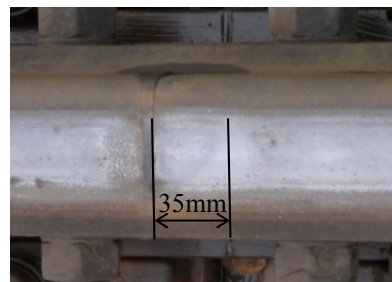
(b) IRJ number 2 with light surface deformation.

In this section the IRJ with a crack in the fastener was investigated (D_2). That is IRJ number 9 in Figure 5g-h. The dynamic responses at this IRJ were compared to the reference IRJ without visible damage in the fastener (Figure 5b).

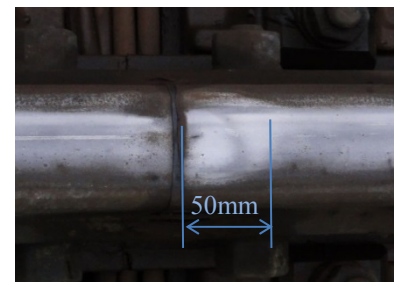
To study the relationships between the state of IRJs and ABA values we compared two IRJ with high ABA magnitude (IRJs number 3 and number 9 indicated with red circles in Figure 4a) and two IRJs with comparatively low ABA magnitude (IRJs number 1 and number 16 indicated with green circles in Figure 4a). As it appeared from the visual inspection of the IRJs, the two IRJs with high ABA magnitudes (above 200 m/s^2) were indeed in a deteriorated condition: the IRJ number 3 had plastic deformation D_1 on the rail surface caused by the impact at the endpost (Figure 5c) and the IRJ number 9 had a crack in the fastener D_2 (Figure 5g-h). As for the IRJs with comparatively low ABA magnitude (below 150 m/s^2), the IRJ number 1 may be considered as in a good condition (Figure 5a), since only light deformation of the rail surface is visible. While the IRJ number 16 had a significant gap between the two pieces of the rail, as a result of the loss of insulation material D_3 (Figure 5j). Thus, the ABA magnitude at IRJs cannot be an indication of D_3 . Therefore, further investigation of the frequency content of ABA is presented in the next section.

(c) IRJ number 3 with severe plastic deformation.

The ABA measured at these four IRJs are shown in Figure 6a. The ABA signals for each IRJ in this section and the next sections are the average signals out of four repetitive ABA signals, filtered with the low-pass Butterworth filter with a cut-off frequency of 2 kHz. The averaging and the filtering were done in order to reduce the noise in the measured signals. The ABA signals at these IRJs had a wavelength of about 50 mm. The local maximum ABA was the highest for IRJ number 3 ($a_{D_I}^{max} = 220 \text{ m/s}^2$) and about 2.4 times higher than ABA at the IRJ number 2 in normal condition ($a_N^{max} = 91 \text{ m/s}^2$). The plastic deformation at IRJ number 3 has the longest wavelength among these four IRJ's, 50 mm (Figure 5c).

IRJ number 3 has the longest wavelength of plastic deformation (50 mm) and the highest local maximum ABA compared to the other three IRJs in Figure 6a. However, the PSD at 500-550 Hz for IRJ number 3 was not the highest among these IRJs, because the energy was distributed over a range of frequencies (270 Hz, 730 Hz, 830 Hz, 1150 Hz, see Figure 6b). This can indicate that there is damage in other components of IRJ number 3 besides plastic deformation of the rail surface (sleeper, fastener, etc.) Thus, there is no direct correlation between degree of plastic deformation of the rail surface and PSD at 500-550 Hz. However, the combination of high ABA magnitudes and high values of PSD at 500-550 Hz can

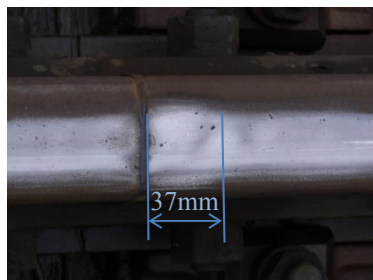
(d) IRJ number 4 with severe plastic deformation.

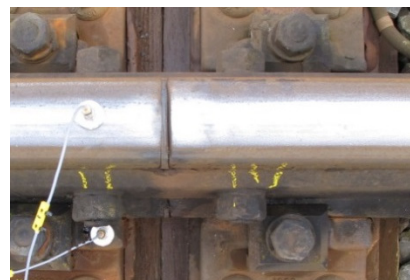
(e) IRJ number 7 with rusty fastening.

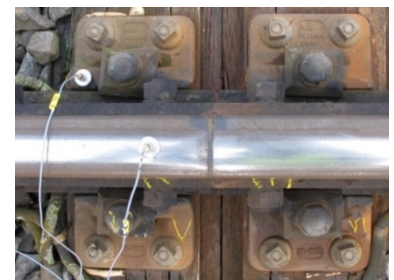
(f) IRJ number 8 with rusty fastening.

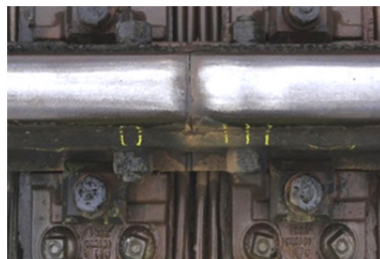
(g) IRJ number 9 with a crack in the fastener.

(h) IRJ number 9 with a crack in the fastener, side view.

The ABA at the IRJ with a crack in the fastener is shown in Figure 6e (solid line) together with the reference IRJ (dashed line). The ABA signal at this IRJ has a high peak of about $a_{D_2}^{max}=220 \text{ m/s}^2$. This peak is also related to high contact force, which caused the deformation of the rail surface, visible in Figure 5g as a broadened shiny wavy running band after the gap. It can also be observed in Figure 6e that the ABA magnitude of the IRJ number 9 is elevated compared to the reference one.

The PSD at the IRJ with a crack in the fastener is presented in Figure 6f. The major peak for an IRJ with a crack in the fastener is at 70 Hz, and the other two peaks at 340 Hz and 520 Hz are similar to the peaks of the reference IRJ. The frequency at 70 Hz is probably related to the change in the stiffness of the fastening caused by the crack. This frequency might be responsible for the higher level of vibration after the gap.

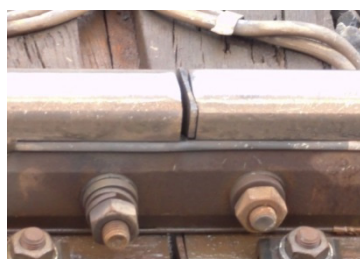
(j) IRJ number 16 with damaged insulation layer and a crack in the fastener.

In this section, an IRJ number 16 with two types of damage was investigated: with damaged insulation layer (Figure 5j) and the crack in the fastener (Figure 5k). The damage of the fastener for this IRJ was similar to the one of IRJ number 9 in Figure 5h.

The ABA at this IRJ is shown in Figure 7a with a solid line. The ABA magnitude at this IRJ is comparable to the reference IRJ ($a_{D_3}^{max}=86 \text{ m/s}^2$), but the wavelength is shorter than that of the reference signal. The PSD at the IRJ with the damaged insulation layer is shown in Figure 7b. The major two frequencies for this IRJ are 100 Hz and 645 Hz.

From these data it is impossible to extract the information about the health state of the IRJ due to low ABA magnitude and PSD. Thus, the retrospective analysis of the ABA measurements was performed to obtain more information. Figure 7c presents the ABA signals measured in October 2009 – July 2010. The ABA magnitude at this IRJ in October 2009 was $a_{D_3}^{max}=134 \text{ m/s}^2$, in March 2010 was $a_{D_3}^{max}=129 \text{ m/s}^2$, and in July 2010 was $a_{D_3}^{max}=257 \text{ m/s}^2$.

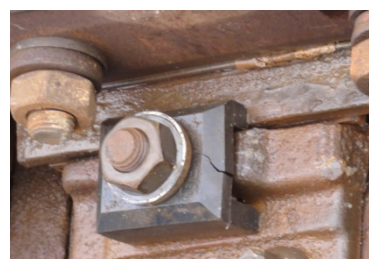
(k) IRJ number 16 with damaged insulation layer and a crack in the fastener.

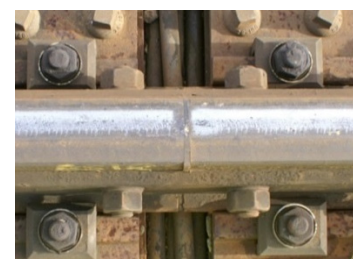
(l) IRJ number 3 on the track Groningen – Assen.

In Figure 4b the ABA on the track Groningen – Assen has less variation in values, than on the track Eindhoven – Weert, with the average local maxima ranging between 50 to 100 m/s². The IRJ with the highest ABA value is number 3, which has moderate degradation of the rail surface D_I (Figure 5l).

Figure 6c presents the ABA measured at IRJs 3 from the track Groningen – Assen (G-A), see photo in Figure 5l. The ABA signal at this IRJs had a wavelength of about 50 mm. The local maximum ABA was $a_{D1}^{max} = 100 \text{ m/s}^2$, which is quite close to the normal condition ($a_N^{max} = 91 \text{ m/s}^2$). The PSD at these IRJs is shown in Figure 6d. There major peaks for this IRJ are 90 Hz, 350 Hz and 570 Hz, which is consistent with the frequencies in Figure 6b.
