# FIELDWORK 2017

CIE5318 Fieldwork Hydraulic Engineering

December 2017

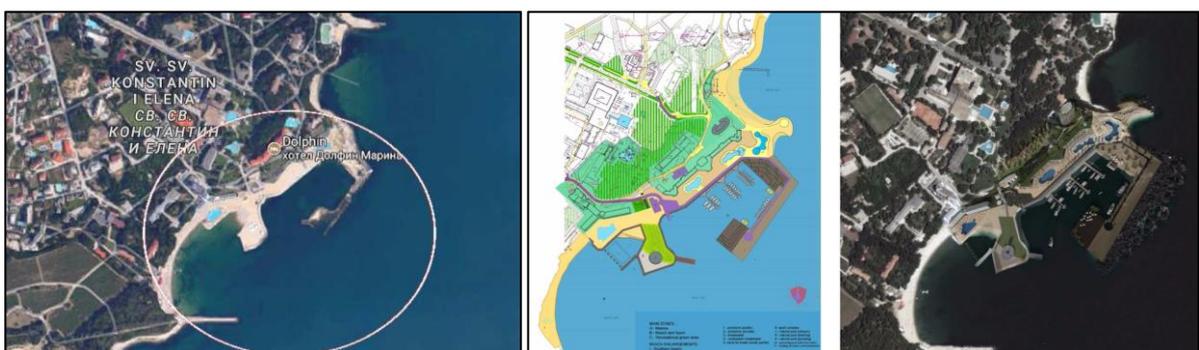
Figure 2: Current state (left) and original design (right) of marina st. Elias and beaches.

The current state and original design are presented on the left and rights in Figure 2, respectively. The picture clearly shows that the large breakwater is not completed and heavily damaged. The beach to north of the marina has a significantly narrower beach compared to the original design.

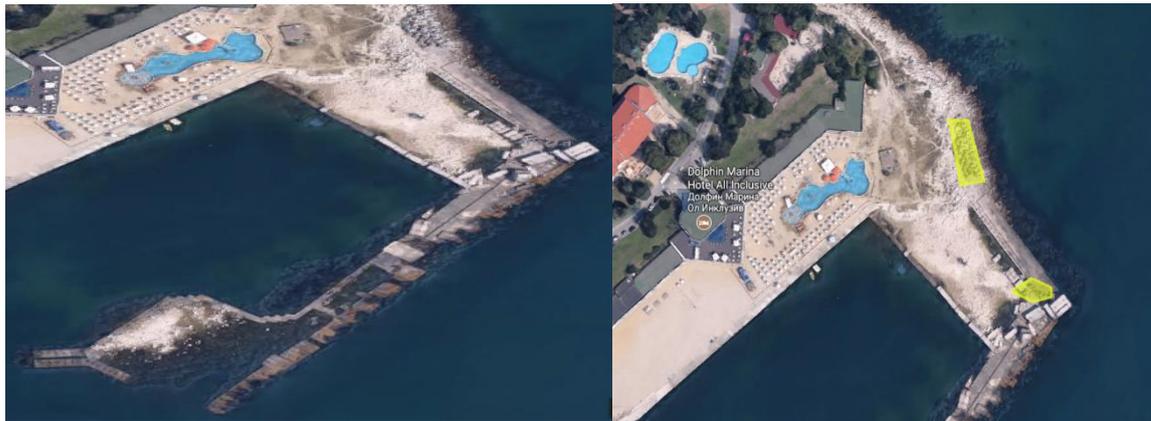
Figure 79: Top view of existing breakwater (left) tetrapod locations (right)

The assessment of the existing breakwater condition was conducted through identification of the current material types in combination with estimation of the quantity and quality of the materials available on the shore and on the vicinity of the breakwater that should be removed. Moreover, the notion of reusing a part of those materials was explored for the construction of the new breakwater. The material types that were observed consist of tetrapods, concrete blocks, rock and concrete debris.

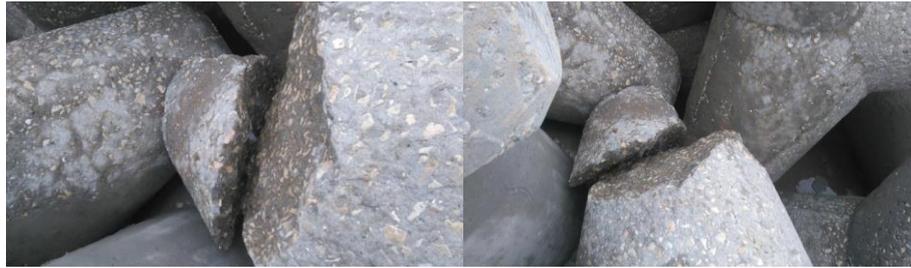
Figure 80: Tetrapod leg cut-off

In terms of quality inspection it should be noted that the quality of the tetrapods was not considered good enough for reuse in their original form. Either due to weathering damage or due to poor construction techniques, the concrete cover thickness was found to be very thin or the aggregates (including shells) were exposed. The tetrapods located at the elbow of the breakwater appear to be smoother and generally in a better condition. There were tetrapods with evident damage (leg cut-off, split in the middle) as can be seen in images 3-5. Additionally, close to the shore tetrapods were attached on concrete that was allegedly dumped there after the construction of the neighbouring hotels. During the inspection there was a wind surge (roughly estimated at 30 cm) and the tetrapods were partly submerged. However, from Google Earth inspection it seems that these tetrapods are on the dry during calm wave conditions.
