Performance of flood defences in the Netherlands during the 2021 Summer floods

André Koelewijn¹, Joost Pol² and Malou van Schaijk³

Abstract

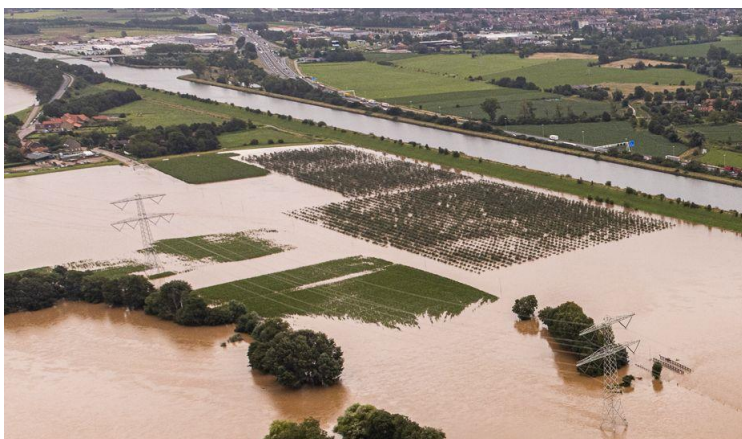
An example of this is the dike section 82, locally known as Aasterberg (Figure 3). During the peak of the floods along the Meuse, locally on Friday 16 July, the water level near to the northern side of this small dike section rose higher than the crest of the dike (contrary to what the previous figure suggests). Sandbags had been installed in time on the raised road behind the dike which prevented the area from flooding. The residents were evacuated (Limburg, 2021a). At the critical sections indicated in Figure 2, most notably dike section 83, sand bags were applied as an effective measure.

Figure 3: Aerial view of Aasterberg (upper left corner) on July 16, 2021, a few hours before peak flood level (photograph Dutch Coast Guard).

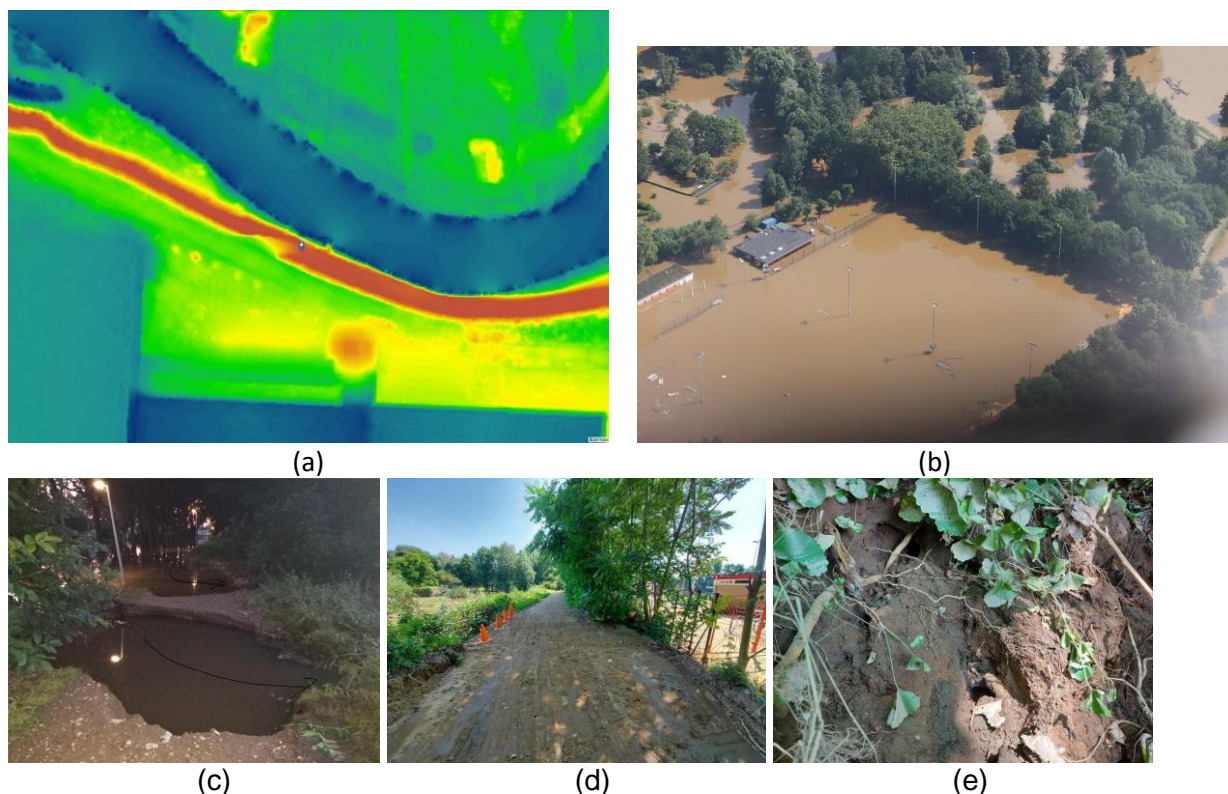
A breach approximately 2 m wide occurred in the dike after an overflow of a slightly lower part of the crest (Figure 4). At this location, the crest height is NAP + 21.10 to + 21.20 m while the maximum water level was NAP + 21.43 m, as indicated by measurements at station “Roermond Andersonweg bij stuw Hoge Bat” [<https://www.waterstandlimburg.nl/Home/Waterstanden/140>]. High-water marks on the nearby floodgate to the west of the Bisschop Lindanussingel indicate a similar level, which must have been the same at the breach location, because there was hardly any current in this branch of the Roer as the downstream floodgate was closed (see Section 2.6). Due to the flooding, the hockey fields were almost 2 metres underwater. Based on several sources of information, the following timeline of events can be reconstructed:

Figure 4: Concordia hockey fields: (a) digital terrain model showing locally lowered crest at the first breach location, situation before the floods (from the nationwide elevation model AHN3), (b) aerial photograph taken on Saturday 17 July at 11:15 AM – the dike with breach is located just behind the clubhouse and the blue container among the trees (photograph Dutch Coast Guard), (c) situation with backflows with the scoured location of the lower crest at the front and the breach location behind (photograph David Knops, HKV), (d) sealed breach, : holes in dike embankment approximately 100 m from the location of the breach.

It is not known when exactly the breach occurred, whether this was before the water entered the area or after. Therefore, the failure mechanism at this location cannot be inferred clearly from the observations. As the maximum water level in the Roer exceeded the local depression in crest level, external erosion by overflowing water is a likely candidate. Traces of external erosion at the inner slope have been observed on the same levee, about 100-200 m from the breach

location. It is also possible that burrowing by animals played a role in the weakening of the levee and the occurrence of the breach: holes several centimetres in diameter were found in a number of places in the dike embankment near the breach location, possibly made by voles (Figure 4e). These holes increase the vulnerability for saturation and slope instability and internal erosion from the embankment body. However, if the breach occurred after the area flooded due to overflow, a possible failure mechanism is that the breach was caused by the outflowing water, for instance external erosion or slope instability of the outward slope (by then, the river level was lower and the levee must have been saturated).

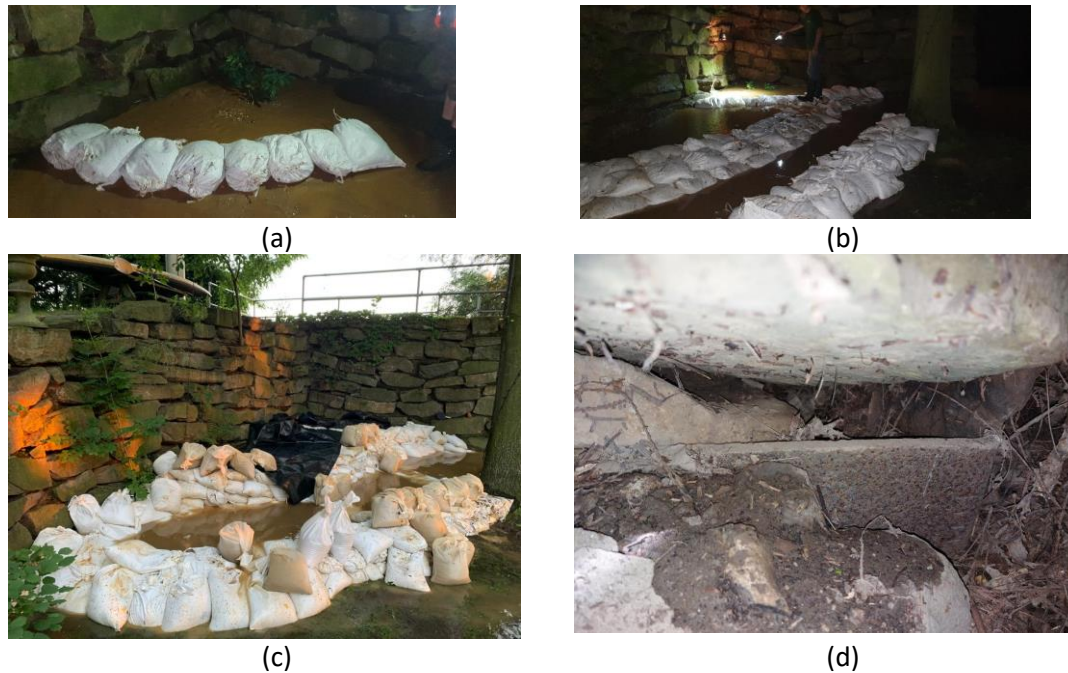
Another incident with internal erosion occurred at a floodgate in the city of Roermond (Figure 8). This floodgate in the Roer river, which is a tributary of the Meuse river, was closed in order to protect the city centre from flooding. At this location, excessive seepage and erosion in the corner of the L-shaped wall on the downstream side was reported on Saturday 17 July at 03:15 AM. The sand boil was bringing up coarse sand and gravel. Half an hour later, the first ring of sandbags was put down (see Figure 9ab) which was eventually built 3 to 4 layers high (Figure 9c). This stopped the erosion process. In the afternoon, again outflow of water and sand was reported, and the ring of sandbags was heightened to a height of 60 to 80 cm which turned out to be sufficient to stop the erosion for the maximum water level drop of more than 1.6 m that was present over the structure. To be sure to stop further erosion, the area near the corner was completely filled with sandbags [Figure 9c].

After the floods, a poor connection was found between the sheet pile and concrete cover on the high-water side (Figure 9d). This opening may have enabled the water to flow through the opening, and down behind the sheet pile, resulting in the formation of the sand boil.

Figure 9: Observations around the Roer floodgate: (a) sand and gravel deposited near the first sandbags (photograph Guido van Rinsum, Witteveen+Bos), (b) ring of sandbags on 17 July at 04:30 (photograph Guido van Rinsum, Witteveen+Bos), (c) sandbags on 17 July at around 20:00 (photograph Guido van Rinsum, Witteveen+Bos), (d) the poor connection of the gate structure between sheet pile and concrete cover on the high-water side, photo taken after the flood.

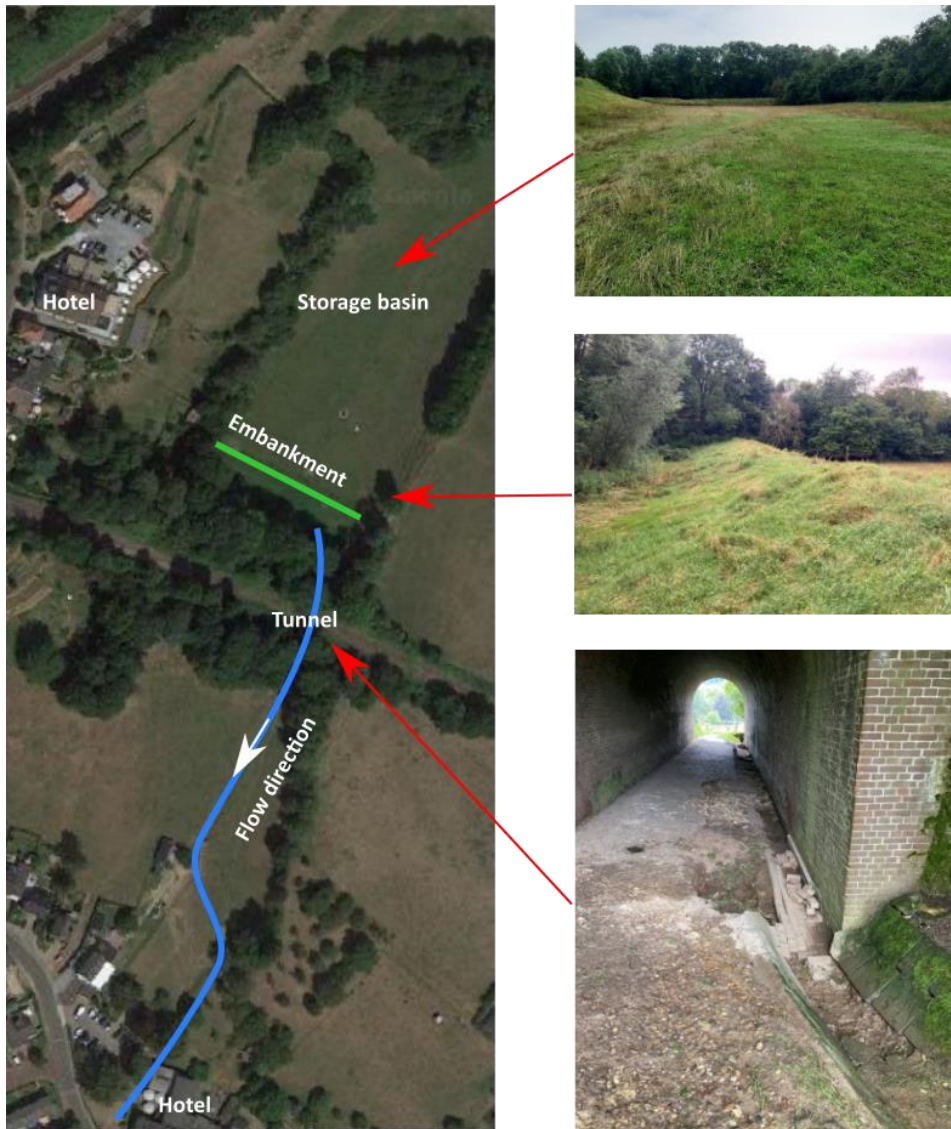
The ‘Ransdaal’ rainwater storage basin is located northeast of the village of Schin op Geul, see Figure 13. During the extreme rainfall event, floods occurred downstream of the area along the Scheumerbeek. For example, the nearby hotel downstream of the storage basin was flooded with several decimetres of water. During the field visit, it was found that water had overtopped the dike – in the middle and along the eastern side of the dam. The water flowed through a tunnel (where there were signs of significant erosion that point to high flow rates), and that led to the flooding downstream along the Scheumerbeek. This affected the hotel and a number of houses.

Figure 13: Location of Ransdaal storage basin near Schin op Geul (left) and images of the basin, the dike/embankment, and the erosion in the tunnel downstream (photographs provided by Bas Jonkman, TU Delft).
