## Investigation of the formation of corrugation-induced rail squats based on extensive field monitoring

2018

International Journal of Fatigue

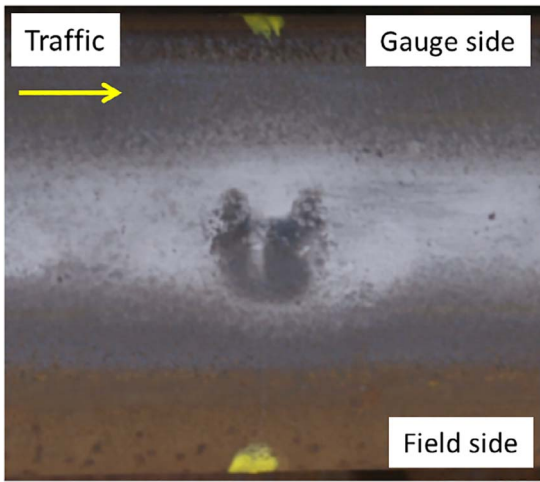
Fig. 1. A typical squat in a two-lung shape with cracks at the monitored site.

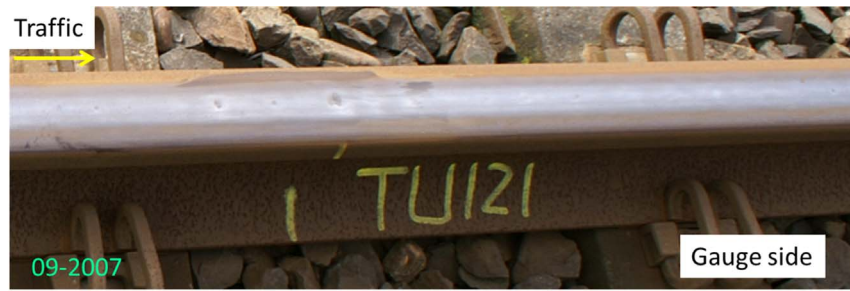
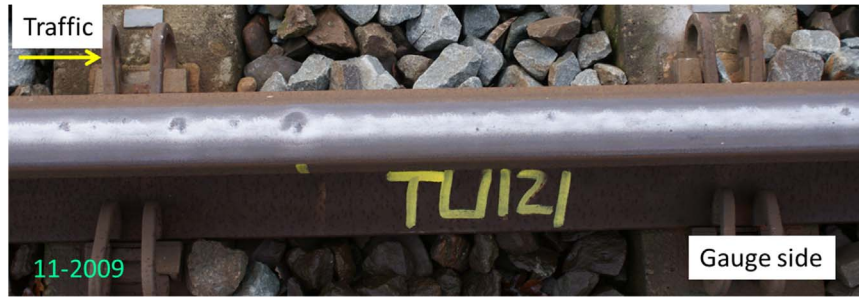
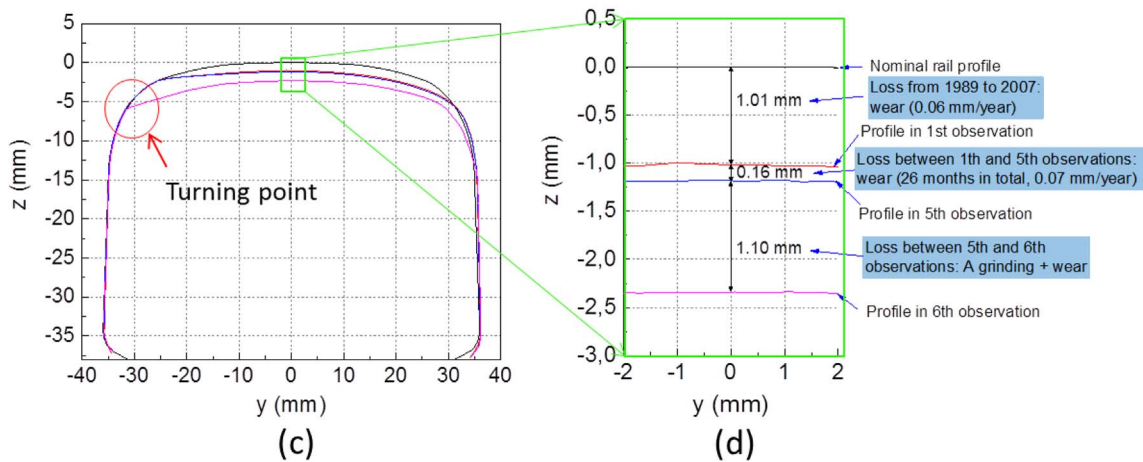
The section of track was selected for monitoring because of the following reasons. First, some corrugation and resulting squats of various severities were observed at the beginning of the monitoring, as shown in Fig. 3(a). In view of the active nature of corrugation-induced squats, it was predictable where new squats would initiate and grow from the developing corrugation. This makes a fruitful selection of monitoring locations possible. The second reason is that there were no visible defects or residual cracks in the rail surface other than the intended corrugation and squats. The third reason is that the rails had not been ground. To prove that any grinding was not performed before the start of the monitoring, the rail profiles measured during the monitoring at a number of defect-free locations were analyzed. It was found that the average rail head loss due to the natural wear was 0.07 mm/year between the first and fifth observations, and the average rail head height loss was 0.06 mm/year between 1989 and 2007. The height loss of 0.06 mm/year would have not been possible if any corrective grinding had taken place. This was further confirmed by looking at the measured profiles, as shown in Fig. 3(c) and (d), where the measured profiles are aligned with the nominal profile (in black) on the field side (the left side). The measurements show good repeatability. The profile (in magenta) measured immediately after a corrective grinding at the sixth observation is as smooth as the other profiles on the gauge side. In contrast, the ground profile has a larger rail head height loss (see Fig. 3(d)) and a sharp turning point at the field side (indicated in Fig. 3(c)), apparently it is different from other profiles. If there was any

Fig. 3. Typical corrugation with several squats of various severities adjacent to a monitored squat and measured rail profiles for analysis of grinding: (a) in the first observation, corrugation and some squats already existed adjacent to a monitored squat; (b) in the fifth observation, the corrugation and squats in (a) had become severe and new squats of different severity appeared; (c) measured rail profiles by MiniProf in the vicinity of one squat: from top to down they were the nominal (black) and those measured in the first (red), fifth (blue) and sixth (magenta) observations, respectively; (d) zoom-in of (c) in the middle of the profiles. (For interpretation of the references to color in this figure legend, the reader is referred to the web version of this article.)

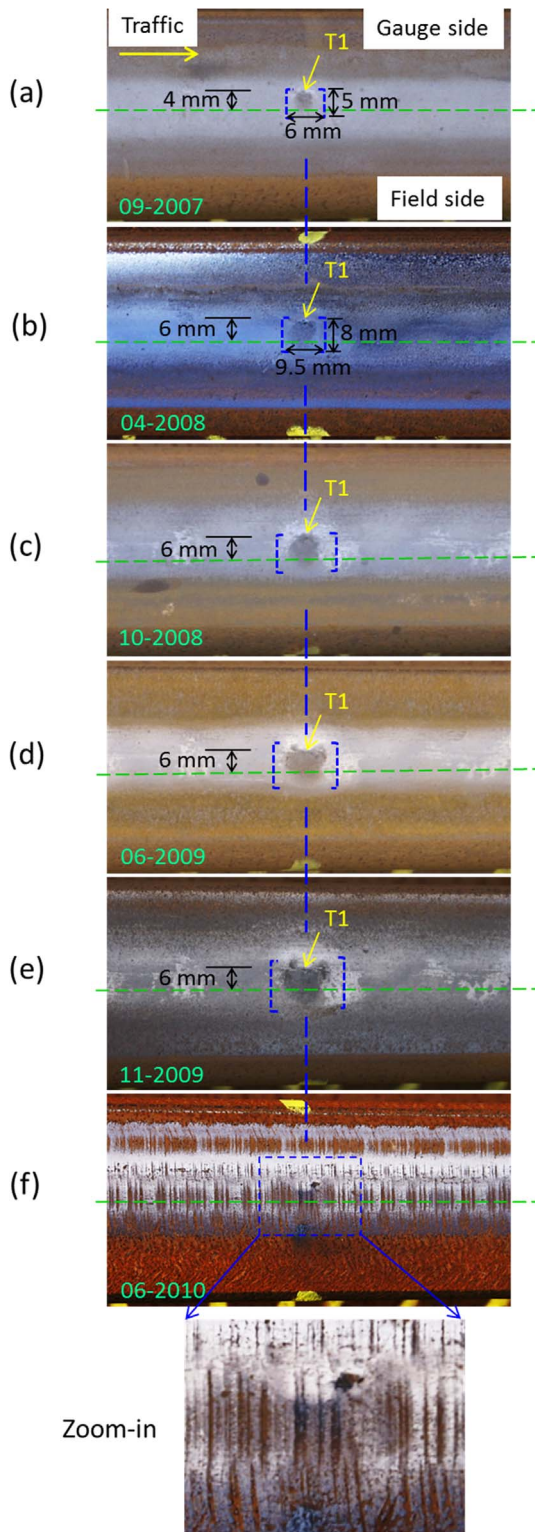
The series of photographs in Fig. 4, which were obtained during the first six field observations, show the evolution of a squat. The changes in size and in the bright running band near the squat can be seen. At the time of the first observation, the squat was a small black depression in an approximately elliptical shape with a size of approximately 5 mm in the lateral direction and 6 mm in the traffic direction. The position of T1 is approximately 4 mm from the rail centerline. This black depression did not have visible surface cracks. It was growing in size until the fifth observation, shortly before the rail grinding. The squat eventually evolved into a kidney-like shape with its concave part resembling a shallow U, as seen in Fig. 4(d) and (e). As will be shown later, this shallow U developed into a full U that was the primary surface crack of the squats. Thus, this concave part is referred to hereafter as U-shaped. At the time of the fifth observation, the running band at the squat was widened on the gauge side, as indicated by the shining part above point T1, indicating that the depression broadened the running band.

Although it was hard to confirm the presence of surface macrocracks by visual inspection during the first five observations, eddy current tests showed that a crack began to appear as of the second observation. At this time, T1 of the depression was approximately 6 mm from the rail centerline, and the dimension of the depression was approximately 8 mm in the lateral direction and 9.5 mm in the traffic direction. These results indicate that cracks initiated when the black depression grew to a certain size. This finding was confirmed by the observations of another 5 squats of the 30 selected squats, which did not have macrocracks in the beginning, but cracks were observed at the sixth observation. This finding is in line with the critical size of squat initiation that was numerically derived in [13] by comparing the maximal von Mises stress with tensile strength, and the material was also R260Mn.

After the crack had appeared, the shape of the depression began to change into a kidney-like shape, and the location of T1 remained approximately 6 mm from the rail centerline. Eddy current tests and ultrasonic tests showed that the crack continued to grow after their initiation. The phenomenon of crack growth with the fixed location of T1 relative to the rail center was observed with all the other monitored squats.

After the rail grinding to a depth of 1.1 mm, the black depression was removed, and a shallow U-shaped crack was exposed, as shown in Fig. 4(f). This observation shows that the crack had propagated into the rail deeper than 1.1 mm and that the depth of the black depression was less than 1.1 mm. This finding confirmed the presence of the cracks measured by the eddy current tests and ultrasonic tests. The removal of the black depression and the exposure of the residual cracks were also observed at the other monitored squats with cracks deeper than

Fig. 4. Evolution of a squat with the critical size of 8 mm for crack initiation and subsequent cracking (the dashed straight green line represents the rail centerline): (a)–(e) Before rail grinding to a depth of 1.1 mm; (f) after the rail grinding, revealing a shallow U-shaped crack, as seen in the zoom-in. (For interpretation of the references to color in this figure legend, the reader is referred to the web version of this article.)

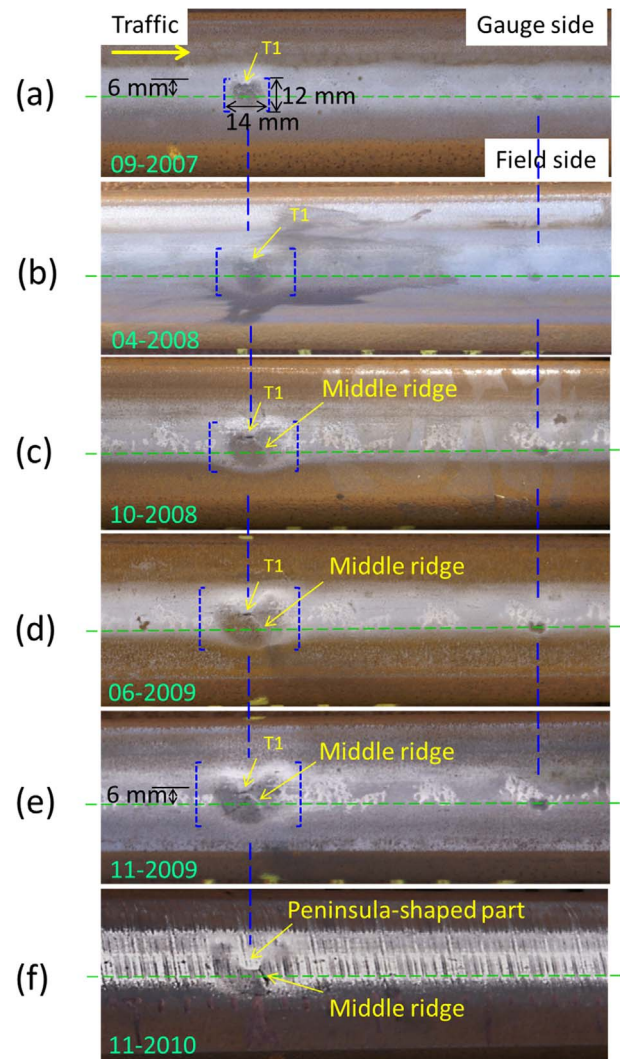
Fig. 5 illustrates the development process from the first five consecutive observations before the rail grinding and from the seventh observation after the grinding; the photo from the sixth observation was not sufficiently clear. These photographs show that T1 was the bottom point of the U shape and that its position stayed fixed not only in the lateral direction, as demonstrated with Fig. 4, but also in the traffic direction. The latter concluded as follows: the rail head has a constant width of 72.2 mm. With this value, the sizes of the depressions and cracks were derived from the photos for this paper. In Fig. 5, there is, beside the squat, another small black spot. With the known rail head width, the

distance between the small black spot and point T1 is determined, and it can be seen in Fig. 5 that T1 remained at a constant distance from the small black spot.

With T1 aligned according to the blue dashed lines, Fig. 5 shows that the squat grew longitudinally in both the traffic and opposite-

Fig. 5. Confirmation of the crack initiation point according to the relative positions of the black spot and point T1 (the green line represents the rail centerline): (a)–(e) Before rail grinding; (f) after rail grinding to a depth of 1.1 mm. (For interpretation of the references to color in this figure legend, the reader is referred to the web version of this article.)

traffic directions as well as laterally toward the gauge side and field side simultaneously. This growth pattern was observed at all 21 of the moderate and severe squats. The squat in Fig. 5 first grew into a kidney-like shape with the concave part of the kidney bounded by a U-shaped crack, and then it gradually evolved into a two-lung shape with a middle ridge (Fig. 5(c)–(f)). After the grinding, the part bounded by the full U-shaped crack took on a peninsula-like shape, as seen in Fig. 5(f). A more detailed discussion about the formation of the middle ridge and the peninsula-shaped part is in Sections 3.4.1 and 3.4.2. Notably, the typical two-lung shape and the peninsula-like shape were not clearly observable at the squat in Fig. 4 because the squat was still in a relatively early stage; the crack and geometry had not yet grown into the typical shape.

The very small black spot in Fig. 5(a), barely visible to the naked eye, was growing before the grinding. At the fifth observation, it turned into an obvious surface depression; its size was already comparable to that of Fig. 4(a), and it should have been able to develop into a squat if not removed. The initiation and growth of black spots are, in the very beginning, driven by the corrugation. At the same time, the black spots are rail surface irregularities that excite (additional) dynamic contact force; the larger the black spot, the larger the dynamic force, creating a positive feedback loop that promotes the continuous and accelerates

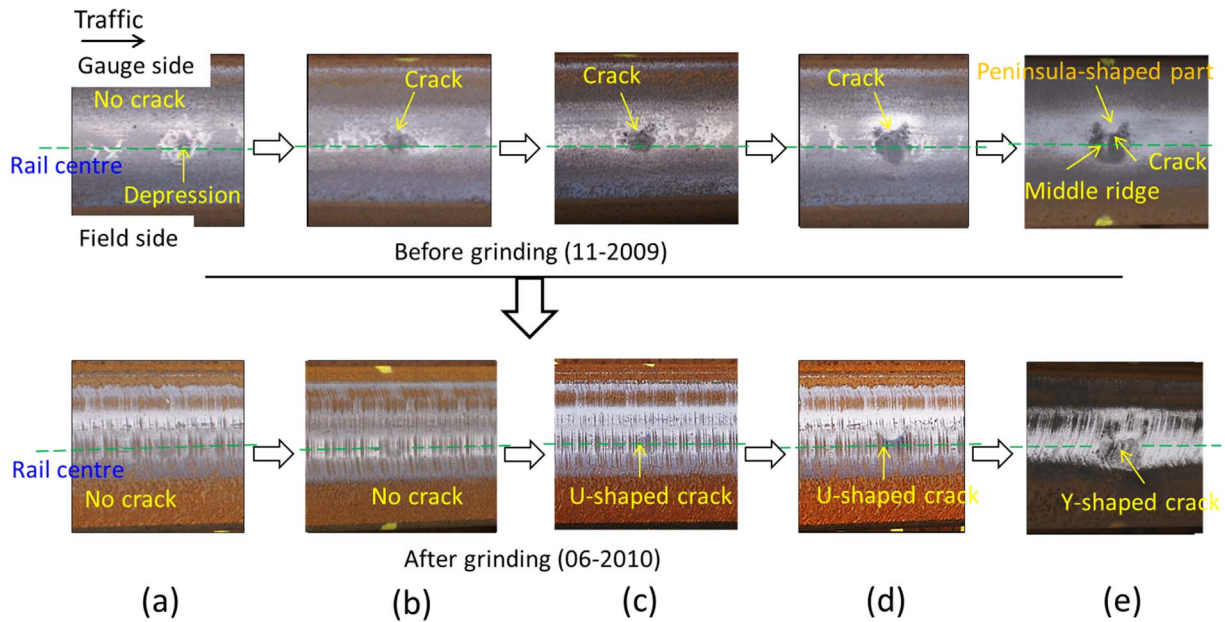
Fig. 6. Different squats at various severities: earlier stages to later stages.

In (a), the black depression was still significantly smaller than the critical size of 8 mm; no crack was observed in the rail surface either before or after the rail grinding, as seen in Fig. 6(a). It is reasonable to assume that the macrocrack had not yet initiated at this time. In (b), the size of the depression (10 mm (in the lateral direction) × 14 mm (in the traffic direction)) was larger than the critical size of crack initiation; a small surface primary crack became visible at this stage prior to the rail

grinding (see the arrow in Fig. 6(b)). After the grinding, the crack was removed. This observation suggested that the crack was shallower than 1.1 mm. In (c) and (d), the squats were in a kidney-like shape before the grinding, and a U-shaped crack became visible after the grinding. The length of the U-shaped crack continued to grow from the bottom along the U in both directions, i.e., in the traffic and the opposite-traffic directions, with the evolution of the squat. These observations confirm that the bottom of the U-shaped cracks was the initiation point of the cracks in or near the rail surface on the gauge side of the depression. The point of the crack initiation corresponded to position T1 in Figs. 4 and 5. After initiation, the crack propagated along the U shape, as well as into the rail toward the field side, as discussed in Sections 3.3 and 3.4. Moreover, the crack grew more rapidly in the traffic direction than in the opposite-traffic direction; see the discussion in Section 4.3. In (e), the squats reached a more severe stage: they evolved into the two-lung shape with a middle ridge, and an I-shaped crack appeared at this ridge after the grinding. More details about the I-shaped crack are provided in Section 3.4.

was not very clearly visible, as shown in Fig. 6(a), the convex part of the kidney-shaped depression was elliptical, as seen in Fig. 6(b)–(d), and this elliptical shape most likely originated from the elliptical contact area between the wheel tread and the rail crown. The elliptical shape is more clearly visible in Fig. 4, especially in Fig. 4(a) and (b). Therefore, the small black depression in (a) should have been approximately elliptical in shape.

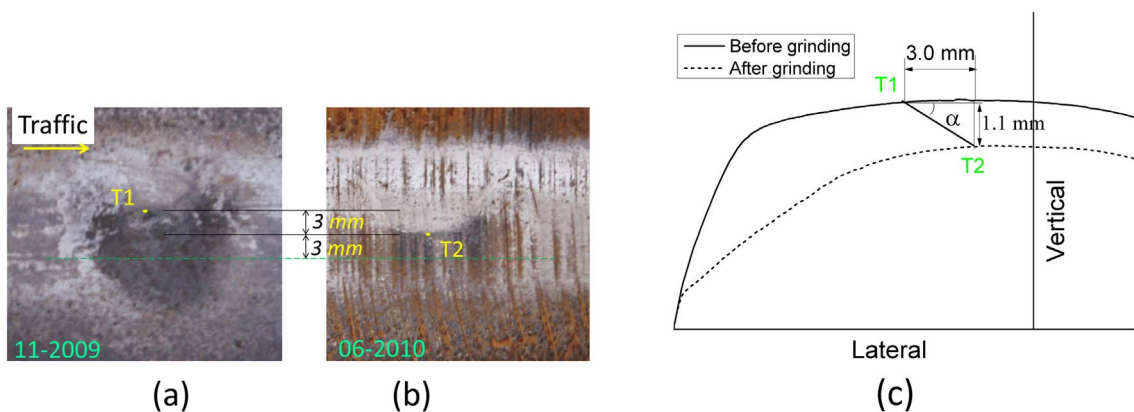
Fig. 7. Determination of the cracking angle relative to the rail surface in the vertical-lateral cross-section (the green line represents the rail centerline; T1 and T2 denote the bottom of the U-shaped crack): (a) Before rail grinding; (b) after rail grinding to a depth of 1.1 mm; (c) cross-sectional profiles of the rail. (For interpretation of the references to color in this figure legend, the reader is referred to the web version of this article.)

A moderate squat with a U-shaped surface crack was examined to determine its cracking angle in the vertical-lateral cross-section, which passes through the bottom of the U shape, as shown in Fig. 7. In Fig. 7(a), bottom point T1 of the crack was the crack initiation point, and it was located on the gauge side at a distance of 6 mm from the rail centerline. After the rail grinding to a depth of 1.1 mm, the bottom of U-shaped crack T2 shifted 3 mm toward the field side, as shown in Fig. 7(b). The cracking angle  $\alpha$  was then approximately  $20^\circ$ , as illustrated in Fig. 7(c), indicating that the surface crack propagated into the rail at an angle of approximately  $20^\circ$  toward the field side. This finding agrees with the findings in the computed tomography investigation in [20].

For verification purposes, another 18 moderate and severe squats with cracks on the gauge side were also examined. All the crack initiation locations were approximately 6 mm from the rail centerline on the gauge side. These locations were also the bottom points of the U-shaped cracks of the squats, and they corresponded to point T1. After the rail grinding to a depth of 1.1 mm, the bottom points moved 3 mm toward the field side. Thus, the cracking angles were again approximately  $20^\circ$  for all the examined squats, 7 of which are shown in Figs. 1, 4–7 and 15. All the results were in good agreement with the cracking angle shown in Fig. 7.

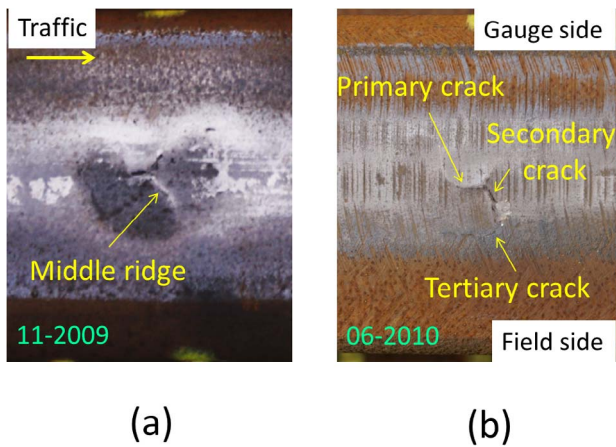
Fig. 9. A typical two-lung-shaped squat with a Y-shaped crack and a semi-circular tertiary crack (the same squat as in Fig. 5): (a) Before rail grinding; (b) after rail grinding to a depth of 1.1 mm.

The two impacts at the peninsula-shaped part punched and pushed the depressed rail material so that a “ridge” was formed in the middle of the black depression, as indicated in Fig. 9(a). This ridge is clearly shown on the surface in Figs. 1, 5(c)–(f), 6(e), 9, 10 and 15. Cracks can develop at the middle ridge, as seen in Figs. 5(f), 6(e) and 8–10, especially in severe squats. This crack is the secondary I-shaped crack. The I-shaped crack is also shown in the 3D geometry of the crack in Fig. 8(b).

When the U-shaped crack and I-shaped crack occur simultaneously, they together become a Y-shaped crack, as shown in Figs. 9 and 10. The Y divides the elliptical shape into the shape of two lungs, which occurs with the typical shape of severe squats.

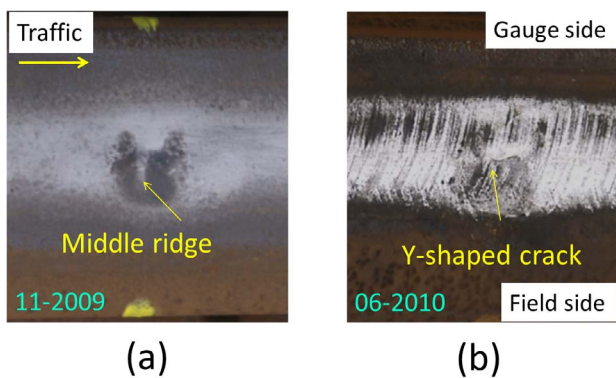
Fig. 10. Another typical two-lung-shaped squat with a Y-shaped crack (the same squat as in Fig. 6(e)): (a) Before rail grinding; (b) after rail grinding to a depth of 1.1 mm.

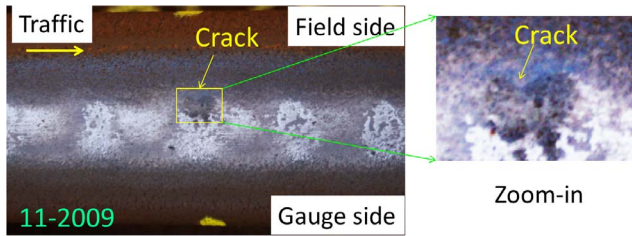
Fig. 14. A squat with a primary crack on the field side edge of the black depression.

When the rail inclination is at the nominal value of 1/40, as shown in Fig. 13(a), the presence of the black depression shifts the main contact area to the gauge side. This shift is determined by the contact geometry, namely the profiles of the wheel and the rail, as illustrated in Fig. 12(b) and, especially, Fig. 12(e): the wheel-rail profiles are more conforming to each other on the gauge side than on the field side so that, when there is a depression, the main contact area is usually on the gauge side. As a result, the crack tends to initiate and propagate into a U shape on the gauge side edge of the black depression. This scenario in which the location of the primary crack is on the gauge side (schematically shown in Fig. 12) occurs at most of the monitored squats, such as those squats shown in Figs. 1, 3–10, 15 and 17, the only exception is the case shown in Fig. 14 corresponding to the situation in Fig. 13(c).

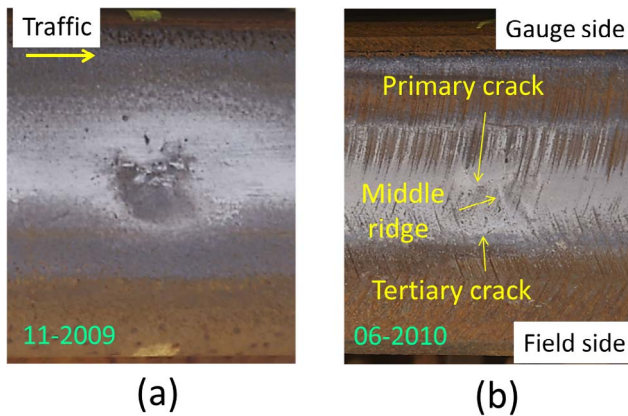
Fig. 15. A squat with two cracks, i.e., a primary crack and a tertiary crack: (a) Before rail grinding; (b) after rail grinding to a depth of 1.1 mm.

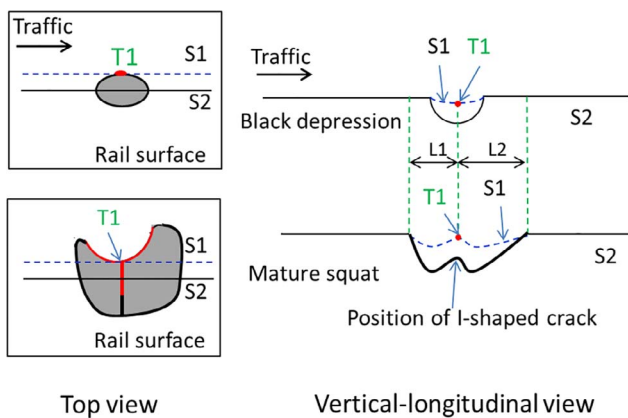
Fig. 16. Evolution of the squat geometry. S1 and S2 indicate the two vertical-longitudinal sections.

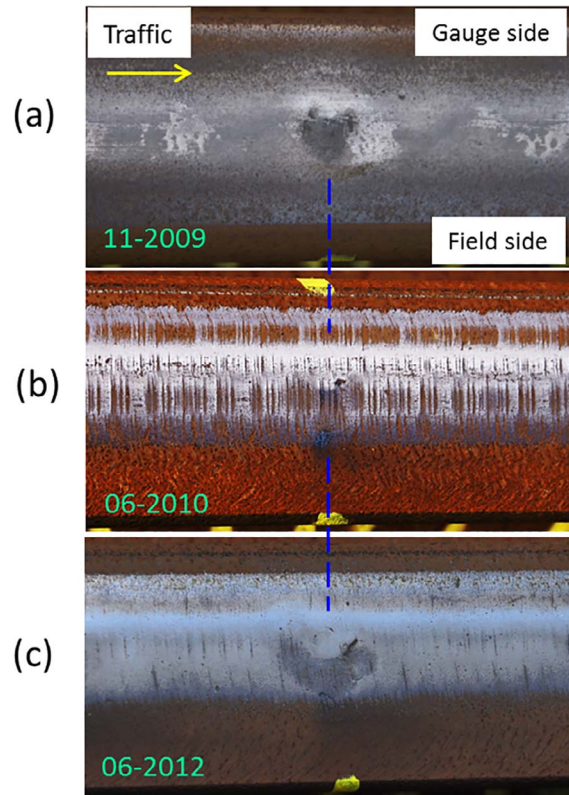
Fig. 17. Squat (the same as in Fig. 4) development after rail grinding: (a) Fifth observation before rail grinding; (b) sixth observation after grinding to a depth of 1.1 mm; (c) tenth observation after another grinding of approximately 0.3 mm between the seventh and eighth observations.

During the ten continual observations, rail grinding to a depth of 1.1 mm was performed after the fifth observation. Some of the squat cracks had already propagated more than 1.1 mm into the rails; therefore, the rail grinding did not remove the cracks completely. The remaining cracks grew further and developed into a new squat, as shown in Fig. 17.
