Investigation of the formation of corrugation-induced rail squats based on extensive field monitoring

Deng, Xiangyun; Qian, Zhiwei; Li, Zili; Dollevoet, Rolf

International Journal of Fatigue

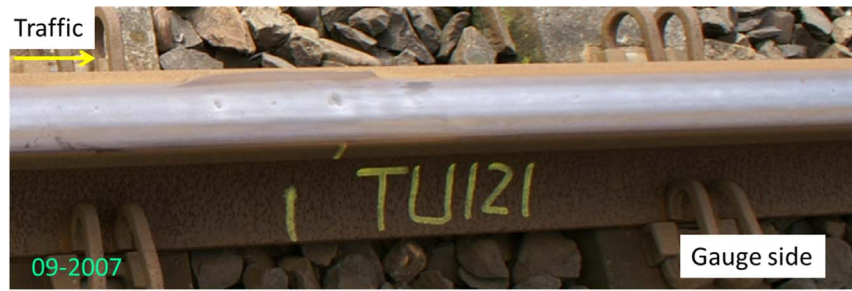
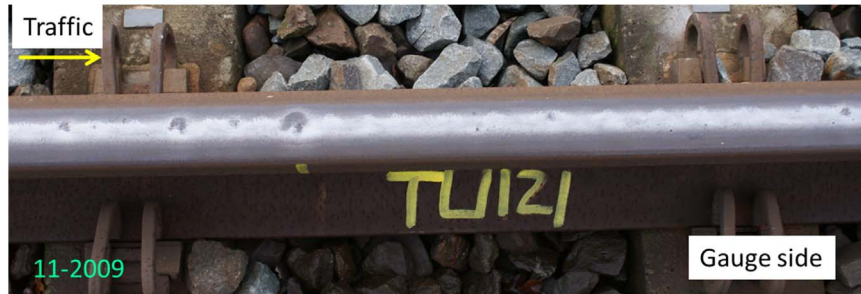
The section of track was selected for monitoring because of the following reasons. First, some corrugation and resulting squats of various severities were observed at the beginning of the monitoring, as shown in Fig. 3(a). In view of the active nature of corrugation-induced squats, it was predictable where new squats would initiate and grow from the developing corrugation. This makes a fruitful selection of monitoring locations possible. The second reason is that there were no visible defects or residual cracks in the rail surface other than the intended corrugation and squats. The third reason is that the rails had not been ground. To prove that any grinding was not performed before the start of the monitoring, the rail profiles measured during the monitoring at a number of defect-free locations were analyzed. It was found that the average rail head loss due to the natural wear was 0.07 mm/year between the first and fifth observations, and the average rail head height loss was 0.06 mm/year between 1989 and 2007. The height loss of 0.06 mm/year would have not been possible if any corrective grinding had taken place. This was further confirmed by looking at the measured profiles, as shown in Fig. 3(c) and (d), where the measured profiles are aligned with the nominal profile (in black) on the field side (the left side). The measurements show good repeatability. The profile (in magenta) measured immediately after a corrective grinding at the sixth observation is as smooth as the other profiles on the gauge side. In contrast, the ground profile has a larger rail head height loss (see Fig. 3(d)) and a sharp turning point at the field side (indicated in Fig. 3(c)), apparently it is different from other profiles. If there was any

Fig. 3. Typical corrugation with several squats of various severities adjacent to a monitored squat and measured rail profiles for analysis of grinding: (a) in the first observation, corrugation and some squats already existed adjacent to a monitored squat; (b) in the fifth observation, the corrugation and squats in (a) had become severe and new squats of different severity appeared; (c) measured rail profiles by MiniProf in the vicinity of one squat: from top to down they were the nominal (black) and those measured in the first (red), fifth (blue) and sixth (magenta) observations, respectively; (d) zoom-in of (c) in the middle of the profiles. (For interpretation of the references to color in this figure legend, the reader is referred to the web version of this article.)

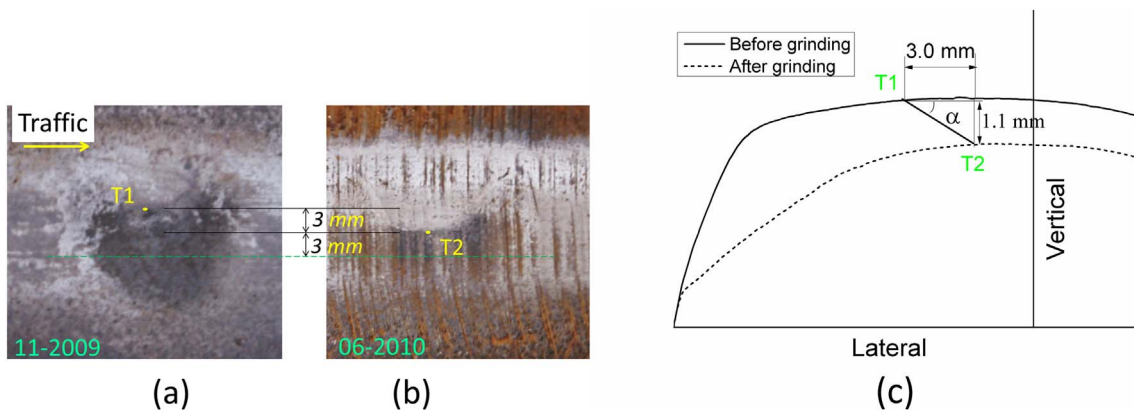
Fig. 7. Determination of the cracking angle relative to the rail surface in the vertical-lateral cross-section (the green line represents the rail centerline; T1 and T2 denote the bottom of the U-shaped crack): (a) Before rail grinding; (b) after rail grinding to a depth of 1.1 mm; (c) cross-sectional profiles of the rail. (For interpretation of the references to color in this figure legend, the reader is referred to the web version of this article.)

A moderate squat with a U-shaped surface crack was examined to determine its cracking angle in the vertical-lateral cross-section, which passes through the bottom of the U shape, as shown in Fig. 7. In Fig. 7(a), bottom point T1 of the crack was the crack initiation point, and it was located on the gauge side at a distance of 6 mm from the rail centerline. After the rail grinding to a depth of 1.1 mm, the bottom of U-shaped crack T2 shifted 3 mm toward the field side, as shown in Fig. 7(b). The cracking angle α was then approximately 20° , as illustrated in Fig. 7(c), indicating that the surface crack propagated into the rail at an angle of approximately 20° toward the field side. This finding agrees with the findings in the computed tomography investigation in [20].

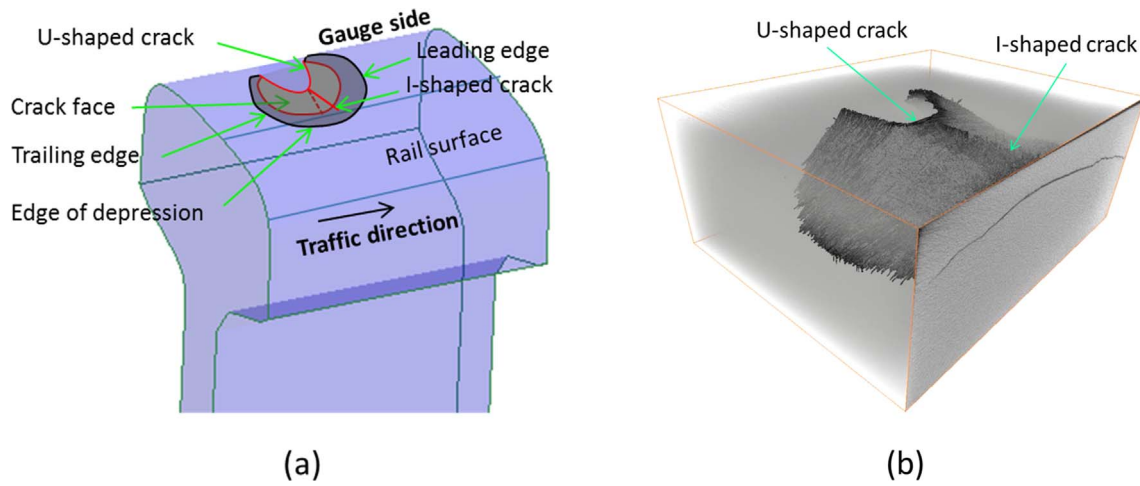
Fig. 8. 3D crack face in a two-lung-shaped squat: (a) Inferred from the surface-visible Y shape and the cracking angle α of Fig. 7(c); (b) obtained from specimen 2b (squat caused by corrugation) from [20] with computed tomography, courtesy of Meysam Naeimi.

The U-shaped crack initiated at the bottom point of the U and then propagated toward the gauge side in both the traffic and opposite-traffic directions simultaneously, as illustrated in Fig. 8. The crack also propagated into the rail at an angle of approximately 20° . This cracking process was observed at more than 20 monitored squats, as shown above. Based on this finding, the shape of the crack was constructed and is shown in Fig. 8(a). This shape was verified with 3D computed tomography [20], as seen in Fig. 8(b).

In Fig. 8, the crack face encloses a peninsula-shaped part. The intersection of the peninsula-shaped part with the rail surface is a U-shaped crack. When the U-shaped crack grows, the two arms of the U extend toward the gauge side; this makes the peninsula-shaped part longer. At the same time, the crack propagates downward into the rail, i.e., the peninsula-shaped part extends deeper into the rail. Consequently, the depressed area grows with the peninsula-shaped part simultaneously in both the surface dimension and depth.
