A case study for scientific research prior to conservation of marine metal artefacts

Journal of Archaeological Science: Reports

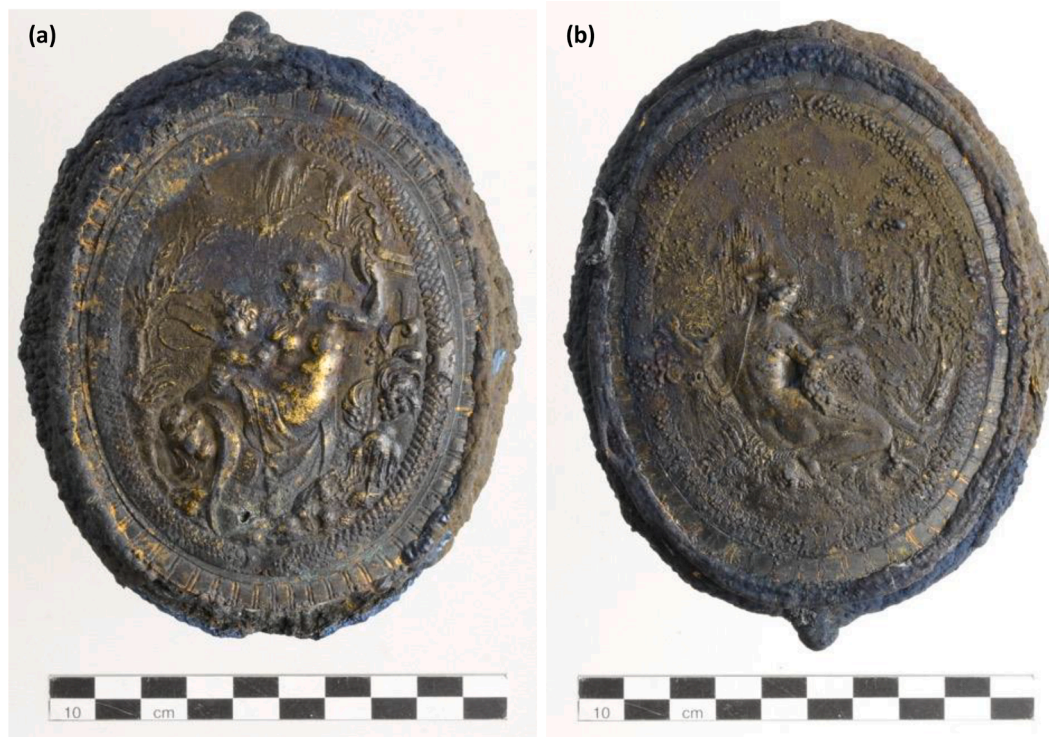
Fig. 1. Oval metal box from shipwreck BZN17. Both decorated faces are pictured, with an additional rotation of 180° for enhanced visibility: (a) Venus and Amor; (b) Leda and the swan. Images: Archeologie West-Friesland.

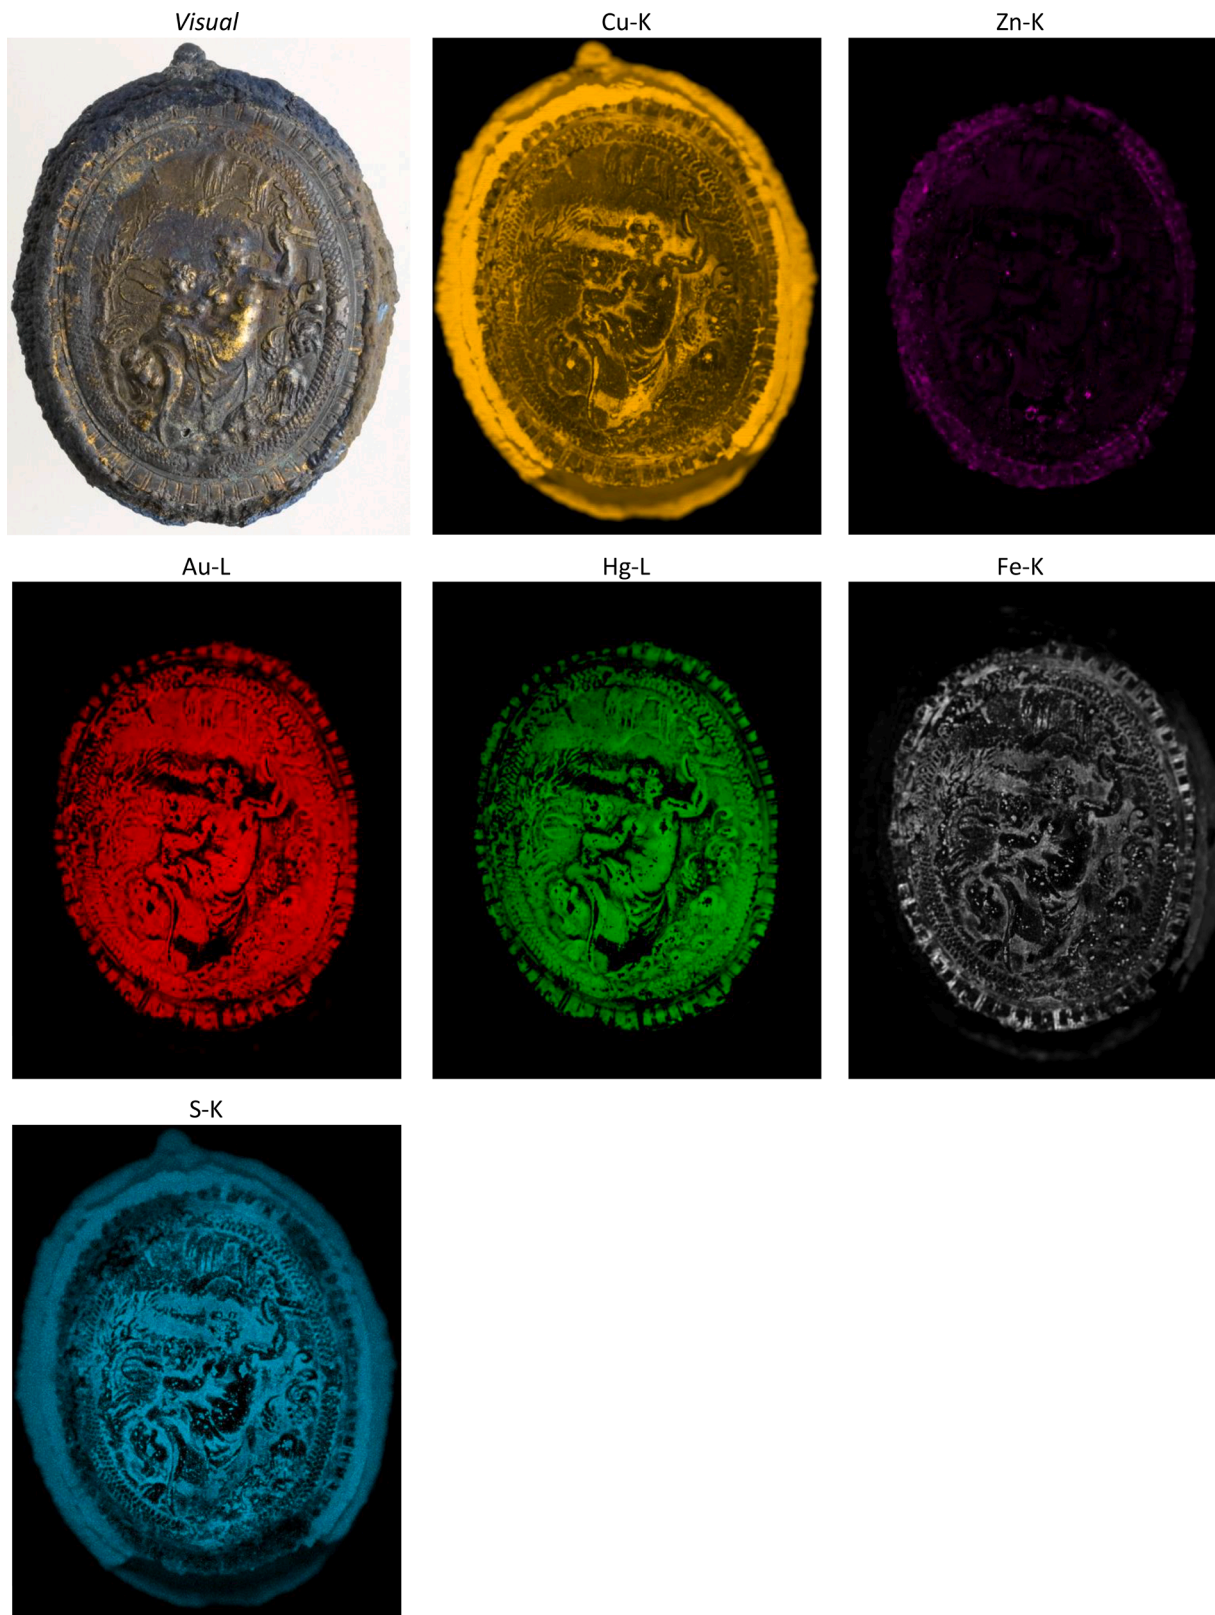
Fig. 4. Elemental XRF-maps of the entire face of the box with Venus, showing the distribution of the major elements. Lighter areas correspond to higher elemental concentration.

To provide an overview of the distribution of chemical elements along the surface of the box, macro-XRF was applied to the decorated faces and the results of the major chemical elements found on the Venus-side are shown in Fig. 4.

Copper is omnipresent on all parts of the face and on the side of the box, while zinc is locally present, especially in the gadrooning. Locations with relatively high zinc content correspond to areas with white powdery corrosion as described in the previous section. Both the heavily corroded side of the box and low-relief areas of the surface are rich only in copper, iron and sulphur, while gold, mercury and zinc are notably absent there (black areas in Fig. 4). This suggests that Cu, Fe and S are part of the corrosion that is also visibly different with the naked eye (blue-black at the side and brown-black on low-relief areas, see Fig. 2). This is in accordance with XRD results (section 4.1). The high-relief areas mostly consist of Au and Hg, for which nearly identical images were produced. Even though a slight peak overlap between both elements should be taken into account, this confirms that the object was

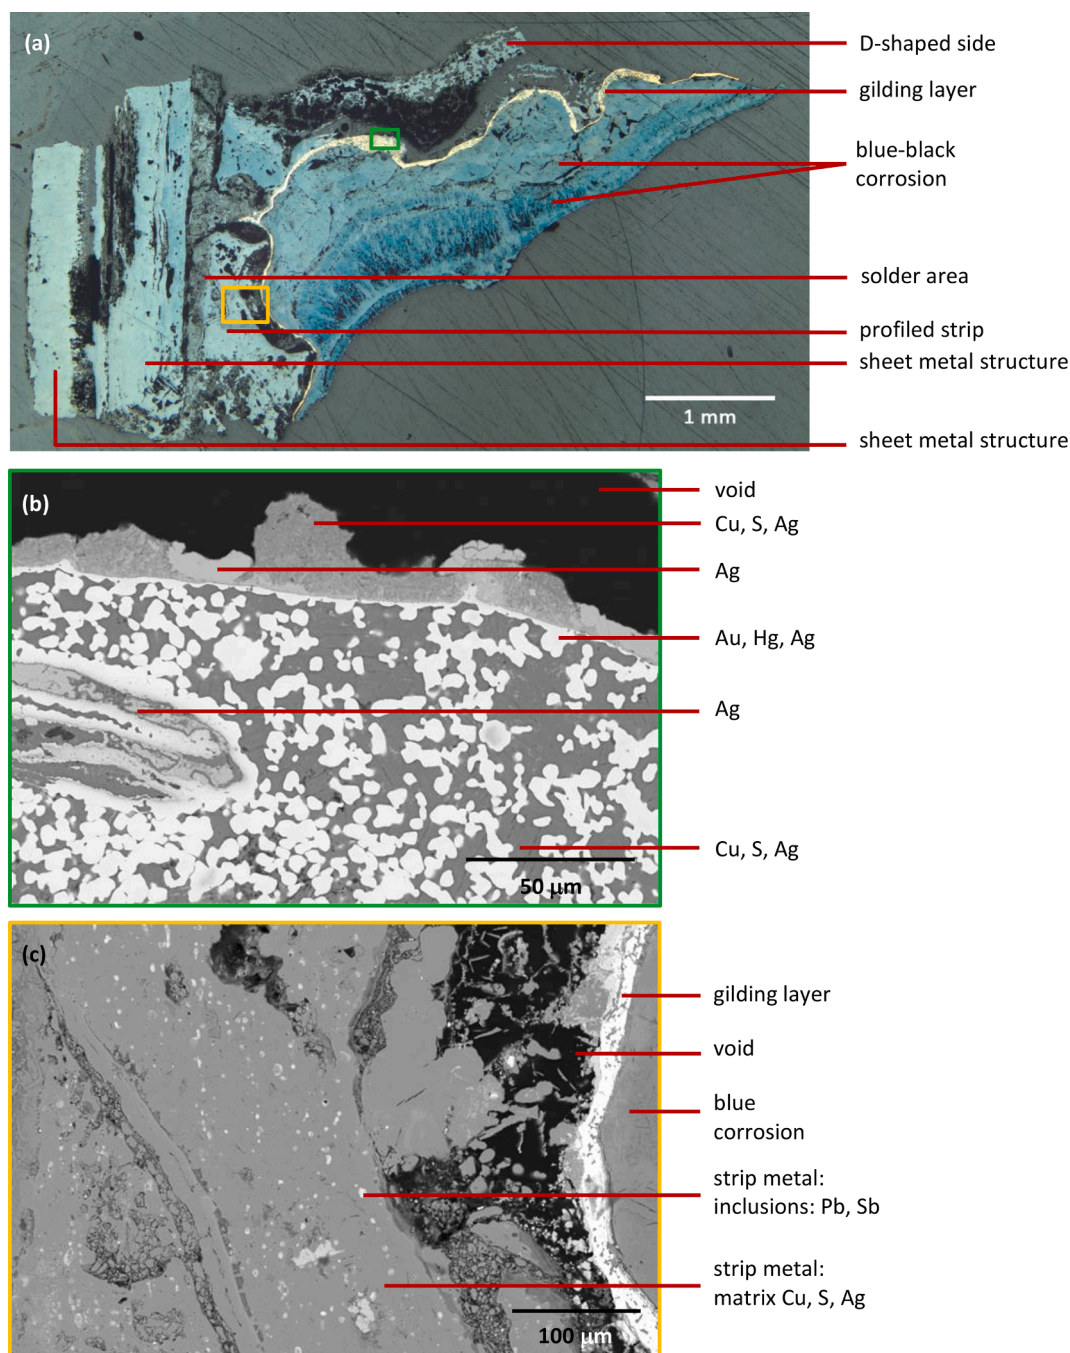
Fig. 5. Embedded cross-section (see Fig. 2). (a) Optical micrograph showing multiple constructional parts of the oval box. In green, the area shown in (b) is indicated, in yellow the area shown in (c); (b) backscatter electron image showing the entire cross-section of the gilding layer, revealing gold (Au) particles (white) with traces of mercury (Hg) and silver (Ag) dispersed in a copper (Cu)- and sulphur (S)-rich layer (grey). Silver-rich areas are present both inside the gilding layer and between the D-shaped side and the gilding layer (light grey); (c) backscatter electron image showing a corroded brass (Cu, Zn) matrix with inclusions containing lead (Pb) and antimony (Sb).

A fragment was found detached from the box and its origin could be reconstructed with high certainty, see Fig. 2. An embedded cross-section of this fragment was studied by OM and SEM-EDS. A clear gilding layer with a thickness varying between 10 and 100 μm is found in between a dark-coloured matrix and a blue-green layer (Fig. 5a).

SEM-EDS analyses (see SOI 4 for more details) of the gilding area (Fig. 5b) show the layer is composed of gold-rich areas (white), containing traces of mercury and silver, dispersed in a matrix of copper and sulphur (grey). The presence of mercury and the globular morphology is consistent with the process of amalgam gilding on copper (Anheuser, 1999, 24, 34). A relatively thick layer with undeformed gold-rich areas (Fig. 5b) is the result of the application of a large amount of amalgam paste that is not subsequently burnished, while a thinner, more compact layer is a typical result after burnishing (Fig. 5c). The copper-based matrix in which the gold-rich areas are dispersed is most likely an infill that has formed during corrosion of the brass box during its presence in the marine environment. The microstructure and composition (Fig. 5c) of the dark-coloured vertically oriented parts as analysed with SEM-EDS (see SOI 4 for more details) lead to the conclusion that these parts are corroded brass components, which belong to the interior sheet metal structure and profiled decoration strip. The blue layer could be identified with SEM-EDS as a layer consisting of copper, sulphur and traces of iron, consistent with the XRD results on the exterior of the box: chalcopyrite (CuFeS_2) and covellite (CuS). The presence of trace amounts of silver in nearly all phases present in the entire cross-section indicates that silver is present in the alloy materials in the form of traces in the copper matrix and/or inclusions.

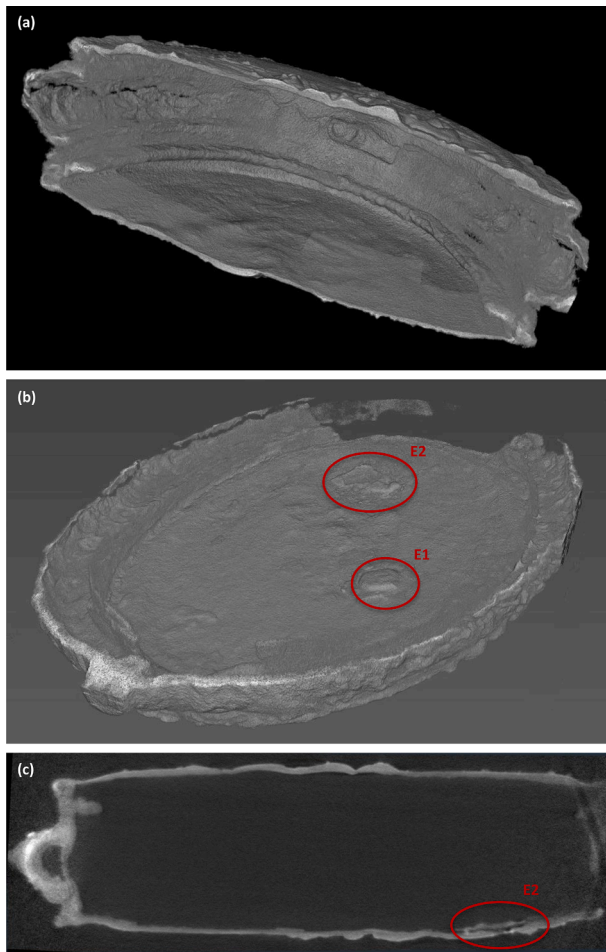
Fig. 7. Reconstructions made from neutron tomography. (a) Interior of the box showing the possible opening mechanism with the Venus-side on top; (b) the bottom side of the Venus-plaquette, showing a smooth outline, indicative of casting. Two old deformations can be seen as well (areas E1 and E2, see Fig. 6); (c) virtual section along the longitudinal axis of the box, with the Venus-plaquette shown on top and the one with Leda on the bottom.

Fig. 7a shows that the possible opening mechanism is now incomplete, with the knob (see Fig. 6) located at the left of the rectangular opening. This shape suggests perhaps the use of a spring system with the steel spring now completely disappeared, probably due to corrosion.

From the reconstructions made from NT, it can be deduced that the backs of the plaquettes roughly follow the form of the decoration (Fig. 7b), and the thickness measures about 2–3 mm, consistent with manufacturing by casting. The gadrooning and other sheet metal structures are embossed, based on their shape and thickness (~1 mm). This is in agreement with the observation of different corrosion morphologies on the different box components (section 4.2).

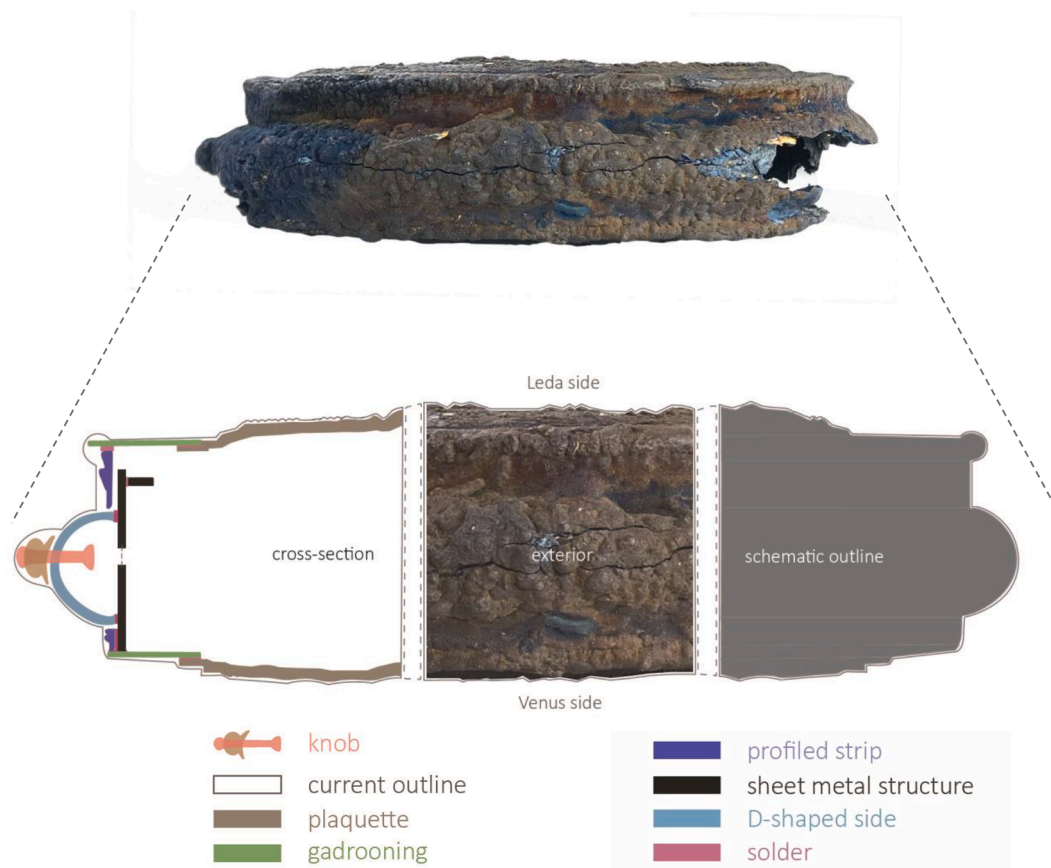
Fig. 8. Reconstruction of the most plausible box construction. Left: schematic cross-section along the longitudinal axis, indicating the different parts used for construction and decoration; middle: photograph of the current exterior; right: schematic outline of the side-view. Illustration: Tracy Han.
