# Contributing human and organizational factors to the collapse of the FC Twente stadium roof

Karel Terwel

*Delft University of Technology, The Netherlands*

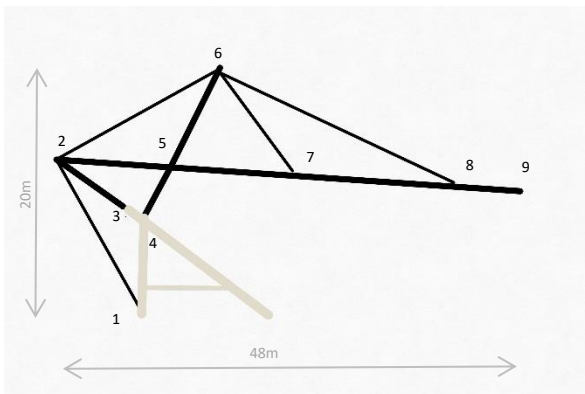
*Figure 1: Schematic overview of bearing frame (Based on [2]).*

The structure for the L-extension of the roof consisted of 11 bearing frames. Each bearing frame had a length of approximately 48m and a height of approximately 20m (see fig. 1). The bearing frame was constructed out of steel tubes. These were mounted on the concrete grandstand structure.

The engineers created stability out of plane by coupling bars and braces at the positions of 2,5,6,7 and 8. The roof, a steel structure with steel sheeting, was positioned below position 2,5,7,8 and 9.

However, the structure appeared not to be fully mounted at the moment of collapse. One coupling bar between the nodes 6 of two frames was lacking. Furthermore, several couplings between nodes 2 of various frames were missing to enable easier construction with the tower cranes. Temporary braces were removed to apply safety nets. Part of the steel roofing was already assembled.

- The main cause of failure was out-of-plane buckling of the outer parts of two frames where the connecting bar at position 2 was missing

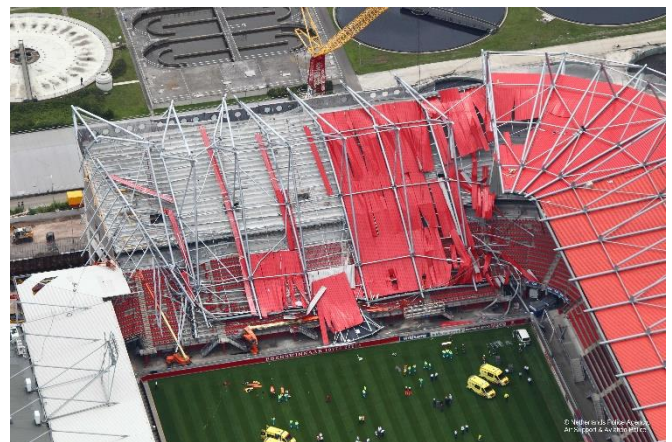
- The frame where the video-wall was connected collapsed first

*Figure 2. Roof of FC Twente stadium after collapse. Reproduced by permission of Netherlands Police Agency; Air support and Aviation Police*
