Durability of pretensioned concrete girders in coastal climate bridges: Basis for better maintenance and future design

This study was based on findings from the Norwegian Public Roads Administration's Bridge Management System and field investigations on corrosion damage in pretensioned Norwegian standard I-beam (NIB) girders in 227 coastal climate bridges. The main durability design parameters are summarized and related to regulations over the last 80 years. Environmental exposure is discussed in the light of the global, local, and micro climate. We found that 51% of the bridges have girder corrosion damage. The percentage is highest for bridges built when the cover thickness required was lowest. Cover thickness below that required (resulting from production faults) caused 74% of corrosion damage. Most of the severe chloride-induced corrosion damage in bridges was found in the inner NIB girders, particularly in the support-zones and their vicinity. This can be due to interaction between geometry and exposure. Corrosion of reinforcement in support-zones can impact structural behavior, particularly NIB girder shear performance.

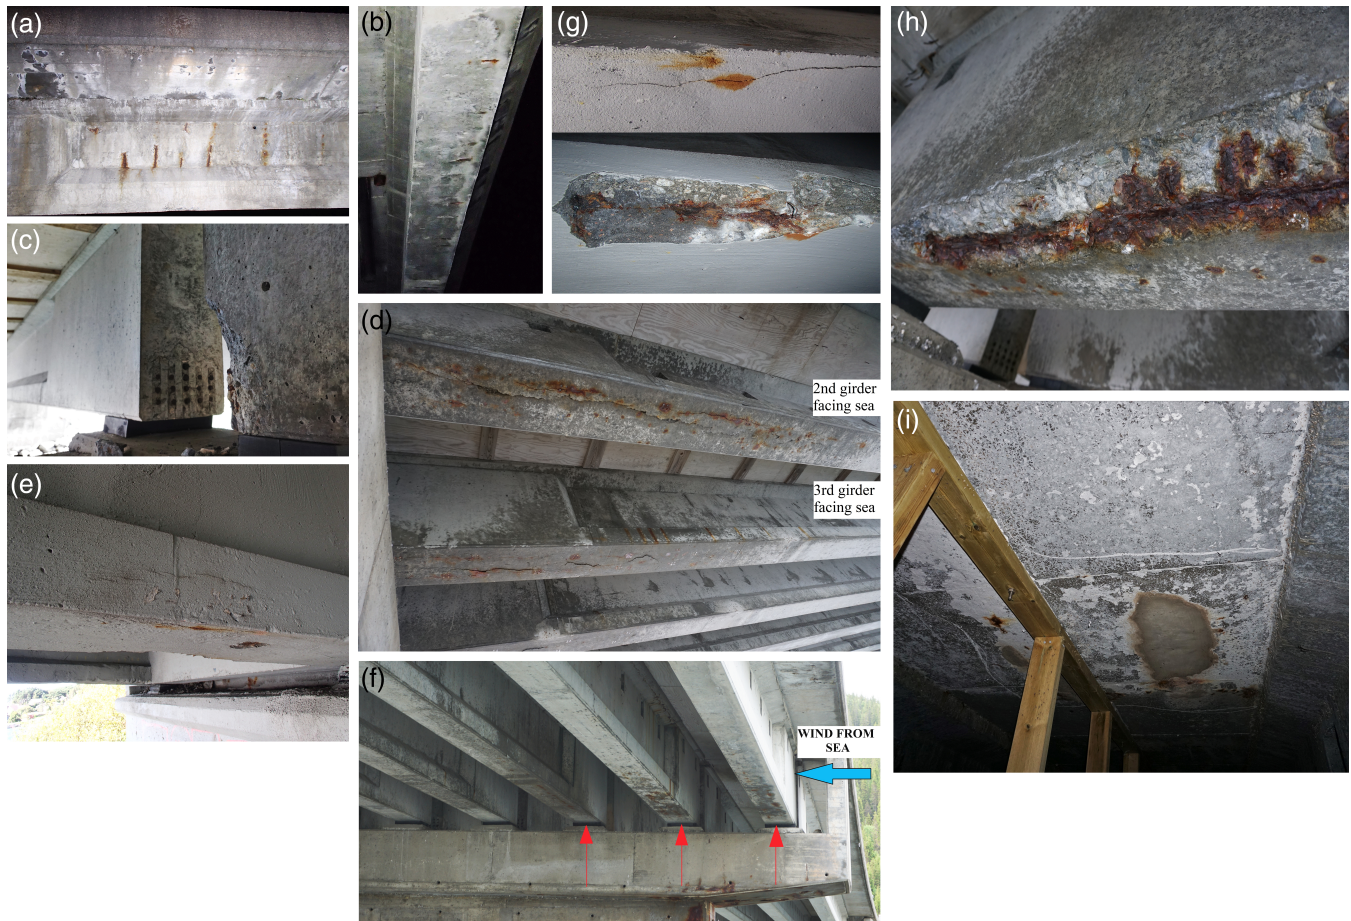
Our inspection of NIB girder bridges revealed corrosion in NIB girders, for both stirrups and pretensioning strands. Most of the damage we saw corresponded well to the damage reported in BRUTUS¹ for these and other bridges. Examples of typical corrosion damage are shown in photos taken on four bridges (see Figure 12). Corrosion of the shear reinforcement with very low concrete cover (0–5 mm) was probably induced by carbonation or an atmospheric exposure. It extended to a considerable length of the bars and along a great part of the girder span (see Figure 12a,b). The remaining ordinary reinforcement with too little concrete cover is probably corroded due to high chloride content. Lack of concrete cover on the NIB girder-ends led to strand

corrosion and concrete spalling just behind the support plates (see Figure 12c).

The visual damage caused by chloride-induced corrosion was in localized areas, mostly in the bottom flange of the NIB girders (see Figure 12d–f). The most severe corrosion damage was on the inner NIB girders, typically on the second and third ones from the windward side (see Figure 12d,f). Corrosion stains, cracking, and concrete cover spalling were also seen in the bottom surface of the outermost NIB girders. Moreover, most of the corrosion damage was usually in the girder's support-zones and their close vicinity (see Figure 12d–f). This suggests high corrosion risk in these areas.

FIGURE 12 Typical visual corrosion damage in pretensioned NIB girders (a–i)

In girders produced without additional mounting bars supporting the stirrups, corrosion of the strands closest to the concrete surface produced rather horizontal and relatively short cracks. These cracks followed the location of pretensioning reinforcement and were not accompanied by extensive corrosion stains on the concrete surface (e.g., in Hafrsfjord Bridge) (see Figure 12e,g [upper photo]). The concrete cover was removed at several places on selected girders and corrosion on strands and stirrups was detected (see Figure 12g [lower photo]). Moreover, when we removed the

In girders with horizontal mounting bars, corrosion attacks these first (see Figure 12h). The corrosion usually produces two cracks following the location of the bars, and slightly more widespread rust stains on the concrete surface. Nevertheless, the visual damage is still rather local and mostly limited to the girder's support-zones.

The corrosion in the slab of Hulvåg Bridge was found by the NPRA in earlier inspections and treated with patch repair (see Figure 12i). During our inspection, we found new large areas in close proximity to the repairs with corroding reinforcement (marked with white lines in Figure 12i). This confirms that repassivated reinforcement in the repaired areas might accelerate corrosion in adjacent, unrepaired places.³⁰

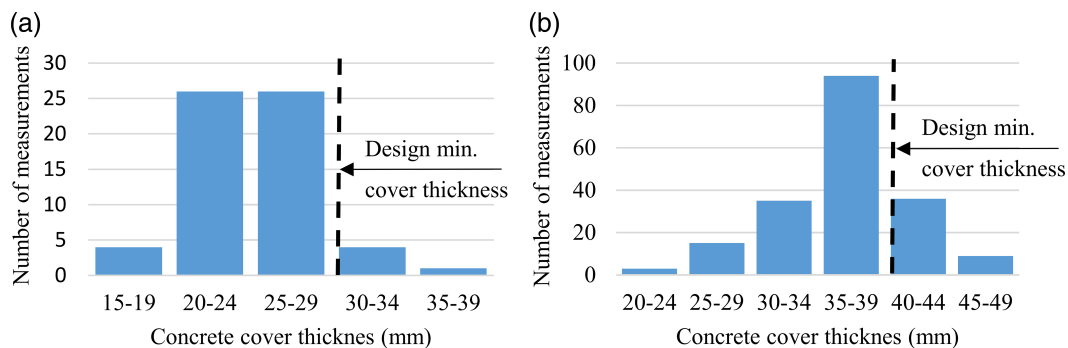
Generally, we found that the concrete cover thickness over the stirrups could differ considerably from the requirements according to the valid standards for the design year. For example, the measurements taken on stirrups in Hafsløf Bridge girders revealed a cover thickness as low as 40% of the design requirement (see Figure 13a). In Dalselv Bridge, about 77% of measurements detected inadequate cover thickness (see Figure 13b). The concrete cover over pretensioning strands should vary less because they are anchored in fixed positions before casting.

FIGURE 13 Variation in the concrete cover thickness over stirrups in the NIB girder webs. (a) Hafrsfjord Bridge. (b) Dalselv Bridge

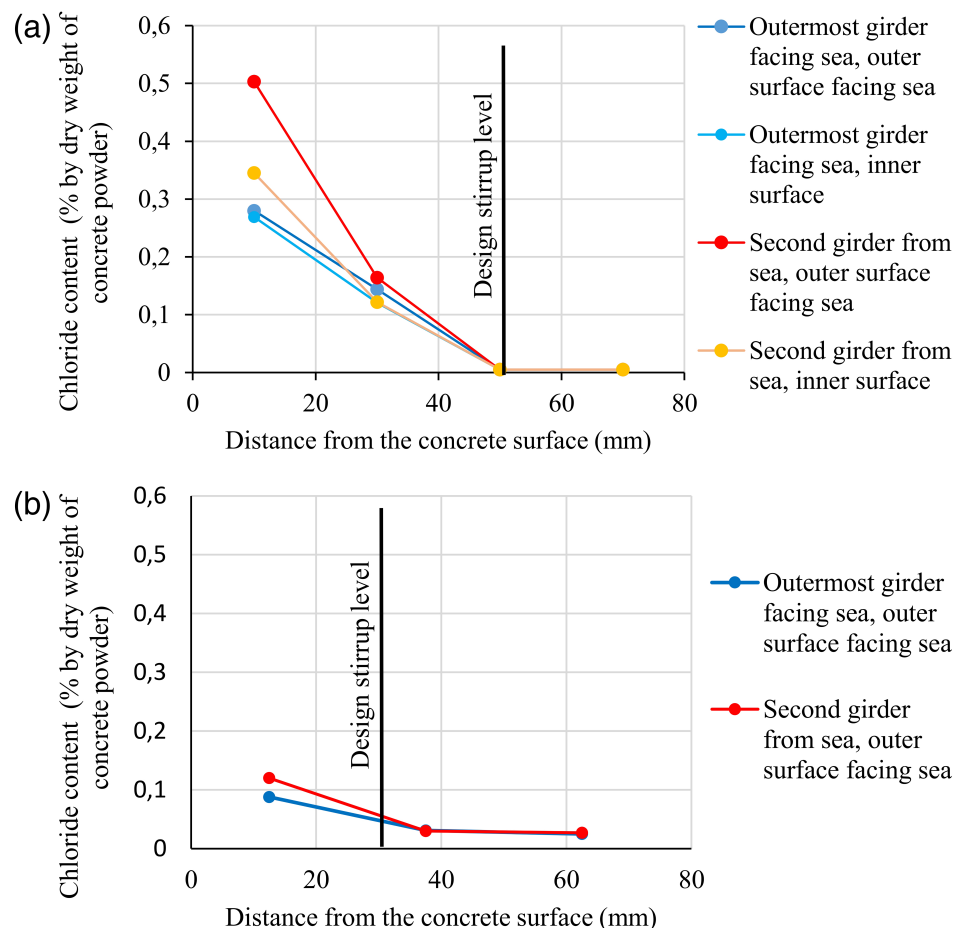
FIGURE 14 Chloride profiles of NIB girder webs of two bridges at different heights above sea level located in the harsh coastal zone. (a) Hulvåg Bridge: NIB girders at about 5.8 m above sea level. (b) Hafrsfjord Bridge: NIB girders at about 12.0 m above sea level (based on NPRA data²⁸)

The chloride content at the reinforcement level in Hulvåg Bridge was close to zero, so corrosion is not expected in the NIB girders, which corresponds well to our field observations.
