Main Functional Elements Having Defects of Illegal Residential Buildings: The Case of Cova da Moura District

ABSTRACT

The defects were identified during a survey to the building stock of the Cova da Moura District (Amadora, Portugal), carried out in 2008. This district is made of illegal constructions, occupies an area of 16.5 ha and has approximately 5,000 inhabitants. During the survey 833 buildings and 1884 units were inspected.

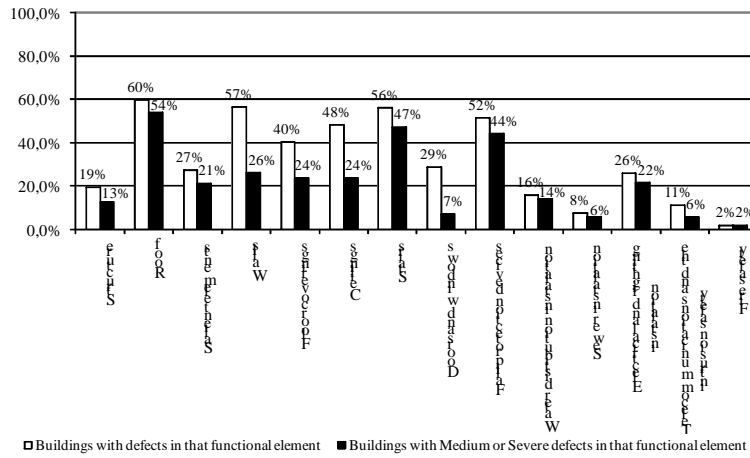
elements the gravity of the defects observed was classified as ‘Medium’ or ‘Severe’ (Fig. 1), setting up situations where the use of spaces as well as comfort, safety and health of users are affected.

Figure 1. Distribution of defects in the functional elements by gravity.

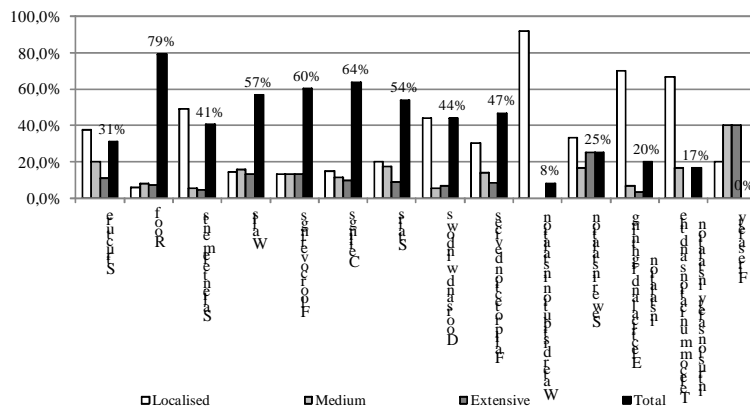
It should also be noted in a large percentage of cases where the defects occur most elements need extensive or total repairs (Fig. 2). This fact, along with the complexity (Fig. 3) and cost of the rehabilitation intervention, shows that even in functional elements that have low defects rates, such as Structure (19%), the extension and the complexity of the intervention must be taken into account.

Figure 2. Distribution of defects in the functional elements by extension of the intervention.

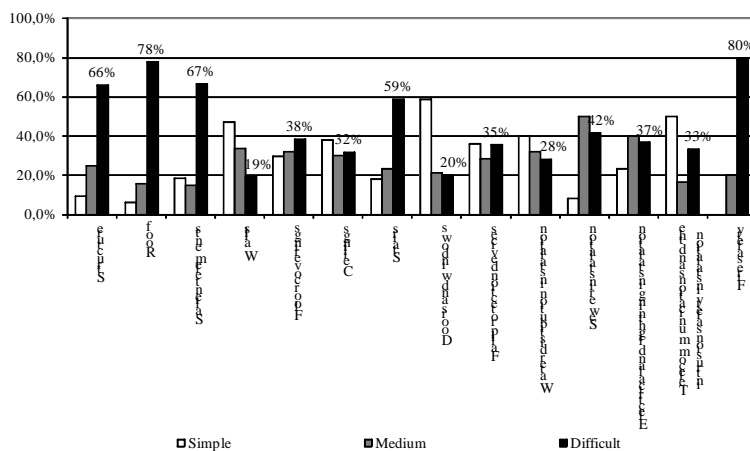
Figure 3. Distribution of defects in the functional elements by complexity of the intervention.

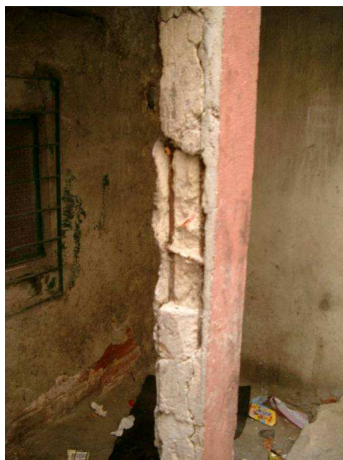
In the case of the functional element *Structure*, although the results of occurrence of defects show a reasonable maintenance condition of structures, building structures with damaged elements (Fig. 4) or lack of mechanical resistance were found. It is recalled that the survey was done by means of visual inspections, registering only the visible defects through evidences either in structural elements or other elements that could be affected by the structure, like walls.

Figure 4. Column with detached concrete covering and insufficient transverse reinforcement.

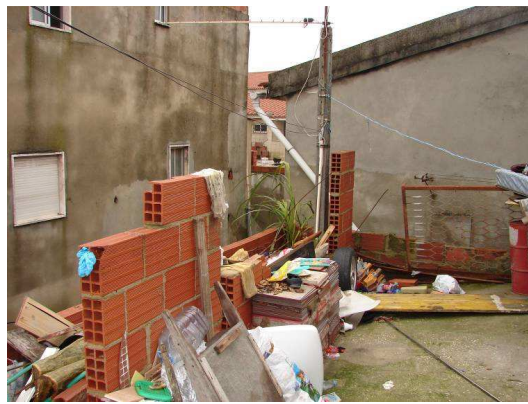
Roof is the functional element that contains defects in a larger number of buildings. This fact is associated with a high rate of cases requiring total assistance, or complete replacement of the existing system. Being an element of the building envelope it is a constructive element with great impact in the living conditions, contributing to the occurrence of many defects in other functional elements (e.g., walls, ceilings, electrical installation). Many of the observed defects are often due to lack of completion in case of flat roofs (Fig. 5), poor construction quality, particularly in pitched roofs, and lack of maintenance and repair works. In the functional element *Stairs*, it was observed stairs are frequently built in places with very small areas, and are often unfinished (Fig. 6); many of them present serious defects both at constructive and dimensional level.

Figure 5. General appearance of a flat roof, without thermal insulation, waterproofing or any coating.

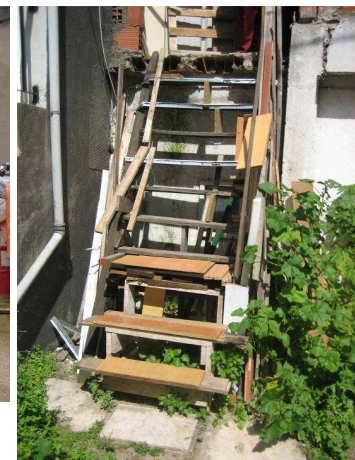
Figure 6. Stairs of poor construction quality.

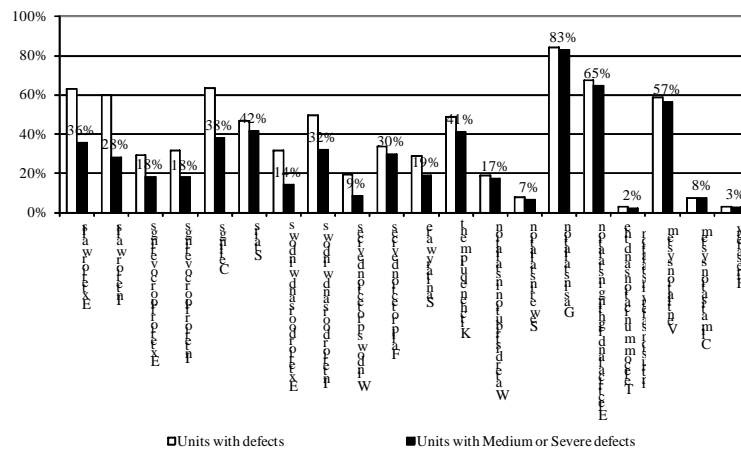
A large number of defects were found in the different functional elements. In more than 50% of the units it was possible to find defects in the following functional elements (Fig. 7): External walls; Internal walls; Ceilings; Gas installation; Electrical and lighting installation; and Ventilation system. In some of these elements (e.g., Stairs, fall protection devices, kitchen equipment, gas installation, electrical and lightning installation, ventilation system), most defects are of ‘Medium’ or ‘Severe’ gravity (Fig. 7), with serious consequences to users’ comfort or health and safety.

Figure 7. Distribution of defects in functional elements by gravity (units).

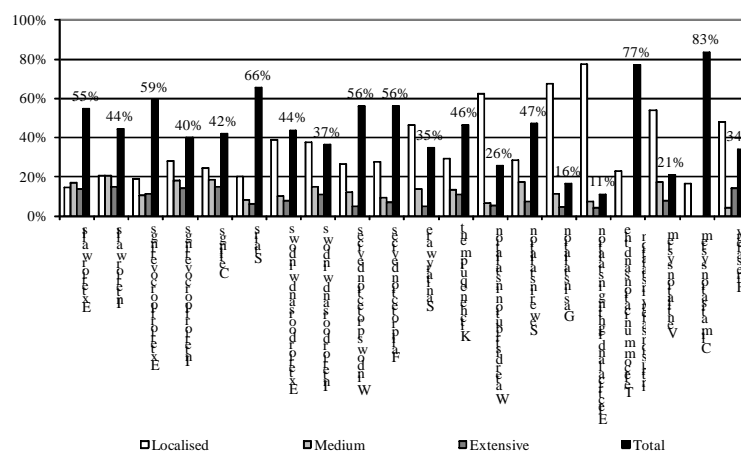
Taking into account the extent (Fig. 8) and complexity (Fig. 9) of the rehabilitation works needed, that there are more functional elements requiring attention than those mentioned, like the water distribution installations or the sewer installations, that present serious need for rehabilitation. A good portion of the dwellings had no kitchen equipment or a defined space for preparing meals, the usual being to use a makeshift space for this purpose.

Figure 8. Distribution of defects in functional elements by extent (units).

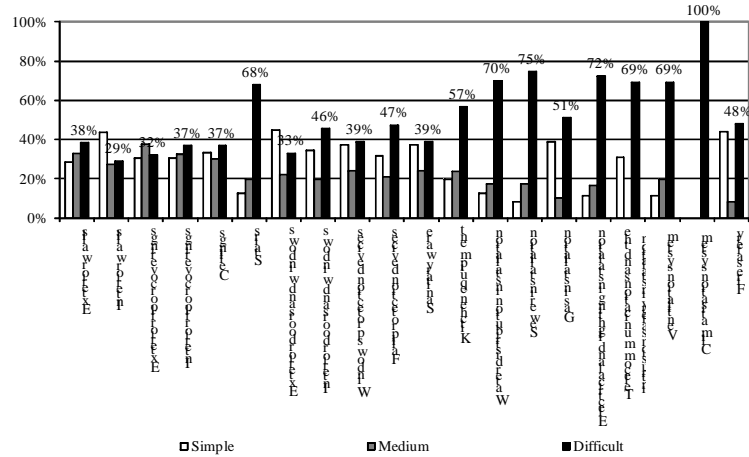
Figure 9. Distribution of defects in functional elements by complexity (units).

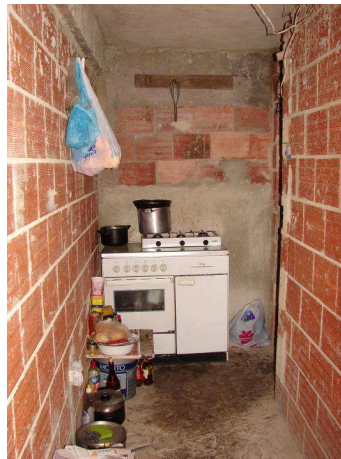
Figure 10. Improved kitchen.
