2024

Journal of Flood Risk Management

Field survey assessment of flood loads and related building damage from the July 2021 event in the Ahr Valley (Germany)

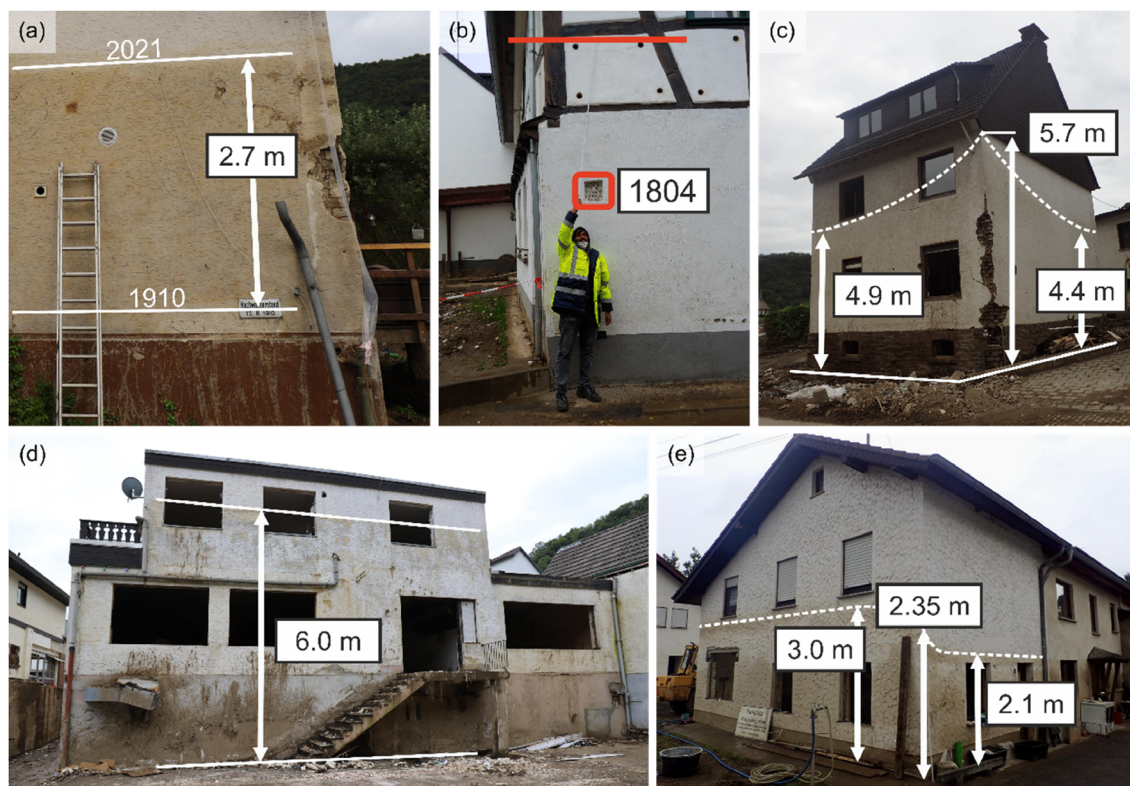
Data showed a large variability of water depths throughout the Ahr Valley, with some villages revealing values substantially higher than others. In particular, the highest values were observed in Altenahr, where water depths exceeded 7 m for the houses closer to the river, while the lowest ones were recorded in Liers and Honningen, with values of 1.4–1.5 m. Such variability is likely associated with: (1) the topography of the region and (2) the local hydrodynamic conditions of the flow during the flood. In particular, the narrow portions of the valley

FIGURE 3 Watermarks in the Ahr Valley: (a) Ahrbrück; (b) Walporzheim; (c) Altenahr; (d) Altenahr; (e) Schuld; (c) and (e) have a non-uniform distribution of water marks on buildings during floods; (a) provides a comparison of the 2021 flood with the extreme event of 13 June 1910, while (b) shows the difference between the 1804 and 2021 floods.

Figure 3c showcases a debris impact on a building, suggesting that the affected corner corresponded to the most upstream edge. The building also shows small impacts near the window openings on the ground floor. Presumably, repeated collisions progressively dislodged the old concrete masonry units and failure was exacerbated by the flow erosion of the joints, which led to the

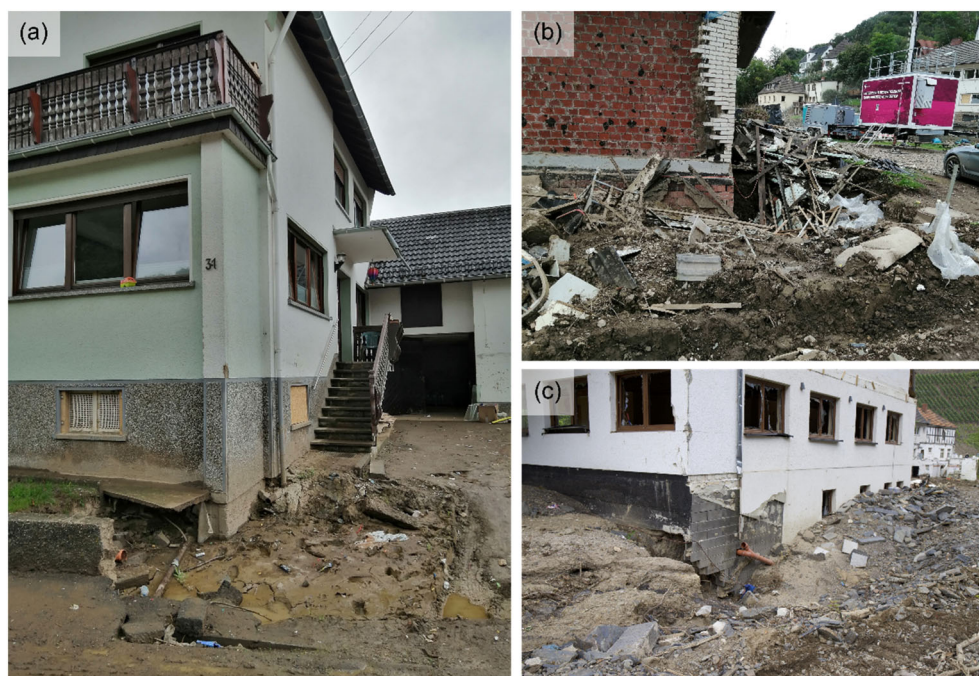
FIGURE 4 Scour at various buildings corners in: (a) Schuld; (b) Altenahr; (c) Marienthal.

Nevertheless, it was observed that in most cases, the scour at the corners did not affect the building's stability since it was not deep enough to reach the foundation (Figure 4). However, the spatial variation of the depth of the scour holes also confirmed the uneven distribution of pressures and increased flood loads on buildings (ASCE 7, 2017; FEMA, 2007), as shown in Section 4.2. For shallow slab or strip foundations, in some cases, the scour depth exceeded the foundation depth (Figure 5). Thus, once the scour reached the foundation, the continuous high-velocity flow likely started undermining the soil under the foundation slab, resulting in an overhanging or a partially supported slab. Nevertheless, the buildings remained stable despite the flood heavily damaging the upper timber storey (Figure 5b).

During the inspection, scour depths of 0.5–1.5 m were frequently observed at building corners, with scour lengths ranging from 1.5 m to 2.5 m (Table 2). Further attempts were made to compare these values with existing empirical equations. For that, the bridge pier equation reported by Richardson and Davis (2001) and Arneson et al. (2012) in HEC-18 (*Evaluating scour at Bridges*) is used, similar to the approach of Bricker et al. (2012) for tsunami-induced scour. Flow parameters

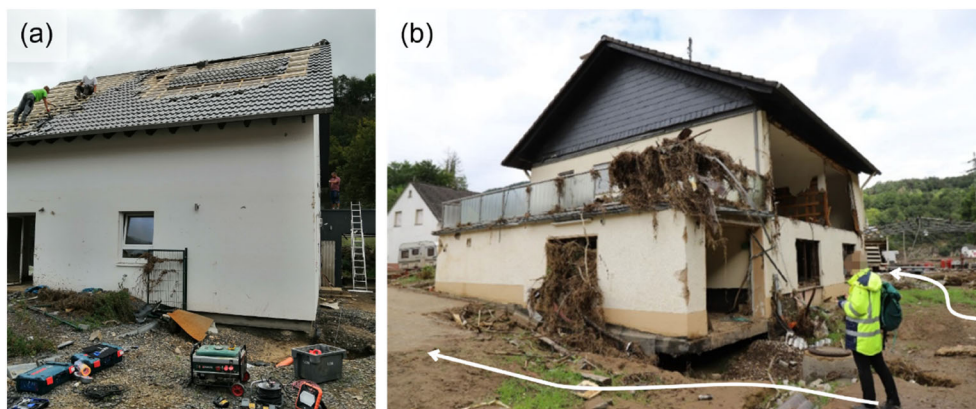
FIGURE 5 Damaged building in (a) Kreuzberg and (b) Brück, where scour at the corner reached the foundation. In (b) debris accumulation can also be observed.

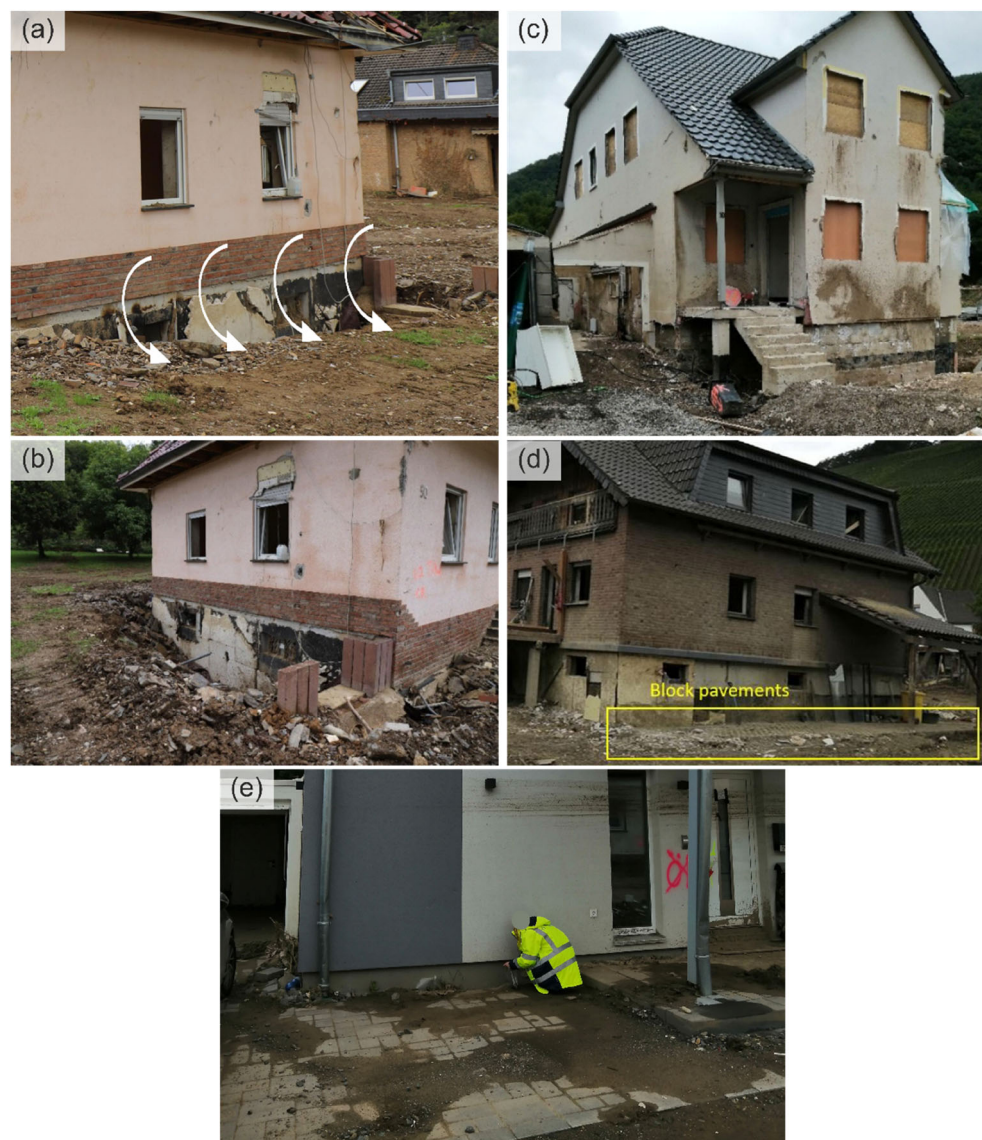
At a few locations, the scour occurred at the front of the building, where the upstream recirculation dug a large amount of material, with a comparatively smaller soil removal along the sides (Figure 6). This pattern aligns with the experimental observation of tsunamis interacting with squared buildings (see figs. 7 and 11 in Mehrzad et al., 2022). This type of scour was found in front of buildings that are un-sheltered (or partially sheltered) by upstream elements, and this pattern is known to depend on the ratio between building width and flow

FIGURE 6 Examples of scour around buildings due to the formation of horseshoe vortex. Figures (a) and (b) were taken in Brück (same building, front and side view), Figures (c) and (d) were taken in Marienthal with (d) and (e) showing scour protection by block pavement; Figure (e) was taken in Kreuzberg.

Figure 6d shows a building on the Marienthal flood plain, where scour would be expected, in line with neighbouring buildings. However, observations revealed no scour-hole around this building, where block pavements likely prevented soil removal. Similar observations were made at several locations (e.g., Figure 6e). Although the pavements were partially broken at a few sites, they still protected the buildings against scour and served as a first layer of protection. The use of revetments for scour and riverbank protection is not new, and deep-routed grass and block pavements have been widely suggested in the past (Gray & Barker, 2004; Julien, 2002). However, these field observations confirmed the effectiveness of these scour protection measures during floods, stressing their importance for flood protection and risk mitigation.

- Revetment and pavements proved to be effective scour protection measures (Julien, 2002). These should be combined with deeper or piled foundations for buildings located near the river to combat bank erosion. Green infrastructures (i.e., grass and trees) were insufficient to prevent damage during this extreme event. Buildings at the extrados and intrados of river bends deserve particular attention.

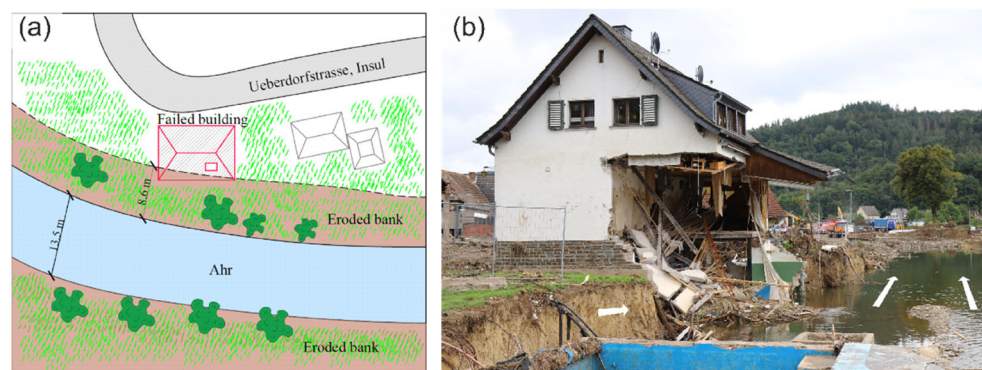
Buildings adjacent to the river suffered largely from bank erosion. The sustained water levels and high velocities removed a significant portion of the river bank, which could not be prevented despite the protection with natural vegetation, including grass and trees (Abernethy & Rutherford, 1998; Gray & Barker, 2004). Locals reported that after the flood the river had doubled its regular width at many locations. In addition, bank erosion reached many buildings adjacent to the river, compromising their foundations. Since most buildings in the Ahr Valley have one or two storeys, the common type of foundation observed was shallow foundation,³ including isolated footings, strip footings or slabs. Shallow foundations transfer building loads to the earth near the surface rather than deeper soil or rock strata. This means that bank erosion often daylighted these shallow foundations, resulting in sizeable structural failures. A typical example is shown in Figure 7b, where a concrete strip footing of approximately 1.2 m was exposed below the basement, triggering the failure of part of the building (Korswagen et al., 2022). Note that despite the grass protection, the bank erosion extended inland for approximately 8.6 m, based on pre-event satellite imagery on

FIGURE 7 Bank erosion-related failure in Insul. Sketch (a) is based on satellite imagery from Google Earth on 24 March 2020; (b) image taken during the suvery.

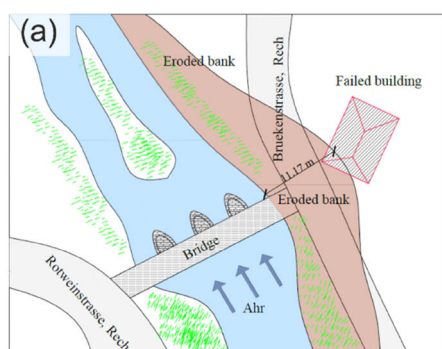
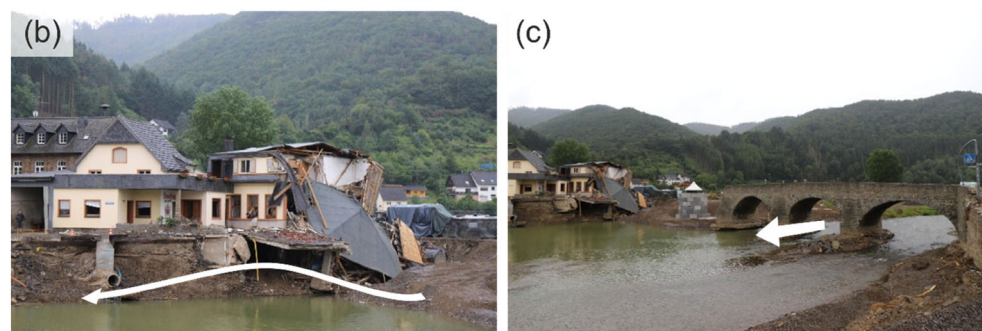
Field observations showed that bank erosion intensified at extrados (outside) of river bends and where the flow was obstructed. Studies by Wu and Molinas (2005) showed that a significant obstruction of the flow (e.g., bridge piers) can trigger a choked flow regime, resulting in higher upstream water levels and higher flow velocities around piers. One example was found in Rech, where the upstream bridge obstructed the flow (Figure 8), probably increasing the downstream flow velocity and resulting in considerable bank erosion with the collapse of one pier (Figure 8c). The building in Figure 8b was constructed at the extrados of the river bend, and the exposure of its simple-footing foundation due to bank erosion prevented any load transfer to the soil. The lack of support for the overhanging part of the superstructure led to the failure of both structural and non-structural members, emphasising the need for deeper foundations near riverbanks. According to BMUB (*German Federal Ministry for the Environment, Nature Conservation, Nuclear Safety and Consumer Protection*), building foundations should be at least 1 m below the expected erosion and scour depth. Preferably, shallow foundations should be replaced with pile foundations in future constructions, especially for buildings near river bends and in proximity of bridges. Furthermore, it is worth mentioning that bridge piers and abutments were also affected by scour at many locations (Figure 8c).

FIGURE 8 Bank erosion related failure in Rech at the extrados (outside) of river bend due to flow obstruction of the upstream bridge. Sketch (a) is based on satellite imagery from Google Earth on 24 March 2020.

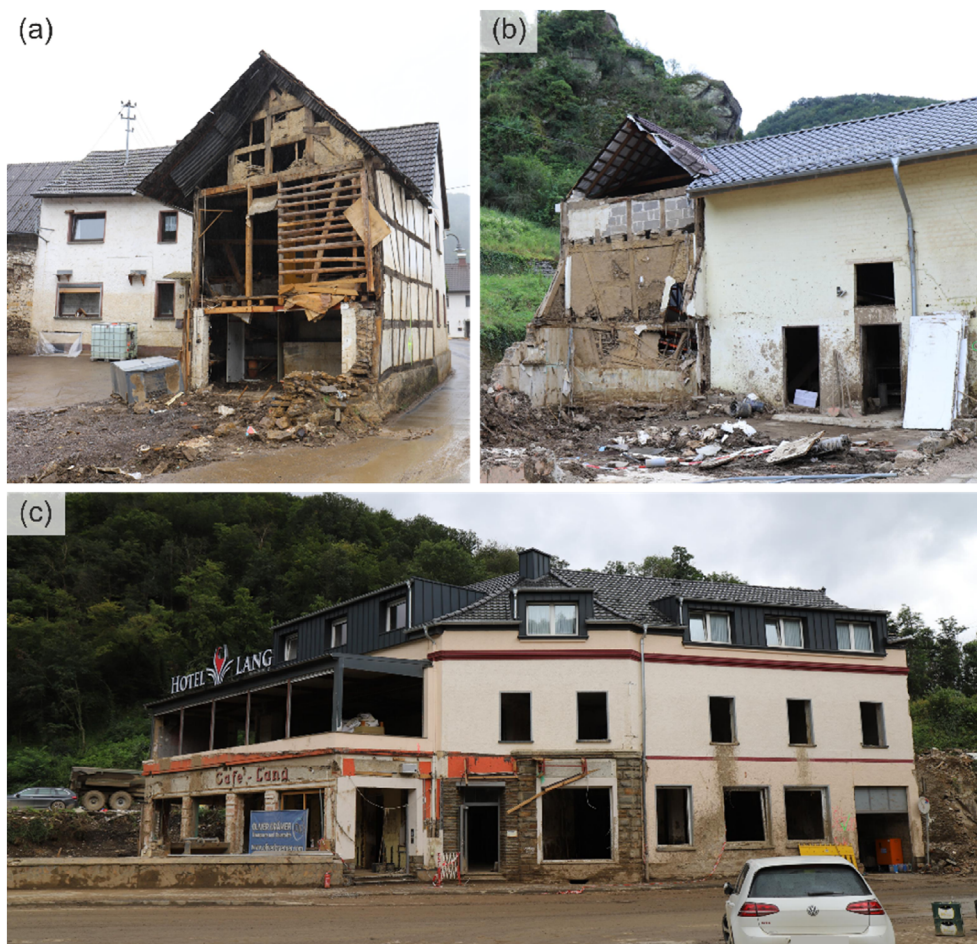
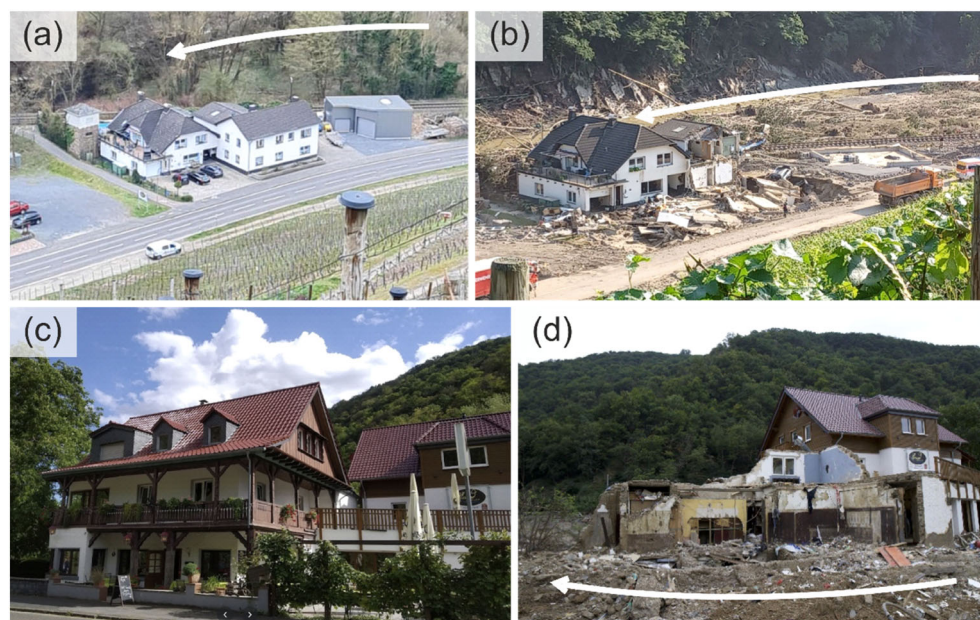
FIGURE 11 Figures (a, b) show a failure due to buoyancy and horizontal loads in Marienthal, and the floor plan layout; (a) before flood; (b) after the flood. Figures (c, d) show the failure of the L-shaped floor plan layout; (c) before flood; (d) after the flood [Source: (a, b) Photographs by Moni Körtgen, house owner. (c) Google photos; photo courtesy of Heidi Möller on August 2020. Date accessed: 30 August 2022] (Möller, 2020). Arrows indicate presumed flow direction.

A critical load during floods is buoyancy, which tends to uplift and destabilise structures. Many buildings in the Ahr Valley are constructed with timber and lightweight materials, which were particularly affected by the buoyancy-induced vertical loads associated with the high water levels. Figure 11a,b presents an example that occurred to the first ‘un-sheltered’ building upstream of Marienthal. An eyewitness reported that part of the building was initially sheared-off from the foundation and turned over by the water. This detachment could be linked to the large buoyancy force resulting from the rapid water level rise, while the movement of the building was likely associated with the strong momentum of the flow. Nevertheless, many buildings sustained the initial buoyancy loads since water entering the structures added weight to the building, inducing a stabilising effect. Such buoyancy effects can be threatening for buildings with large enclosed areas, facilitating uplift. Similar observations were also observed during tsunamis (Chock et al., 2013; Sundar et al., 2007) and in laboratory experiments by Wüthrich et al. (2018) and Harish et al. (2022a, 2022b).

Interestingly, the building in Figure 11a was built with an ‘L-shaped’ plan, which was severely damaged during the flood. Similar observations were made for other buildings (e.g., Figure 11d), suggesting that the L-shape layout generates large loads at the junction, due to flow accumulation and recirculation (Figure 11a). A specific analysis of pressure distribution for such layouts would be of interest to better understand the physical processes involved.

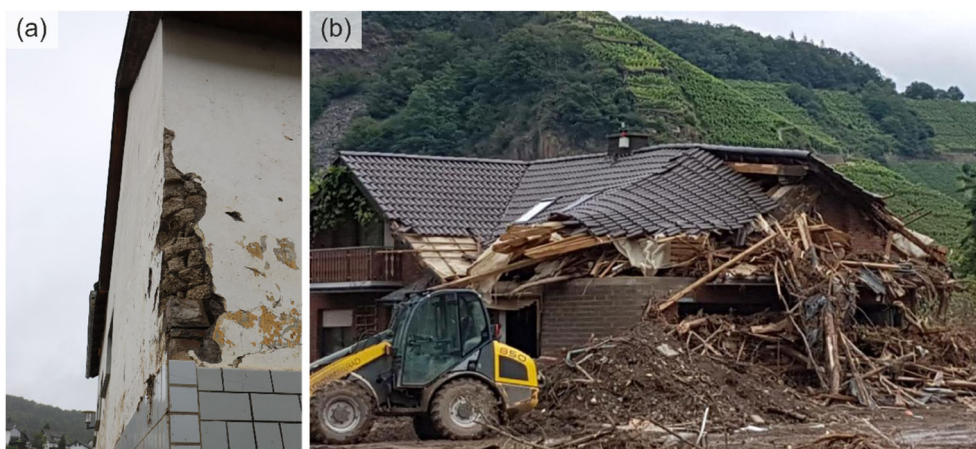
FIGURE 12 Damage associated with debris (a) marks on buildings by debris impact (Schuld); (b) debris damming around a building (Dernau).

located upstream of each village, which were often the most damaged (e.g., Figures 11b, 12b, and 15d,e) and the most affected by debris accumulation (e.g., Figure 12b). Similar observations were provided for tsunamis, where unshielded buildings near the shore are the most damaged (Moris et al., 2021; Pringgana et al., 2021). Similarly, for floods, Maiwald and Schwarz (2015) pointed out that the location of the building relative to the flow velocity vector (flow direction) and the urban integration had an influence on the structural damage, providing a simplified characterisation based on the arrangement of surrounding housing and flow characteristic. This highlights the importance of considering spatial planning as a tool to achieve community resilience and to limit building damage.

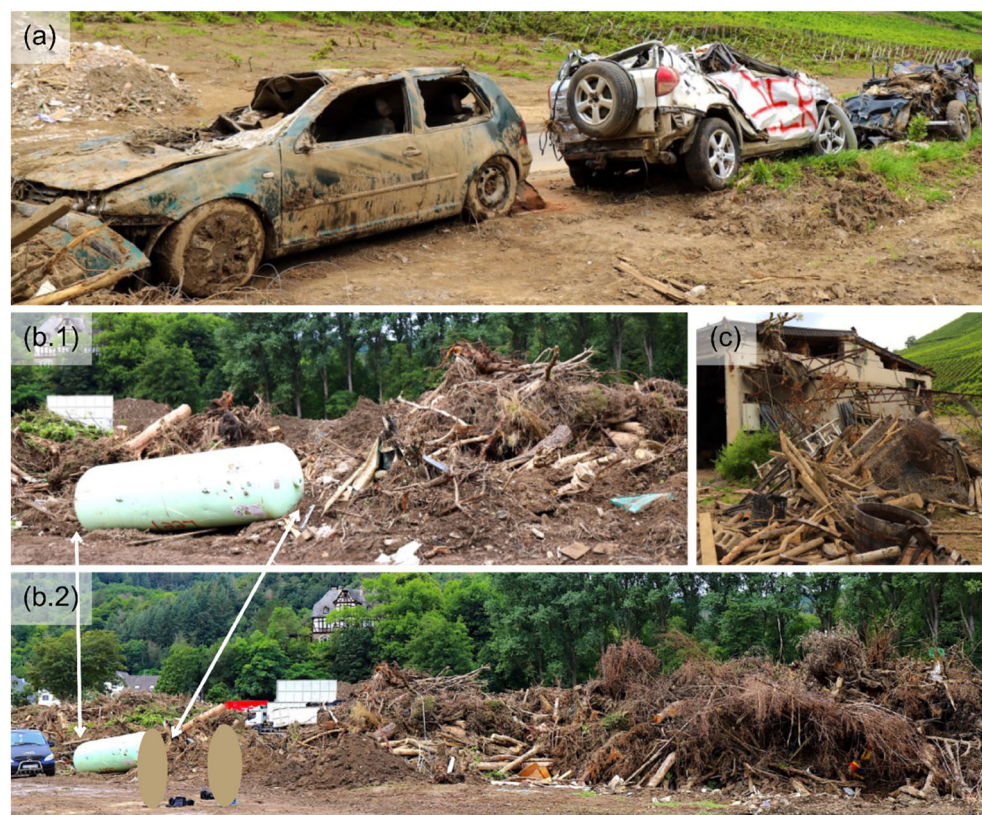
to damages to upstream buildings. Similarly, household and city appliances such as washing machines, (oil) tanks and furniture were often seen, together with benches and (farm or garden) fences. Additional large floating debris included vehicles such as bicycles, motorcycles, cars, motorhomes and caravans. Altogether, this man-made debris became entangled with the wooden debris (Figure 13), increasing the accumulation volumes.

FIGURE 13 Various types of debris: (a) cars dragged and rolled by the flood (Dernau); (b.1, b.2) car-sized tank among a large pile of woody debris (Kreuzberg); and (c) several timber items collected in front of a house (Kreuzberg).

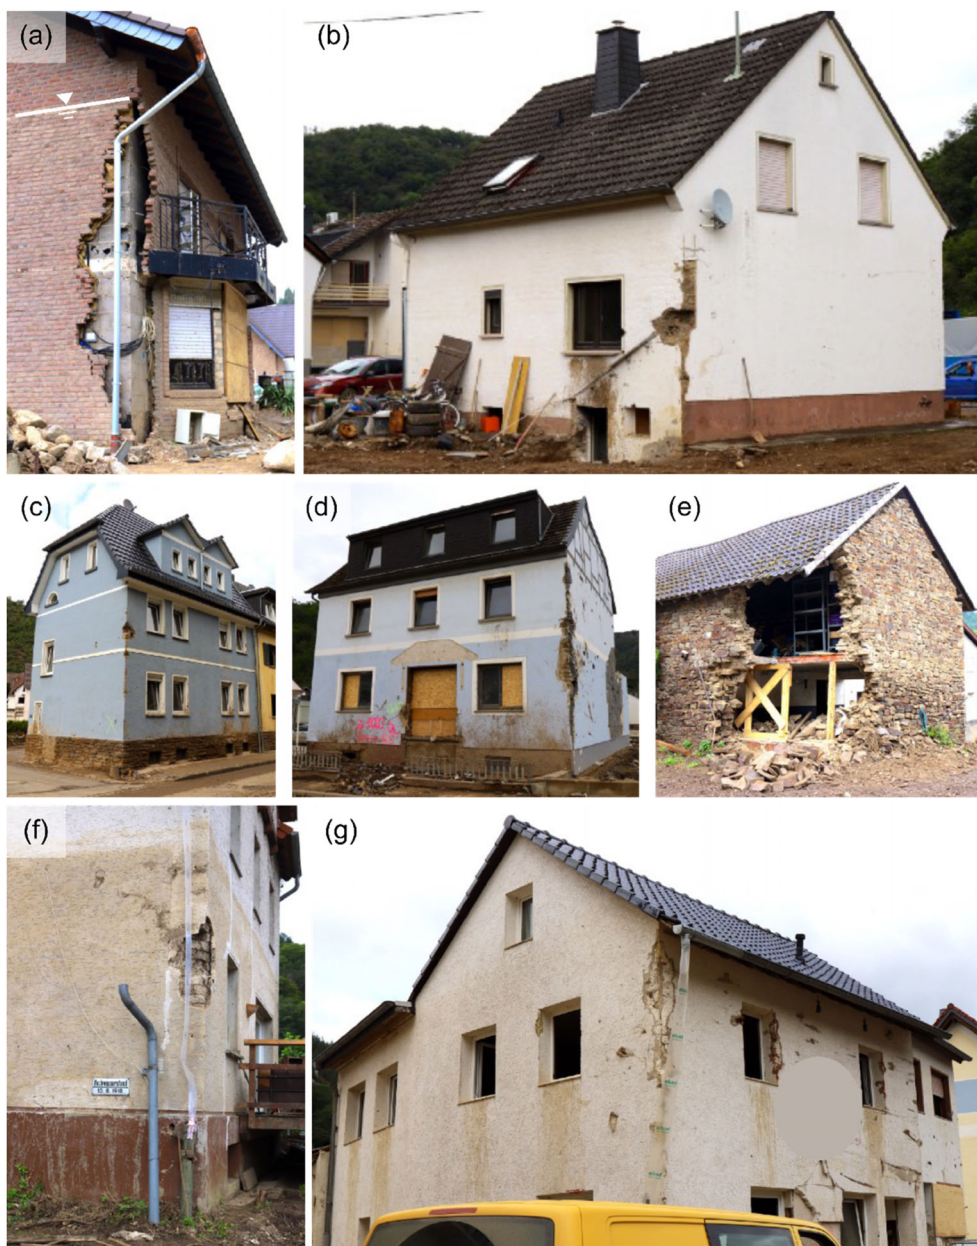
observed corner failure. Similarly, Figure 14a depicts a house with an outer veneer of fired-clay brick masonry which failed in the corner, presumably due to the impact of floating debris. The veneer was insufficiently supported by the inner structural walls of concrete blocks and floors; the ties, connecting both leaves of the cavity wall through the air or insulation chamber, are designed to provide stability and withstand wind loads. The examples provided in Figure 14c,d,f present traces of similar debris collisions on buildings edges, while Figure 14g shows additional impacts at window corners on the first storey. Finally, Figure 14e shows a traditional rubble stone masonry building, also revealing a structural failure, likely due to debris impact.

FIGURE 14 Damage and partial failures caused by the impact of floating debris, below the water-mark. (a) Dernau; (b) Altenahr; (c, d) Kreuzberg; (e) Schuld; (f) Brück; (g) Kreuzberg.

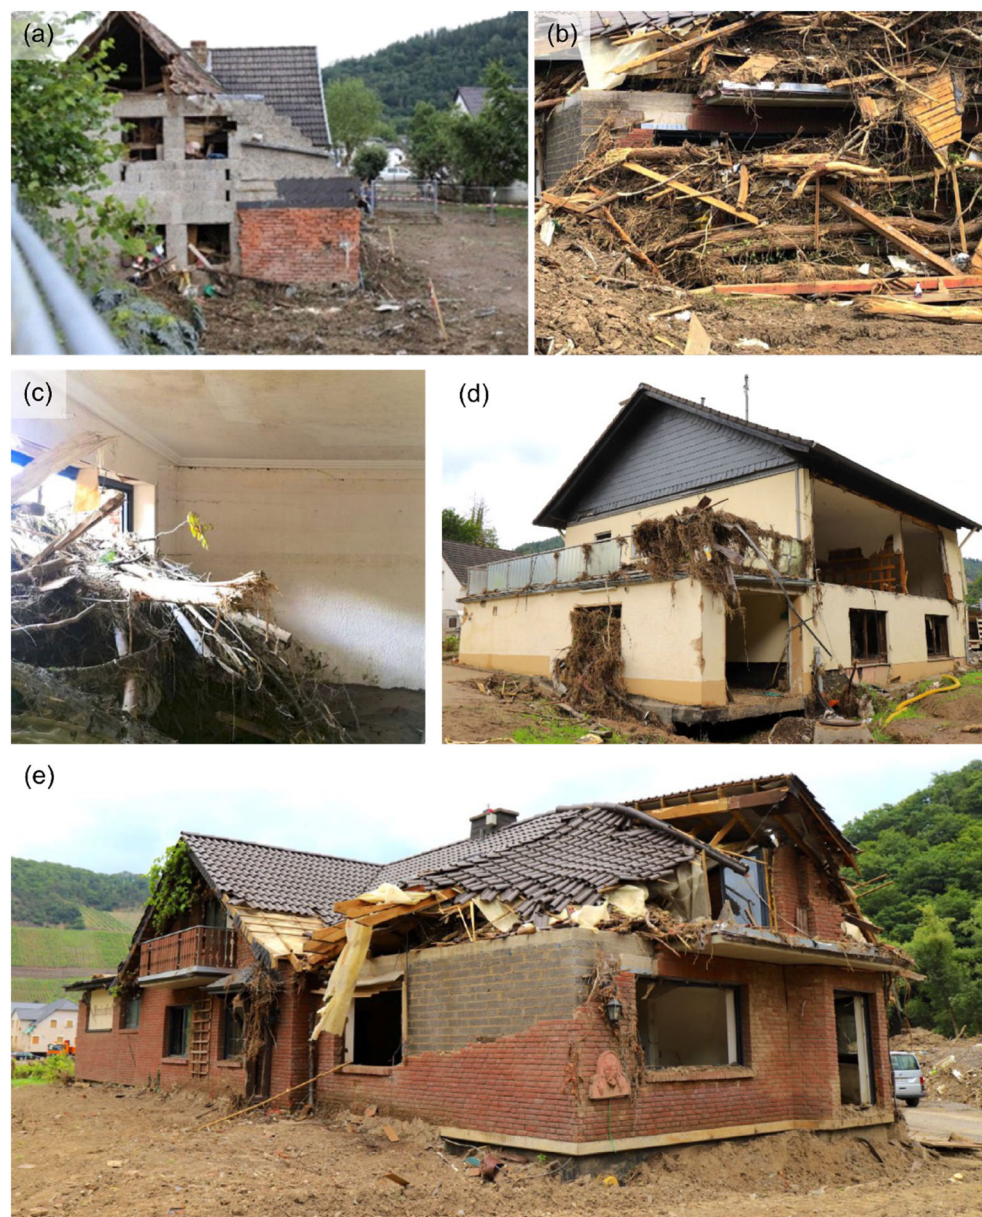
structure. This was shown in laboratory experiments by Stolle et al. (2018) and Wüthrich, Ylla Arbós, et al. (2020), confirming that woody debris forms a more compact and entangled dam, which blocks the flow more effectively in comparison with other debris, thus leading to a higher backwater effect. This resulting force may be sufficient to cause serious structural damage to the buildings, especially when the *debris-dam* pushes the roof, typically constructed of timber frames. Figure 15 shows locations, where debris around buildings had not yet been removed, visualising potential configurations of these dams. Figure 15e shows the damaged building after the debris was removed. Figure 15d depicts the debris accumulated in front and partly through an opening.

FIGURE 15 Photographs of remains of debris-dams accumulated at buildings. (a) Insul; (b, c, e) Dernau (same building); (d) Brück.

The survey showed that the structures most affected by debris-dams were located on the upstream end of each town. This is understandable since these structures acted as local debris collectors, therefore providing shelter to buildings located further downstream.

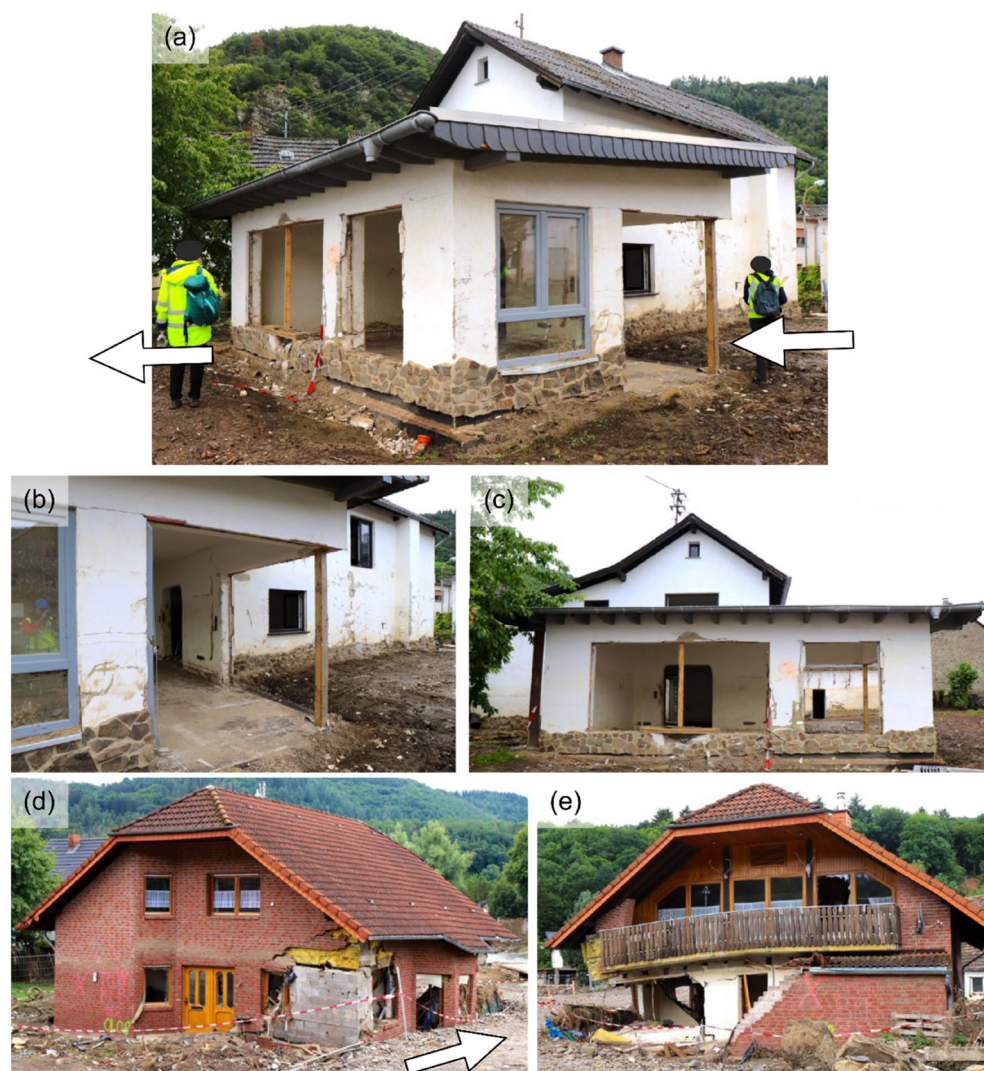
The survey showed that some structures suffered from inwardly collapsed columns or walls. Discussions with local witnesses revealed that large amounts of debris had accumulated against these structures. At the time of the survey, many (partly) collapsed buildings had already been removed, so it is not possible to comment on the flood action that led to failure. However, Figure 17 presents two examples where flood loads, presumably related to debris, affected columns. The first case (Figure 17a–c), shows two missing columns temporarily supported with timber poles. The column on the leading edge (Figure 17b) was surrounded by flowing water which favoured debris collision. After the failure of the column, the debris accumulated inside the structure and pressed against the other two (Figure 17c), with the left one collapsing. The remaining column showed outwards out-of-plane deformation, while in Figure 17b the remaining column showed an inwards deformation. Similarly, in Figure 17d, the flood led to the partial collapse of a masonry wall, which tilted forward due to the flood actions acting primarily near its base. At the back of

FIGURE 17 Building damage associated with the failure of single elements: (a–c) failure of a pillar in Schuld, likely associated with the debris reported inside the structure (removed, hence not visible in the picture); (d) wall tilting forward and (e) column missing at the corner in Insul. Red arrows indicate the suspected flow direction.
