Microstructure evolution and damage development in the rails of a single-track railway line after preventive grinding

Rail grinding
Single track
Damage
Rail steel
WEL
Rolling direction reversal
Corrugation

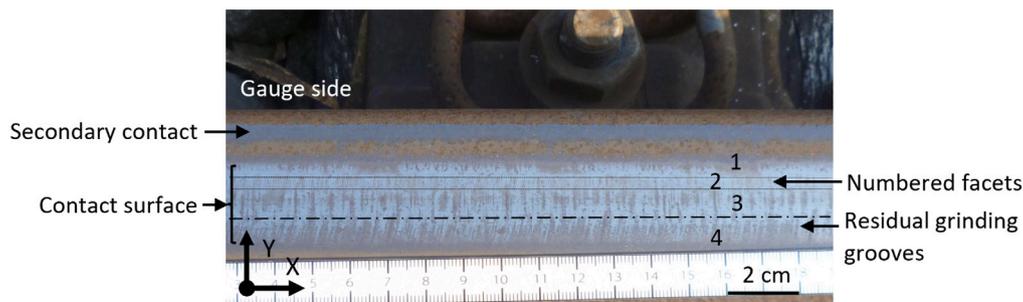
As a result of the preventive grinding maintenance in 2017, four facets are still present, which are numbered 1 to 4 in this study. The facets are distinguished by the partly worn grinding grooves and the smooth transition zones separating them. Facets 1 and 2, close to the gauge side of the rail, where the rail head radius is small, have a width of 4 mm and 3 mm, respectively. Facets 3 and 4 have a width of 8 mm

Fig. 3. Railway track construction and characteristic contact surface, just before rail sample extraction in 2020. The numbers indicate the ground facets at the contact surface.

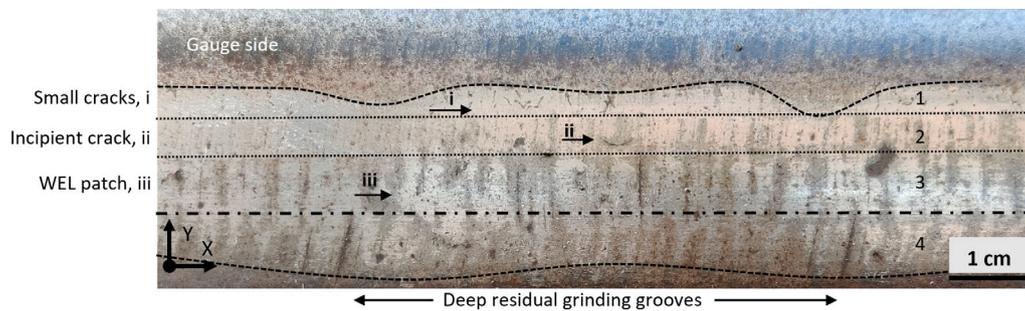
Fig. 4. The rail contact surface as a result of the preventive grinding and wheel–rail contact. The deviations in the contact surface width are depicted with dotted lines. The ground facets are numbered 1 to 4. Small cracks are present at facet 1 (see *i*), an incipient crack at facet 2 (see *ii*), and WEL at facet 3 (see *iii*).

Fig. 4 shows a detailed observation of the contact surface in which the facets are also indicated. At the gauge side, next to facet 1, repetitive, localized waves, with an interspacing of 49 ± 2 mm are present. These localized waves are typical for the surface of the rail sections in this study. The surface corrosion visualizing the waves is the result of the absence of wheel contact and is most likely caused by local deviations in the rails' longitudinal profile. The darker spots, outside the contact surface at the gauge side, are formed by repetitive patches of corroded grinding grooves.

At the field side, next to facet 4, a more gradual wave is observed and depicted with a dotted line. A repetitive pattern of notch-like residual grinding grooves decorates the widest points. The notch spacing is 57 ± 1 mm and represents the characteristic length of the preventive grinding process performed at 12 km h^{-1} with a grinding train equipped with 64 grinding motors each operating at 3600 rpm.

The facets 1 to 4 differ in the depth of the remaining grinding grooves. At facet 2 and especially facet 1, the surface is smooth and the grinding grooves are only recognized by a repetitive pattern in gray or as very shallow wrinkles. At the surface of facets 3 and 4 the pattern is clearly present and some deep, black colored residual grinding grooves are observed.

The damages in the surface of facet 1 are small and show a variety of orientations, whereas in facet 2 a larger incipient crack is observed, indicated with *ii*. Fig. 4 shows that the incipient crack is positioned close to the facet transition zone and between the deep residual grinding grooves at the gauge side of the contact surface.

The incipient crack has initiated in the valley of the corrugation wave at the running surface, as shown in Fig. 4. Wild et al. [42] showed that wheel–rail contact in the valley zones results in lamellae that are strained parallel to the surface. Rolling contact fatigue cracks tend to initiate between these elongated lamellae. Simon et al. [7] studied the strain orientation within the rail steel to explain the incipient squat initiation position. They observed that the deformation underneath the contact surface is not uniform as a result of the shear orientation distribution in the wheel contact. Squats are found to initiate preferentially at positions where bands with opposing deformation orientations meet.

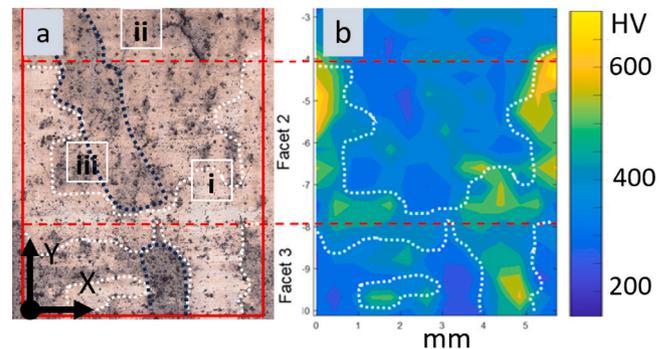
Fig. 5a shows that the residual grinding grooves are surrounded by load-carrying surfaces and that a continuous band of WEL, indicated with *i*, is formed at the facet transition zone between facets 2 and 3. The surfaces of the grinding grooves are darker as a result of the absence of wheel contact and damage initiations, indicated with *ii* and *iii*, are present in the grinding grooves in both facet 1 and facet 2.

Fig. 5b shows that large hardness differences are present in the rail surface, with strong gradients. The highest hardness of ~ 700 HV indicates the presence of WEL which is supported by the surface observations in Fig. 5a. The crack in facet 2 initiates at the edge of the residual grinding groove.

Fig. 5. Detail of the rail surface: (a) Load-carrying surfaces, on which WEL-stripes are present (see *i*), surround the residual grinding groove, highlighted with dotted lines. In the grinding groove damage initiations are present (see *ii* and *iii*). (b) The hardness distribution of that rail surface, showing the locations of lower hardness, the grinding groove (blue) and the locations with higher hardness and WEL (yellow/green). The regions where WEL is observed are outlined by the white dotted lines. (For interpretation of the references to color in this figure legend, the reader is referred to the web version of this article.)

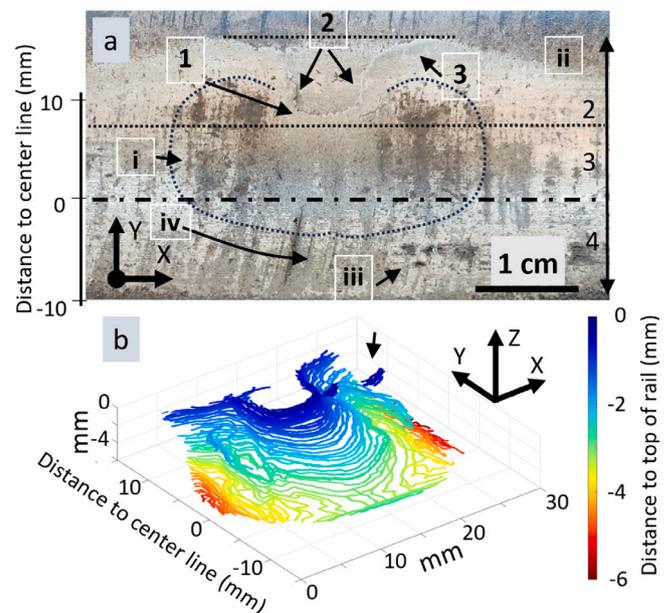
Fig. 6 shows a characteristic symmetric squat defect. Fig. 6a presents three of its distinguishing features: (1) the semi-elliptical crack tip with a length of 7 mm, (2) the parallel propagation paths towards the gauge side, and (3) the material extrusion at the side of the contact, where the crack deflects and becomes parallel to the running direction. All features are symmetrical in both running directions, with a slightly more pronounced development in positive *X*-direction.

Because of the defect size it is concluded that the damage initiation took place before the preventive grinding maintenance was performed. Cracks at the surface tend to shift towards the center line of the rail due to grinding. A displacement as much as 3 mm can occur [38]. The actual position of the semi-elliptical crack tip is close to the facet transition zone between facets 2 and 3.

Fig. 6a shows a dark spot that is formed at the rail surface (see *i*). Locally reduced contact allows for the build-up of intermediate surface layers to form the dark spot. It indicates, together with contact surface widening (see *ii*), the presence of a subsurface crack plane [35]. The increased wheel slip causes longitudinal slip marks (see *iii*), spalling, and

Fig. 6b shows the subsurface crack plane situated under the dark spot in Fig. 6a. Each line represents a crack contour observed at the milled surface. During each of the first 20 milling passes a layer thickness of 0.05 mm is removed, followed by 0.1 mm per pass until the crack was fully removed. Two additional superficial U-shaped cracks were found close to the crack tip, both initiated at a similar *Y*-position. These cracks are indicated by the arrow in Fig. 6b.

At a distance from the surface, $Z = -2$ mm, shallow crack branches are found. Crack branching and the subsequent development of parallel crack planes is a known propagation sequence [35]. These secondary cracks initiate at a later crack propagation stage. Therefore crack length and the distance to the surface are no indication for the moment of initiation.

The subsurface crack plane develops in $-Y$ -direction, towards the field side of the rail, and in both longitudinal directions. The saddle-shaped plane forms a plateau at a depth of $Z = -3.1$ mm and $Y = -2$ mm. Initially, the crack propagates at a high angle and then deflects to a shallow crack plane orientation of 11° . The crack plane bends upwards at the field side.

Fig. 6. A symmetric squat defect with semi-elliptical crack tip: (a) Three distinguishing features are indicated: (1) the semi-elliptical crack tip, (2) the parallel propagation paths, and (3) the deflection of the crack path. The dark spot (see *i*) is the result of intermediate-layer build-up and evidences the subsidence of the surface. The contact surface shows contact surface widening (see *ii*), longitudinal slipmarks (see *iii*), and spalling of material. The arrow indicates the probable wheel-contact displacement (see *iv*). (b) 3D-representation of the subsurface crack plane composed of all contour lines after surface milling. The arrows indicate crack initiations present at a similar transverse position.

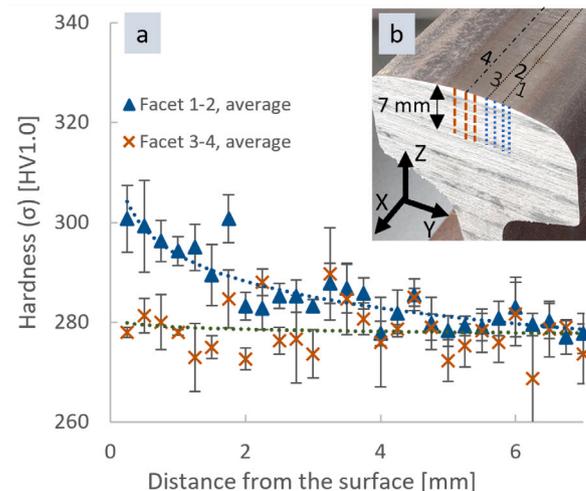
The hardness in facets 1 and 2 is 301 ± 7 HV close to the surface and decreases gradually to the measured bulk hardness at a distance of 5 mm. The hardness at facets 3 and 4 only shows an increase at a distance 3 mm to 4 mm while close to the surface no increase in hardness is measured. The hardness variation in the running surface is an indication of uneven contact stress distribution in the running surface. The subsurface increase is most likely caused by the maximum subsurface stress from the wheel–rail contact patch [4].

Fig. 7. The hardness distribution below the running band: (a) graph presenting the hardness measured on the cross-section of facets 1 and 2 in blue and facets 3 and 4 in orange. The hardness is measured from a distance of 0.25 mm to the surface, until 7 mm distance. (b) The location of the hardness indents on the cross-section. The colors correspond with the colors in the graph. (For interpretation of the references to color in this figure legend, the reader is referred to the web version of this article.)

Fig. 7 shows the hardness distribution along the contact surface. The bulk hardness of the R260Mn rail steel is $278 \pm 8 \text{ HV}_1$ and it is observed that the same hardness is present at facets 3 and 4. But in facets 1 and 2, where also numerous small surface cracks are observed, the hardness is higher. From the observed differences in hardness, and the observed microstructure deformation in facets 1 and 2, it is concluded that WL is higher in facets 1 and 2 compared to 3 and 4.

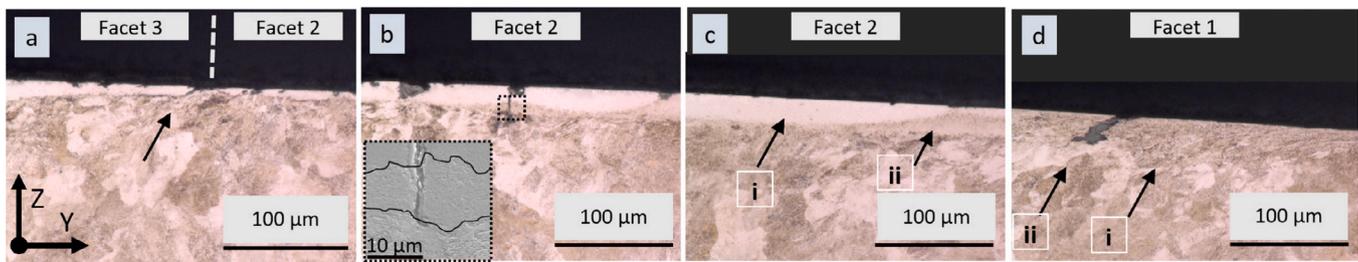
Figs. 8a–d show the cross-section of facets 1 to 3 to observe the surface, which is virtually free of corrosion, and the microstructure. Fig. 8a presents the facet transition zone between facets 2 and 3. Locally no WEL is present at the surface. The WEL detachment, indicated in the figure, forms a damage initiation site that has been reported in the literature [24,28,40].

Figs. 8b and 8c show the surface of facet 2. The lens-shaped WEL at the surface is embedded in a BEL, evidencing a history of slip events. The crack in Fig. 8b starts at a corrosion pit and propagates through these layers, but the stresses do not exceed the critical level to grow

In facet 2, close to facet 1, the lens-shaped WEL is partly embedded in BEL, which is in Fig. 8c indicated with *i* and *ii*, respectively.

Fig. 8d shows the surface of facet 1. This surface is WEL free and subsurface deformation is present. The deformation orientation is in Y -direction, towards the gauge side of the rail, see *i*, and the maximum depth of deformation is $\sim 50 \mu\text{m}$. The orientation suggests the presence

Fig. 8. Cross-section of facets 1 to 3 observed in X -direction: (a) At the facet transition zone between facets 2 and 3 is locally no WEL observed. WEL-detachment is indicated with the arrow. (b) WEL is present at the surface of Facet 2. The observed crack does not propagate into the bulk. (c) WEL is present (see i) and partly embedded in BEL (see ii). (d) Unidirectional deformation is present beneath the surface of facet 1 (see ii), and a superficial crack is present (see i).

of a shear stress component in the wheel–rail contact that points in that direction. The superficial crack, indicated with ii , is one of the many cracks observed in facet 1.

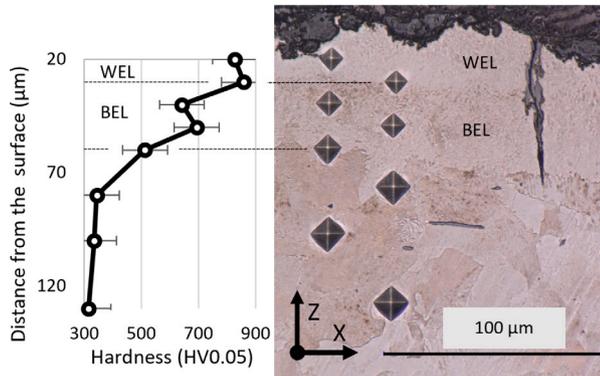
Fig. 9. Longitudinal section of Facet 2, closest to the facet transition with facet 3. A 80 μm corroded WEL and BEL is present at the surface. The graph presents the measurement results at the corresponding measurement positions.

Fig. 9 shows the micrograph of the surface condition in facet 2, closest to the transition to facet 3. Although the WEL surface is corroded, the presence of thick WEL and BEL indicates a history of wheel slip events. The total thickness of WEL and BEL is $\sim 80 \mu\text{m}$, allowing hardness measurements to be carried out. The hardness of the WEL is 828 HV, which increases to 859 HV at the WEL–BEL interface. The hardness of the BEL is significantly lower, between 650 HV and 700 HV. WEL and BEL layers are prone to crack initiation [23,31,40]. In this micrograph a crack is present, which is one of a group of closely clustered cracks. None of these cracks propagates into the bulk material.

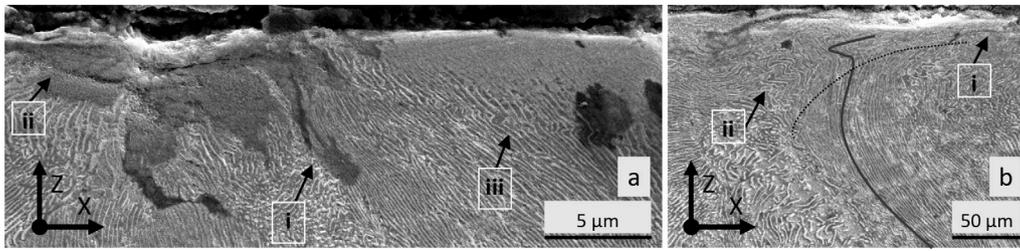
Fig. 10 shows micrographs from the same specimen as shown in Fig. 9. Fig. 10a presents the surface which is defined by a rough zone next to a WEL. The WEL has a smooth surface and is $\sim 3 \mu\text{m}$ thick. The pearlite lamellae at the edge of the layer, indicated with iii , are wrinkled. The rough zone is filled with debris and detached layers, see ii , which is an indication of the absence of wheel contact. Two cracks are observed, although some over-etching limits the observation clarity. The first crack initiates at the bottom of the irregularity, and the second at the edge of the WEL patch, which is indicated with i . It is known that the dominant direction of the tangential shear forces defines the deformation orientation [24,27,31] and also that, in this study, the shear stress direction reverses after almost every train passage. Fig. 10b shows the microstructure close to the surface. A $10 \mu\text{m}$ refined surface layer is present which is the result of intense plastic deformation [1,7]. Wear tongues are pointing in the X -direction, see i . The full black line highlights the long C-shaped deformation with a sharp S-shaped pattern, closer to the surface. This pattern is concentrated in a band

which is marked by a dotted line. Wrinkled lamellae are sometimes observed in pearlite as a result of compression or thermal contraction. The wrinkled lamellae, indicated with ii , show evidence of multiple deflection occurrences and it is concluded from the sharp bending and amplitude variations that these are the result of external shear stress reversal. This specific pattern was also observed by Tyfour and Beynon [10] in rolling direction reversal experiments.

Fig. 10. Longitudinal section of Facet 2, closest to the facet transition with facet 3. The observations are made using high-magnification SEM: (a) Damage initiates (see *i*) between the oxide-filled irregularity (see *ii*) and the WEL patch at the contact surface. Wrinkled pearlite lamellae are present at the edge of the WEL (see *iii*). (b) A wear tongue and s-shaped deformation patterns, associated with the bi-directional use of the railway line, are present (see *i*). Wrinkled pearlite lamellae evidences multiple deflection occurrences (see *ii*).
