## Failure Analysis of Two HP-Nb Heat-Resistant Tubes after 46,000 h Exposure to Reformer Service Conditions

# Failure Analysis of Two HP-Nb Heat-Resistant Tubes after 46,000 h Exposure to Reformer Service Conditions

**Abstract:** This study presents a failure analysis in two reformer tubes used for hydrogen production in a petrochemical industry. These tubes (Tube A and Tube B) were made by the centrifugal casting of HP-Nb alloy in such a way that one contained titanium as a micro-element, and the other was free from titanium in its chemical composition. Although the two tubes were subjected to similar creep conditions, Tube A failed after only 46,000 h of operation against the design life of 100,000 h. SEM images showed initiation and growth of creep pores next to chromium carbide particles, as well as the formation of microcracks in Cr<sub>23</sub>C<sub>6</sub> carbides. Pore initiation occurs as a result of grain boundary sliding and is strongly dependent on structural morphology. The tube containing titanium (Tube B) showed higher thermal stability and higher creep resistance than the tube without titanium (Tube A), which was due to the formation of finer and more discrete c

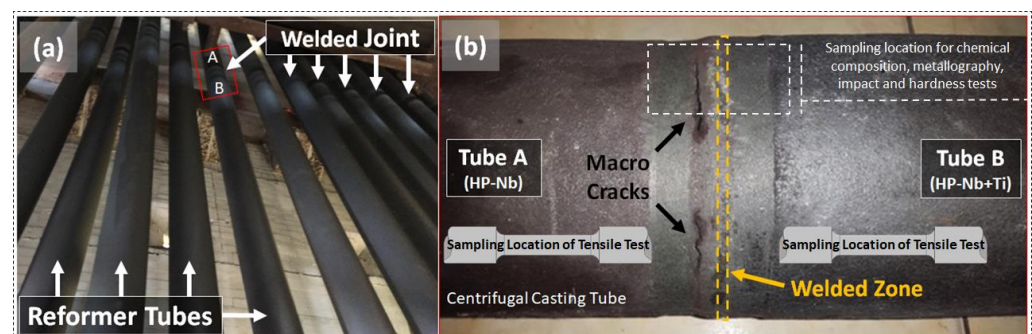
Figure 1a shows the location of these tube sections (Tube A and Tube B) in the reformer furnace. Although both tubes were under similar temperature and stress conditions, Tube A showed premature cracking and failure (Figure 1b). According to visual inspection, latitudinal cracks were observed at a distance of 6 mm from the welded joint in Tube A while no macroscopic cracks were observed in Tube B. The premature failure of the HP-Nb reformer tube without Ti (Tube A) after 46,000 h of service at the approximate temperature of 1000 °C as compared to Tube B (with 0.12% Ti) was studied. The observed damages included latitudinal cracks adjacent to the welding area, resulting in the need to replace the tubes after 46,000 h of service which is significantly lower than the expected life of the tubes.

**Figure 1.** (a) Centrifugal cast tubes in the reformer furnace and (b) latitudinal cracks formed perpendicular to the stress direction on Tube A.

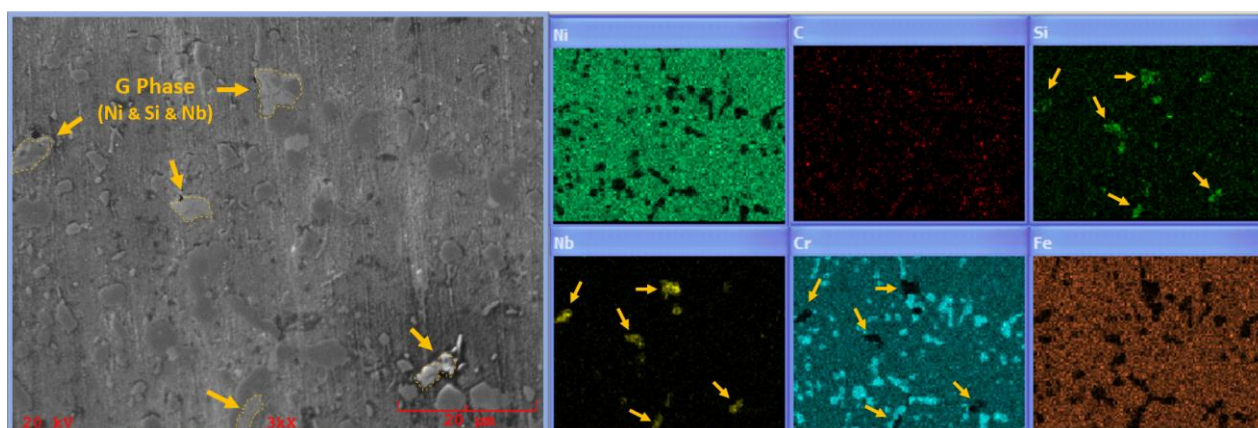
Our investigation showed that there is no evidence of the G phase in tubes containing titanium (Tube B). A low titanium concentration can result in the formation of niobium-titanium carbide complexes. Since titanium is insoluble in the G phase, it can increase the stability at higher temperatures and delay the transformation of (NbTi)C to the G phase. Therefore, the volume fraction of the G phase is lower in HP steel modified with Ti [22,24]. According to the X-Ray Mapping images presented in Figure 4, there are nickel, silicon, and niobium-rich areas identified in Tube A which is due to the presence of the G phase in tubes without titanium. These areas, indicated with arrows, have low chromium content, which, due to the lower strength and ductility of this phase compared to niobium carbides, are suitable areas for the initiation of creep pores. The volume expansion as a result of niobium carbide to G phase transformation can result in stress and therefore the formation of creep pores [12]. On the other hand, the transformation of niobium carbide into the G phase removes the hard phase (NbC) that can prevent the movement of dislocations and thus this phase transformation reduces the creep resistance [17].

**Figure 4.** X-Ray Mapping images of tube A showing the distribution of various elements in SEM images.

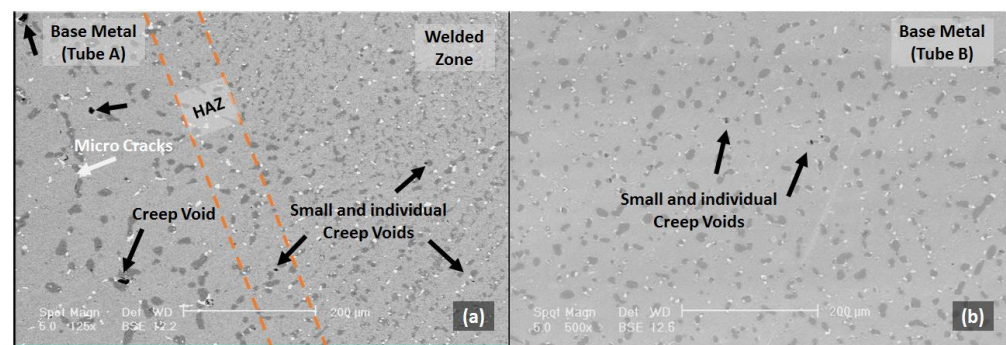
The SEM studies of the interface between the welded area and base metal in Tube A show no evidence of creep pores or microcracks in the welded zone. However, creep pores and microcracks are apparent at approximately 200 microns from the welded line in the base metal of Tube A (Figure 8a). This can be due to the presence of larger carbide particles in the base metal compared to the welded zone. As shown in Figure 8b, small and individual creep voids have nucleated in a base metal of the Tube B, but they have not been able to grow. This issue can be caused by the difference in microstructural morphology between Tube A and Tube B in terms of the distribution and size of chromium carbides.

**Figure 8.** SEM images of (a) the interface between welded zone and base metal in tube A, (b) base metal in tube B.

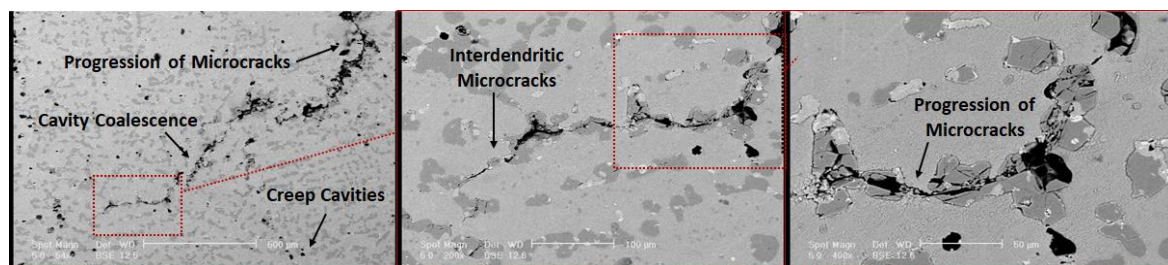
The decrease in the life cycle of reformer tubes is determined under the influence of creep damage which is indicated by progressive changes in the microstructure. The transfer of carbides, initiation of microcracks, and formation of creep pores often occur in the final stage of the creep damage and immediately before the failure. The growth of these creep pores mostly occurs perpendicular to the direction of the applied stress, and their growth rate is controlled by localized creep strain. The final fracture occurs due to pile-up of the pores, formation of grain boundary cracks, and an increase in the number and size of cracks. According to Figure 9, creep cavities are mostly observed in the triple or wedge-shaped areas and on chromium carbide particles. Coarsened chromium carbide particles merge under the influence of reformer temperature, and create suitable areas for initiation of creep pores. The pile-up of grain boundary cracks also occurs along the length of chromium carbide particles, indicating merged carbide particles as preferred crack initiation zones.

**Figure 9.** SEM images showing the pile-up of creep pores along the length of grain boundaries or inside grain boundary carbide particles and coalescence for the formation of cracks in the failed tube.
