CHAPTER 4

STRUCTURAL DAMAGE BY TSUNAMIS

Orville T. Magoon
Navigation and Shoreline Planning Section
Engineering Division
U. S. Army Engineer District, San Francisco
100 McAllister Street
San Francisco, California

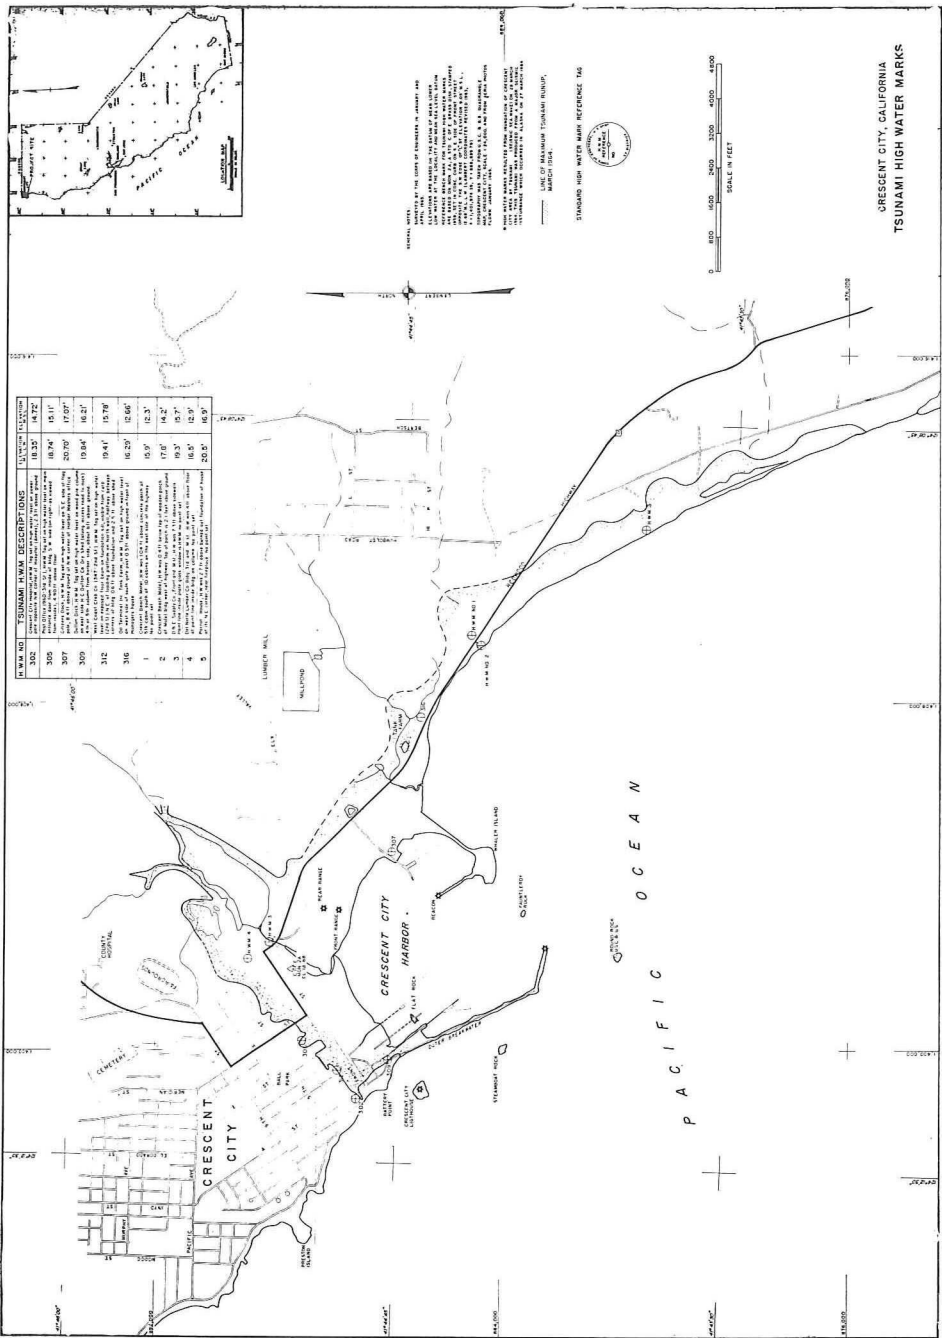
Due to the relatively severe tsunami damage produced at Crescent City in 1964, an investigation was made of the coast on both sides of Crescent City to determine the water levels reached by the tsunami. Based on elevations determined at locations positively identified as those caused by the tsunami, it is concluded that the runup elevation reached by the third wave (fifth wave of Tudor 18/) of this tsunami was essentially constant at the shore for a distance of almost 2 miles southwest of Crescent City and probably only slightly diminished for 1 mile northeast of Crescent City. This high water elevation along the shore reached 20 to 21 feet above MLLW. The line of maximum tsunami inundation, as shown on Figure 6 generally followed the +20 MLLW contour where the ground elevations increased to landward from the shore. This would include most of downtown Crescent City and the pasture land in the vicinity of HWM No. 5.

low areas to landward thus reducing the runup. This condition was reported both in the area of HWM 316 and also at HWM's 1 and 2 shown on Figure 6.

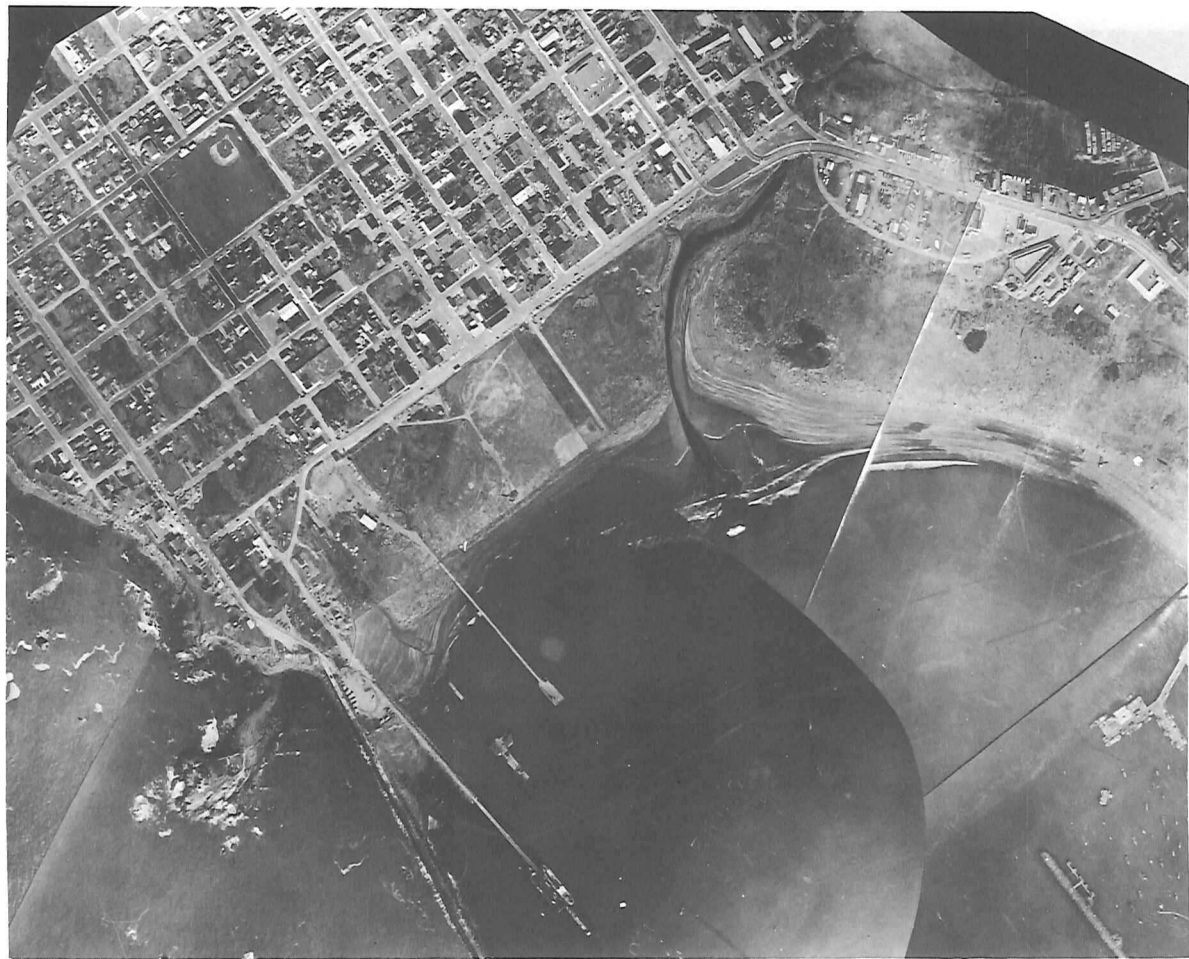
Figure 8 Crescent City 18 October 1962

Figure 8 shows the harbor area about 2 years before the tsunami. Figure 9 shows the harbor one week after the tsunami. Note the increased width of the small creek in the harbor and also the erosion scars along the beach. Severe damage was observed in areas where the tsunami exceeded 4 to 6 feet above the ground surface (see Figure 7). The water depth reached or exceeded 6 feet along the entire length of Front Street, and about nine blocks of the main portion of Crescent City. The majority of the one story wood frame structures in this area were either totally destroyed or damaged to such an extent that they were a menace to public health and had to be torn down.
