## Confirming Debonding of Non-Metallic Inclusions as an Important Factor in Damage Initiation in Bearing Steel

Nikolic, Ksenija; De Wispelaere, Jelle; Ravi, Gopalakrishnan; Hertelé, Stijn; Depover, Tom; Verbeken, Kim; Petrov, Roumen H.

Metals

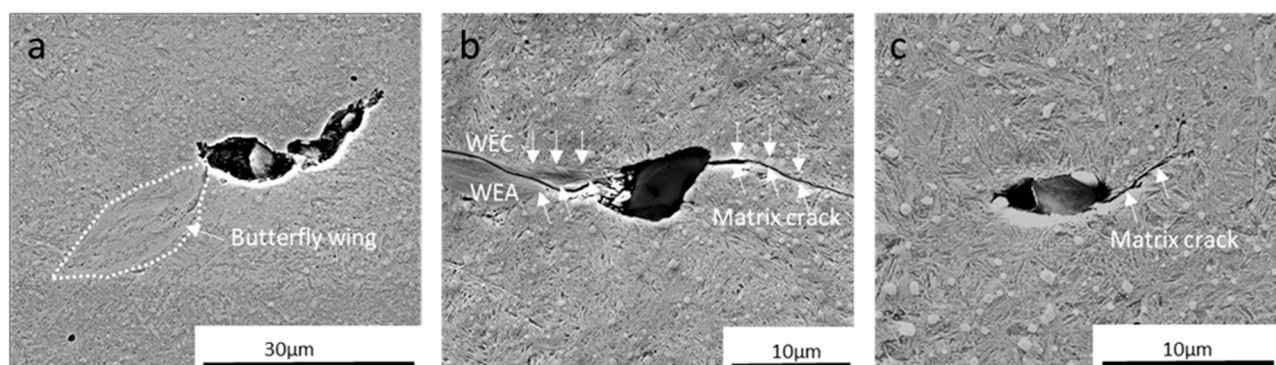
This work distinguishes between inclusions forming “butterfly wings”, white etching cracks/white etching areas, and matrix cracks. In the investigation, WECs were observed with a WEA, and no WEA was present without a WEC. The EDS spectra and point analysis of WEA can be found in Appendix A, Figures A1 and A2. “Butterfly wings” are small features measured in tens of micrometers—these are wings-shaped white etching zones with a typical 45-degree orientation to the raceway surface. White etching cracks are recognized as cracks with shallower angles that typically exhibit a longer appearance than BWs, with an accompanying white etching area. Matrix cracks refer to cracks starting from inclusions in the bulk material without the formation of a WEA. These three different types of damage are shown in Figure 3. Some inclusions showed two types of damage: a matrix crack observed on the left side and a butterfly wing on the right (Figure 3b). Therefore, one inclusion may fall into two categories. The damage orientation is measured as the angle between the matrix crack/WEA/WEC and the orientation of the image.

**Figure 3.** SEM-SE images of different types of damage observed in this study. (a) Appearance of butterfly wings. (b) White etching crack and white etching area. Arrows in the upper part point to the WEC, and arrows in the lower part indicate the WEA and (c) matrix crack.

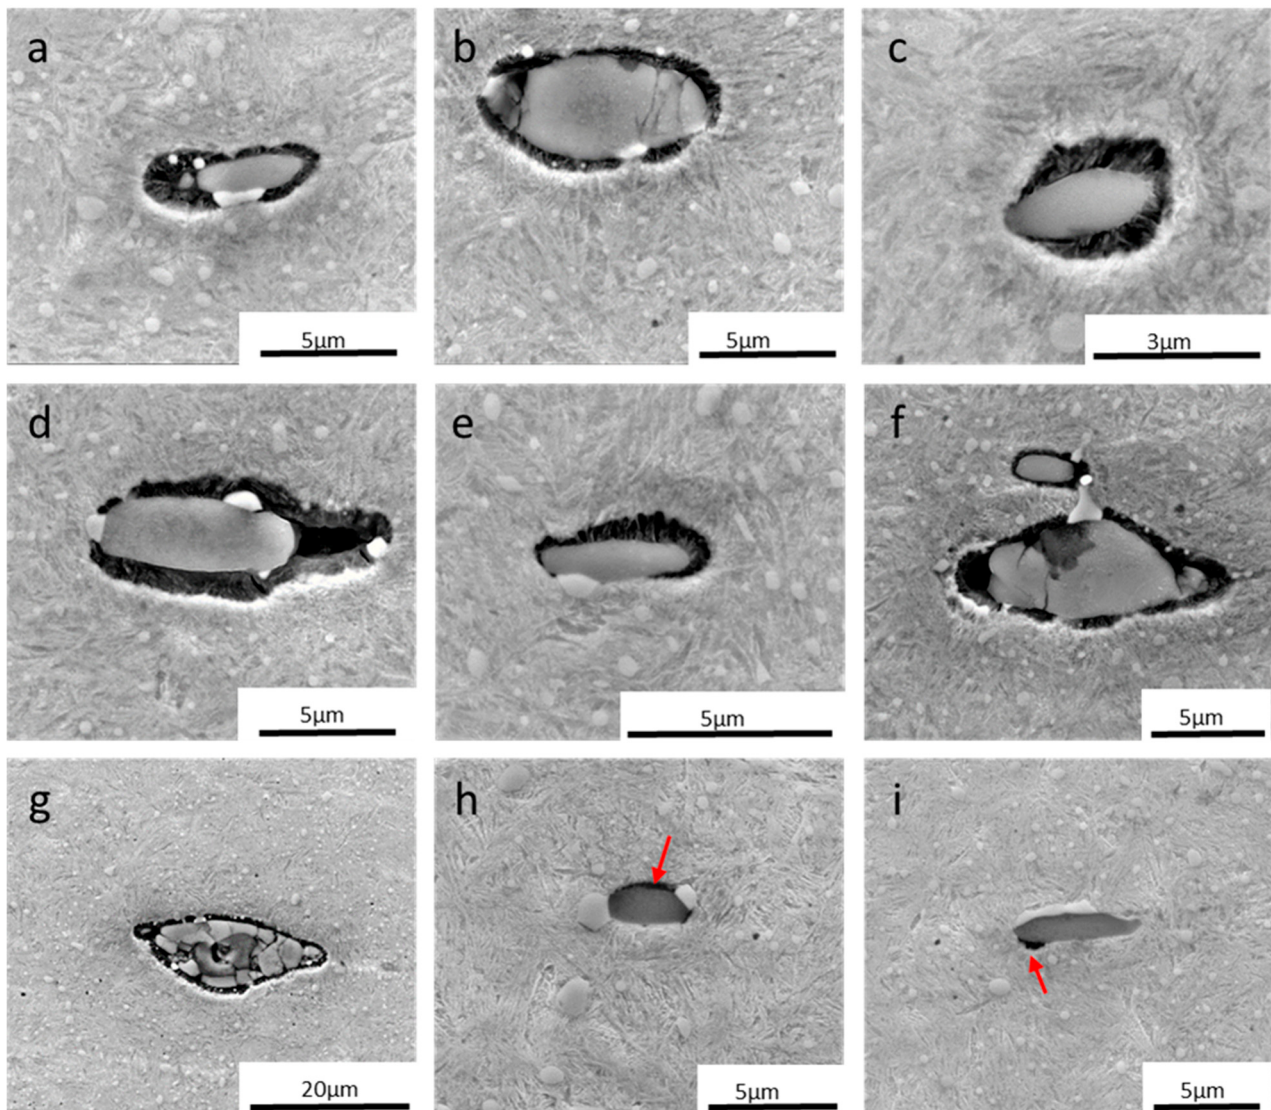
To understand the role of non-metallic inclusions in damage formation, we first investigated the non-metallic inclusions in the non-loaded zone. For that purpose, 70 inclusions were characterized at distances greater than 3 mm below the raceway surface. According to [23], this distance is sufficiently far below the loaded zone and, thus, will allow assessment of the attachment of inclusions to the bulk material in the initial state prior to the rolling. Microstructural alterations associated with WECs, BWs, and matrix cracks were not observed in this zone. Figure 4 illustrates nine inclusions in the non-loaded zone, showing that seven of them are marginally bonded to the martensitic matrix (a–g). Figure 4h,i depict inclusions that are intensely bonded to the bulk material, although there were slight indications of debonding (indicated in red). Figure 4 shows fragmented inclusions; this is rather unexpected due to the insignificant stress state. Fragmentation of inclusions can be associated with the ring rolling process. To verify that inclusion debonding is not caused by acid damage resulting from the etching process, the sample was repolished and

**Figure 4.** SEM-SE overview of the inclusions in the non-loaded zone. (a–f) Most of the inclusions shown (6 out of 9) are debonded from the bulk material. (g–i). Examples of bonded inclusions notwithstanding slight detachments indicated by red arrows.

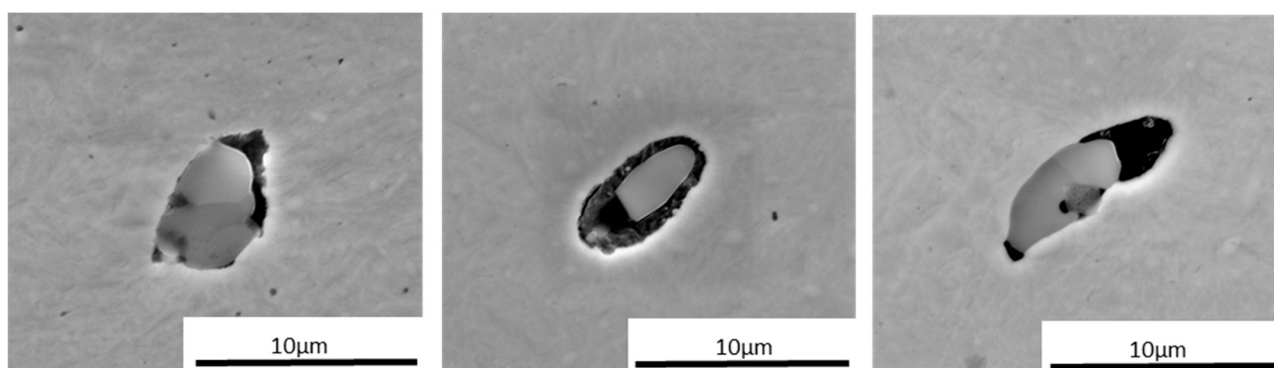
re-examined using SEM, as shown in Figure 5. It can be seen that debonding is still present within the material and was not altered due to the etching process. The average size of the inclusion, average length, aspect ratio, and the number density of the inclusions in the non-loaded zone are presented in Table 2. Most of the inclusions (77%) were MnS, and 88% of all inclusions were detached from the steel matrix. Given the fact that inclusions were already debonded prior to service, the question arises as to whether the initial stage of bonding plays a significant role in damage initiation and development, and consequently influences the bearing lifetime.

**Figure 5.** The SEM–BSE images of non-etched inclusions in the non-loaded zone confirm debonding in the absence of rolling contact fatigue.

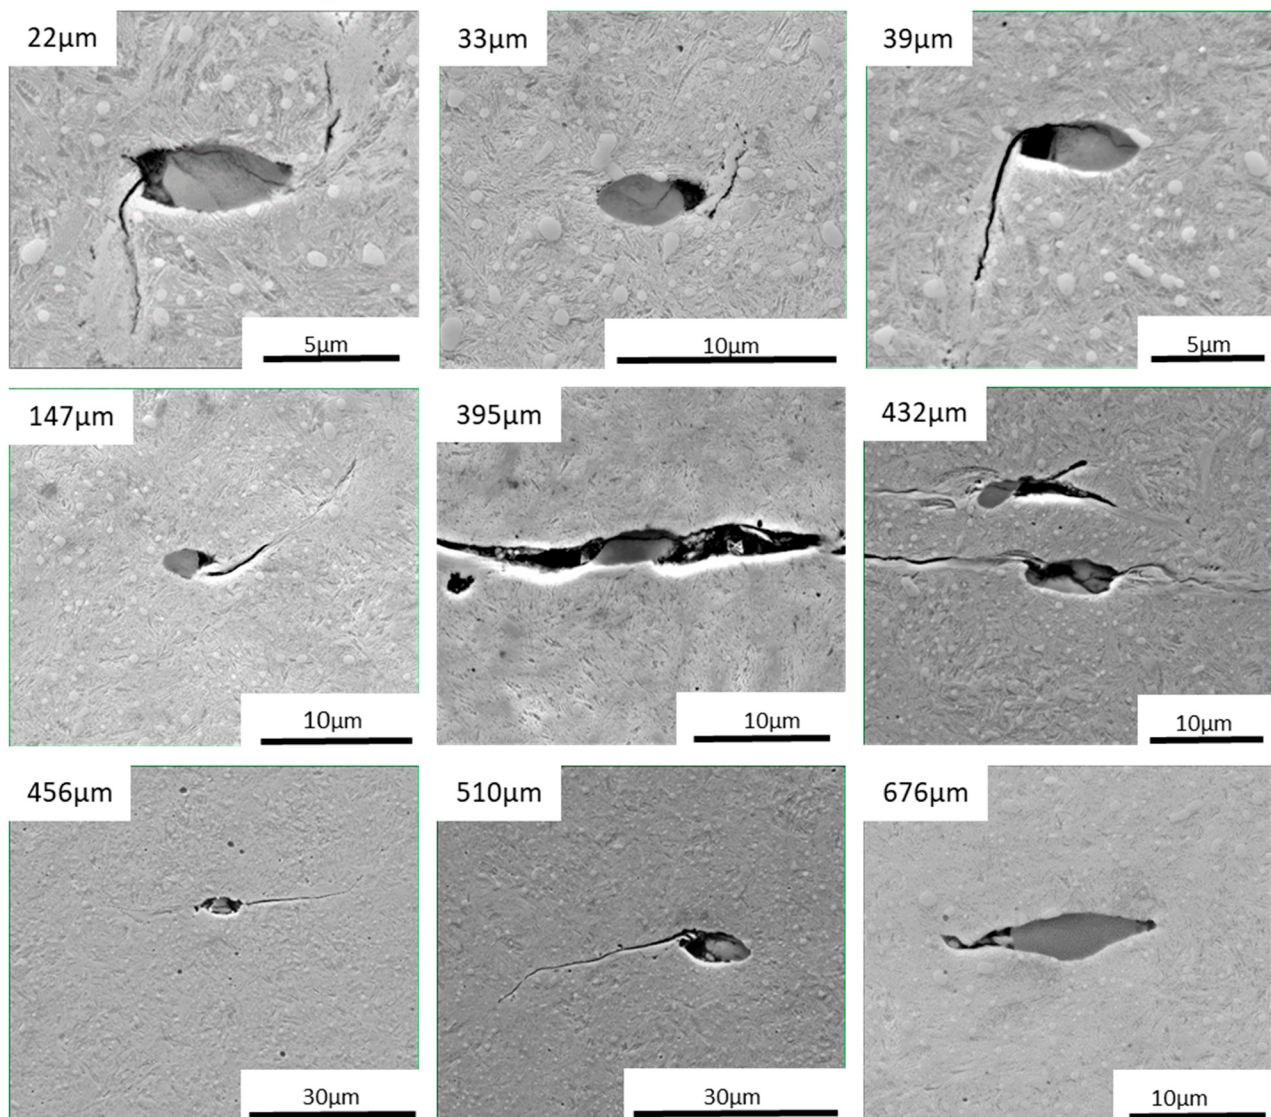
The examination of the loaded zone revealed micro-damaged zones present as butterfly wings, matrix cracks, and white etching cracks. None of the BWs reached the raceway surface; they do not grow, and they do not create networks. Furthermore, WECs were found with a length of a few hundred microns, and no larger networks spanning millimeters in size were detected within the material, although connections between WECs were observed. Figure 6 shows inclusions and the damaged zones around them; the upper-left corner insertion indicates the distance from the raceway surface. It was found that damage is mainly present on the side of the inclusion detached from the bulk material. In addition, 72% of MCs and 73% of WECs started from the debonded side. The distance from the raceway surface varied from 22 to 676  $\mu\text{m}$ , suggesting that debonding plays a role in the majority of the loaded zone rather than at the region of maximum shear stress, the latter of which was determined in [21,24]. Internal inclusion cracking is reported to be one of the forms of damage initiation [21,23,29]. In this study, a possible link between inclusion cracking and stress can be established since inclusion cracking peaked at 500  $\mu\text{m}$  below the raceway surface. Under this distance, fewer cracked inclusions were observed. The inclusions with an equivalent diameter of 2–7  $\mu\text{m}$ , determined as an average of major and minor inclusion axes, showed a larger tendency to crack. However, not all inclusions that developed BW/WEC/matrix cracks showed internal cracking.

Considering debonding as an important factor, all inclusions in the loaded zone were analyzed, and it was found that most of the inclusions (85%) in the loaded zone were detached from the steel matrix. The investigation of the inclusions in the non-loaded zone suggests that the load is not responsible for the debonding. This is most likely due to the different thermal expansion coefficients and/or strain incompatibilities being enhanced during the deformation processing. Moreover, the different thermal expansion coefficients of inclusions with the bulk material can result in the development of tensile and compressive residual stresses parallel to the normal inclusion–matrix interface. In addition, strain incompatibilities during the formation processing of the steel can result in the formation of cavities at the inclusion interface [42]. Given such a high number, it is suggested that size, shape, and chemical composition do not influence debonding of the inclusions.

**Figure 6.** SEM-SE images of damage around inclusions in the loaded zone. The top-left number represents the distance from the raceway surface. The damage started on the side of the inclusion that was debonded from the bulk material. This is applicable for the wide range of distances (from 22 to 676  $\mu\text{m}$ ) from the raceway surface, suggesting that debonding plays a role in the entire loaded zone.

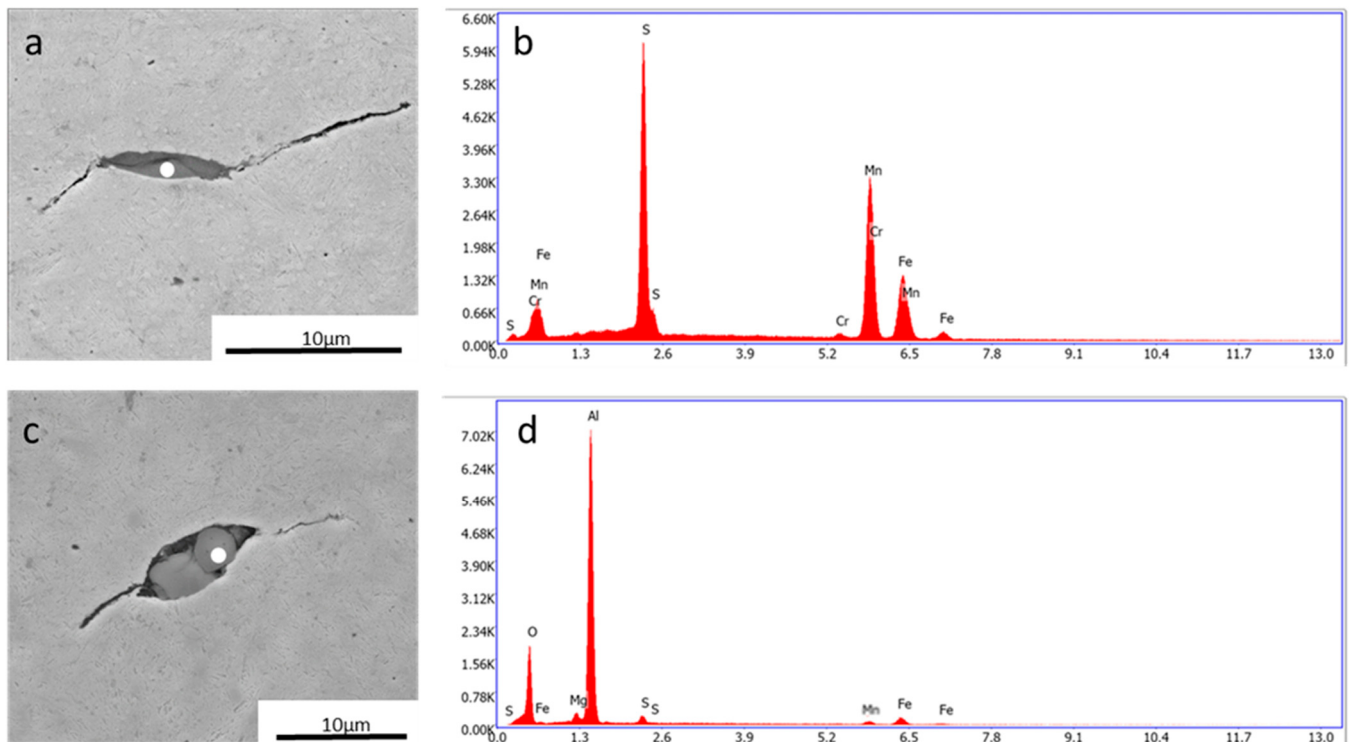
The chemical composition of the studied inclusions was analyzed with energy-dispersive spectroscopy. Only two types of inclusions were present in the studied bearing: pure MnS (77% of the studied database) and MnS with the addition of alumina (aluminum oxide). TiN and pure alumina were not detected in the material. Figure 7a,c show the

non-metallic inclusions captured by SEM, with white dots representing the locations of the EDS analysis. The corresponding EDS spectra of (a) and (c) are represented in (b) and (d), respectively. The different chemical composition of inclusions can also be observed in SEM figures; MnS is light grey without a different contrast, while two ‘particles’ (MnS + Al<sub>2</sub>O<sub>3</sub>) have different contrast, visible in (c). The percentage of the inclusions that caused a WEA is similar for both types: 34% for pure MnS and 37% for the MnS + Al<sub>2</sub>O<sub>3</sub> type. Thus, our observations do not indicate a markable influence of the chemical composition of the inclusion on damage initiation.

**Figure 7.** Types of inclusions present in this study. (a) SEM–SE figure of MnS inclusion; the white dot is where the spectra were taken. (b) EDS spectrum of the dot in (a). (c) MnS + Al<sub>2</sub>O<sub>3</sub> inclusion type; this is also visible in the SEM figure, where contrast is present within different non-metallic compounds. (d) EDS spectrum of the white dot presented in (c).

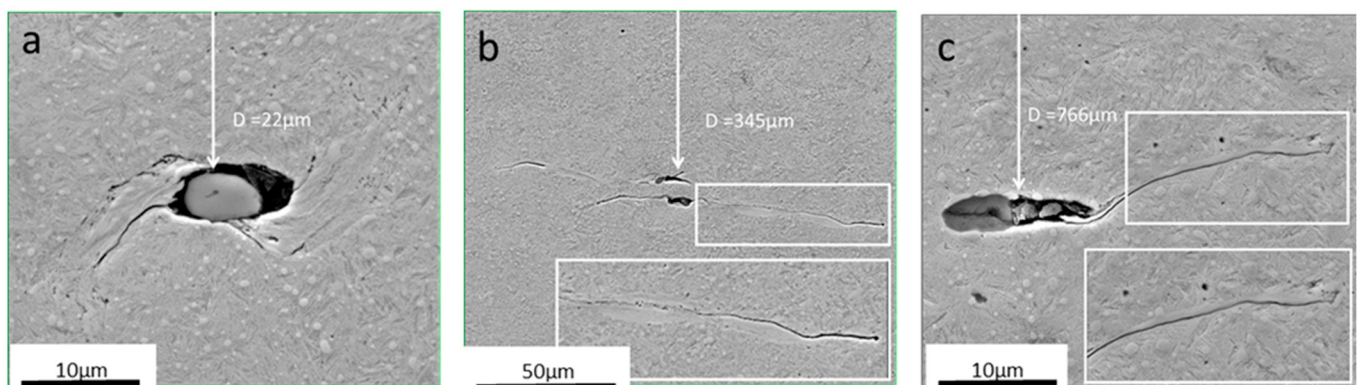
To illustrate potential damage orientations, examples of microstructural alteration are shown in Figure 10. A typical butterfly wing pattern of 45 degrees is depicted in Figure 10a, where both sides of the non-metallic inclusions developed BWs. The distance of this inclusion was very close to the raceway surface (22  $\mu\text{m}$ ); however, no connection of the crack to the surface was observed. Further away from the surface (345  $\mu\text{m}$ ), microstructural alterations propagate at shallower angles (cf. Figure 10b). Here, cracks also developed from both sides of the inclusions; cracks are longer than BWs, and the altered zone is broader in this zone. On the contrary, at distances greater than 500  $\mu\text{m}$ , cracks were typically evolving from only one side of the inclusions, and a very thin WEA was observed around them (Figure 10c). These findings were consistent throughout this investigation and supported the hypothesis that WECs are an extension of BWs.

**Figure 10.** Development of damage at the depth of the sample. (a) Orientation of butterfly wing, (b) Orientation of white etching cracks, (c) orientation of matrix crack.

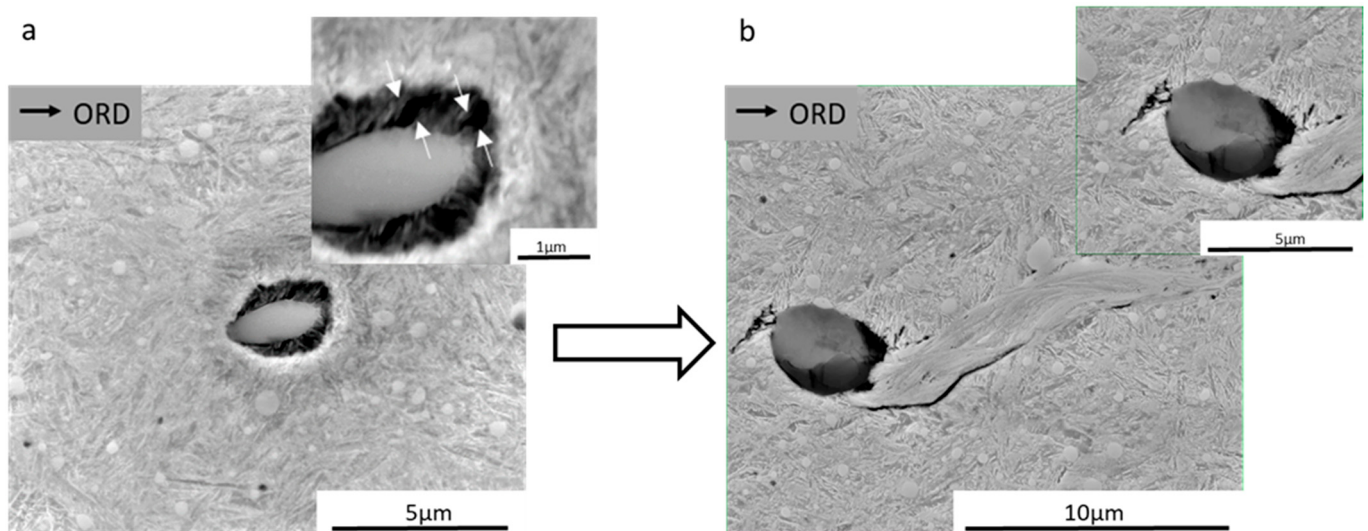
The microstructural observation that proves the proposed formation mechanism of the crack initiation in the bulk material is shown in Figure 13. The debonded inclusion is located in the loaded zone (up to 1 mm from the raceway surface). As the rolling cycles occur, local stress concentration develops around the debonded area, as shown in Figure 13a. Over successive rolling cycles, the stress levels increase, resulting in the formation of voids (regions with white arrows in Figure 13). These voids serve as regions of local high-stress concentration, which eventually develop microcracks into bulk material as means of stress relief. Figure 13b shows an inclusion with a fully developed butterfly wing on the right-hand side, while the left side only has a small indication of the crack in the bulk material.

**Figure 13.** Proposed damage development. ORD represents the over-rolling direction. (a) Non-metallic inclusion in the non-loaded zone. (b) Once the non-metallic inclusion located in the loaded zone experiences rolling cycles, damage first initiates in the debonded zone and initiates a crack in the bulk material as a way of stress relief.

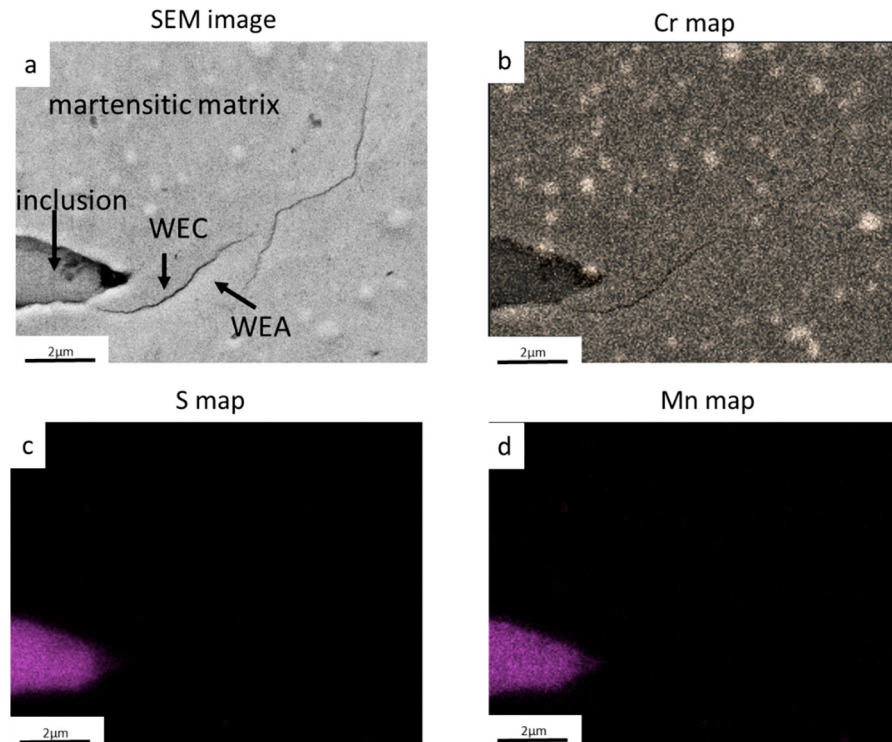
Figures A1 and A2 represent the energy EDS analysis over the white etching area. Figure A1a shows the SEM–SE image over the area of interest. Depletion of chromium carbides in the white etching area is visible from the chromium map in Figure A1b. Sulfide and manganese compositions of the non-metallic inclusion are shown in Figure A1c,d,

**Figure A1.** EDS spectrum on white etching area and inclusion. (a) SEM–SE image on the area of interest. (b) Chromium map. (c) Sulfur map. (d) Manganese map.

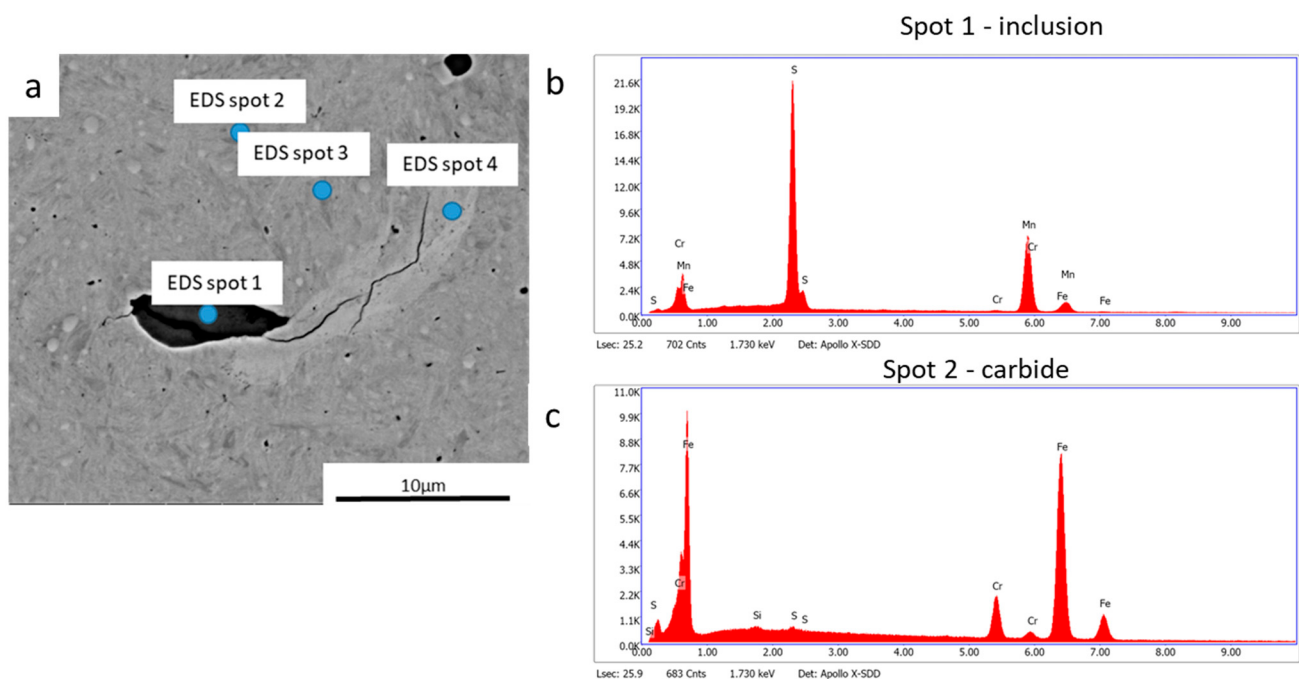
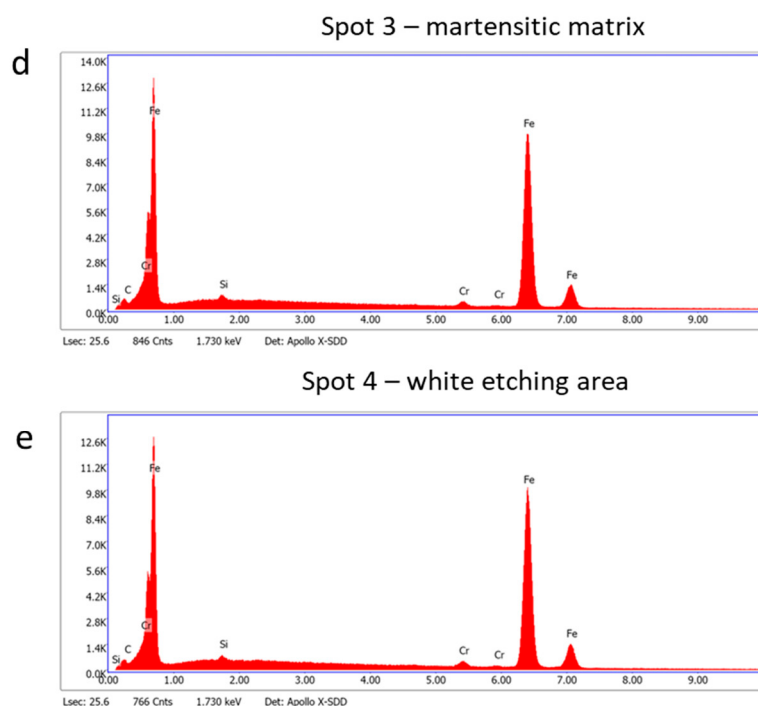
respectively. The spot EDS analysis shows the same area as in Figure A1. The altered zone (white etching area) is more visible in the backscattered image in Figure A2a. The spectra from the inclusion, carbide, martensitic matrix, and white etching area are represented in Figure A2b–e, respectively.

**Figure A2.** EDS spot analysis. (a) SEM–BSE area of interest; blue dots represent the location where the spectra analysis was taken. (b) Inclusion. (c) Chromium-rich carbide. (d) Martensitic matrix. (e) White etching area.
