## Failure Analysis of Two HP-Nb Heat-Resistant Tubes after 46,000 h Exposure to Reformer Service Conditions

# Failure Analysis of Two HP-Nb Heat-Resistant Tubes after 46,000 h Exposure to Reformer Service Conditions

**Abstract:** This study presents a failure analysis in two reformer tubes used for hydrogen production in a petrochemical industry. These tubes (Tube A and Tube B) were made by the centrifugal casting of HP-Nb alloy in such a way that one contained titanium as a micro-element, and the other was free from titanium in its chemical composition. Although the two tubes were subjected to similar creep conditions, Tube A failed after only 46,000 h of operation against the design life of 100,000 h. SEM images showed initiation and growth of creep pores next to chromium carbide particles, as well as the formation of microcracks in Cr<sub>23</sub>C<sub>6</sub> carbides. Pore initiation occurs as a result of grain boundary sliding and is strongly dependent on structural morphology. The tube containing titanium (Tube B) showed higher thermal stability and higher creep resistance than the tube without titanium (Tube A), which was due to the formation of finer and more discrete c

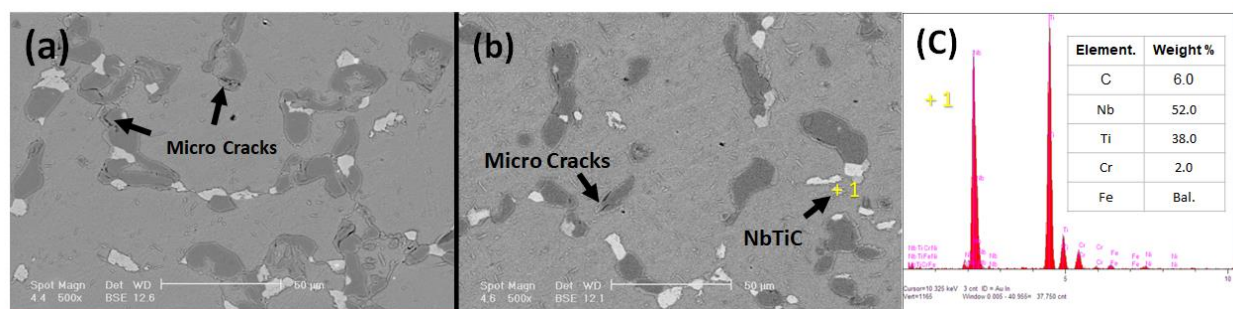
According to Figure 5, the coalescence of the carbide network in the titanium-free sample is higher compared to the sample containing titanium. Furthermore, the tube

containing titanium as an alloying element (Tube B) has a finer structure. Therefore, based on the effects of microstructural morphology on the initiation, growth, and coalescence of creep pores, it is expected for the Tube B to have higher ductility and creep resistance compared to the Tube A. This improvement in creep behaviour can be due to the presence of Ti carbonitrides and their effect on secondary carbide precipitates during ageing. The reason for the lack of failure in Tube B, despite tolerating similar service conditions to Tube A, is the positive effects of titanium on the creep behaviour of the alloy.

**Figure 5.** SEM images of tube microstructures after ageing: (a) Tube A without titanium and (b) Tube B containing 0.12 wt. % of titanium (c) point elemental analysis of NbTiC phase using EDS system.
