UAV-Visual Inspection

Bridge Condition Assessment Over a Decade

UAV-Visual Inspection: Bridge Condition Assessment Over a Decade

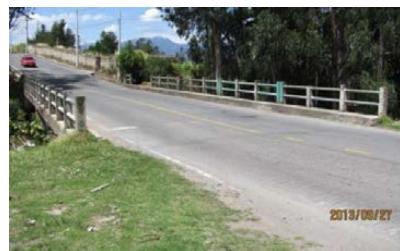
Figure 8. Road safety and accessories elements of the bridge in 2013

The traffic signs have no visible damage, so GD rating is assigned as 0. The lighting was not present on the bridge, the vehicle barrier exhibited minor deterioration that did not compromise its integrity, and the sidewalks showed minimal wear but were still safe for pedestrian use. Hence, all these elements have a GD rating of 1. All this can be seen in Figure 8.

The road surface has no cracks, potholes, or signs of deterioration. In addition, it provides a smooth and safe surface for vehicle traffic. Additionally, the bridge's drainage system because it is still able to drain water effectively to prevent pooling and structural damage and there is no sign of obstructions or deterioration. Hence, these elements have a GD rating of 0. On the other hand, the expansion joints have been completely covered with pavement, thus losing their ability to fulfill their function, so GD rating is assigned as 3. All this can be seen in Figure 8.

The road surface has minor signs of deterioration. However, it is in safe and functional condition for vehicular traffic. Additionally, the approach fill is in optimal condition and have no presence of any deterioration that could compromise the stability or safety of access. Hence, these elements have a GD rating of 0. All this can be seen in Figure 8.

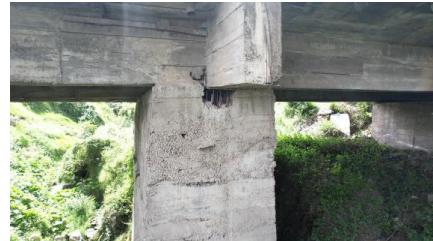
The supports have excessive deterioration or non-existence. Also, pieces of wood are used as bearings, which prevents them from performing their function correctly. Hence, GD rating is assigned as 3. The piers have severe deterioration, with visible signs of deterioration such as pile settlement cracks and scour. In addition, a loss of concrete material under the diaphragm is observed as shown in Figure 10 and Figure 11. Hence, GD rating is assigned as 3.

Figure 11. Bridge piers in 2024
