Damage behavior of ground pearlitic railway steel

Schotsman, B.

Dissertation

for the purpose of obtaining the degree of doctor
at Delft University of Technology

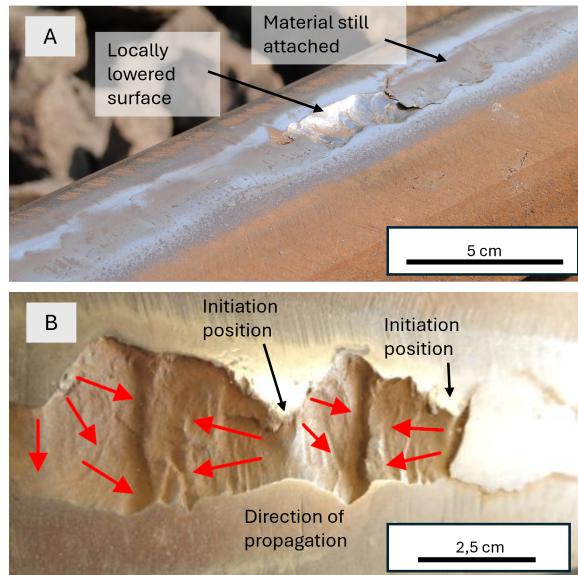
Figure 1.3: The grinding-related rail defects in a rail from a steel with increased wear resistance. A) The rail with the repetitive rail defect in track. The bright polished surface where the material is removed evidences the recent removal. B) The repetitive damage initiation positions are indicated by the black arrows. This mutual distance of the initiation positions is equal to the characteristic length of the grinding process. The red arrows indicate the local damage-propagation direction. The material spalls off after the subsurface crack planes of different damages intersect.

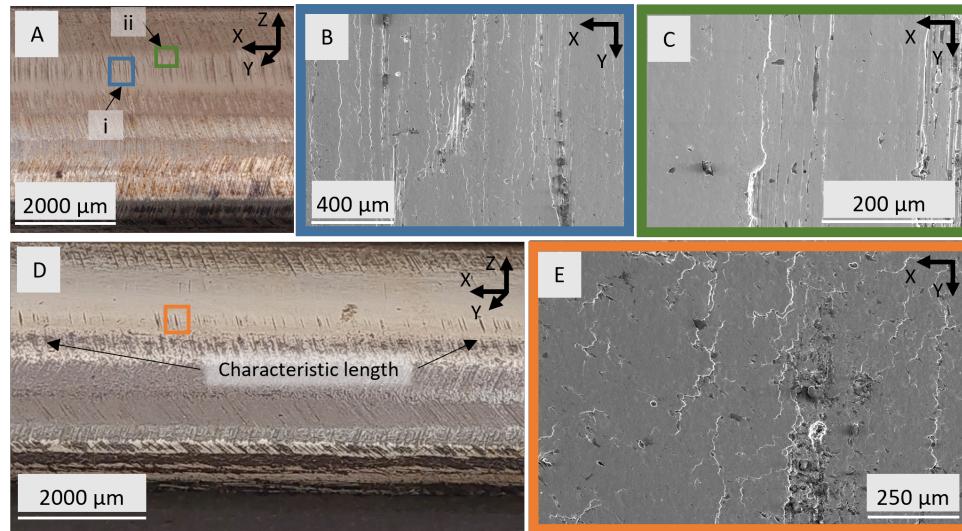
Figure 2.8: The contact surface at rail sample RS0.4, A-C, and rail sample RS6.9, D-E. A) Micrograph of the rail surface. Load-carrying surfaces develop between grinding grooves, see *i*, and the facet-transition zones are smooth, see *ii*. B) On the facet surface in the blue frame, vertical lines and partly covered grinding grooves are present. Both are the result of extrusion of roughness asperities. C) Extrusion lines on the surface in the facet-transition zone of the green-framed area. The parallel lines exhibit a lower density. D) Micrograph of the rail surface. The middle of the contact surface is smooth but on both sides the deeper grooves remain. E) The contact surface in the orange-framed area. The serrated edges of the lines on the surface exhibit various orientations and length. These are associated with rolling contact fatigue damage initiation.

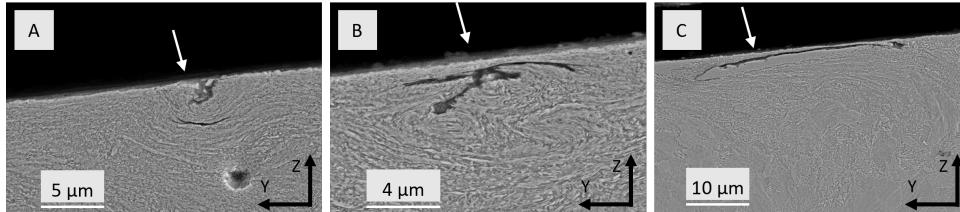
Figure 2.10: The freshly ground surface characteristics affect the contact surface formation, and are related to various features at the surface in rail sample RS6.9. A) Coil-shaped material filling a grinding groove cavity. B) Material extrusion which results in the coverage of a grinding groove. C) Material covering a WEL patch at the running surface.

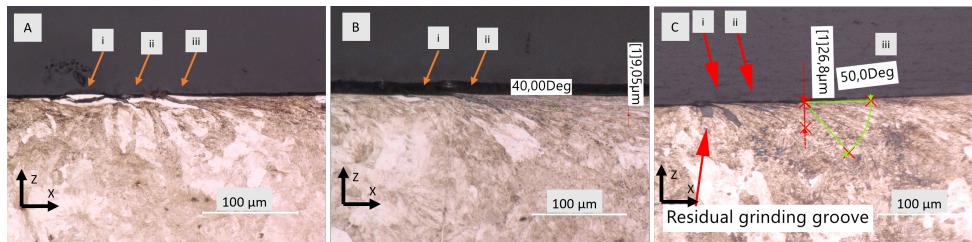
Figure 2.12: Evolution of damage in the facet-transition zone of the rail surface. A) RS0.4; the WEL in the grinding groove acts as a boundary for deformation and is submerged. The figure shows a detached WEL caused by grinding, see *i*. The freshly formed surface is partly embedded by material that has been extruded, see *ii*. A second extrusion is present which also traps the WEL at the surface. Here the deformation is more evident and a slip-related WEL has formed at the surface, see *iii*. B) RS2.0; damage initiates at the surface. The WEL patch is pressed and embedded into the surface, see *i*. The crack that forms next to it reached a crack depth of 19 μm and the propagation orientation is 40° with respect to the surface, see *ii*. C) RS6.9; at the surface two cracks are observed. One crack is present next to the residual grinding groove and is filled with corrosion products, see *i*. The second crack is closed and has a slightly shallower propagation orientation, see *ii*. The crack depth is ~27 μm and the propagation orientation is 50° with respect to the surface, see *iii*.

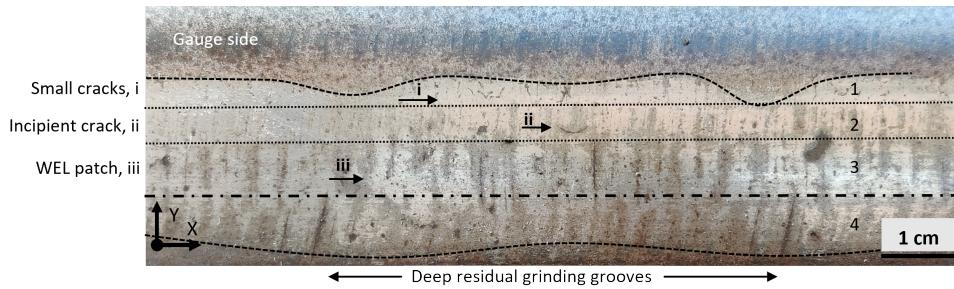
Figure 3.4: Rail contact surface as a result of the preventive grinding and wheel-rail contact. The deviations in the contact surface width are depicted with dotted lines. The ground facets are numbered 1 to 4. Cracks are present at facet 1, see *i*, an incipient crack at facet 2, see *ii*, and WEL at facet 3, see *iii*.

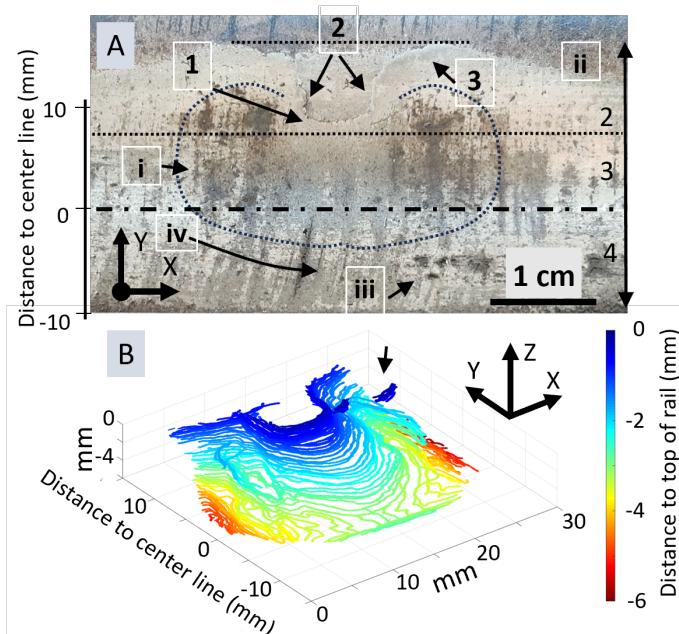
Figure 3.6: Symmetric squat defect with semi-elliptical crack tip. A) Three distinguishing features are indicated: (1) the semi-elliptical crack tip, (2) the parallel propagation paths, and (3) the deflection of the crack path. The dark spot, see *i*, is the result of intermediate-layer build-up and evidences the subsidence of the surface. The contact surface shows widening, see *ii*, longitudinal slipmarks, see *iii*, and spalling of material. The arrow indicates the probable wheel-contact displacement, see *iv*. B) 3D-representation of the subsurface crack plane composed of all contour lines after surface milling. The arrow indicate crack initiations present at a similar transverse position.

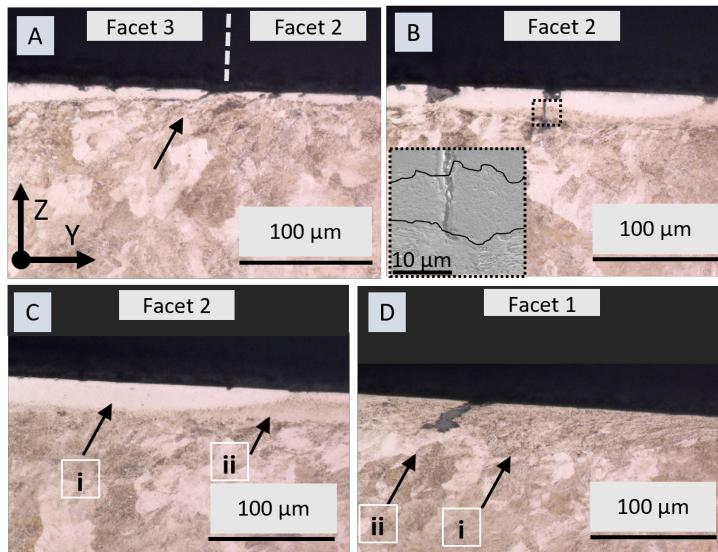
Figure 3.8: Cross-section of facets 1 to 3 observed in X-direction. A) At the facet transition zone between facets 2 and 3 is locally no WEL observed. WEL-detachment is indicated with the arrow. B) WEL is present at the surface of Facet 2. The observed crack does not propagate into the bulk. C) WEL is present, see *i*, and partly embedded in BEL, see *ii*. D) Unidirectional deformation is present beneath the surface of facet 1, see *i*, and a superficial crack is present, see *ii*.

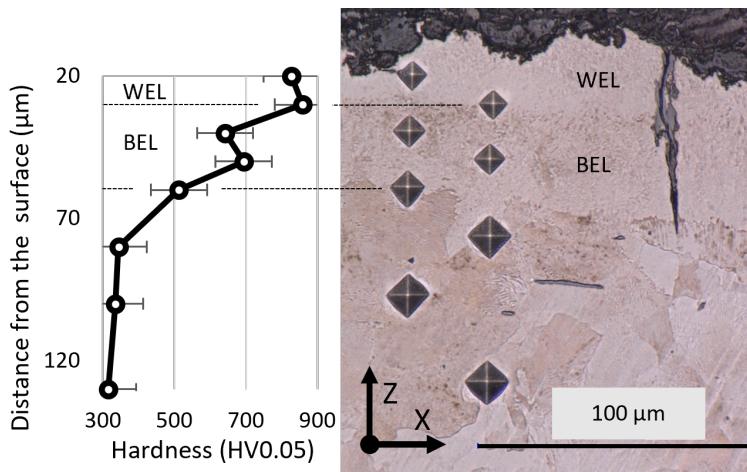
Figure 3.9: Longitudinal section of Facet 2, closest to the facet transition with facet 3. A $80\text{ }\mu\text{m}$ corroded WEL and BEL is present at the surface. The graph presents the measurement results at the corresponding measurement positions.

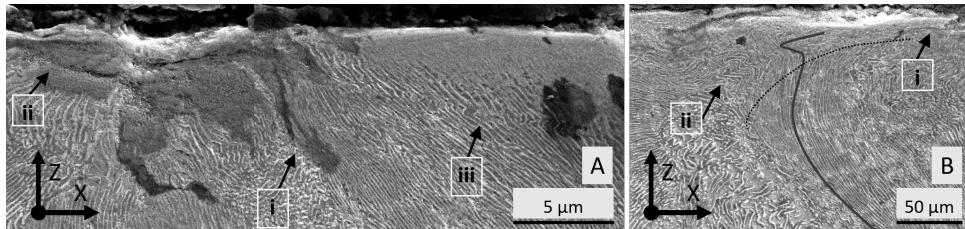
Figure 3.10: Longitudinal section of Facet 2, closest to the facet transition with facet 3. The observations are made using high-magnification SEM. A) Damage initiates, see *i*, between the oxide-filled irregularity, see *ii*, and the WEL patch at the contact surface. Wrinkled pearlite lamellae are present at the edge of the WEL, see *iii*. B) A wear tongue and s-shaped deformation patterns, associated with the bi-directional use of the railway line, are present, see *i*. Wrinkled pearlite lamellae evidences multiple deflection occurrences, see *ii*.

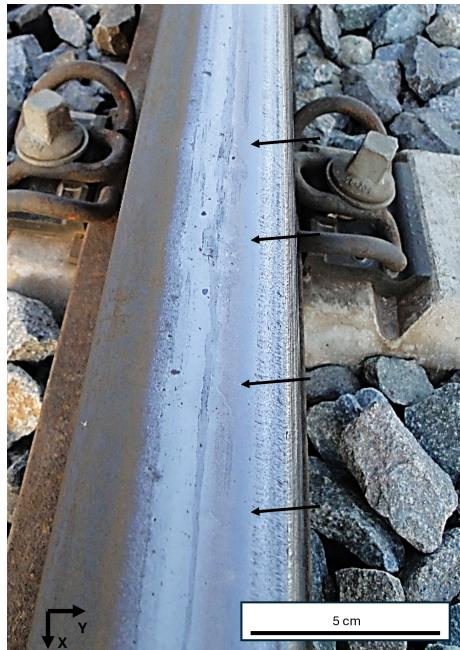
Figure A.3: Running surface of the rail made from rail steel with improved wear properties. The arrows indicate the squat-type defects that are present. Defects cause only minor subsidence of the surface which is typical for rails made from these steels.

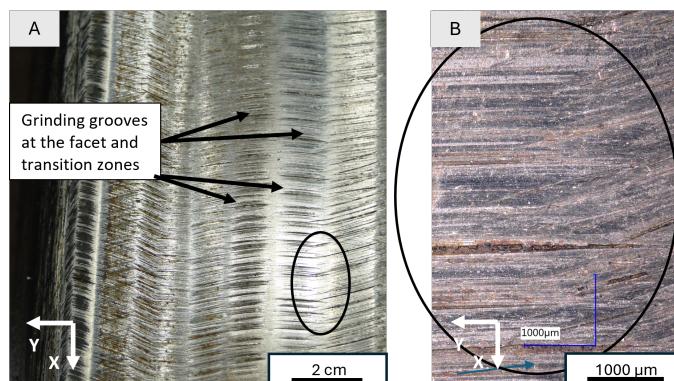
Figure A.6: Quick scan of the surface of RS0.4. A) The contact surface formation. B) A deeper grinding groove at the facet transition zone.
