Commision of the European Communities
Guyana Sea Defence Lome IV Project
Essequibo/West Demerara Locations

Investigation of slip failures at
Henrietta and Anna Regina

Delft Hydraulics
Delft Geotechnics

October 1996

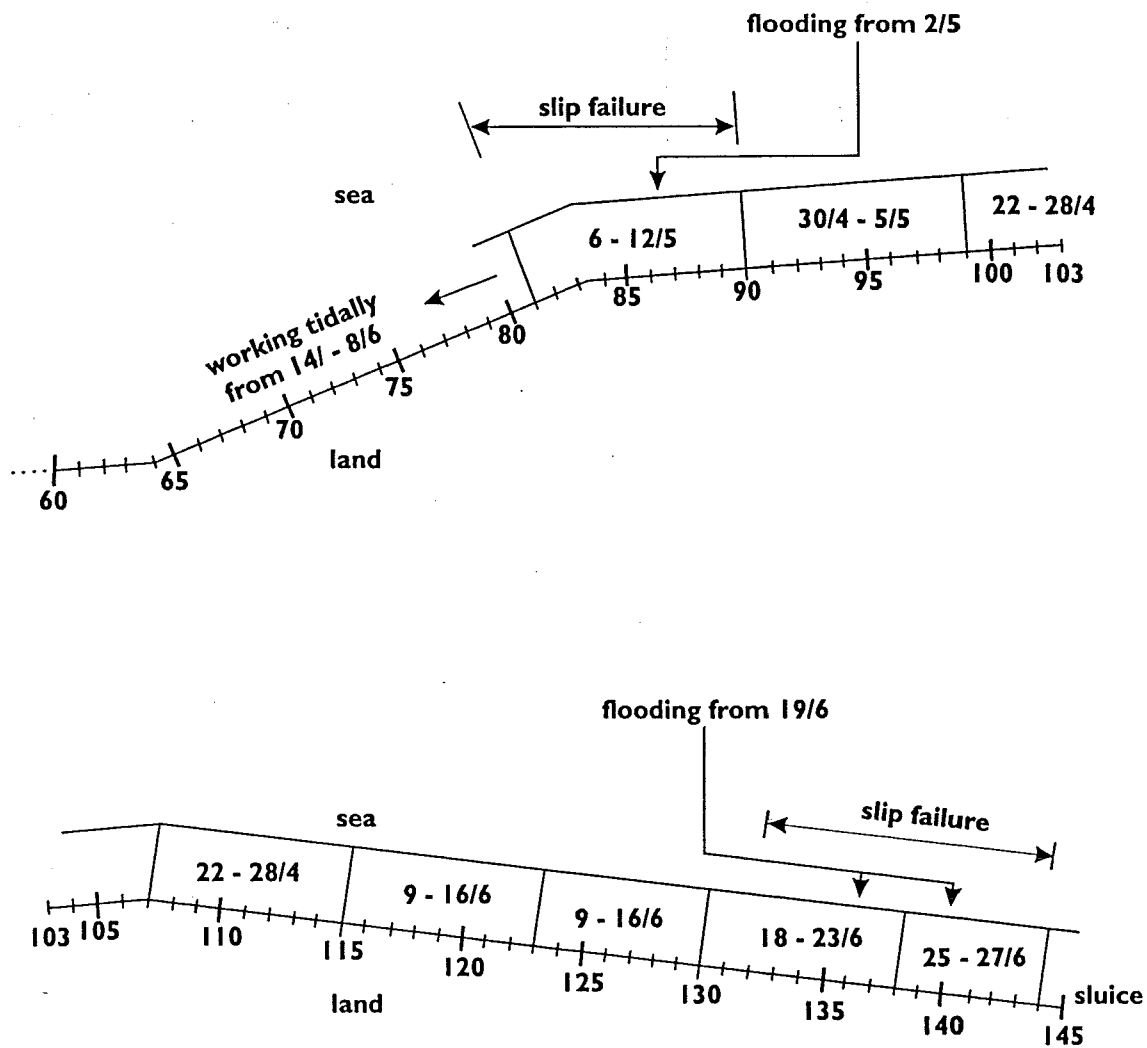
Plan view of area B from sections
60 - 145 with locations of slip failures

In Area B slip failures occurred on 2 June and 6 July 1996. A plan view of Area B with the location of cross-sections is given in Figure 2.1.2. The distance between the cross-sections is 10 m.

Subsequent to the completion of the work in the Rehabilitation area B a 90 m long section at the estate "Henrietta" experienced a slip failure on the 2nd of June 1996. The exact location of the slip failure is from Section 81 to 90. The failure has been described in PEU (5 June 1996). The slip failure was evidenced by an about 1.6 m drop at the crest of the slope and outward movement of about 1.3 m. The toe of the sea defence embankment in the failed area had risen about 0.4 m. Directly following the failure a detailed soil investigation has been carried out as described by GSEC, commissioned by PEU. The final report is given in GSEC (1996).

On the 6th of July in the same Rehabilitation area B another 120 m long section failed at the estate "Anna Regina". The exact location is from Section 132 to 144. The distance between both failures was about 400 m. This slip failure has been described by PEU (11 July 1996, PEU/EEC/61/930). Initial investigation showed that the crest had settled some 1.6 m and moved 0.7 m seaward. The toe had risen some 0.2 to 0.3 m. Photo 1 gives both a stable section and the situation after the slip failure at Anna Regina.

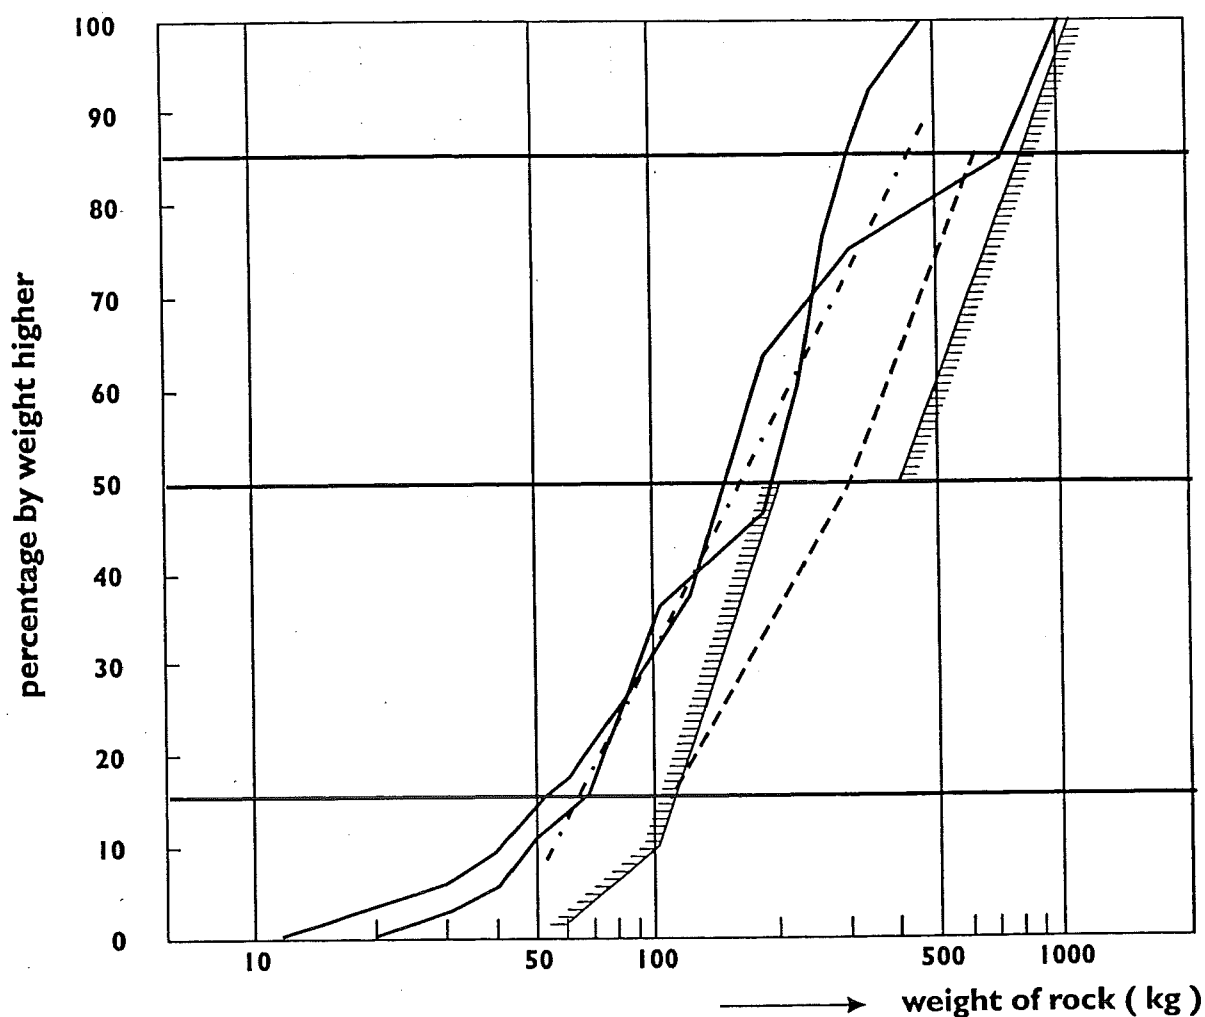
Grading curves armour rock at site I

9. The size of armour rock on the sea defence has been checked. It can be concluded that the armour rock is much too small, compared with the specifications. Instead of 100-600 kg rock with a mean weight of 300 kg, a 60-400 kg rock class is present with a mean weight of 150 kg. The difference in behaviour between 150 kg and 300 kg rock is well described by the DHV Tender Documents. In general more damage to the armour layer can be expected during high tides and waves, and probably more maintenance has to be done.

- measured grading
- - - average measured grading : 60 - 400 kg
with mean weight 150 kg
- . - . required grading : 100 - 600 kg
with mean weight 300 kg
- /// limits for grading
according to specs.

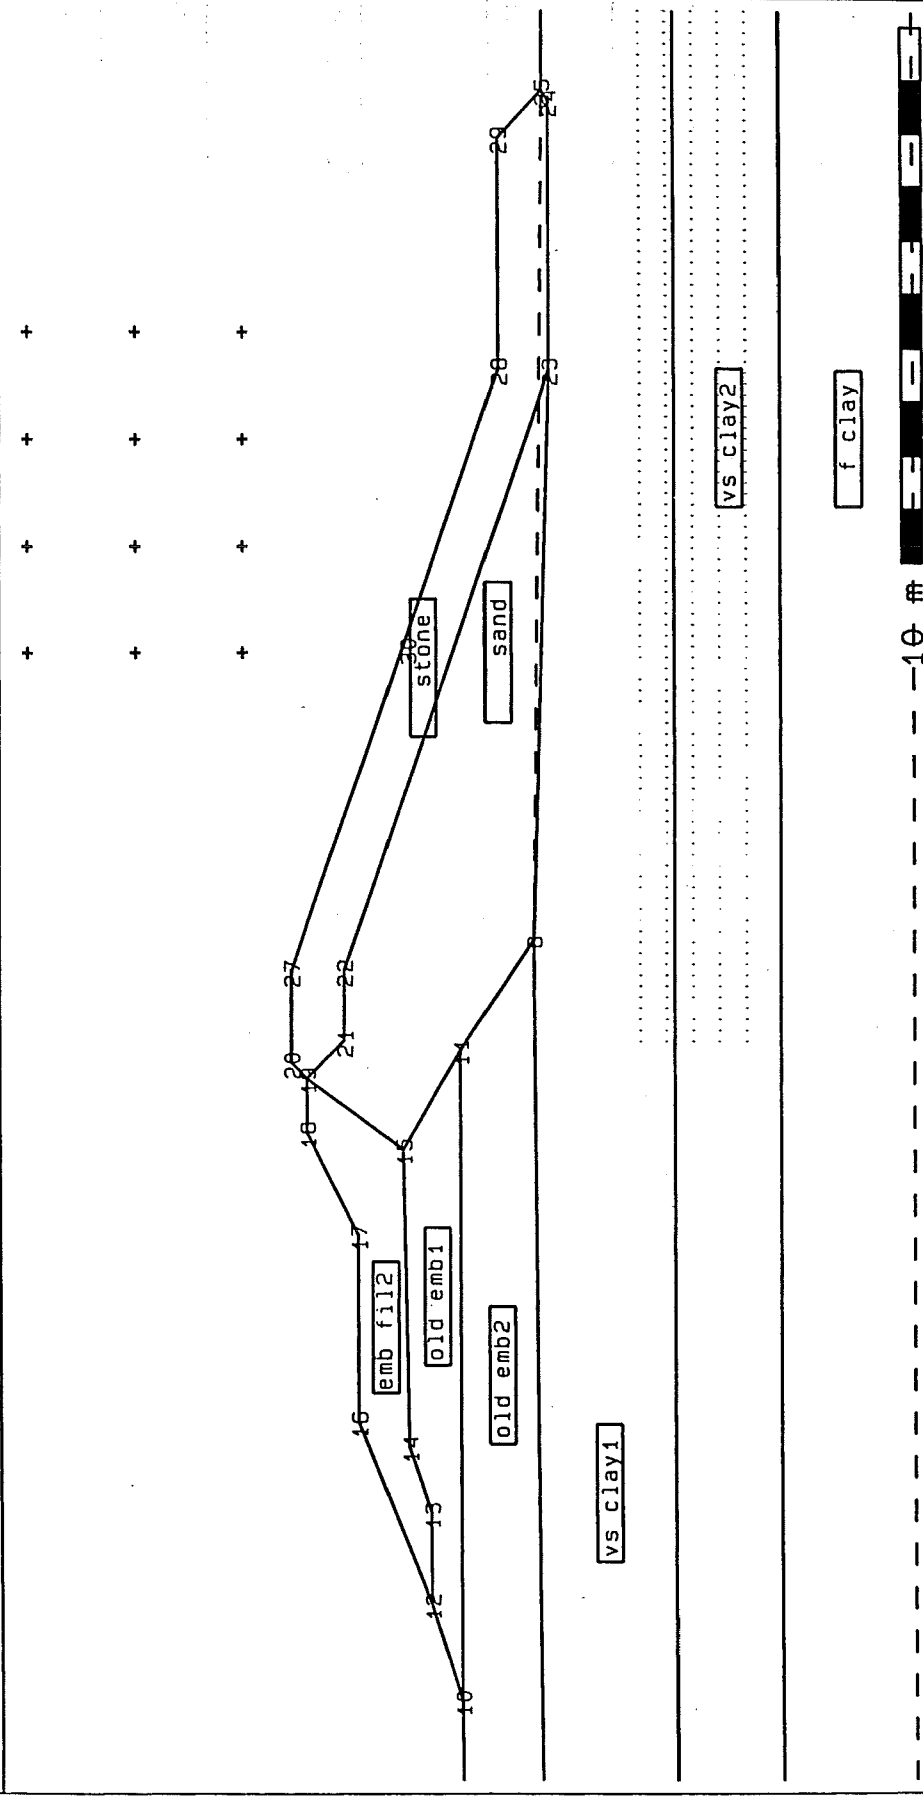
FIG. 2.5.1

Figure 2.5.2 shows the soil parameters chosen for input in the computer programme. The calculation has been done using the undrained condition (total stress analysis) which enables determining the degree of stability of the sea defence (cross-section 117) at the moment before the failure. The most unfavourable loading condition, being the low tide period right after a high tide, has been analyzed.

CRITICAL SLIP CIRCLE : Measured Cu-value

Xm = 20.00 m	R = 12.00 m	ISO 1 = 1.199
Ym = 22.00 m	Fmin = 1.199	ISO 11 = 1.809

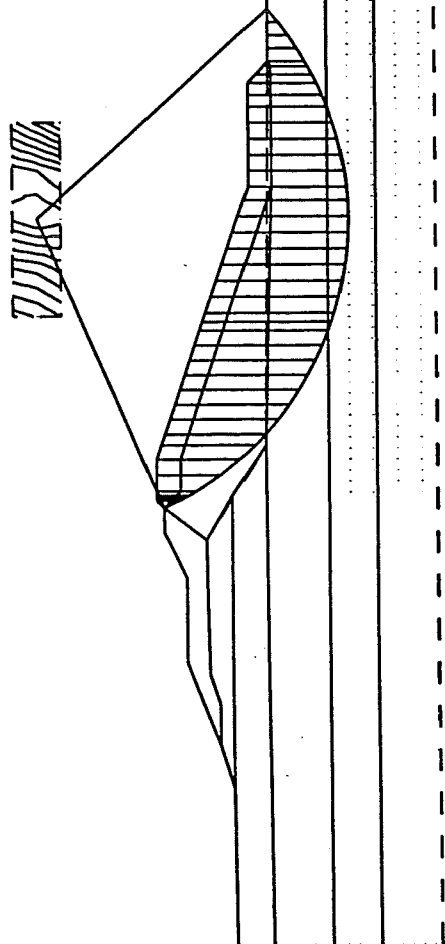
In order to determine the effect of the much lower shear strengths measured near the seaside toe in the Henrietta site after the failure, the calculation has been done applying the lower C_u -values, measured in the soft clay layers near this toe. The corrected C_u values decreased to 12 kPa in the very soft clay, see the table in Figure 2.5.3. The result is that the minimum stability factor decreased to 0.62, which means slip failure.

CRITICAL SLIP CIRCLE : Measured Cu-value

$X_m = 20.00 \text{ m}$ $R = 13.00 \text{ m}$ $Iso \ 1 = 0.620$
 $Y_m = 24.00 \text{ m}$ $F_{min} = 0.620$ $Iso \ 11 = 0.912$

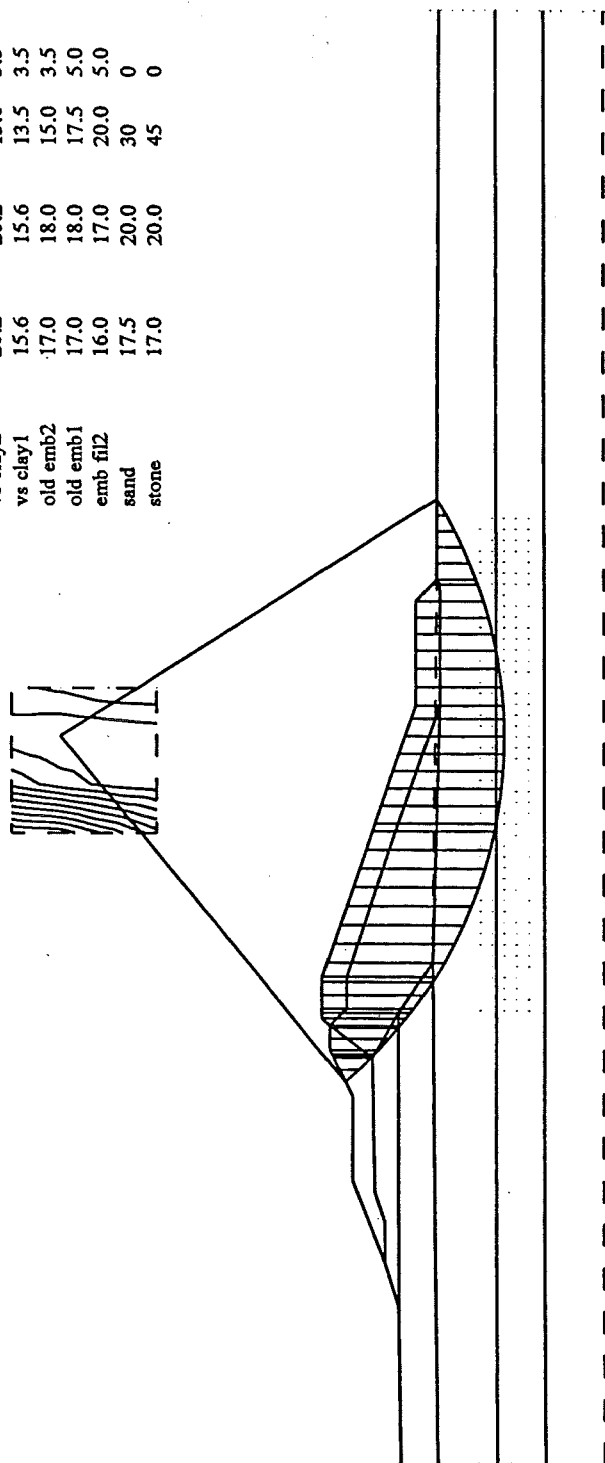
Further the stability of the sea defence has been analyzed using effective stress parameters and taking into account the rate of dissipation of the pore pressures at the moment before the failure. The rate of dissipation has been derived from the consolidation parameters, determined in the laboratory (GSEC, 1995-1). See also Section 2.5.4 on settlement. The stability model and the parameters for the embankment fill material and the rip rap are the same as used in the total stress analysis. The effective stress parameters for the cohesive materials are estimates. Those for the soft clay have been taken from the Nedeco (1972).

CRITICAL SLIP CIRCLE : Bishop

DELFT GEOTECHNICS	Xm = 20.00 m	R = 18.50 m	Iso 1 = 0.948
Lic: INTERN Cop: S1	Ym = 30.00 m	Fmin = 0.948	Iso 11 = 1.310

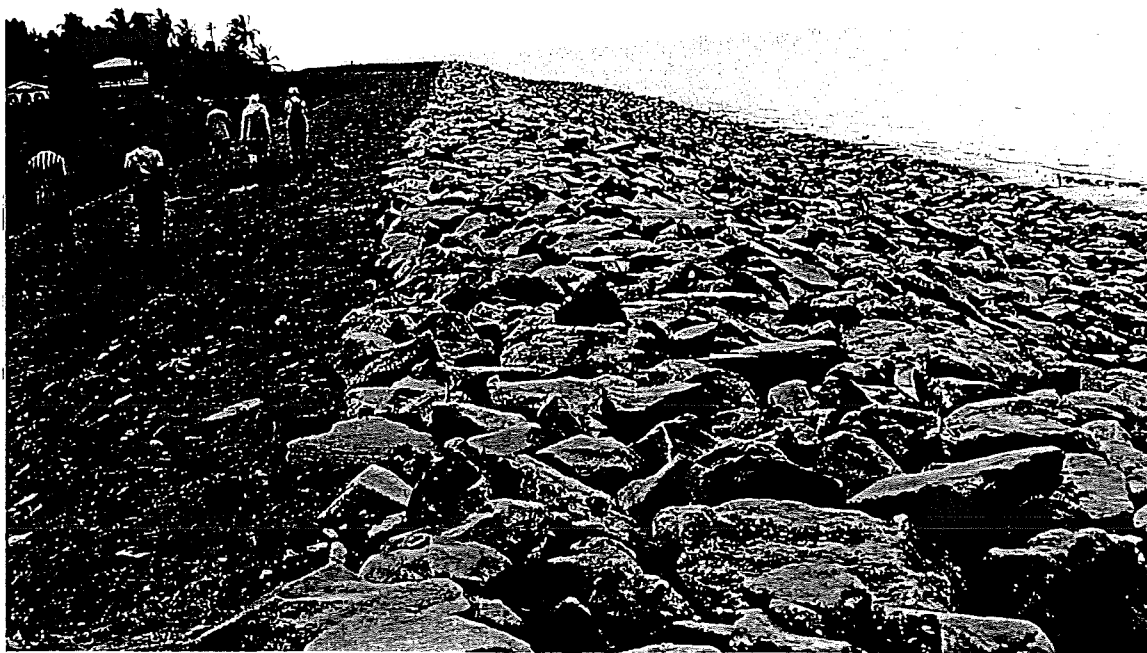
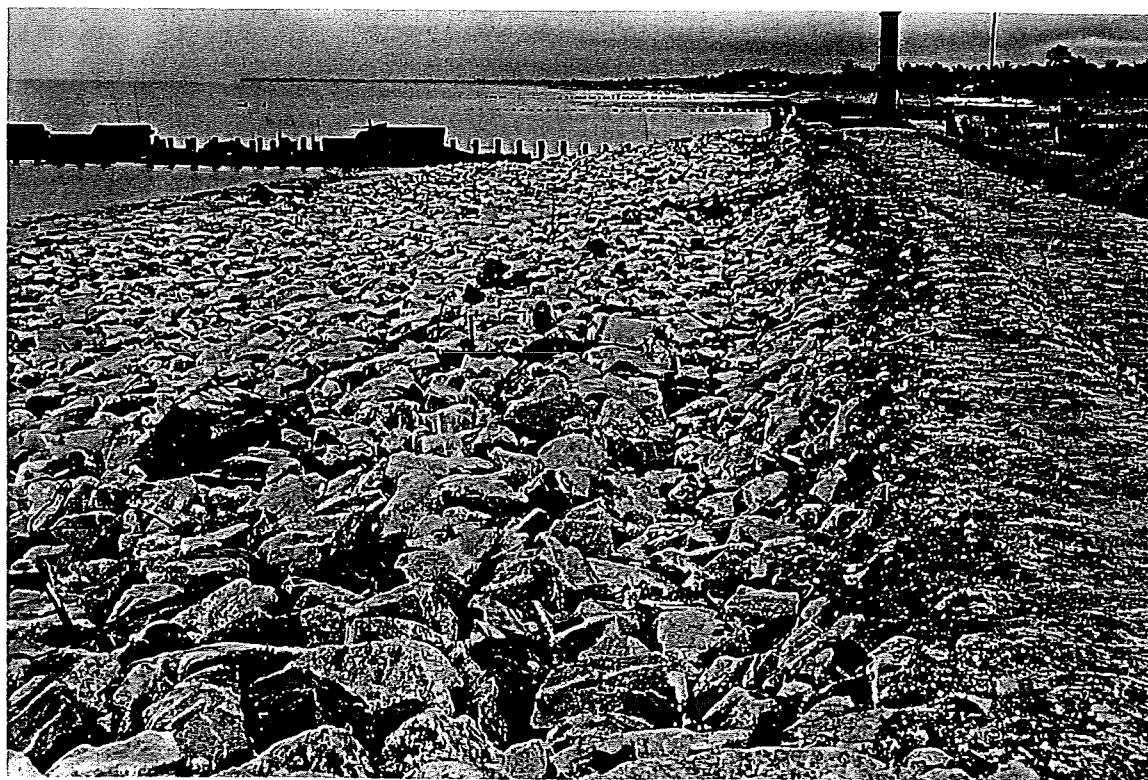
Constructed and stable section (above)
and slip failure at Anna Regina (below)
