Failure of the breakwater
at port Sines,
Portugal

ASCE Port Sines Investigation Panel

1982

*This report is an investigation of the breakwater
failure that occurred on February 26, 1978,
and a compendium of data and reports relevant to this failure.*

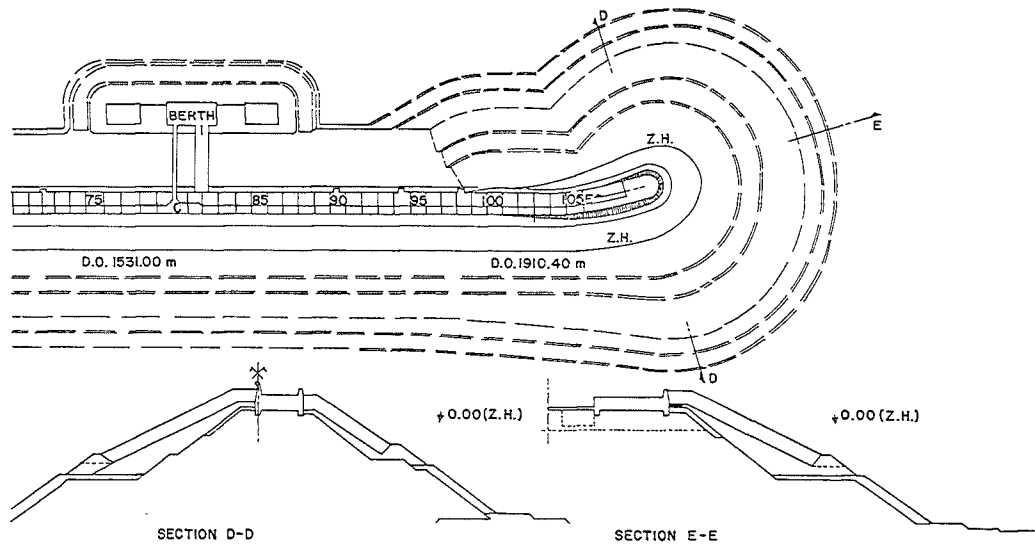
FIGURE 5.2 LOCATIONS OF MISSING 3-6 TON STONE AT TIME OF STORM

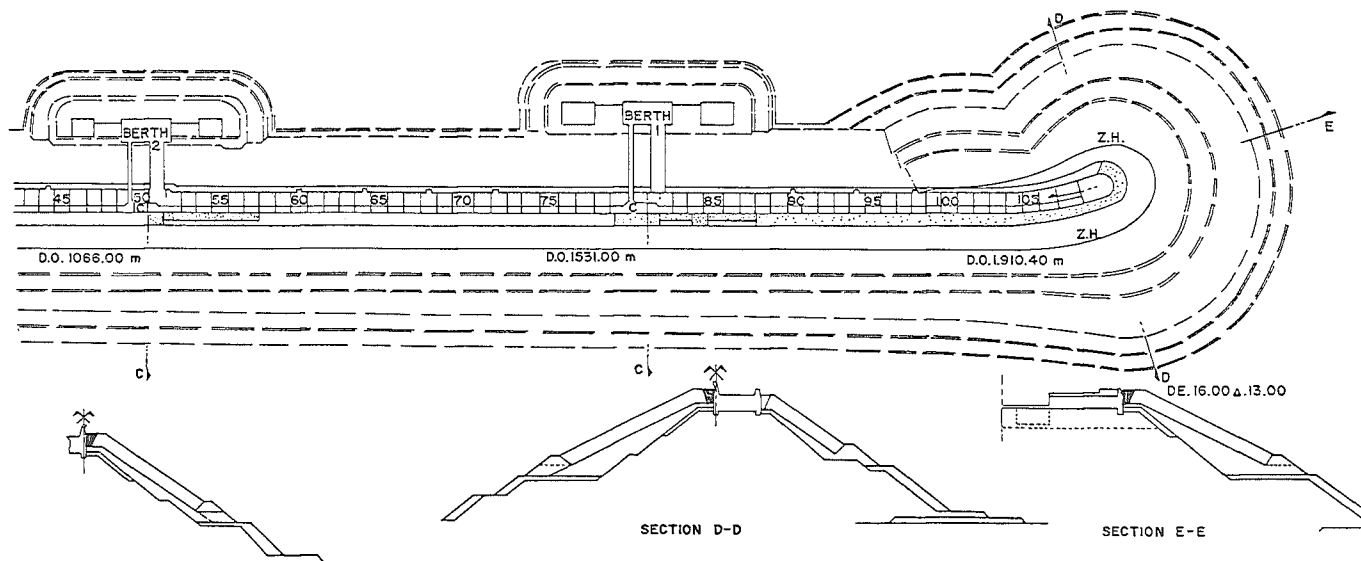
FIGURE 5.3 LOCATIONS OF MISSING DOLOS AT TIME OF STORM

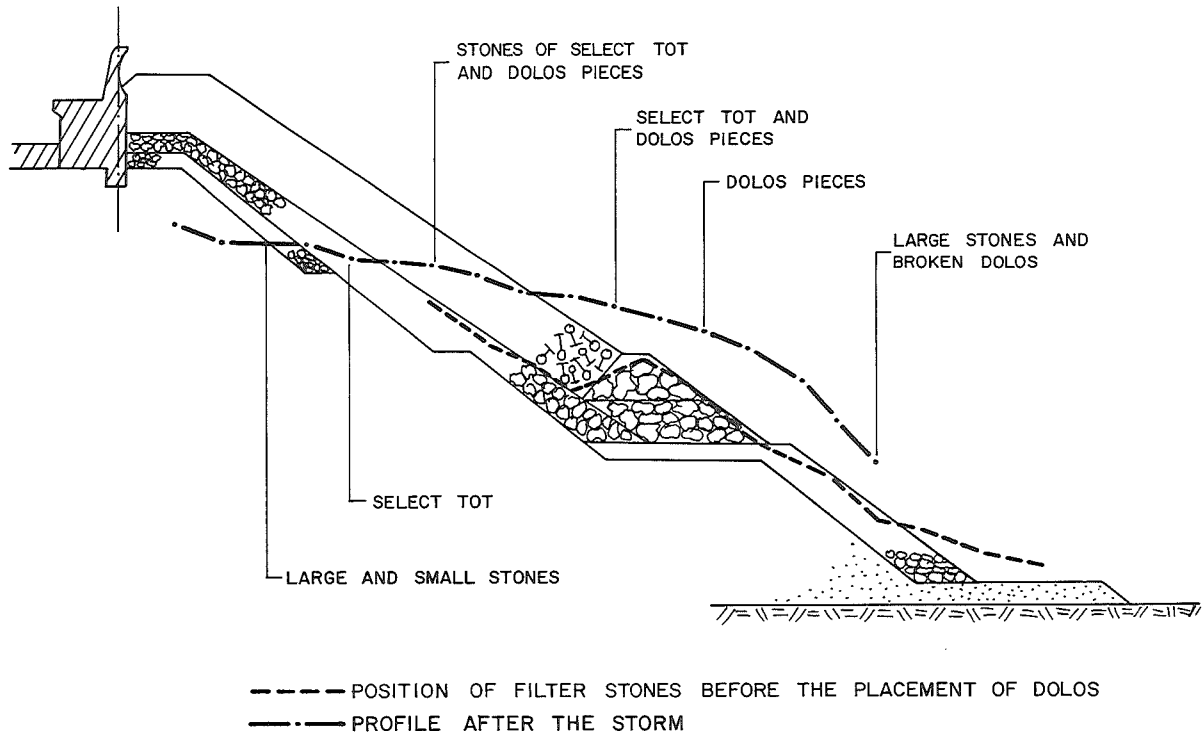
FIGURE 7.1 A TYPICAL CROSS-SECTION AS OBSERVED BY DIVERS

face of the breakwater near caisson number 81 (these numbers are located in Figure 5.2) to a depth of -30 m where the bed rock is at a depth of -45 m. From there they swam along at that depth to a point near caisson 83 and ascended over the face of the breakwater. On their dive no whole or intact dolos were observed. Moreover, very little other material was lying with the fragments of dolos except at the maximum depths reached. Essentially the inspection by the panel members corroborated the data reports referenced in Appendix I by the Navy divers that virtually all of the underwater units were broken, irrespective of the state of the dolos above the water level. It also revealed recent movements of the broken dolos parts.

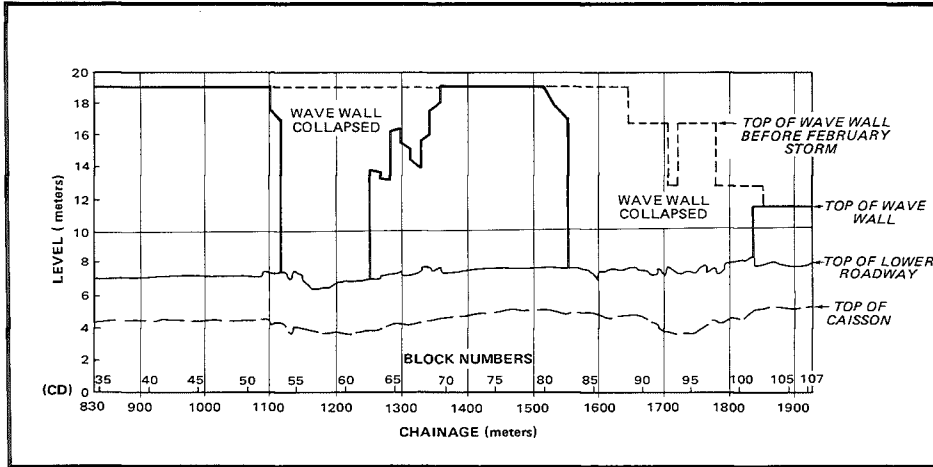
FIGURE 7.2 LONGITUDINAL PROFILES OF THE SUPERSTRUCTURE
AFTER THE STORM (GAS)

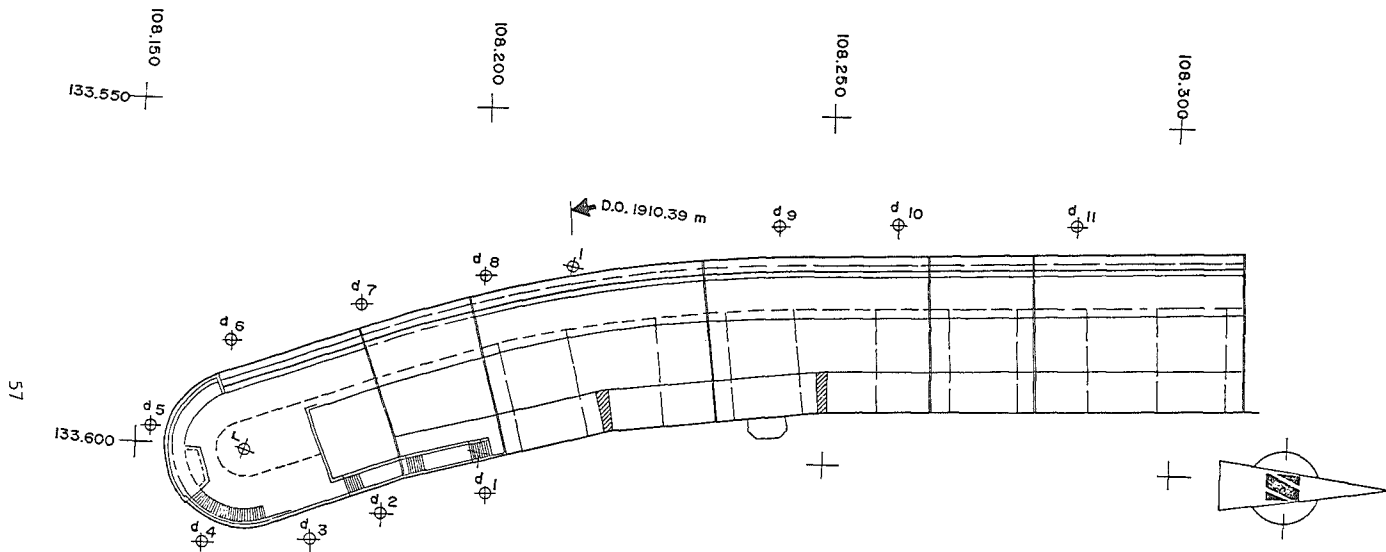
NET MOVEMENT OF INDIVIDUAL DOLOS AT THE HEAD
AS DETERMINED BY PRE- AND POST-STORM SURVEYS (METERS)

FIGURE 7.3 LOCATION OF INDIVIDUAL DOLOS AT HEAD FOR WHICH PRE AND POST STORM POSITIONS WERE OBTAINED

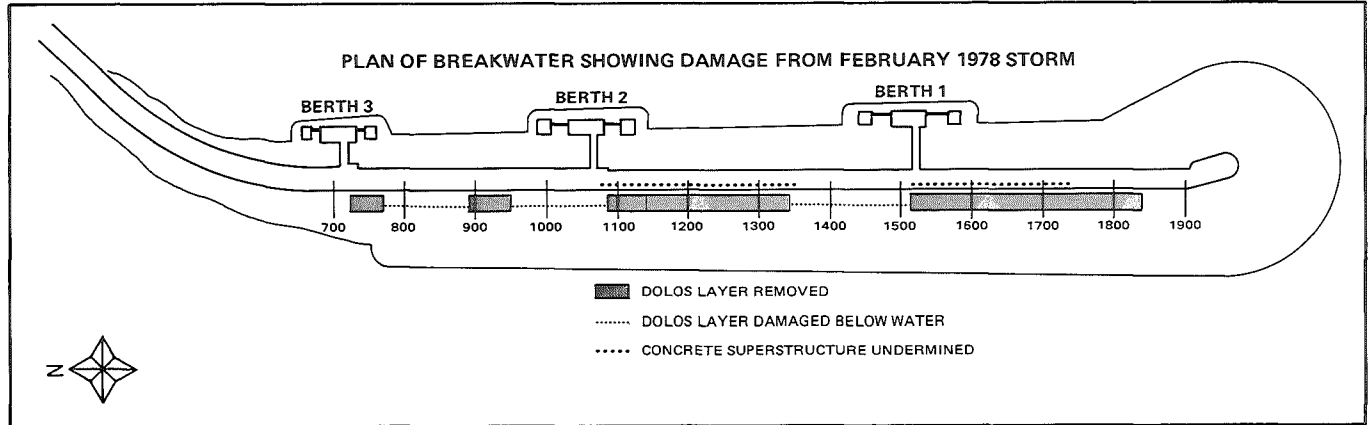
In many sections of the breakwater the dolos armor above the water level was completely removed, leaving the primary filter layer, and in some cases the core material, exposed. Only near berth number 3 and shoreward did the armor layer remain intact. Near the head, as indicated previously, some settlement and a few broken units were observed. Between the head and berth number 3 the heavily damaged sections were distributed as shown in Figure 7.4. It must again be emphasized that although the armor units were intact above the water level in some locations, the armor units were by-and-large damaged below the water level.

FIGURE 7.4 PLAN OF BREAKWATER SHOWING DAMAGE
LOCATIONS FROM FEBRUARY 1978 STORM

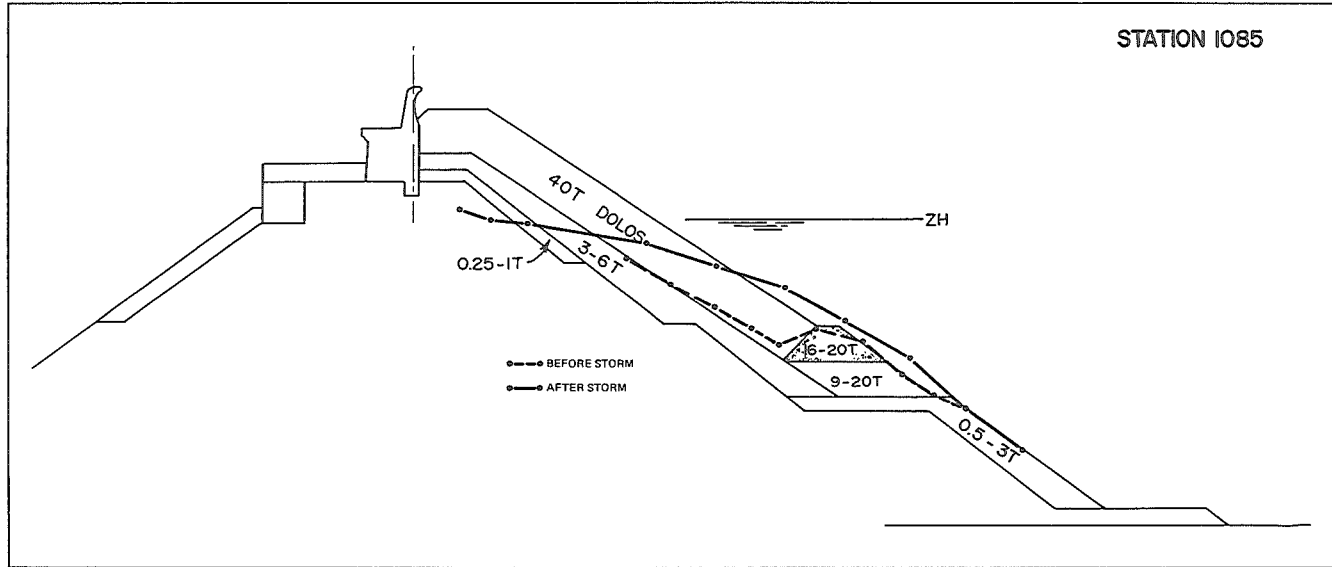
STATION 955

Cross Sections of Breakwater Before
and After February Storm
