## The Quay Walls of Amsterdam, Netherlands

### An Approach for Collapse Risk Mitigation at the Municipal Scale Based on Multisource Monitoring and Surveying Data

Luongo, Davide; Nicodemo, Gianfranco; Venmans, Arjan; Korff, Mandy; Sartorelli, Luca; Maljaars, Hanno; Peduto, Dario

Journal of Geotechnical and Geoenvironmental Engineering

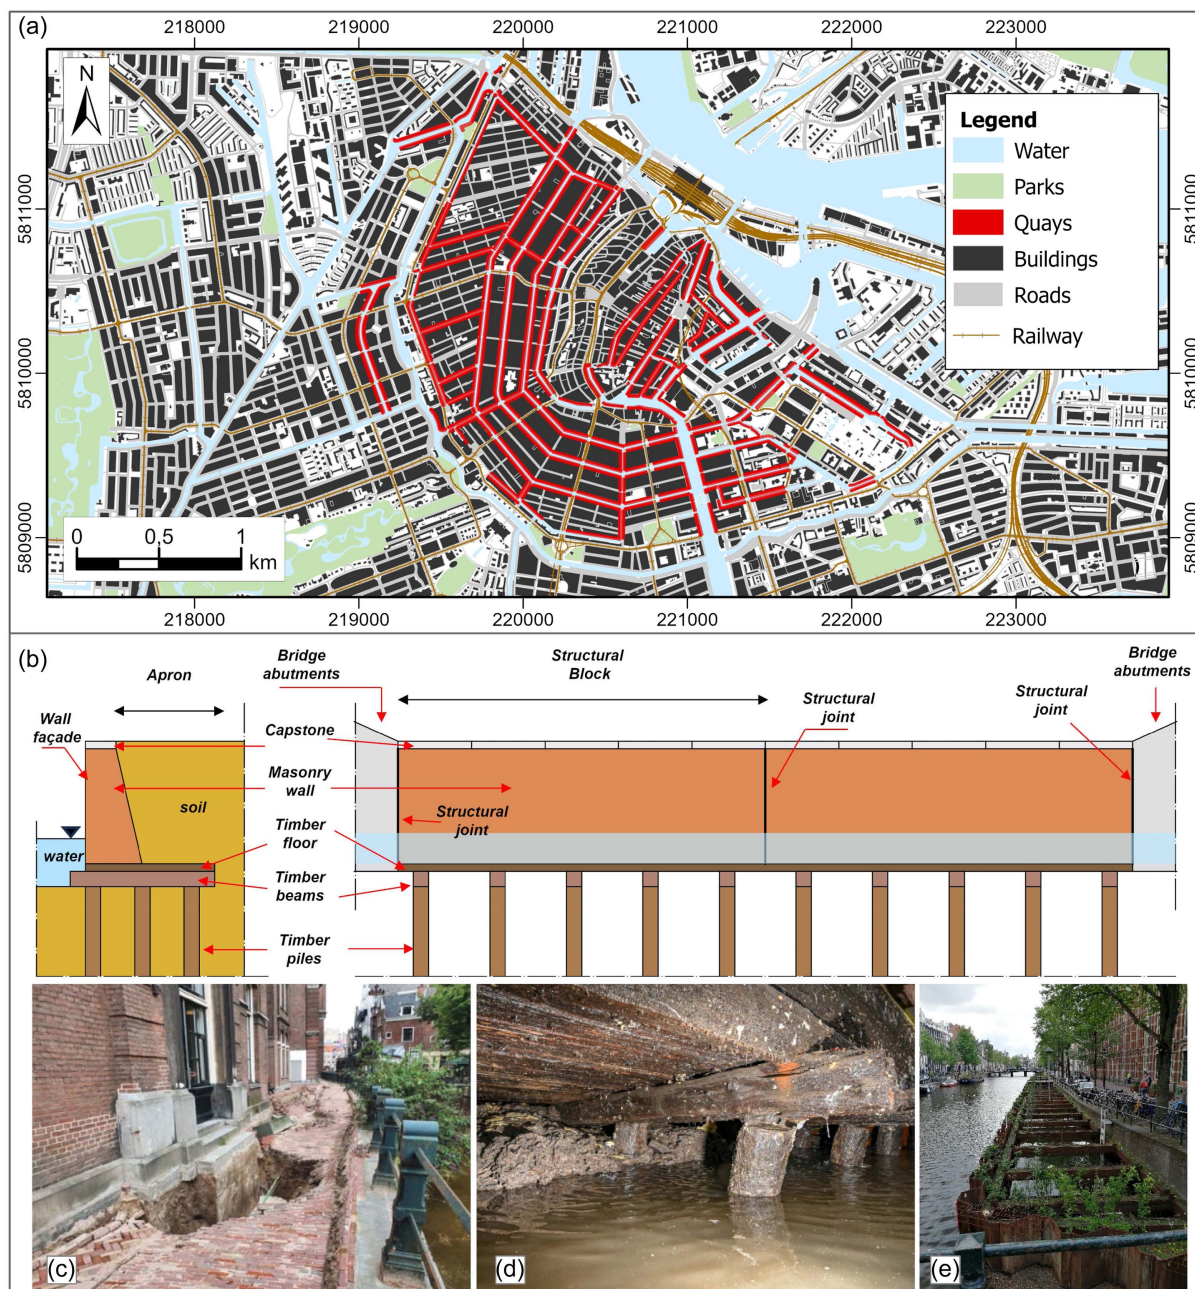
The municipality of Amsterdam has developed a program *Routekaart Amsterdam Klimaatneutraal 2050* (Roadmap Amsterdam Climate Neutral 2050) (Amsterdam Gemeente 2020) to reduce the impacts of climate change. In recent years, several quays have reached collapse; notable examples are the Entrepotdok (Van Belzen 2017) and the Marnixstraat in 2017 (AT5 2017), the Nassaukade in 2018 (AT5 2018) and the Grimborgwal in 2020 shown in Fig. 2(c) (Korff et al. 2022).

**Fig. 2.** (a) Map of quay walls in Amsterdam city center (map data © OpenStreetMap); (b) typical quay wall structure; (c) example of collapsed quay wall in Grimburgwal in 2020; (d) decay of wooden piles (reproduced with permission from [van Maarschalkerweerd 2022](#)); and (e) example of temporary intervention in May 2022.

There are several phases that lead to the possible replacement of the quays. First, mitigation measures aimed at reducing the magnitude of the transfer loads are used when the presence of heavy loads on the land side of the quay wall poses the main risk for the stability of the wall. Alternatively, temporary measures, such as the installation of sheet piles [Fig. 2(e)], are used when the quay wall structure must be supported from the water side to guarantee its stability. When the quay wall and the waterfront are no longer safe, the replace measure is applied; the old wall structure and waterfront behind must be demolished. The process of replacing inner-city quay walls is complex, because of the limited working space on both land and water (think of the presence of houseboats), and many functions and interests have to be taken into account. The traditional method, which involves the creation of a building pit in which the old wall is

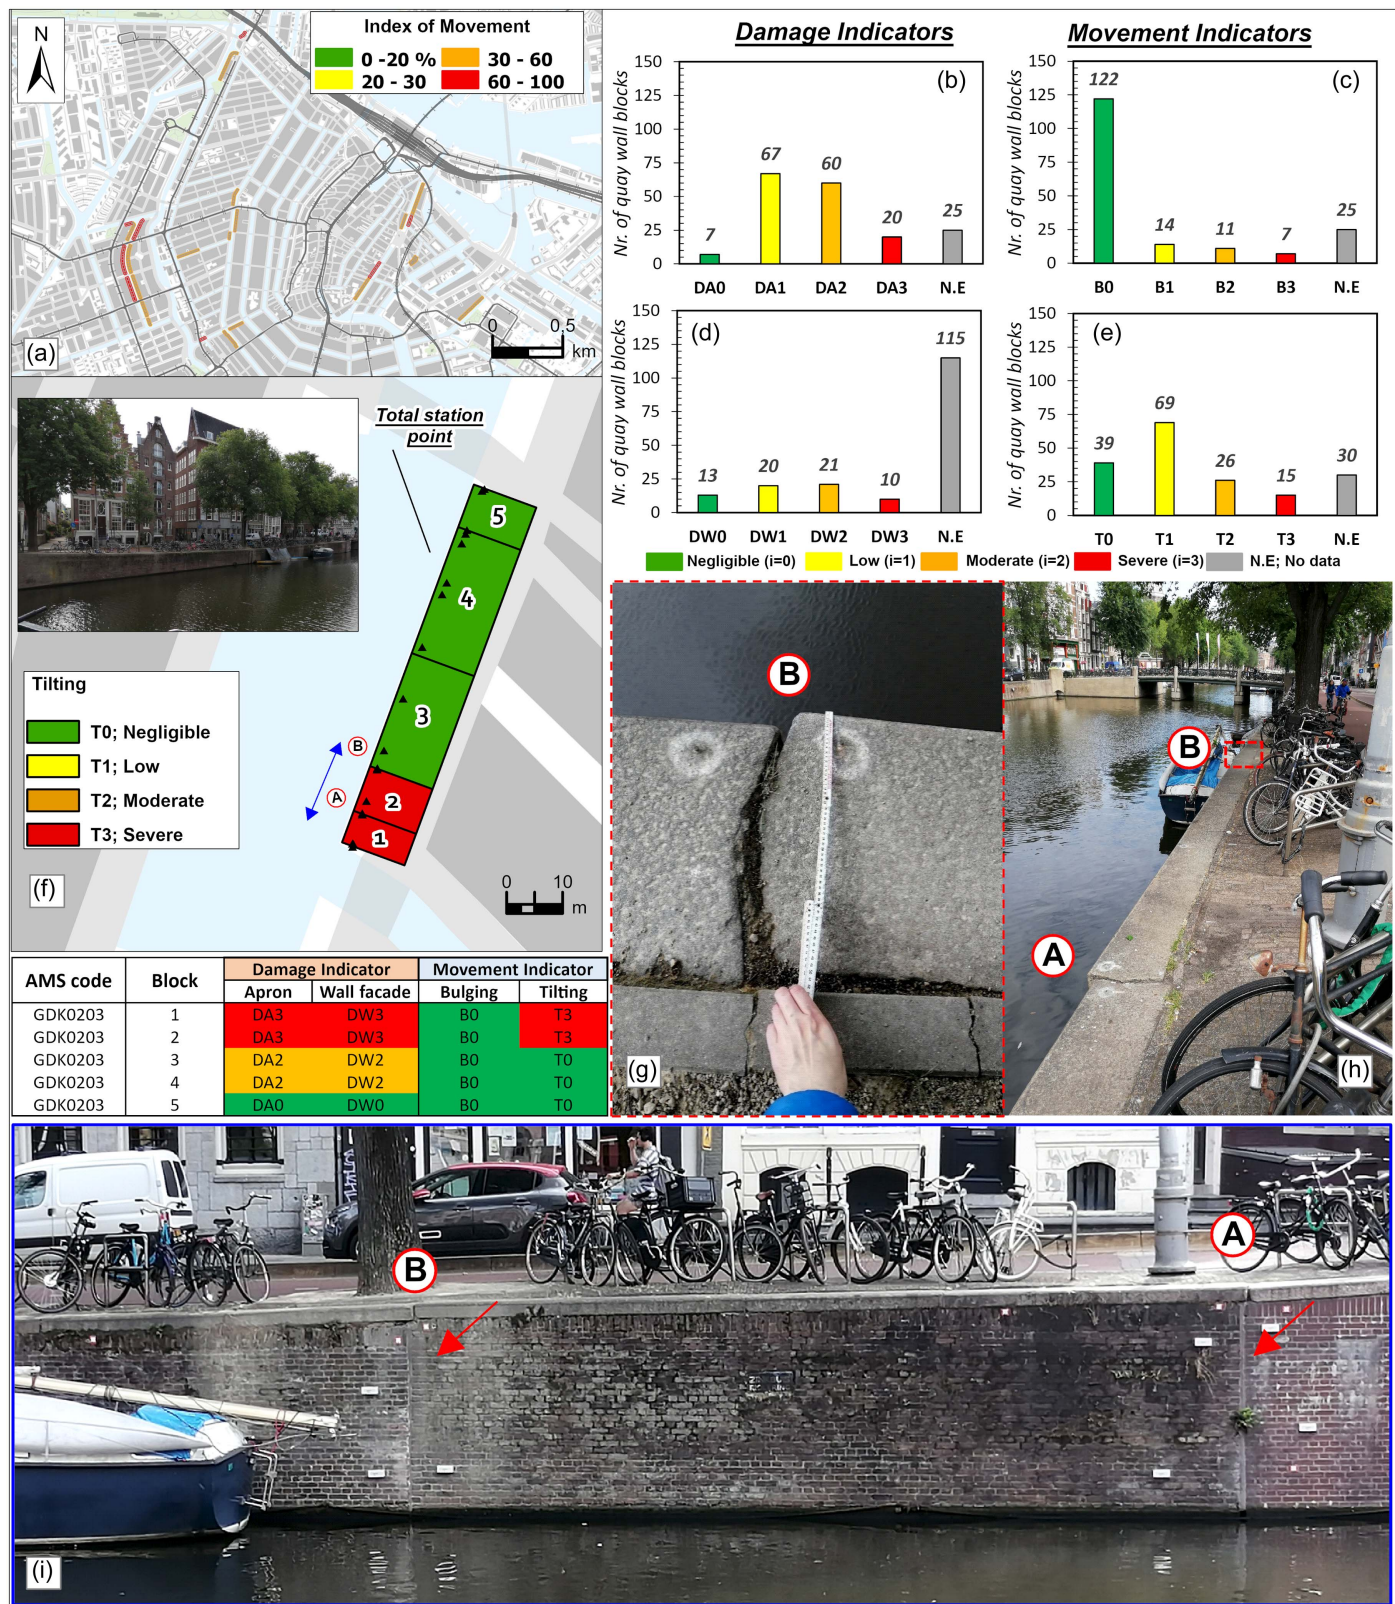
A total of 179 blocks comprising the 26 quay walls was identified. Damage indicators (damage to apron,  $DA_i$ ; damage to wall façade,  $DW_i$ ) and movement indicators (bulging,  $B_i$ ; tilting,  $T_i$ ) were associated with each block. Importantly, for some blocks it was not possible to assess the damage and movement indicators because of, for instance, the presence of boats moored along the quay walls or the temporary inaccessibility of the quay; in Figs. 8(b–e) this group of blocks is classified as N.E. (not evaluable, colored in gray).

Fig. 8(f) provides an example of the analysis of the tilting along with the distribution of its severity levels, and the summary table of all the indicators along the blocks of the quay wall GDK0203 located in Geldersekkade 101; Figs. 8(g–i) displays some photos taken during the in situ investigations highlighting the presence of displacements and cracks at points A and B on the dock GDK0203.

**Fig. 8.** (a) Map of 26 surveyed quay walls (map data © OpenStreetMap). Frequency of severity level with reference to: (b) damage to apron (DA<sub>i</sub>); (c) bulging (B<sub>i</sub>); (d) damage to the wall façade (DW<sub>i</sub>); and (e) tilting (T<sub>i</sub>). (f) Example of tilting severity levels on different blocks of the quay wall GDK0203 (located in Gelderse kade 101; map data © OpenStreetMap) and summary table of damage and movement indicators for each block comprising the GDK0203 quay wall; and (g–i) photos of the first two blocks (taken during the in situ survey dated August 2022).

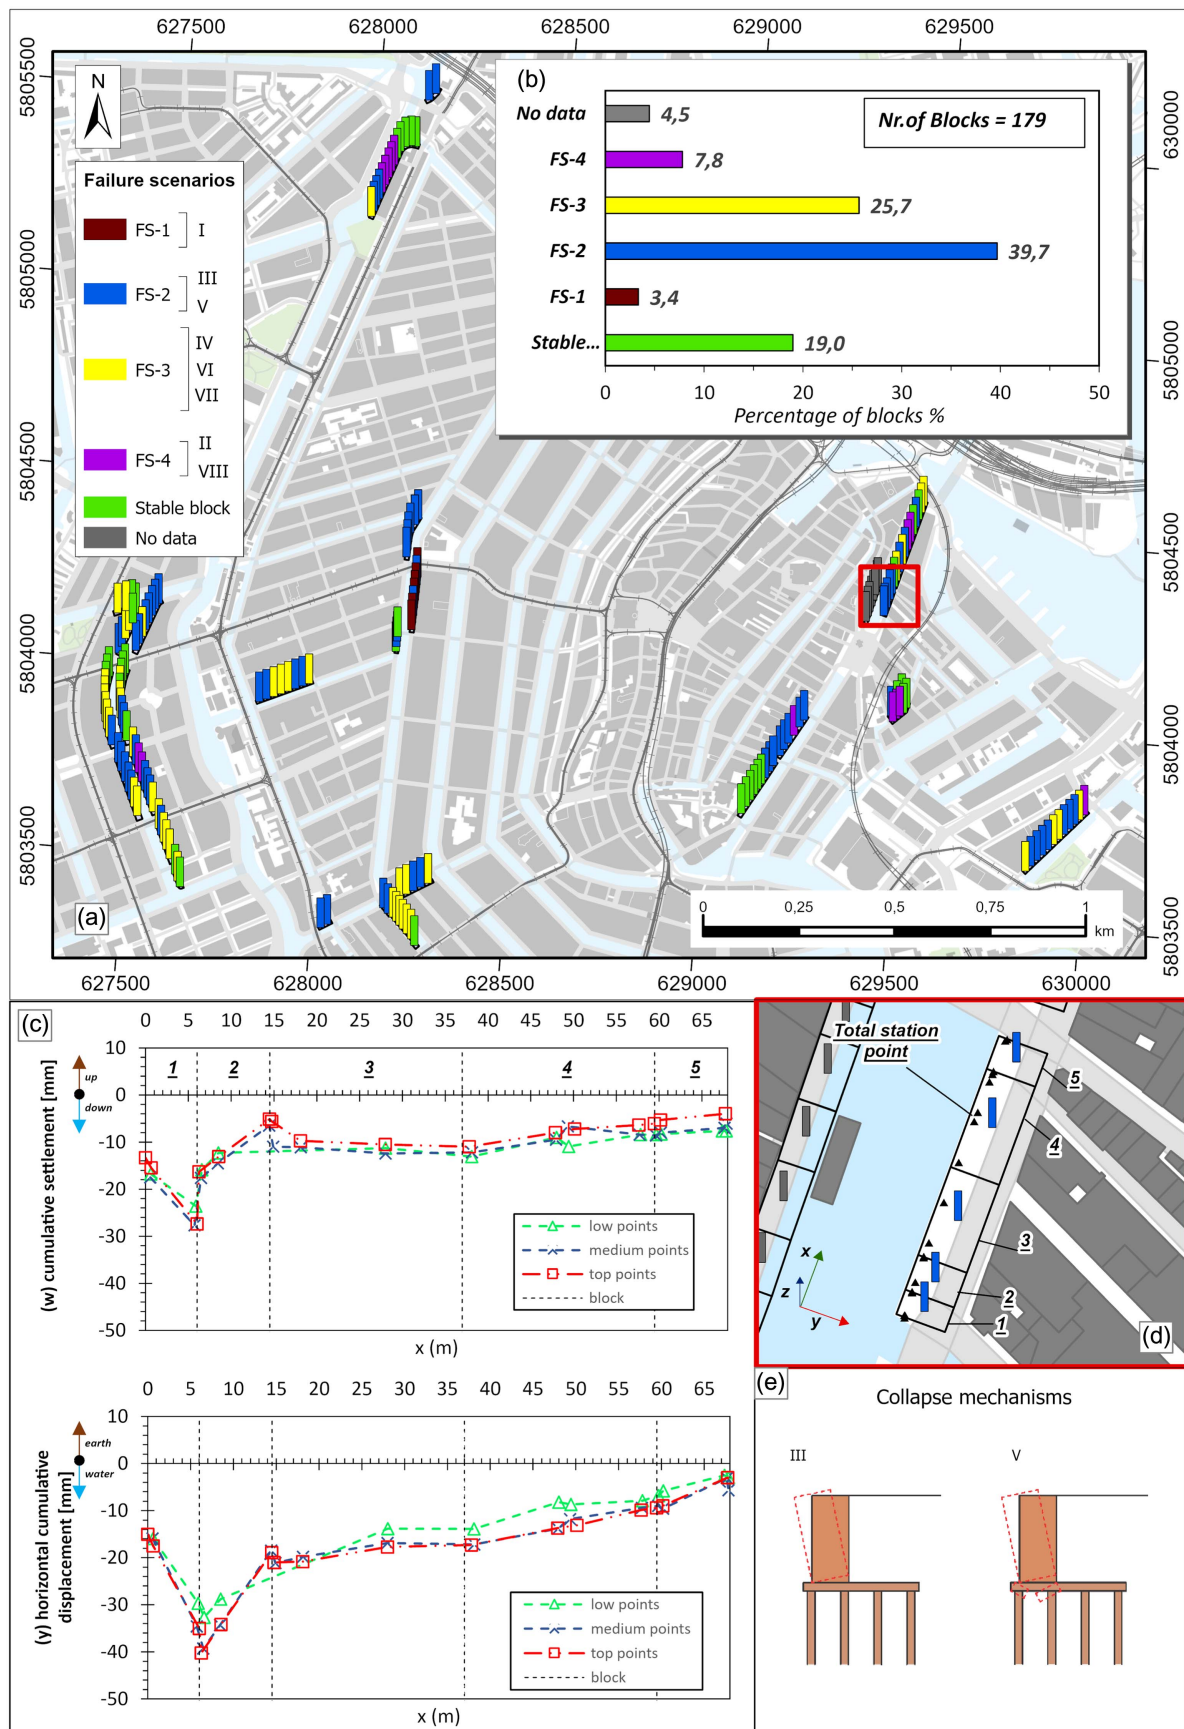
**Fig. 12.** (a) Spatial distribution of the collapse mechanisms on the 26 investigated quay walls (map data © OpenStreetMap); (b) distribution of collapse mechanism and their different combinations (failure scenarios, FS); (c) example of vertical and horizontal displacement plot and identification of possible collapse mechanism for each block comprising GDK0203 quay wall; (d) Zoom on GDK0203 (map data © OpenStreetMap); and (e) collapse mechanisms assigned to GDK0203 quay wall.

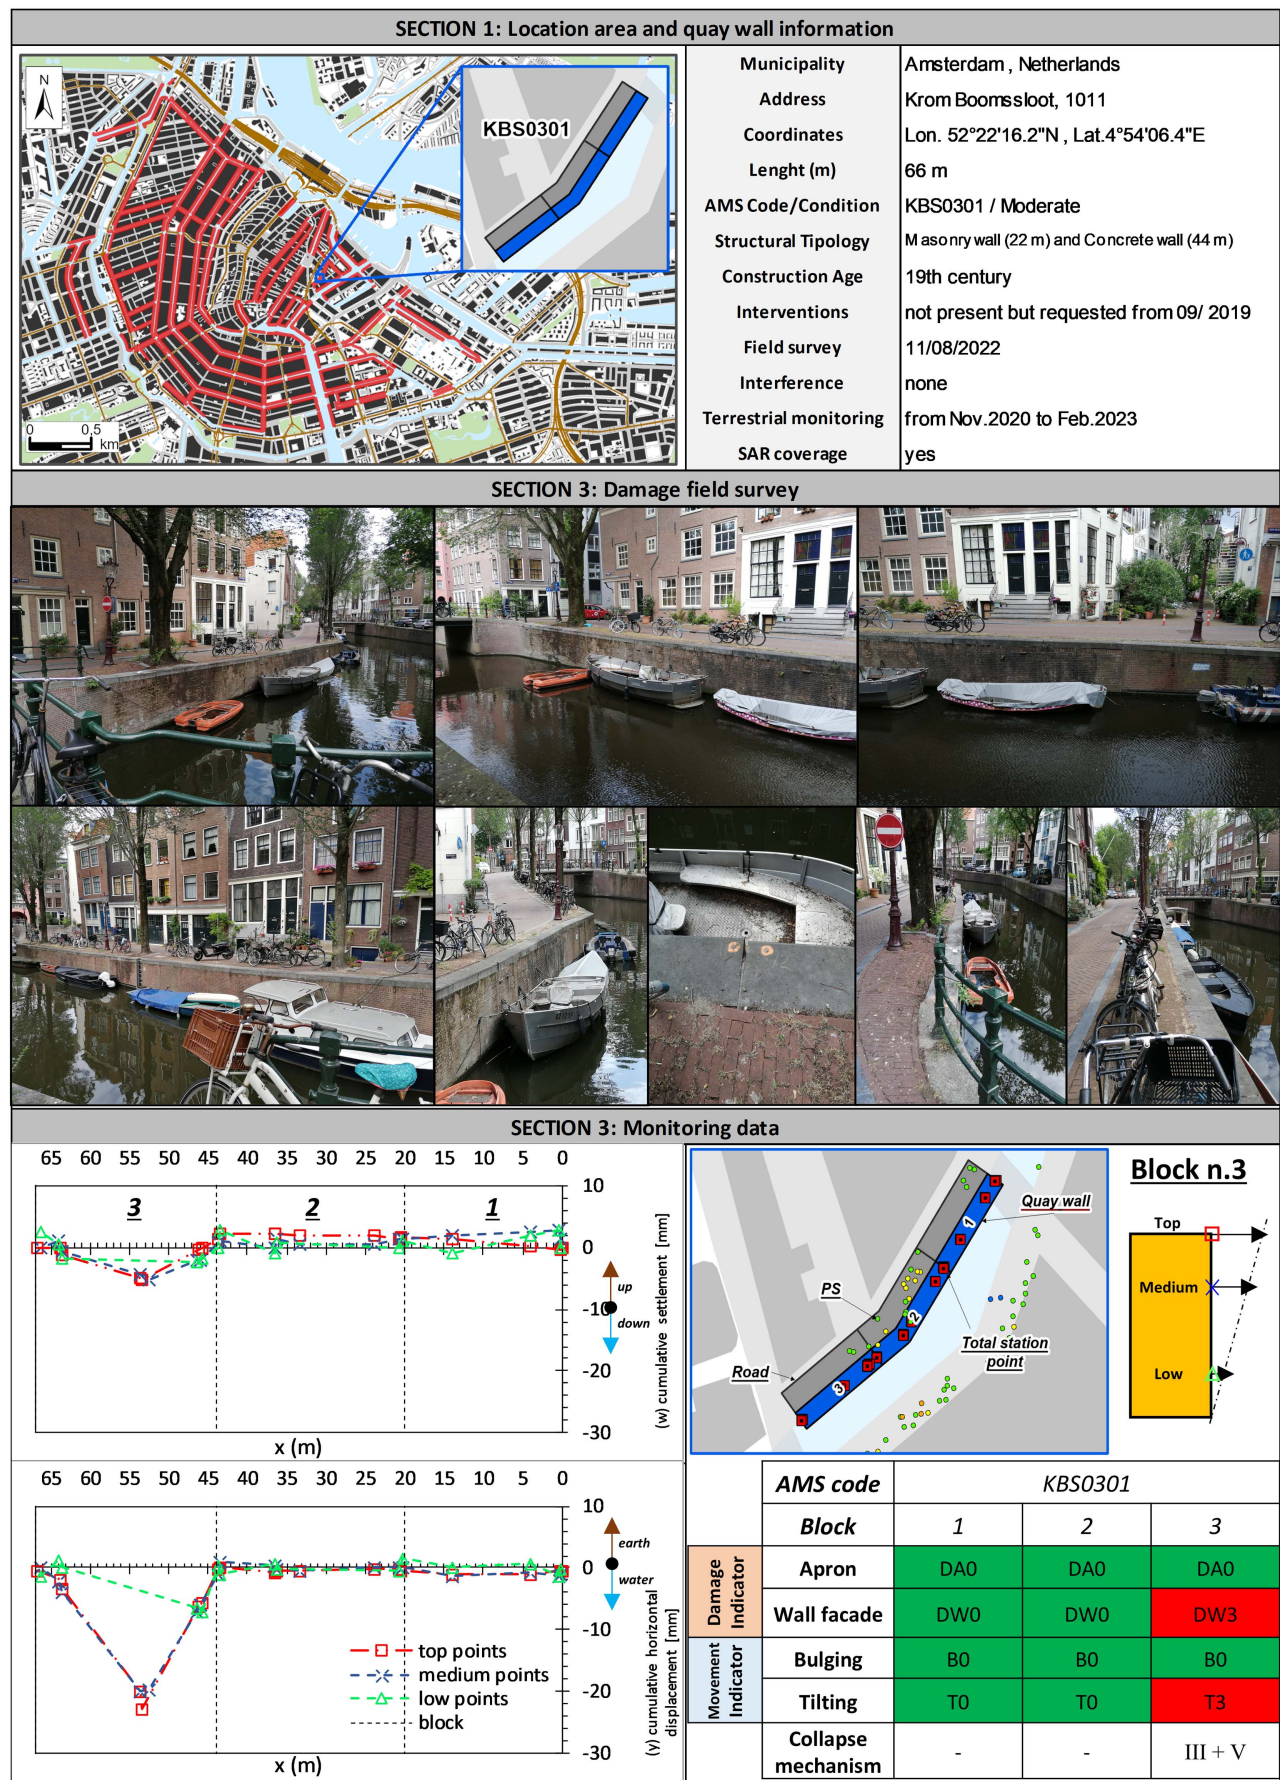
the results for block 3 show that the possible tilting mechanism (see the matrix in Fig. 13 where tilting is ranked T3) could be caused by a problem with the first row of foundation piles [this condition is highlighted in red in the table of Fig. 13(e)].

**Fig. 13.** An example of the factsheet of quay wall KBS0301 located in Krom Boomssloot. (Map data © OpenStreetMap.)

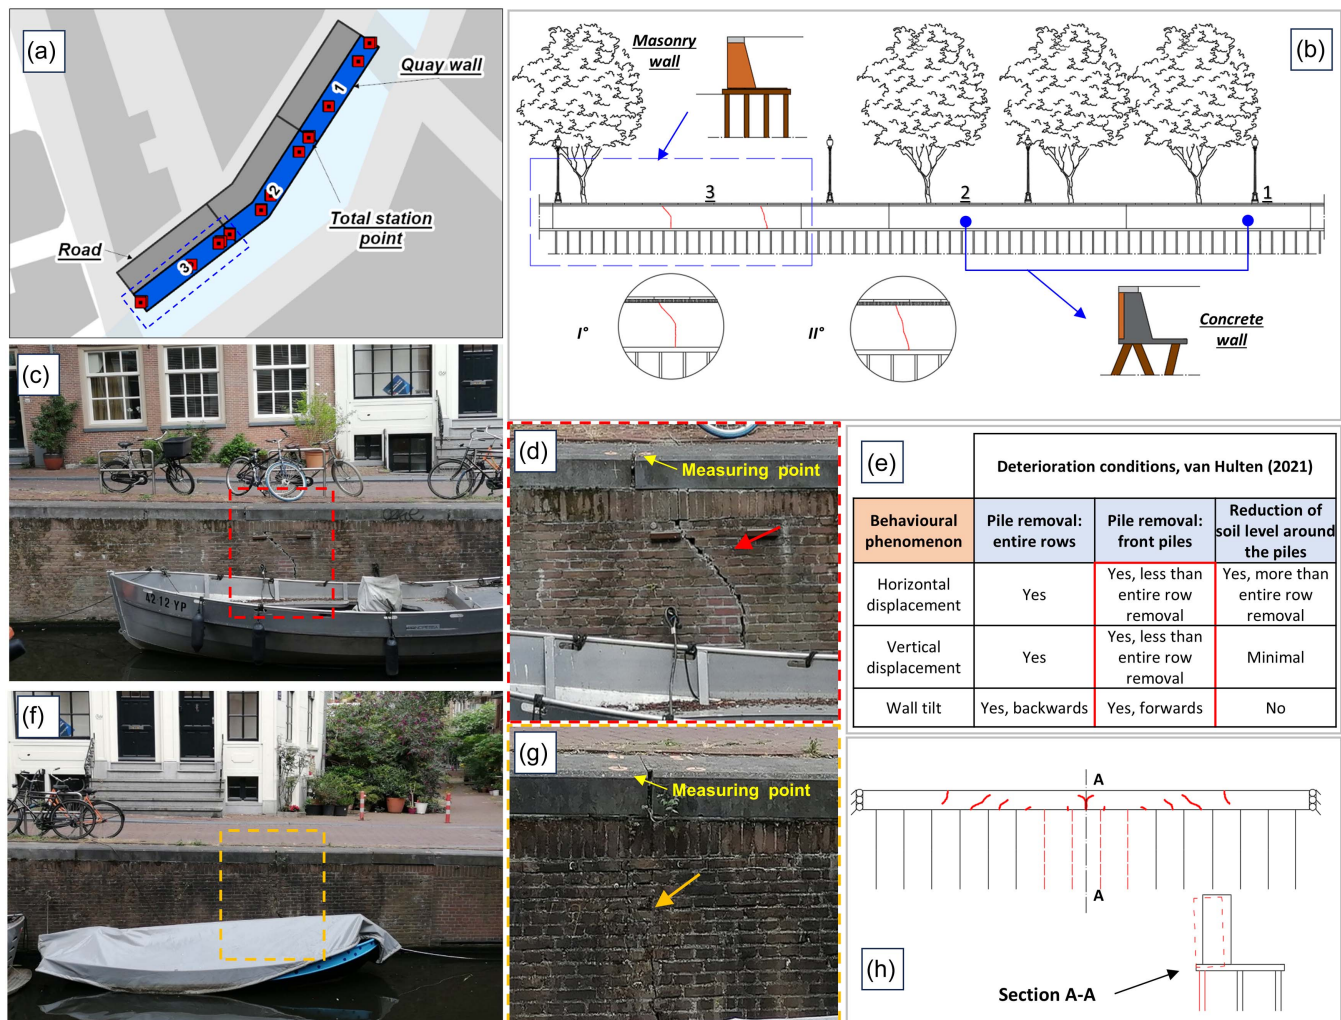
Fig. 14(a) shows the quay under analysis, divided into three structural blocks and the measuring points of the total stations. Through reports acquired in the AMS portal, it was possible to identify the structural typology of the blocks constituting the quay. Fig. 14(b) reports a front view of the quay with the blocks, their structural typology and the cracks on the façade. Particularly, the block 3 consists of a masonry wall and is affected by visible cracks; blocks 1 and 2, reconstructed during the early 2000s, consist of reinforced concrete walls with no cracks. Figs. 14(c, d, f, and g) show some photos of both the cracks found on the façade of block 3 [Fig. 14(b)] and the corresponding measuring points of the total stations. After analyzing the crack pattern, in particular of block 3, the analysis of the collapse mechanisms was deepened by using the results derived from FEA numerical modeling by Van Hulten (2021). Fig. 14(e) identifies the different deterioration conditions and the associated behaviors resulting from the FEA model. In particular,

In Fig. 14(h), the structural scheme with the corresponding cracking pattern deriving from the FEA model and the associated section A-A showing the effect of tilting of the quay wall toward the channel is shown. Importantly, this result agrees with the cumulative displacements along the  $z$  and  $y$  directions of the total stations available for three different heights as shown in Fig. 13. On this block diving inspection detected damage to the kespens and deterioration of timber piles; in this regard, cores for strength test have been taken.

**Fig. 14.** Example of crack pattern interpretation of damaged quay wall (KBS0301) using FEA model by Van Hulten (2021): (a) identification of KBS0301 quay wall; (b) front view of quay wall and front view of the quay wall with structural blocks, typology and crack pattern; (c, d, f, and g) photo of cracks derived by in situ surveys; (e) deterioration conditions deriving from FEA model; and (h) the structural scheme and the corresponding cracking pattern deriving from the FEA model with associated section A-A showing the effect of tilting.
