Root cause analysis of surface cracks in heavy steel plates during the hot rolling process

Root Cause Analysis of Surface Cracks in Heavy Steel Plates during the Hot Rolling Process

Abstract: This paper investigates the root cause of the formation of surface cracks on hot-rolled C–Mn constructional steel heavy plates. Cracks are rather evenly distributed over the surface in the form of colonies of cracks. Samples were cut from the heavy plate. The microstructure of samples in the as-cast and hot-rolled states were studied using optical and electron microscopes as well as energy dispersive X-ray spectroscopy (EDS). Results show that cracks are heavily oxidized. De-carburized areas are also seen alongside cracks. The crack tip is in the form of a deer-horn, indicating that crack branching has taken place during deformation. The crack initiation sites are V-shaped grooves on the surface of as-cast slabs. Correlations between microstructures, processing parameters, and crack formation are discussed.

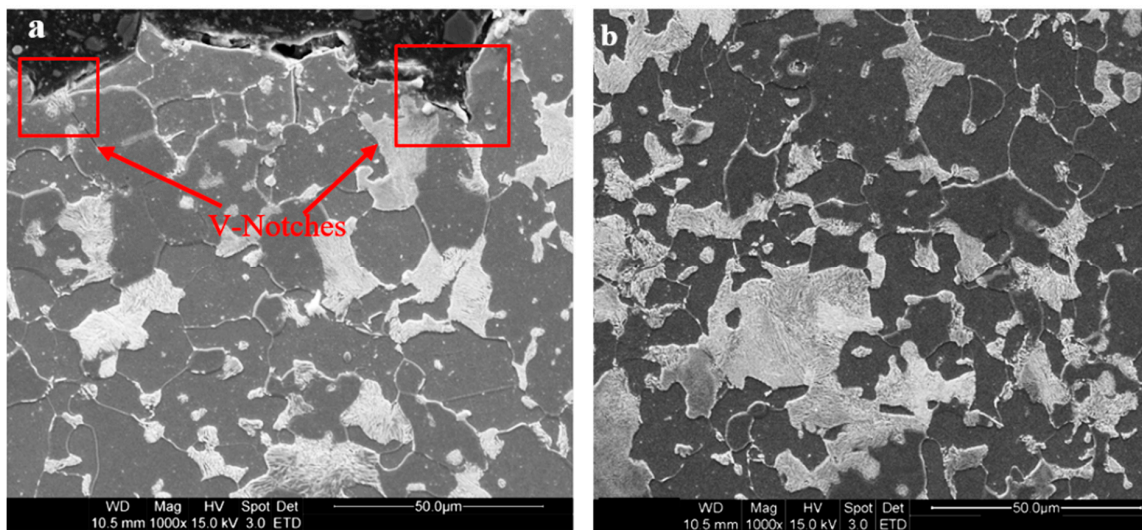
Figure 3 shows a SEM image of the typical ferritic–pearlitic microstructure of heavy plates in the bulk and surface of slabs (before hot rolling). There were not many inclusions found in the microstructure, inferring that the quality of the alloy in terms of secondary oxide/sulphide particles was overall very good. Typical features at the surface of the slab were surface V-notches, as marked in Figure 3a. These V-notches have depth in the order of a few tens of micro meters and are filled with surface oxide scales/phases. V-shaped grooves are possibly formed because of oscillation during the casting stage. Oscillation marks are a normal surface feature in continuously cast slabs. They periodically form at the meniscus because of mold oscillation. Yet, in case of improper control, the depth of these oscillation marks can increase to levels that they act as crack initiation sites [17,18].

Figure 3. Typical ferritic–pearlitic microstructure from (a) the surface and (b) the bulk of slabs.

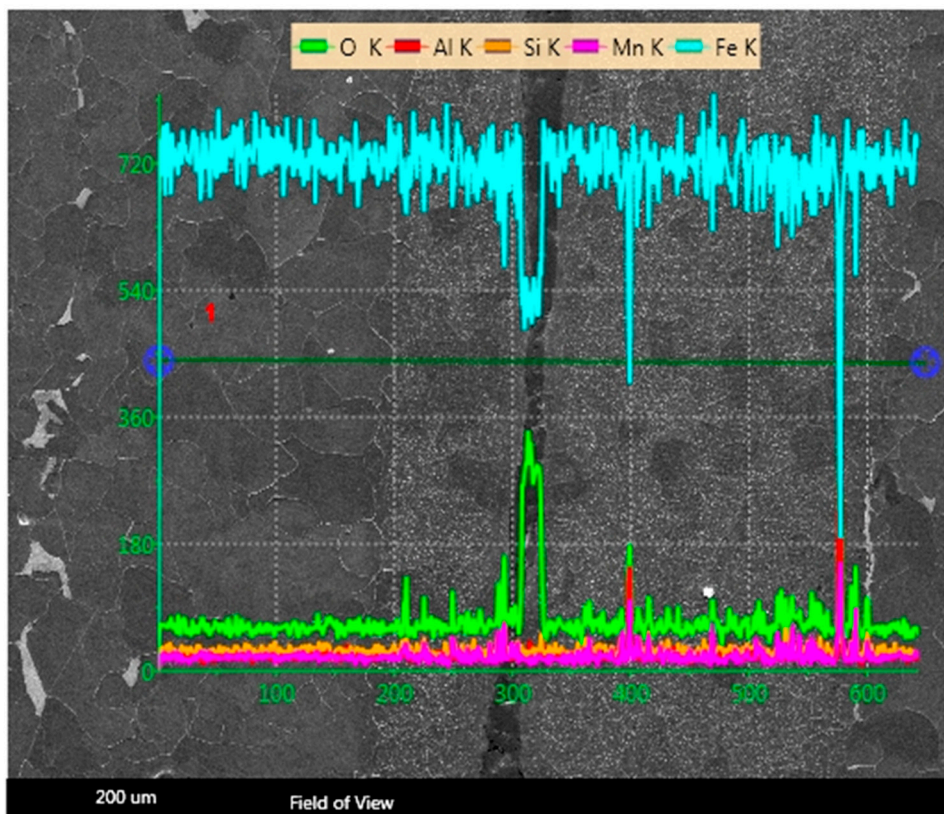
Figure 4 represents an elemental line scan on top of a crack. As can be seen in this figure, the concentration of oxygen at the crack is significantly higher than that in the vicinity of cracks, inferring that the crack is filled with an iron oxide phase.

Figure 4. Elemental line scan on top of a crack at the surface of the heavy plate.

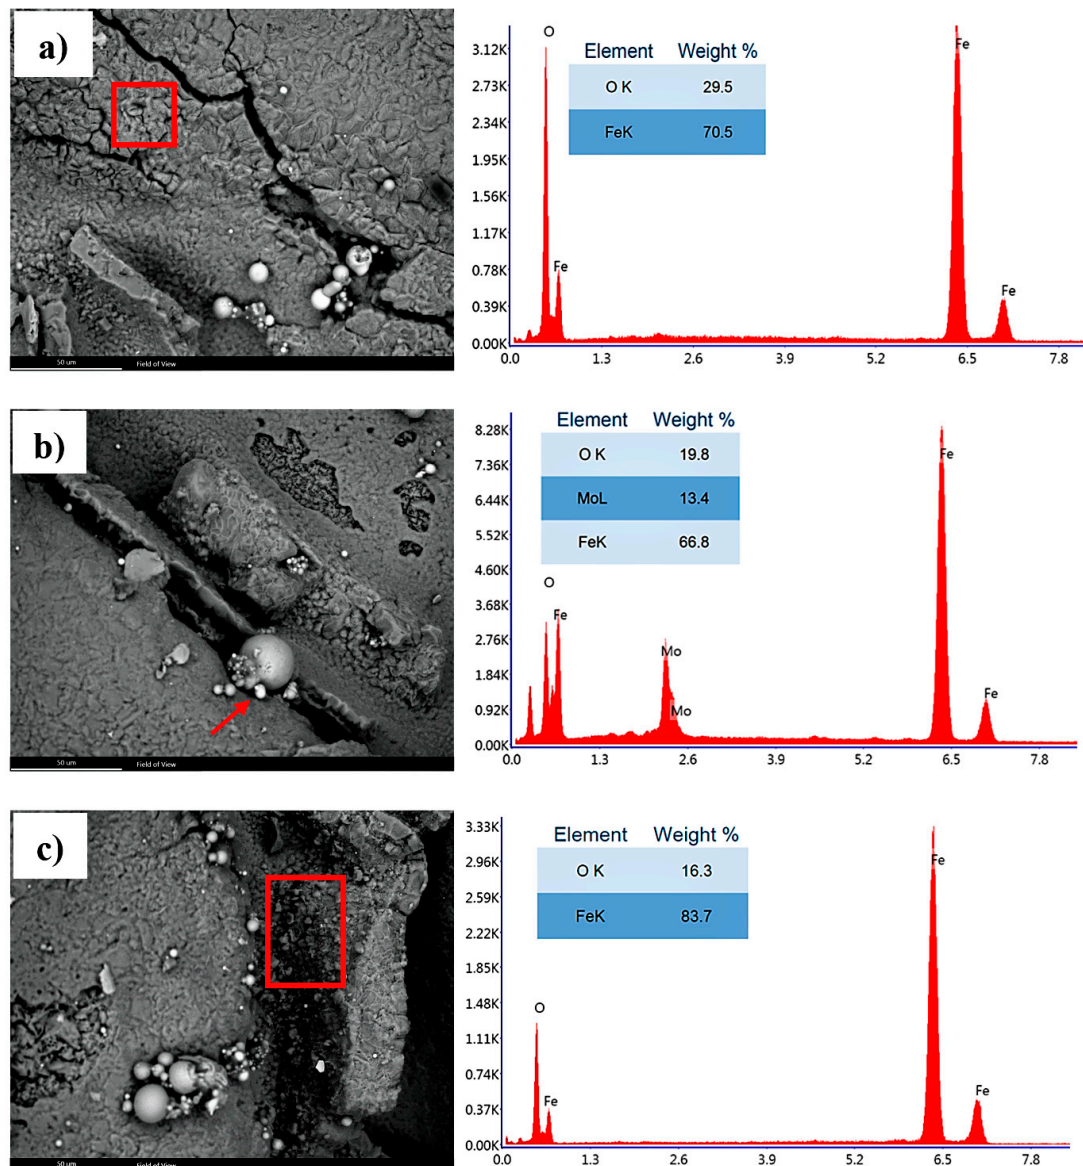
Figure 5 shows SEM images of a crack at the surface. It appears that the crack is formed due to the breakage of the oxide layer on the surface. Some rounded particles are also observed inside cracks and in areas in the vicinity of the cracks with their sizes ranging from a few microns up to 30 microns. Three different features were analyzed using EDS, i.e., the surface, as shown in Figure 5a, rounded

white particles, as shown in Figure 5b, and small particles inside cracks, as shown in Figure 5c. Results of EDS analyses indicate that rounded particles are either iron oxide particles or molybdenum-rich particles. Small molybdenum-rich particles are only in small percentages of rounded particles inside cracks. Most particles inside cracks are iron oxide particles. Given that the starting material is not expected to contain any molybdenum, and as molybdenum is not added to the melt, the only option left for the origin of these molybdenum-rich particles must be residues from the processing.

Figure 5. SEM images and energy dispersive X-ray spectroscopy (EDS) analysis of cracks on the surface of a hot-rolled heavy plate. The highlighted spot is analyzed by EDS. (a) Surface area surrounding crack, (b) rounded white particles, and (c) small particles inside cracks.

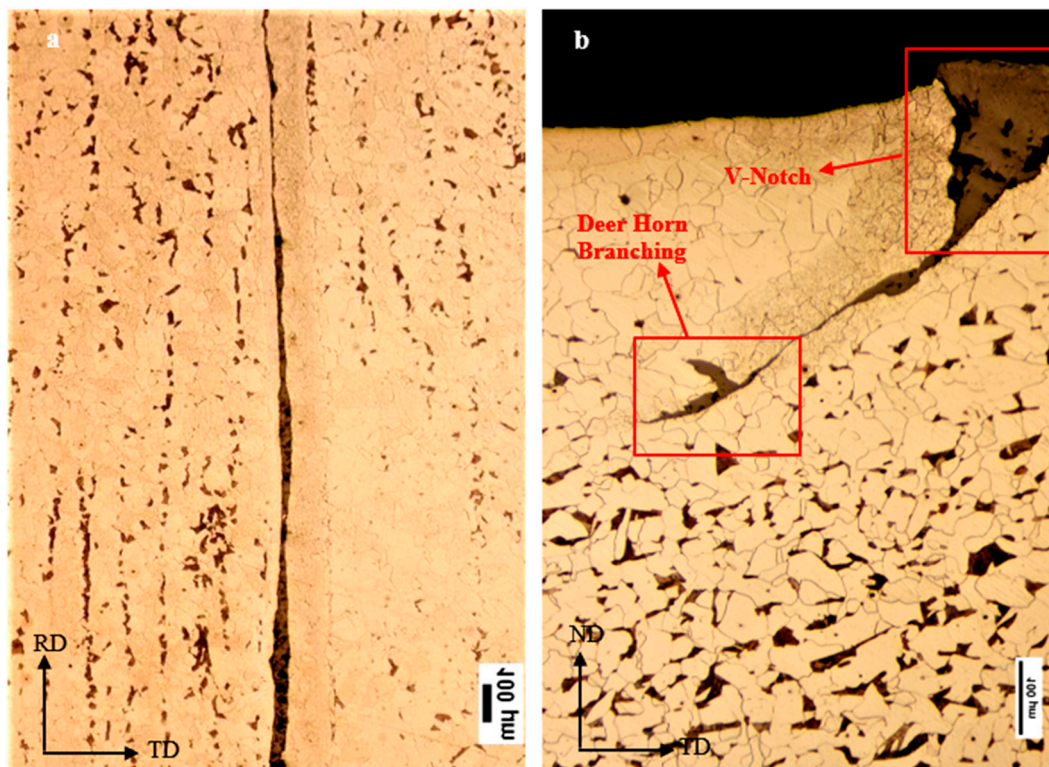
Figure 6 reveals optical microscope images of the microstructure around the crack. There are several features worth mentioning. First of all, the crack is completely filled with an iron oxide phase. The presence of this oxidizing environment inside the crack results in de-carburization in the vicinity of cracks, in such a way that there is a band of fully de-carburized ferritic microstructure alongside the crack. The microstructure of the steel away from the crack is ferritic–pearlitic as commonly observed in plain carbon steel plates. Other than this de-carburized layer, there is no other

microstructural abnormality, like excessive grain coarsening or deformed/elongated grains in either side of the surface crack.

Figure 6. Optical microscope images of cracks (a) from the top and (b) perpendicular to the crack.

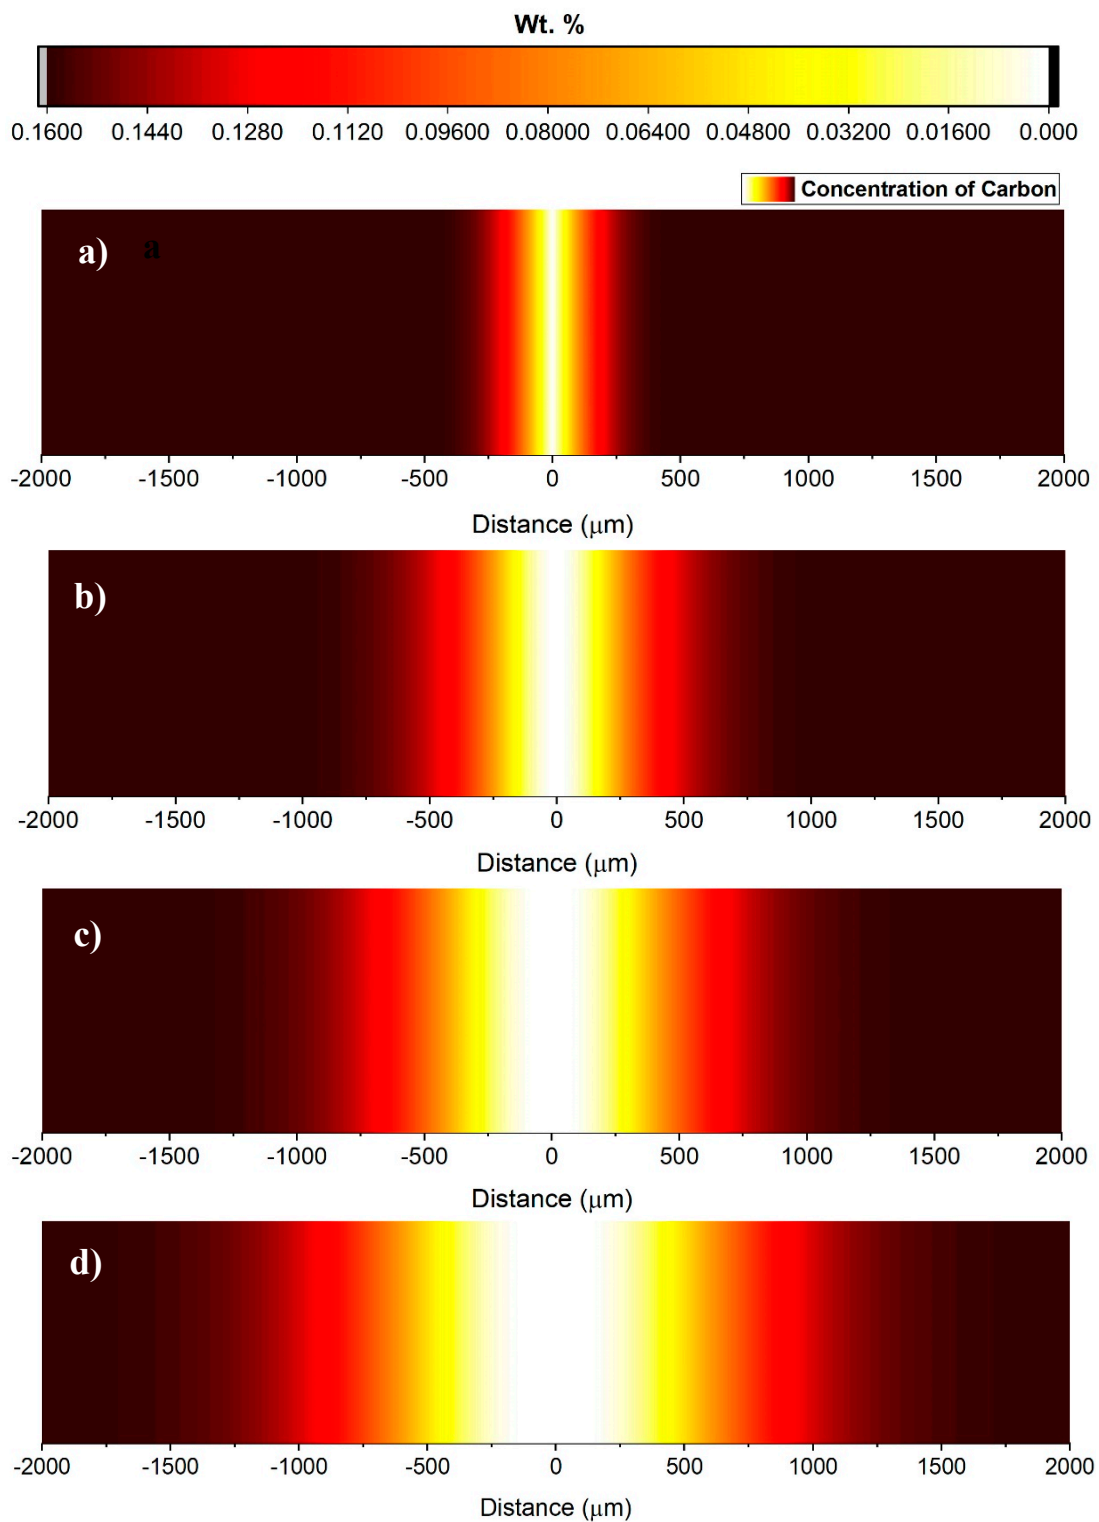
where $D_0 = 2.3 \times 10^{-5} \text{ m}^2/\text{s}$, $Q = 148 \text{ kJ/mol}$, and $R = 8.314 \text{ J/mol}\cdot\text{K}$ [20]. An average value of $1100 \text{ }^\circ\text{C}$ was assumed for the rolling temperature. Figure 7 shows the contour of carbon diffusion across the crack. Results show that after 16 passes carbon is heavily depleted in approximately $300\text{--}400 \text{ }\mu\text{m}$ distance from the crack. It is also seen that with increasing pass numbers, the depletion layer gets wider. According to Fe-C diagram, pearlite is not expected to form in carbon content less than $0.008 \text{ wt. } \%$. Results of this calculation is very well in accordance with the experimental results.

Figure 7. Contour of carbon diffusion in and around areas of a crack (a) after 1 pass of hot rolling, (b) after 5 passes, (c) after 10 passes, and (d) after 16 passes.

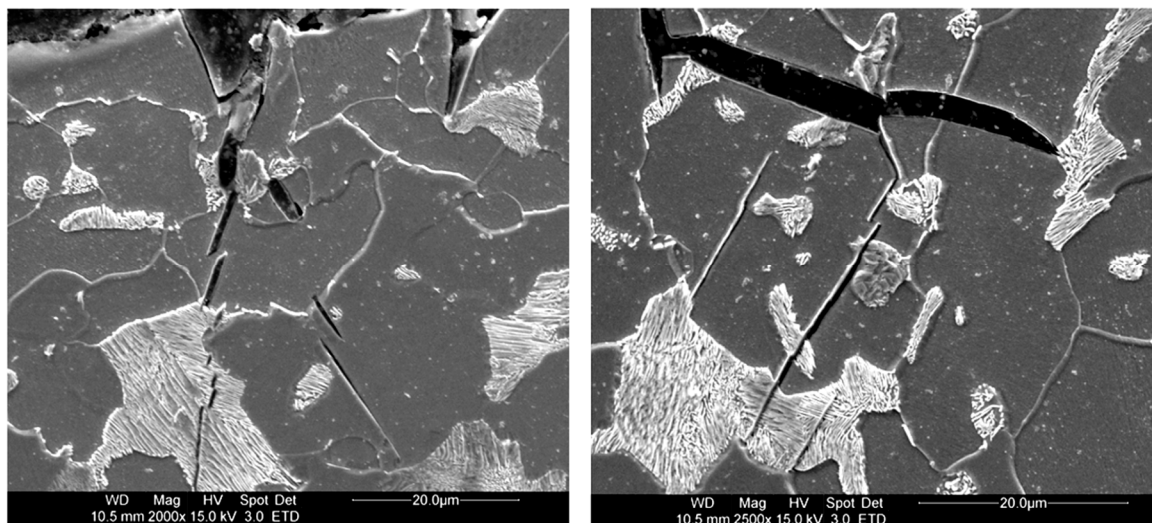
Observed cracks in most cases consist of two distinctive features; firstly, cracks are all nucleated on V-notches. The other characteristic feature is that cracks end up in a deer-horn-type branching at the end. This kind of crack branching is reported to be due to the deformation during hot rolling [8].

Figure 8 shows other examples of deer-horn crack end branching. It appears that surface cracks are initiated at the tip of V-grooves and are propagated during differential loading. The crack propagation

path is initially straight in the sense it does not seem that crack is following the grain boundary path. The last stages of rolling are associated with crack branching. The cracks must have developed in the initial rolling stages and branched during the subsequent rolling passes. There are many influencing factors that might result in surface cracking on hot-rolled steel heavy plates [10]. Defects of the surface are due to different reasons, but generally they are confined into two main categories: (1) primary defects existed on continuous casting process slabs which propagate or are inherited from defects generated by rolling processes and are originated from upstream rolling processes defects and (2) also these defects can occur because of incorrect rolling technologies and foreign bodies were unevenly rolled in the interface of the strip rolled [6]. In this case the origin of cracks is certainly V-notches. Any mitigation strategy needs to address this problem by trying to eliminate these V-grooves at the surface. Surface notch V-grooves have a very sharp end which obviously is a place where stress intensity goes up and this in turn results in the crack initiation and propagation.

Figure 8. Examples of crack ends branching.

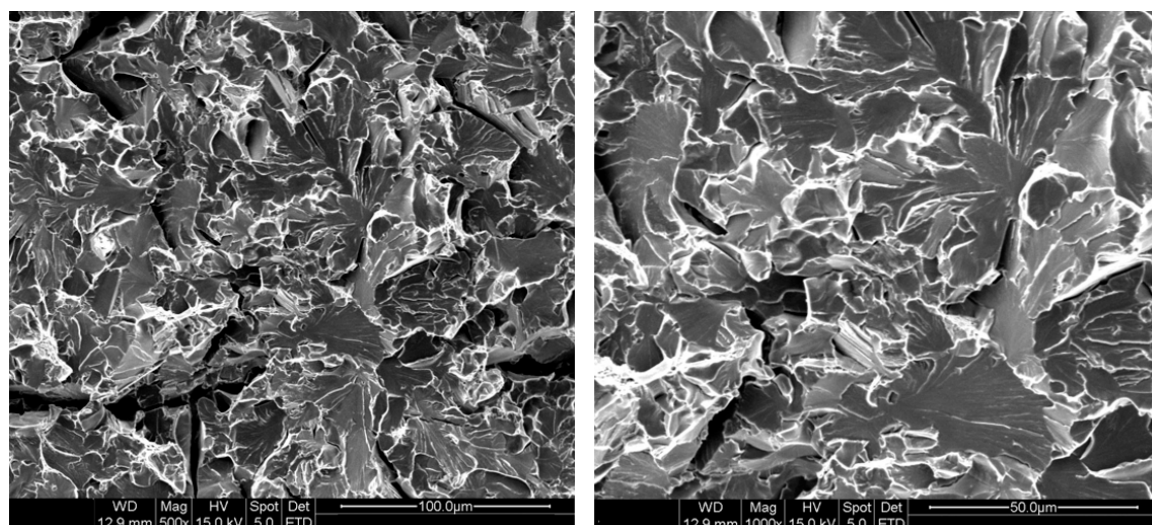
Figure 9 shows the fracture surface of the sample, taken from the surface of heavy plates, containing cracks. The fracture is typically transgranular in nature. As well, one can see de-cohesions and discontinuities at the fracture surface, which are due to the presence of surface cracks in the sample.

Figure 9. Examples of the fracture surface of the sample, containing surface cracks.
