## Some learning cases in the Port of Rotterdam

J G de Gijt<sup>\*1,2</sup>, H E Brassinga<sup>2</sup> and A A Roubos<sup>1,3</sup>

**Abstract.** This paper present several cases in the Port of Rotterdam where both in the design and construction phase several different did not marched as expected. These cases are interesting for both the design as well the construction phase of a project. People will make mistakes however the mistakes describes in this paper have to be judged in time as not always everything was understood during the design and construction and the people of that time still these huge structures.

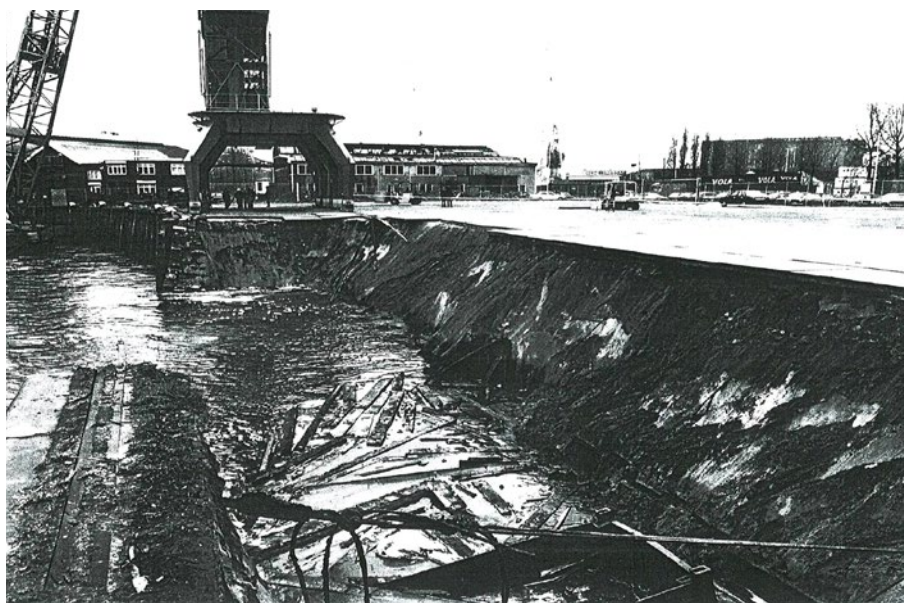
2” Katendrechtse haven ± 1980

**Figure 4.** Failed quay wall Katendrecht.

This quay wall, built in 1938 and consists of a foundation of wooden piles while the underwater slope was stabilized with fascine mattresses[7]. This quay wall failed in 1990 due to increased scour by propeller loads from the containerships and lack of inspection. The quay wall collapsed over a length of 100m. The design in 1938 was a proper design, however the scour effect of the ships propellers was underestimated. This caused the failure of the quay walls after 50 years.

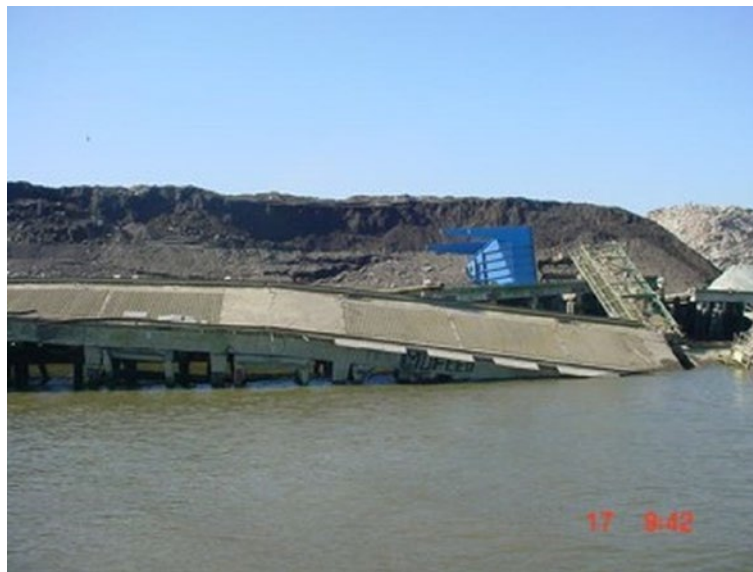
The jetty, figure 5, failed due to overloading. The acceptable loads were 20 kN/m<sup>2</sup>, however the jetty was loaded up to 80 kN/m<sup>2</sup>. This high load and the combination of bad soil conditions lead to this failure.

**Figure 5.** Failed jetty.

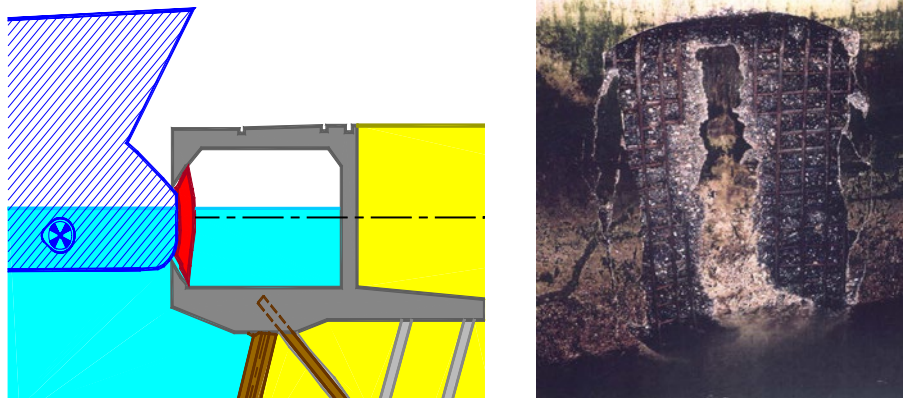
**Figure 7.** Damaged quay wall and impression of the damage of front of quay wall.

The ECT terminal on the Maasvlakte consists of a quay wall with a box structure founded on a comb wall and prefab concrete piles [7]. In 1992 a ship could not stop in time so the bulbous bow severely damaged the front wall. After inspection it was shown that only the front wall was displaced over ca 0,7 m. Due to the MV-piles the damage was limited to the front wall only. The rest of the structure remained intact.

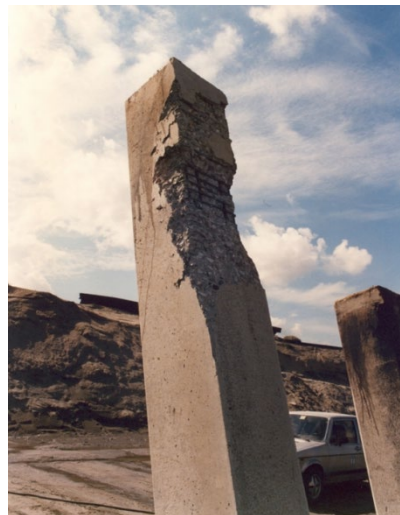
**Figure 9.** Pile damage.

Within structural design the foundation was first designed as mat foundation and later by wooden piles [7]. The wooden piles were replaced by prefab concrete piles and they are still used. However, on the Maasvlakte in 1990 severe damage was observed with prefab concrete piles both at the head the pile as well as at the tip. This damage was caused by heavy driving in very dense sand layers. Since then that vibro piles are mostly used in Rotterdam and recently even steel tubex piles are used to prevent damage a the pile tip.

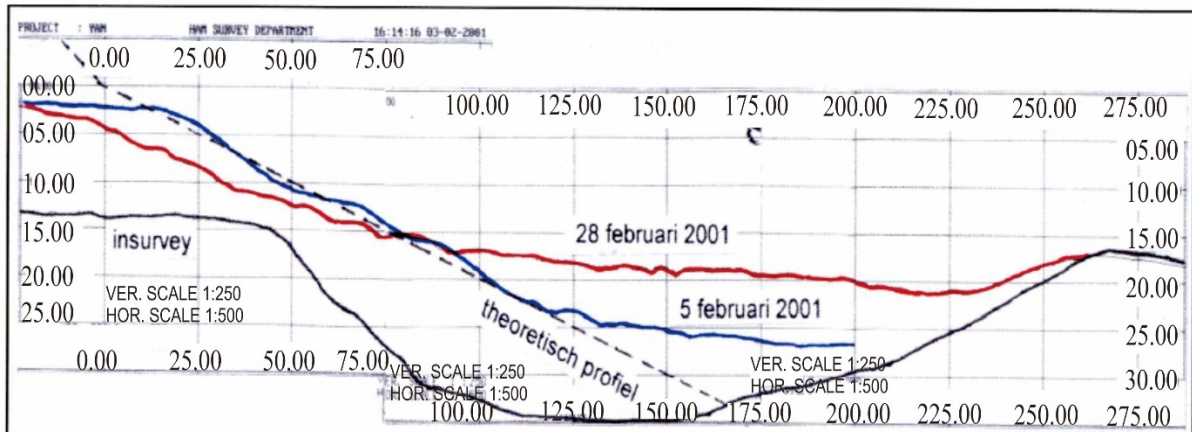
During the reclamation of the central area of Maasvlakte 1 by the method of hydraulic filling, the boundary dam, a bund of mine stone, failed [7]. This failure was initiated by the high speed of reclamation and an overlap which was too little within the mine tailing dam structure. In figure 11, it can be observed how the extent of the flow was developed.

**Figure 11.** Bund construction and failed slopes.

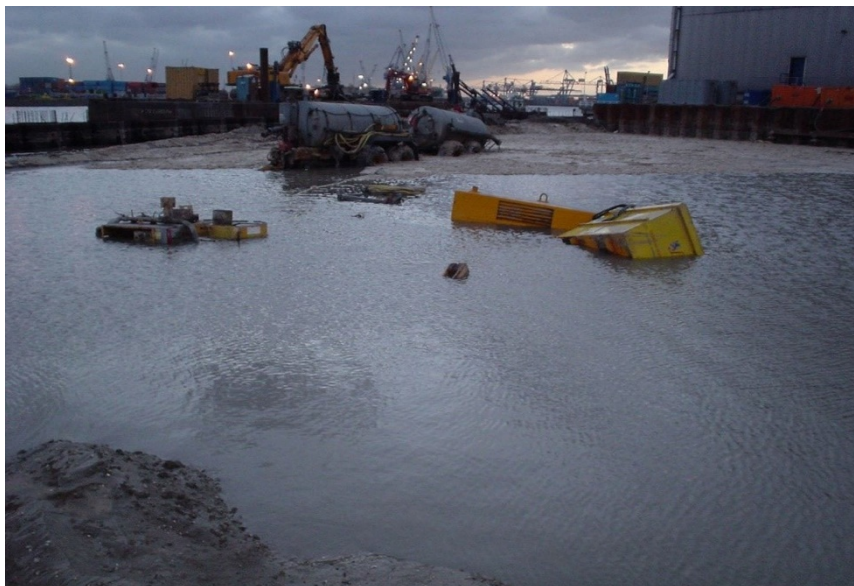
**Figure 12.** Flooded excavation.

This figure 12 shows a construction pit flooded due to high water at the riverside [7]. The contractor was warned and advised to construct a protecting wall at a higher level as in winter and springtime high water can be expected. However the contractor took the risk not to take these precautions and the result was a flooded construction pit and a lot of damage.

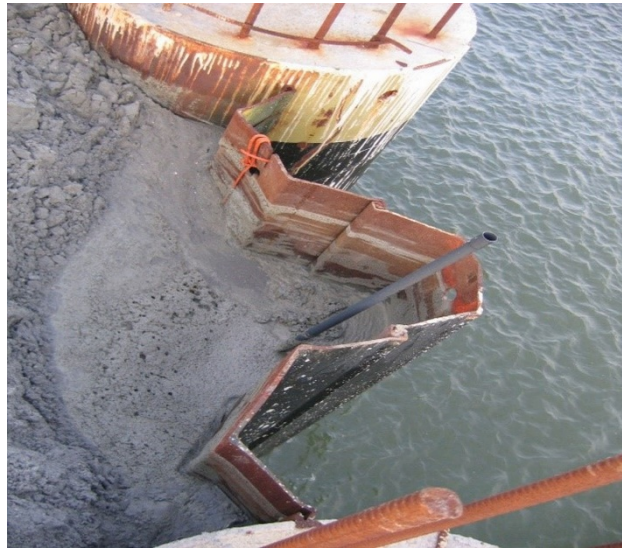
**Figure 13.** Failure due hydraulic fill behind quay wall.

The wall as shown in figure deformed too much due to high hydraulic loads during the construction period [7]. Thus due to time constraints the area at land side must be filled up. The sheet pile elements should be designed to make that possible.

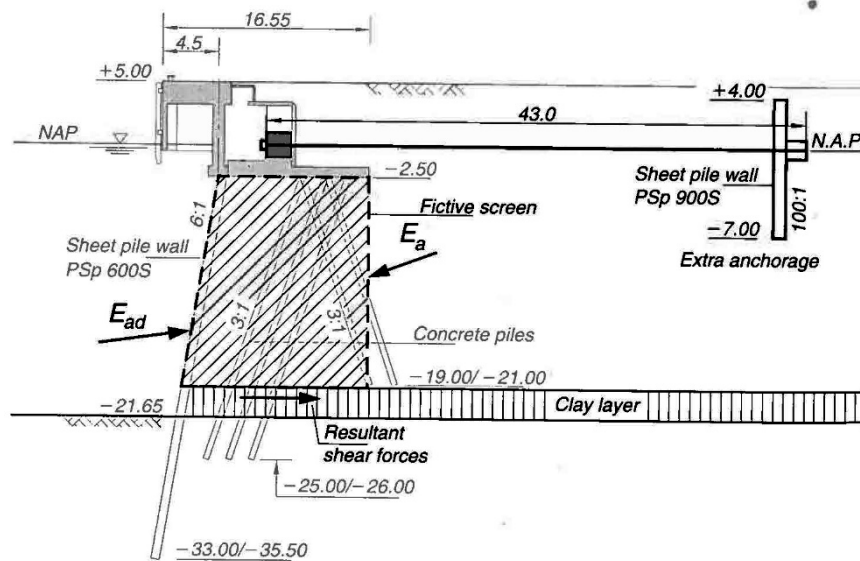
**Figure 18.** Quay wall with relieving floor.

The figure 18 shows the same structure. However, the concrete piles at the back site should have been driven deeper. As this was not realized due the very dense sand layer the structure showed too much deformation as well. It had to be anchored too with a horizontal anchor screen.

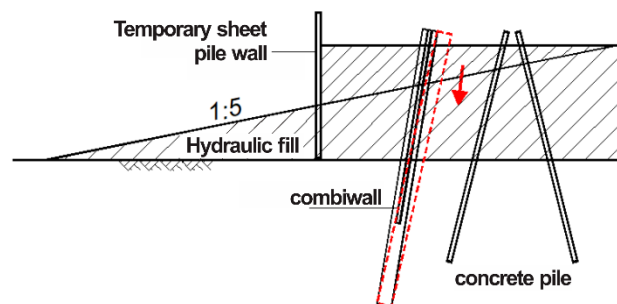
**Figure 20.** Deformation combi wall due to severe densification.

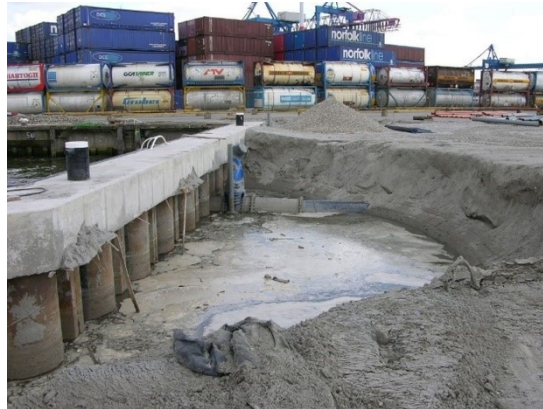
**Figure 21.** Hole due interlock opening in combi wall.
