Collapse of the Grimborgwal, a historic quay in Amsterdam, the Netherlands

Research Article

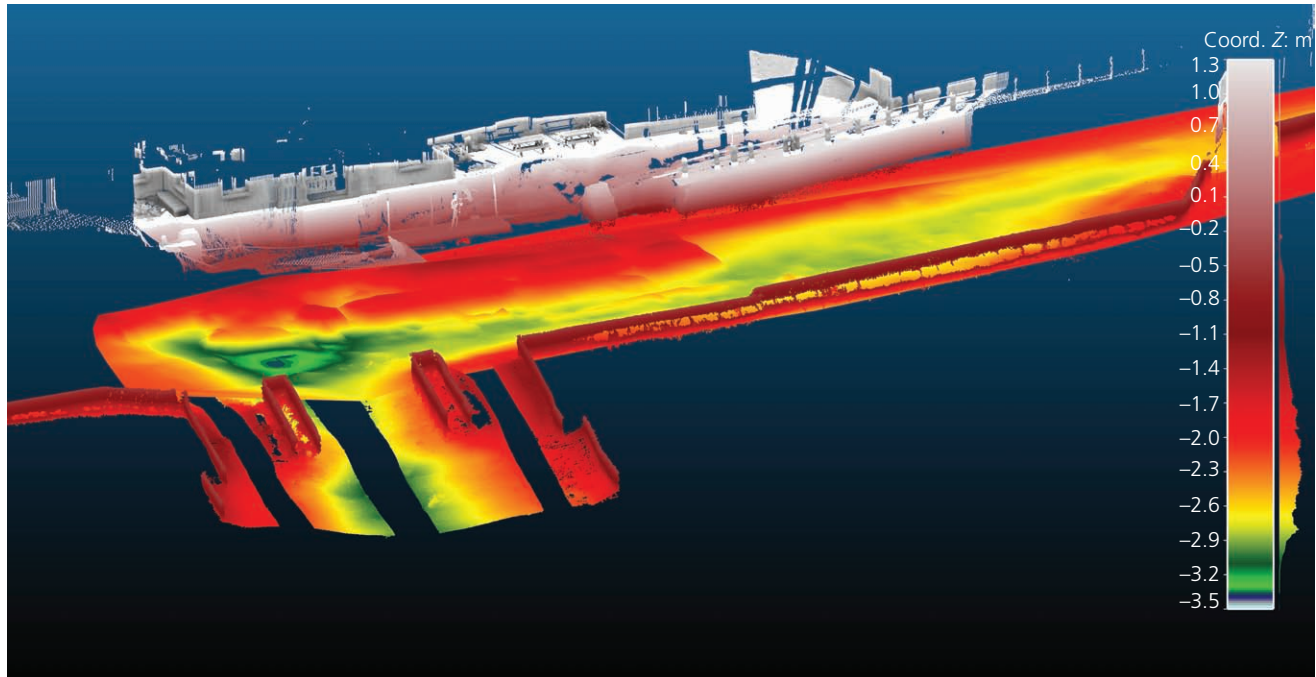
Figure 4. Visualisation of the multibeam and three-dimensional scan made after collapse of the quay by Van Gellecum (2021). The colour red refers to shallow bed levels, showing debris in canal and quays and bridge foundations opposite of collapsed stretch, and colours green to blue refer to the deepest canal bed level (NAP -3.25 m and locally to NAP -3.5 m)

The cause of the deeper canal bed is likely related to the fact that the canal is very narrow at this location and exactly at this spot the four boats turn sharply under a bridge. It has been

observed that the depth of the canal increases in the direction of the bridge and then decreases again. The repeated collisions of the tour boats have weakened the quay. Ship traffic was a cause of masonry damage, which caused a precondition with less ability to distribute loads along the quay. The trigger for the collapse was believed to be the renewal of the pavement in May and August 2020. This repaving was necessary as a result of the deformation of the quay that occurred before. The effects of this repavement were clearly recognisable in the satellite measurements that show an increased settlement rate over time during repaving. Groundwater flow and drought/rain may also have played a role in accelerating the failure in combination with the horizontal quay deformation that had already occurred and the leakage path from behind the quay towards the canal for the formation of holes in the pavement as shown in Figure 1.

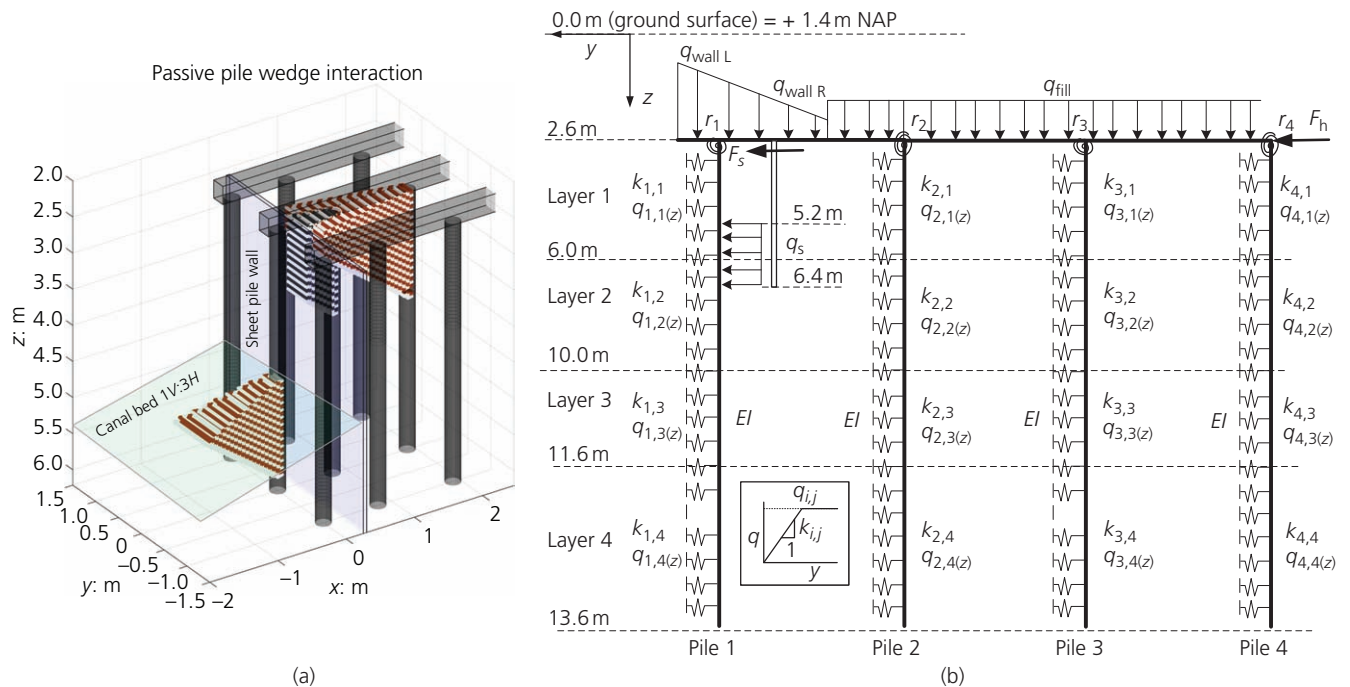
Figure 10. (a) Three-dimensional passive wedge model for computing the plastic limit of p - y springs with nine piles and three cross-beams shown as well as the sheet pile wall behind the front pile row and the canal bed; (b) structural model showing in cross-section the schematised springs resisting and loads acting on the piles and the cross-beam
